Revised Final Plan
Attachment 9.12

Structures & Operational Sites - Working at Heights - Appendix B

August 2025

**Dampier Bunbury
Pipeline**

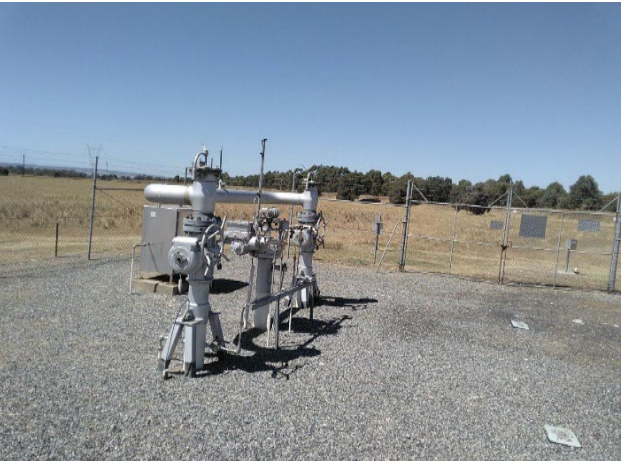
MLV153-1	5/03/2024	MLV153 - All Areas	1) Access to Risers and Vents ~2000mm for maintenance tasks currently completed using a platform ladder on blue metal. This creates the potential for the ladder to be unstable and cause a fall from height. 2) Cable markers / inspection pits pose a trip hazard. 3) Spare piping is being stored onsite, near the roadside fencing.	C. Unlikely	3. Severe	Medium	1) Option A: Install concrete landing for platform ladder to be set up on. Option B: Install a purpose built platform and access stairs or ladder that is AS compliant. 2) Relocate, accommodation into above works or build up blue metal to eliminate the trip hazard. 3) Consider removing pipework that is not being used and stored onsite near the roadside fencing.

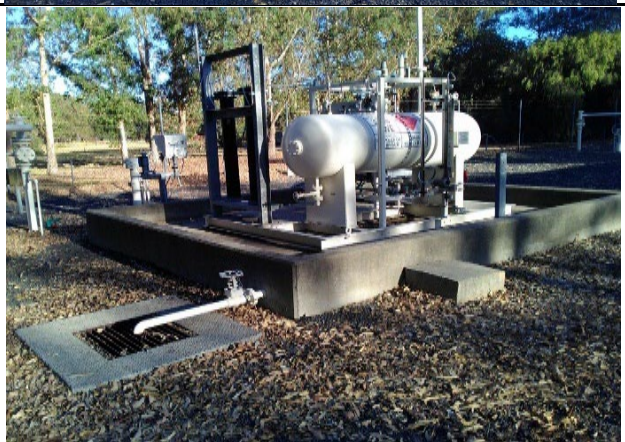
MLV156 / MLV157-2	1/03/2024	MLV156 / MLV157 - Mercaptan Tank and Bund	1.1) Steps provided on two sides of the bunds are loose and can move under your feet and do not meet the sizing requirements in AS1657. 1.2) Step up from the ground, to hop over the bund is 450mm which requires 1-2 stairs (if 2 handrails too) to provide safe access in line with AS1657. 2) Small piping poses a trip hazard if walking around the bund.	C. Unlikely	2. Minor	Low	1) Remove the temporary stairs and provide permanent access stairs that comply with AS1657. 2) Install a hop over or paint the pipes yellow so they stand out. 3) Consider installing hi vis (yellow) anti slip tread on the nosing of the platform where access will access.

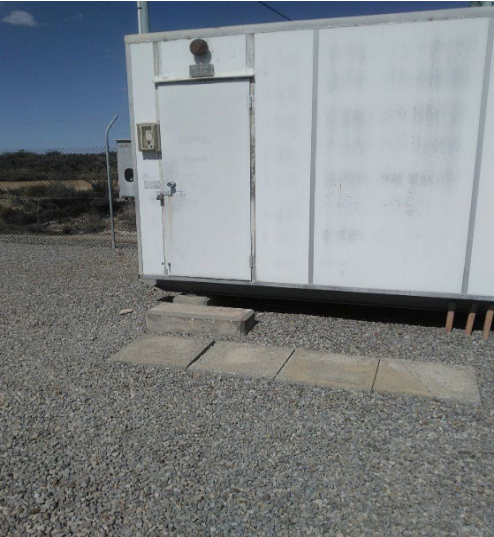
MLV095-3	6/02/2024	MLV095 and Eneabba Meter Station - Pav Hut	1) The landing for the stairs does not meet AS1657 requirements of 900mm. 2) Stair riser exceeds AS1657 requirement of 130-225mm (actual 300mmm). 3) No hi vis (yellow) tread installed onto the nosing of each stair.	C. Unlikely	2. Minor	Low	1) Pour a new landing. 2) Replace stair with AS1657 compliant stairs. 3) Install hi vis (yellow) tread onto the nosing of each stair.

23/04/2024 Raised with Robert Van Der Wilk and requested the recommended actions are incorporated into the Eneabba Meter Station Re-Lifing Project, during the Design Review Meeting. 05/06/2024 Robert has requested this item to be covered by Paul Reilly's W@H Improvement Project.
MLV095-4	6/02/2024	MLV095 and Eneabba Meter Station - Metering Skid	1) No non-slip tread on the edge of skid and nosing of stairs. 2) Requirement for handrail and stair risers in AS1657 not met. 3) Landing does not meet the AS1657 requirements and is currently blue metal.	C. Unlikely	2. Minor	Low	1) Install hi vis (yellow) non-slip tread installed on the edge of the skid and nosing of all stairs. 2) Replace stairs and install handrail that meets AS1657 requirements. 3) Pour a landing that meets AS requirements.

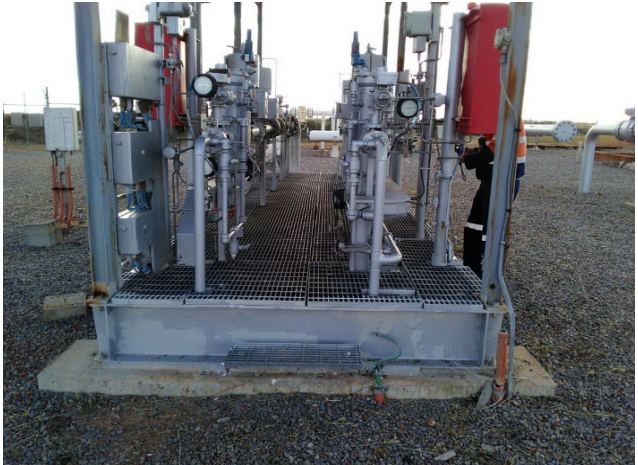
Reference	Date Added	Site	Issue	Likelihood	Consequence	Risk Score	Suggestions	Evidence	Date Planned For Completion	Date Completed	Comments
MLV091-1	2/10/2023	MLV091 Nangetty Road Meter Station - Multiple Risers	1) Access to Risers and Vents for maintenance tasks currently completed using a platform ladder on blue metal. This creates the potential for the ladder to be unstable and cause a fall from height.	C. Unlikely	3. Severe	Medium	1) Option A: Install concrete landing for platform ladder to be set up on. Option B: Install a purpose built platform and access stairs or ladder that is AS compliant.	 			
MLV091-2	2/10/2023	MLV091 Nangetty Road Meter Station - Metering Skid	1) No non-slip tread on the edge of skid and nosing of stairs. 2) Landing does not meet the AS requirements and is currently blue metal.	C. Unlikely	2. Minor	Low	1) Install hi vis (yellow) non-slip tread installed on the edge of the skid and nosing of all stairs. 2) Pour a landing that meets AS requirements.

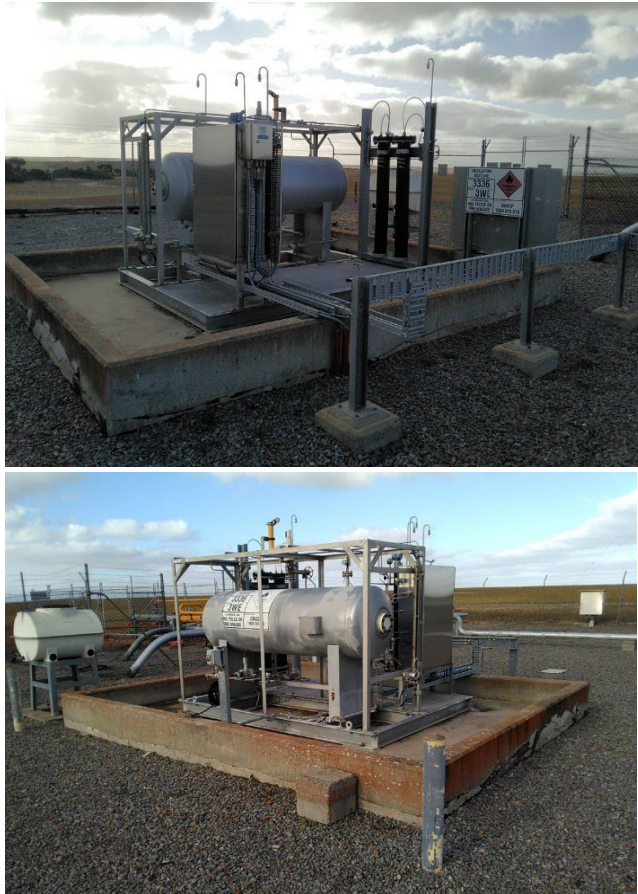
MLV091-3	2/10/2023	MLV091 Nangetty Road Meter Station - Mercaptan Skid and Bund	1) No access stairs for personnel to use to enter / exit bund (height 400mm). Small concrete block sighted that may be used as a step.	D. Occasional	2. Minor	Medium	1.1) Install access stairs on two sides of the bund. If 2 or more steps are in place, then handrails are required. 1.2) Install hi vis (yellow) non-slip strip on the nosing of each stair. 1.3) Pour a landing for each access stairs, that meet AS requirements.

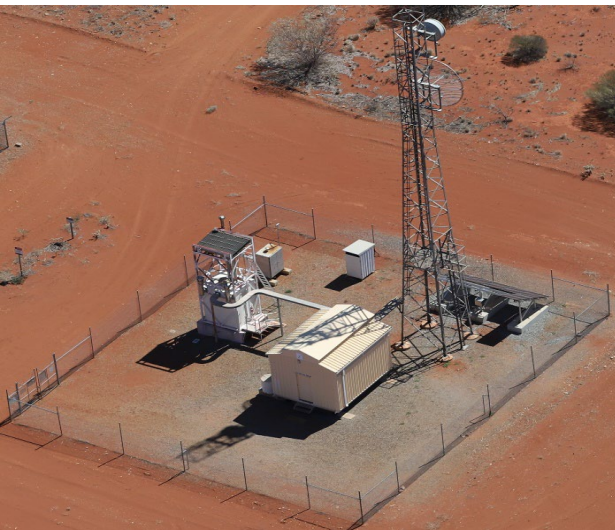
Spur 5 - 2	22/04/2024	Spur 5 - TEG	1) No hi vis (yellow) anti-slip tread installed on the nosing of the stairs. 2) No handrails are installed and therefore the AS requirement (2 or more stairs) is not being met. Note: Non-compliance identified but not action is recommended as minimal risk of a fall from height and low usage. Assessed using surveillance photo. Additional photos requested to confirm accuracy of assessment.	B. Remote	2. Minor	Low	1) Ensure hi vis (yellow) anti-slip tread is installed on the nosing of all stairs (width top step 870mm, bottom step 770mm). 2) No action required.

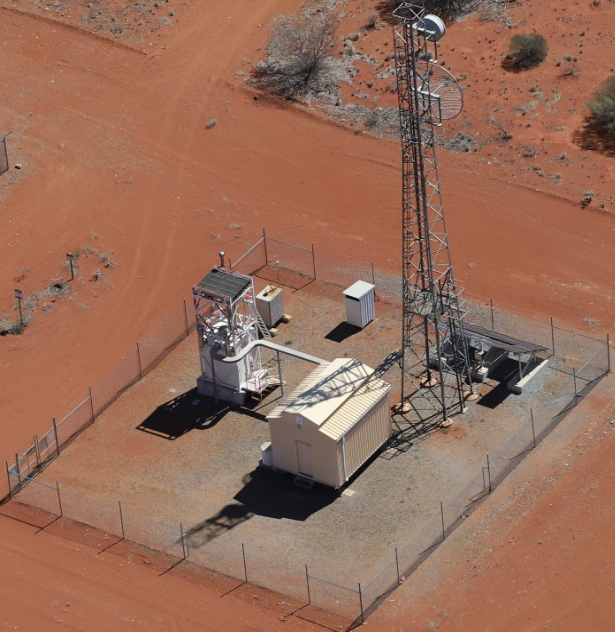
Spur 5 - 3	22/04/2024	Spur 5 - Tower	1) Unlike some other Repeater Stations, the ladder at this location can be access from ground level. No gate or means of accessing the ladder on a platform at height to prevent unauthorised access, has been implemented. 2) No fall restraint/arrest system in place for personnel using the ladder. This exposes personnel to a significant fall that would likely result in a fatality or serious injury. 3) The width of the ladder appears it does not meet the AS requirements (375mm to 525mm) and may create a hazard to personnel using the ladder. 4) No hi vis (yellow) anti-slip tread installed on the ladder rungs. They are currently smooth metal rungs. Note: Assessed using surveillance photo. Additional photos requested to confirm	C. Unlikely	4. Major	High	1) Consider installing a lockable gate or similar and signage is provided to prevent unauthorised access. 2) Install a certified fall restraint/arrest system that is suitable for the end users. 3) Replace the ladder with a AS compliant ladder. 4) Install hi vis (yellow) anti-slip tread on the ladder rungs.

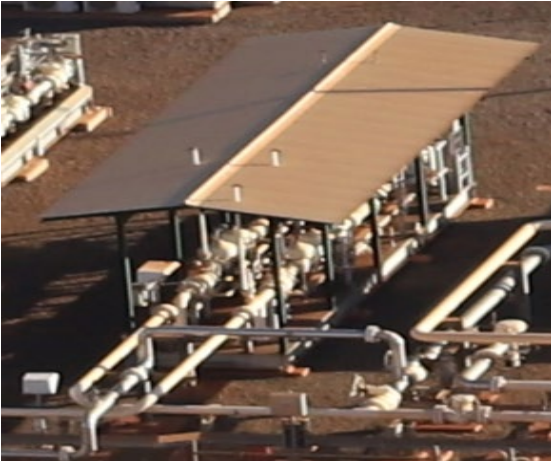
Solomon Meter Station - 4	8/04/2024	Metering Skid	<p>1) Has blue metal as the landing surface.</p> <p>2.1) Step up from ground level to the first stair appears to exceeds AS1657 requirements (300-450mm requires a step).</p> <p>2.2) The stair riser appears exceeds the AS1657 requirements (130-225mm).</p> <p>3) No hi vis (yellow) tread installed onto the nosing of each stair.</p>	C. Unlikely	2. Minor	Low	<p>1) Pour a landing to meet AS requirements.</p> <p>2) Verify step up and riser of stairs and if require, replace the stairs with AS1657 compliant stairs. If 2 or more stairs are required, then handrails must be installed.</p> <p>3) Install hi vis (yellow) tread onto the nosing of each stair.</p>

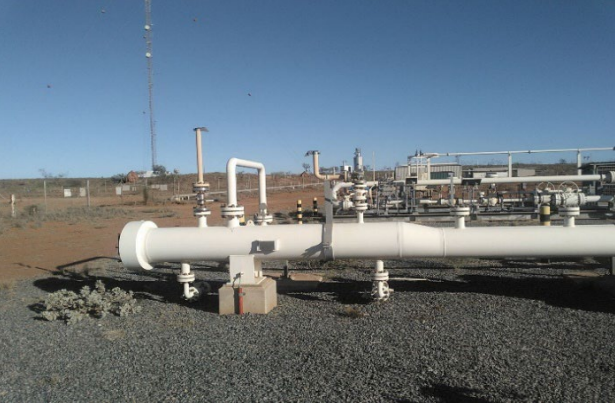
Ashburton West Facility - 1	27/03/2024	All Areas	1) Access to Risers and Vents for maintenance tasks currently completed using a platform ladder on blue metal. This creates the potential for the ladder to be unstable and cause a fall from height.	C. Unlikely	3. Severe	Medium	1) Option A: Install concrete landing for platform ladder to be set up on. Option B: Install a purpose built platform and access stairs or ladder that is AS compliant.

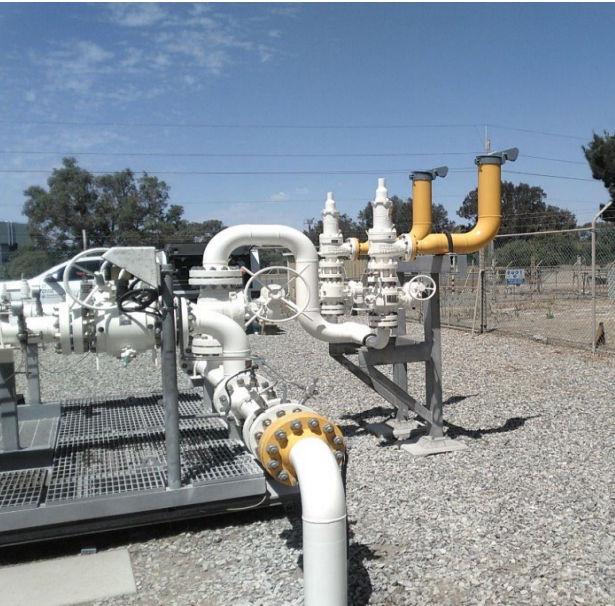
Kwinana Nickel Refinery - 3	5/03/2024	Kwinana Nickel Refinery (KNR) - Risers / Vents adjacent to Metering / Pressure Control Skid	1) Access to Risers and Vents ~1500mm for maintenance tasks currently completed using a platform ladder on blue metal. This creates the potential for the ladder to be unstable and cause a fall from height.	C. Unlikely	3. Severe	Medium	1) Option A: Install concrete landing for platform ladder to be set up on. Option B: Install a purpose built platform and access stairs or ladder that is AS compliant.

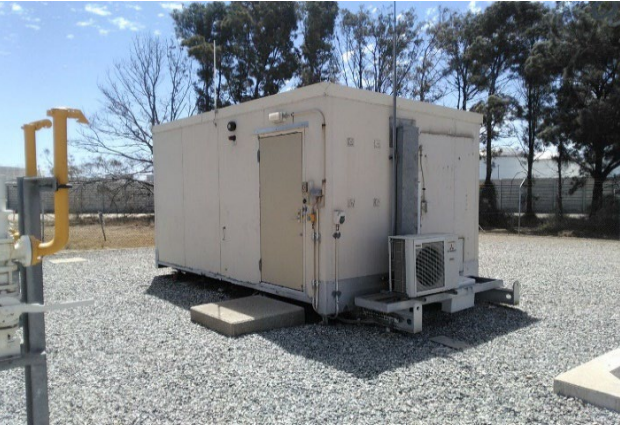
Wagerup West - 1	5/03/2024	All Areas	<p>1) Access to Risers and Vents ~2000mm for maintenance tasks currently completed using a platform ladder on blue metal. This creates the potential for the ladder to be unstable and cause a fall from height.</p>	C. Unlikely	3. Severe	Medium	<p>1) Option A: Install concrete landing for platform ladder to be set up on.</p> <p>Option B: Install a purpose built platform and access stairs or ladder that is AS compliant.</p>

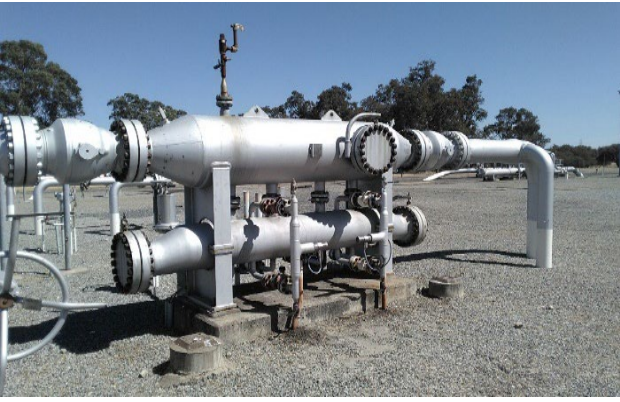
Wagerup West - 2	5/03/2024	Redundant Equipment / Pipes Onsite	<p>1) Redundant equipment and concrete footings found in two areas of site.</p> <p>2) Spare piping is being stored onsite, near the roadside fencing. Potential theft risk?</p>	B. Remote	2. Minor	Low	<p>1) Consider removal of redundant equipment onsite or barricade area.</p> <p>2) Consider removing pipework that is not being used and stored onsite near the roadside fencing.</p>

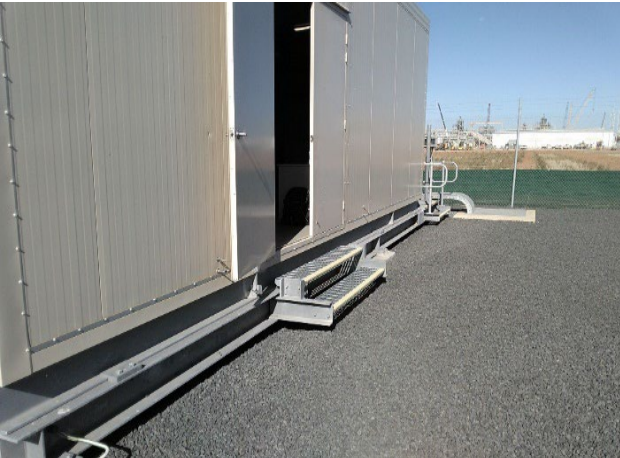
Clifton Road Meter Station-1	1/03/2024	Metering Skid	<p>1) Has blue metal as the landing surface.</p> <p>2.1) Step up from ground level to the first stair (340mm) exceeds AS1657 requirements (300-450mm requires a step).</p> <p>2.2) The stair riser (240mm) exceeds the AS1657 requirements (130-225mm).</p> <p>3) No hi vis (yellow) tread installed onto the nosing of each stair.</p>	C. Unlikely	2. Minor	Low	<p>1) Pour a landing to meet AS requirements.</p> <p>2) Replace the stairs with AS1657 compliant stairs. If 2 or more stairs are required, then handrails must be installed.</p> <p>3) Install hi vis (yellow) tread onto the nosing of each stair.</p>

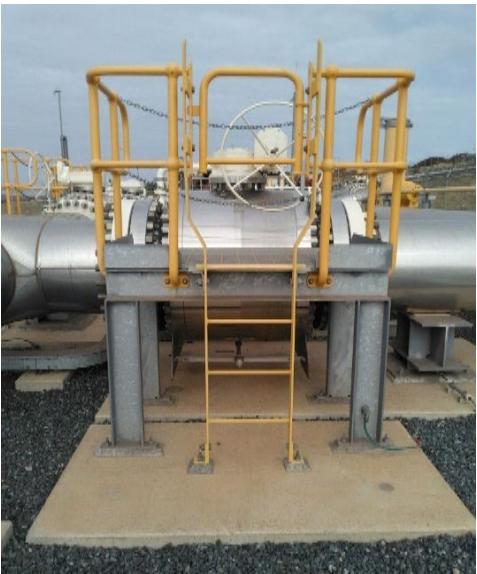
Pluto Interconnect Compressor / Metering Station - 5	11/08/2023	Multiple Hand Valves	1) Existing landings are off centre and insufficient size to position a platform ladder or safety step, to access the hand valves. This creates the risk off a fall.	C. Unlikely	3. Severe	Medium	Option A: Install concrete landing for platform ladder to be set up on. Option B: Install a purpose built platform and access stairs or ladder that is AS compliant.

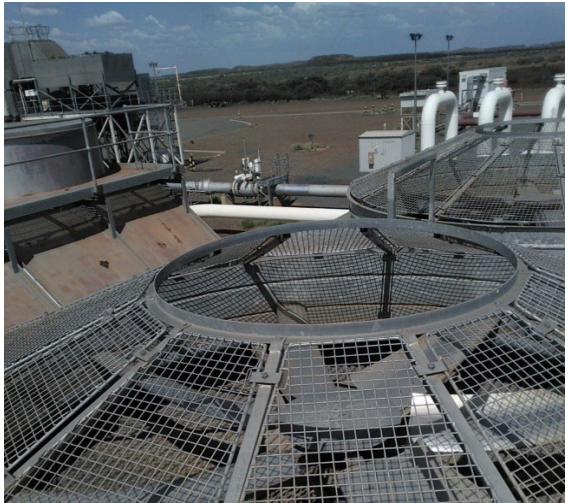
C502-5	21/02/2023	After Cooler Fans - Top Platforms	1) 2 x Pins sticking out from the handrail, exposing personnel to injury.	C. Unlikely	2. Minor	Low	1.1) Hazard raised in InControl (#18423) by DBP Head of Health and Safety - Transmission 1.2) The protruding pins are to be cut and grinded until flush with the handrail.

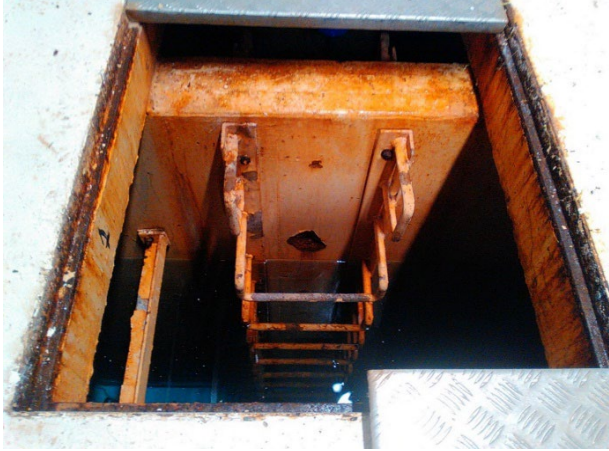
CS03-5	21/04/2023	Compressed Air Unit For Battery Rooms	1) No non-slip tread on ladder runs. 2) Landing does not meet the AS requirements. 3) ~200mm Gap between the vessel and the handrail is not compliant with AS requirements (max 100mm).	B. Remote	2. Minor	Low	1) Install hi vis (yellow) non-slip tread installed on the rungs. 2) Extend landing to meet AS requirements. 3) Extend the handrail to within 100mm of the vessel. Change to recommend the ladder is removed if it not required. Ask a FMO or David Martin from this work group.

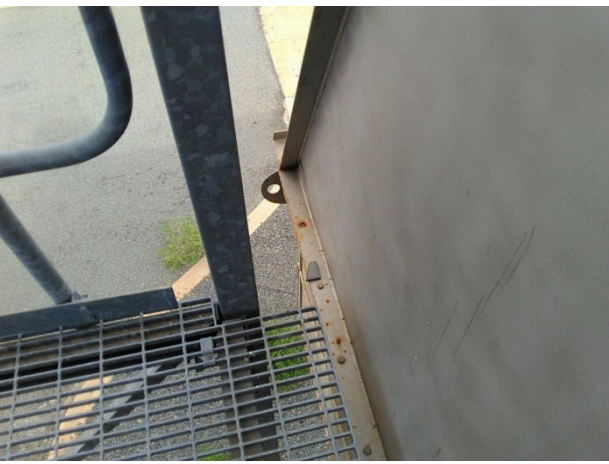
CS03-13	21/04/2023	ACS Inlet Duct - Top Deck	1) The landing for the ladder does not meet AS1657 requirements of 900mm. 2) The steps are small in size (~110mm), have no hi vis non-slip tread fitted, do not meet AS1657 requirements and posings a slip/fall risk. 3) Handrail does not meet AS requirements by not extending the full length of the stairs.	C. Unlikely	3. Severe	Medium	1) Modify the platform to provide adequate landing or modify the access method. 2) Ensure the new stairwell has suitably sized steps or a access ladder that meet AS1657 requirements. Hi vis non-slip tread is also to be fitted to the nosing of each stair. 3) Extend the handrail the full length of the stairs.

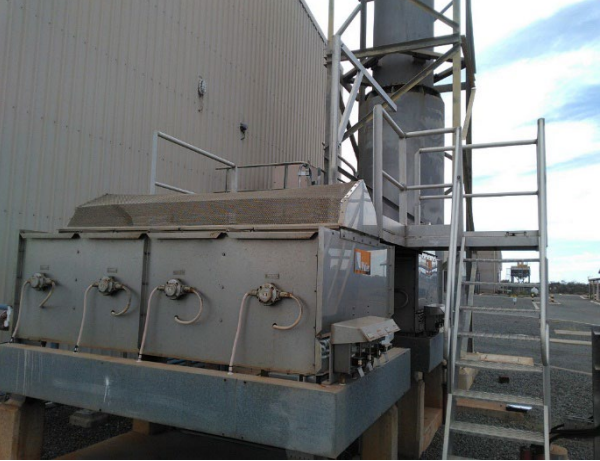
CS03-21	21/04/2023	GEA 1 and 2 - Oil / Hydraulic Fluid Tank	1) The stairs riser (260mm) does not meet AS requirements. The stairs are being used as a work platform. 2) No hi vis (yellow) tread installed onto each stair.	C. Unlikely	3. Severe	Medium	1.1) Install a platform with stair access to replace the temporary stairs. <i>Note: If 3 stairs will be required so handrails will also be required.</i> 2) Install hi vis (yellow) tread onto each stair

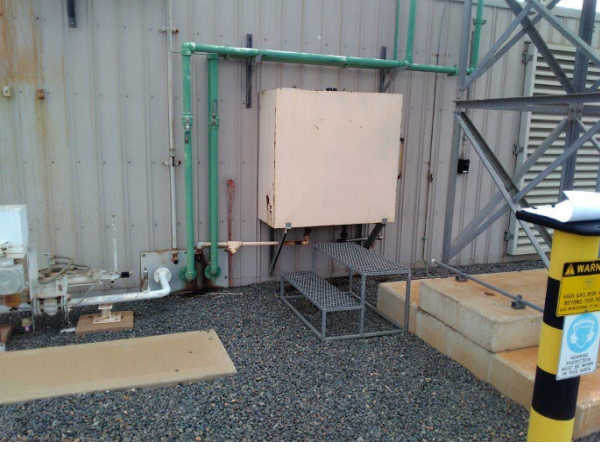
CS03-22	21/04/2023	GEA 1 and 2 - Fuel Gas Skid	1) The step up (370mm) from the ground to the grid mesh platform exceeds AS requirements (130-225mm).	C. Unlikely	2. Minor	Low	1) Install a step between the landing and grid mesh platform to provide safe access at the four access points.
