Revised Final Plan
Attachment 9.12

Structures & Operational Sites - Working at Heights - Appendix B

**Dampier Bunbury
Pipeline**

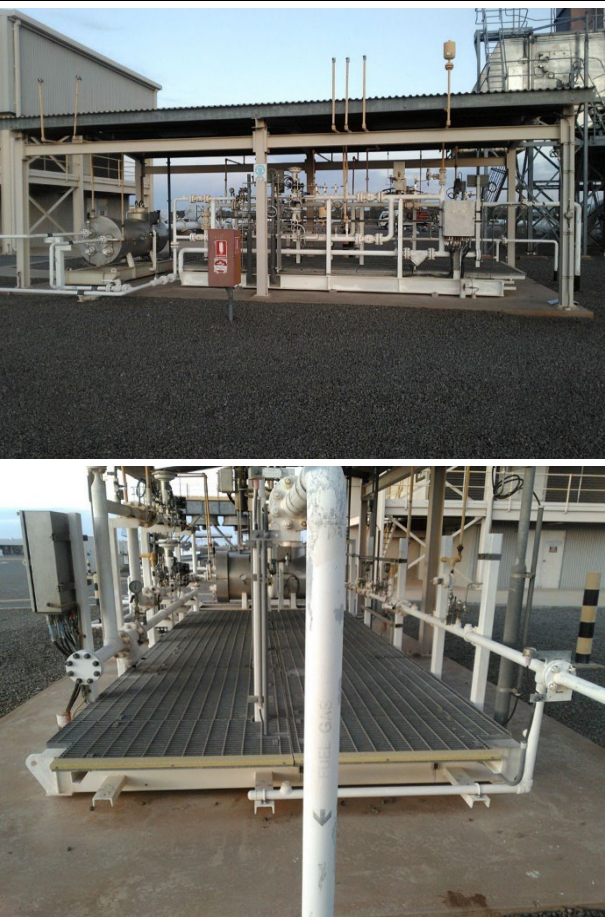
Reference	Date added	Location on Site	Issue	Likelihood	Consequence	Risk Score	Suggestions	Evidence	What is being completed	Date planned for completion	Date completed	Comments
CS05-12	23/05/2023	Compressor Unit 1 Fuel Gas Skid	1) The Step Up for the four access points for the platform is 420mm and therefore the AS requirements state at least 1 step be provided for safe access.	C. Unlikely	2. Minor	Low	1) Install a stair with hi vis (yellow) tread on the nosing, at each access point to to enable safe access and compliance with the AS requirements.

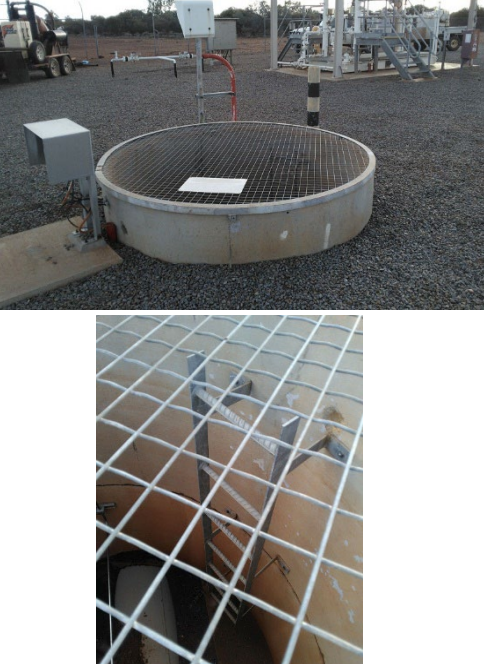
CS05-29	21/06/2023	Confined Space - Access Ladder (West Side of Plant)	<p>1) Ladder does not extend 1m past the landing at the top of the ladder and does not have sufficient locations to hold onto when mounting / dismounting.</p> <p>2) No non-slip tread on ladder rungs.</p>	B. Remote	3. Severe	Medium	<p>1) Modify or replace the ladder, ensuring it extends 1m past the top landing, with sufficient locations to hold onto when mounting / dismantling the ladder.</p> <p>2) Modified or replacement ladder to have hi vis (yellow) non-slip tread installed on the rungs.</p>

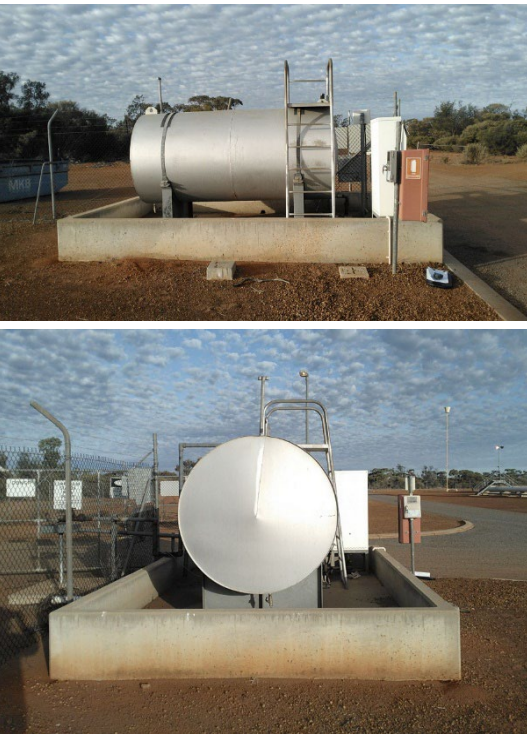
CS06-36	6/10/2023	Combustible Liquid Tank Near Unit 3	<p>1) Access stairs do not provide safe access to the 2 x hatches. Currently personnel have to over-reach.</p>	D. Occasional	2. Minor	Low	<p>1) Remove the existing access stairs and install with AS compliant stairs, platform and landing.</p>

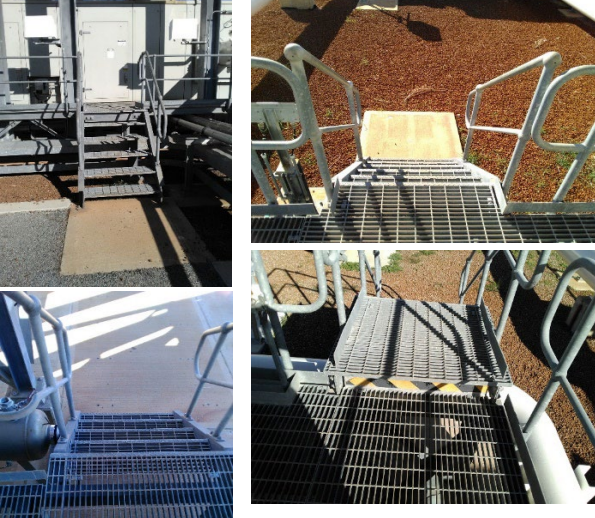
C507-29	27/11/2023	Pipework on the South Side of Unit 3	1) Access to Risers and Vents for maintenance tasks currently completed using a platform ladder on blue metal. This creates the potential for the ladder to be unstable and cause a fall from height. Alternative personnel may choose to sit on the pipe itself. Note: Potential for a fall of 1.5-2.5m.	C. Unlikely	3. Severe	Medium	1) Option A: Install concrete landing for platform ladder to be set up on. Option B: Install a purpose built platform and access stairs or ladder that is AS compliant.

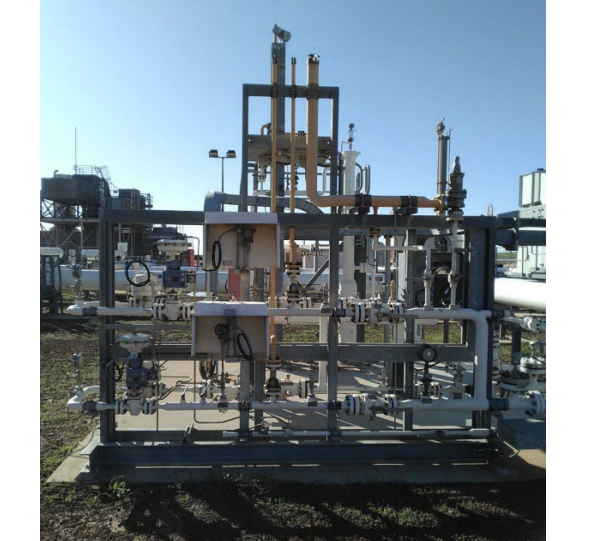
C507-32	27/11/2023	Platform for Vent / Riser near Unit 3	1) Existing design of the platform does not permit personnel to access the top vent without the use of a large platform ladder at ground level or using a safety step (or similar) on the platform. Both means of access exposes personnel of a fall ~3m.	C. Unlikely	3. Severe	Medium	1) Modify the platform and handrail to provide safe access to the vent.

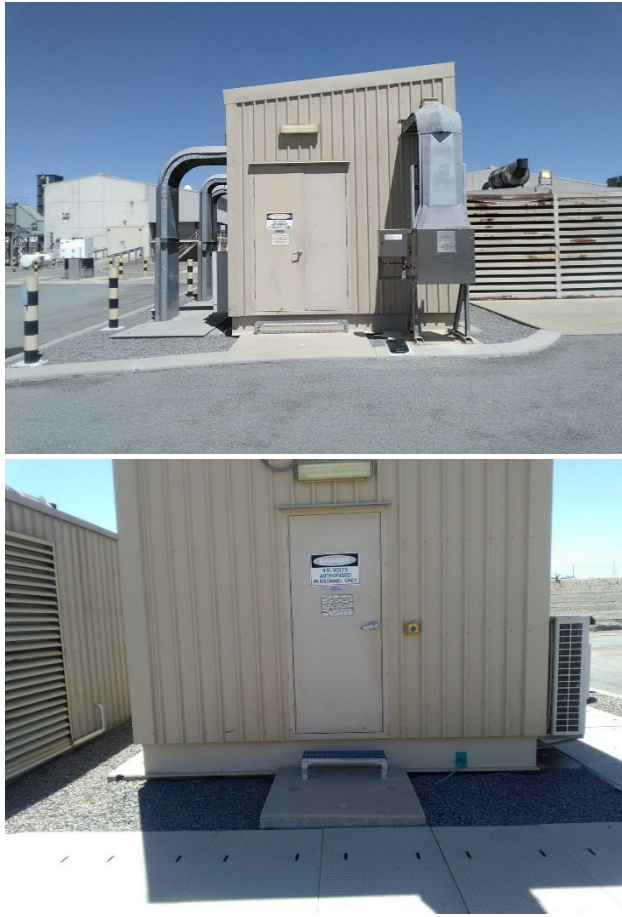
CS08-4	13/02/2024	DEA Junction Box (CS000-5249-3001-03)	1) The landing when accessing the DEA Junction Box is concrete kerbing. This uneven surface poses a slip / fall (same level) risk.	C. Unlikely	2. Minor	Low	1) Extend the concrete landing and modify the kerbing to suit.

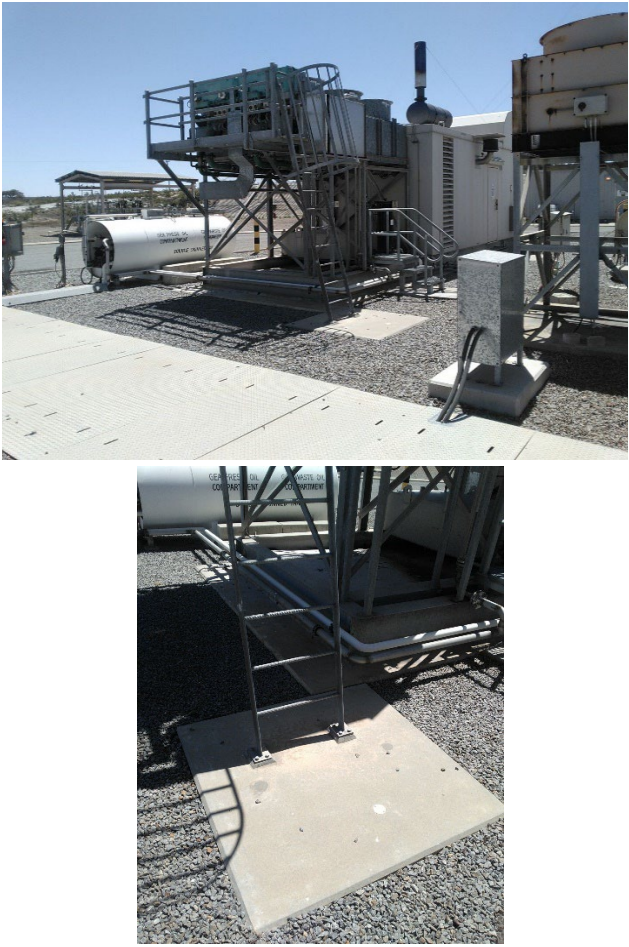
CS08-10	13/02/2024	GEA Fresh Oil and Waste Oil Tank	<p>1) Temporary access stairs are also used as a work platform. Requirements for work platform not met.</p> <p>2) No hi vis (yellow) tread installed onto each stair.</p> <p>3) Two pipes adjacent to the stairs pose a trip hazard.</p>	C. Unlikely	2. Minor	Low	<p>1) Install a platform with stair access to replace the temporary stairs. Note: If 3 stairs or stairs are <=1m wide, then handrails will also be required.</p> <p>2) Install hi vis (yellow) tread onto each stair.</p> <p>3) Consider installing a handrail to prevent access or a hopover to provide safe access.</p>

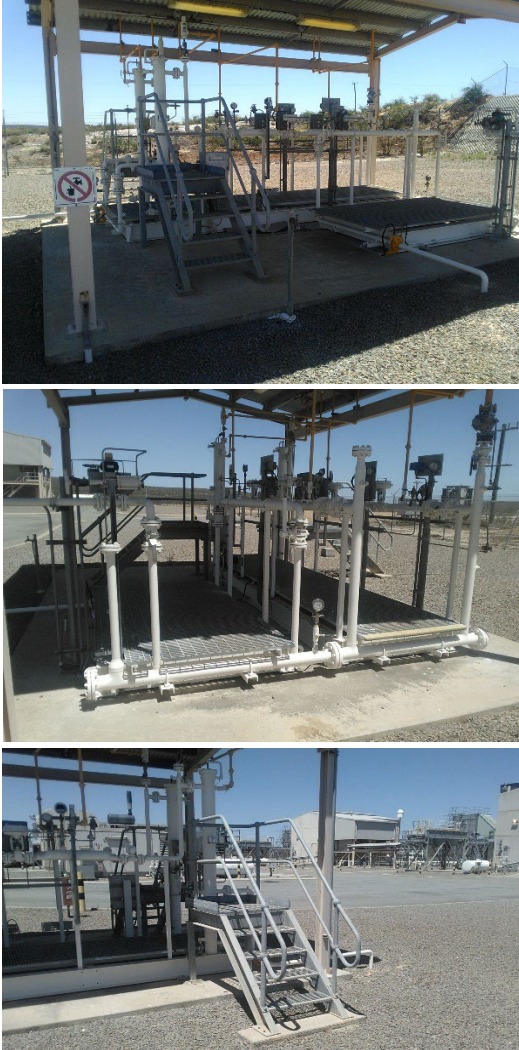
CS08-15	13/02/2024	GEA Waste Oil Tank	1) Temporary access stairs are also used as a work platform. Requirements for work platform not met. 2) No hi vis (yellow) tread installed onto each stair.	C. Unlikely	2. Minor	Low	1) Install a platform with stair access to replace the temporary stairs. Note: If 3 stairs or stairs are <=1m wide, then handrails will also be required. 2) Install hi vis (yellow) tread onto each stair.

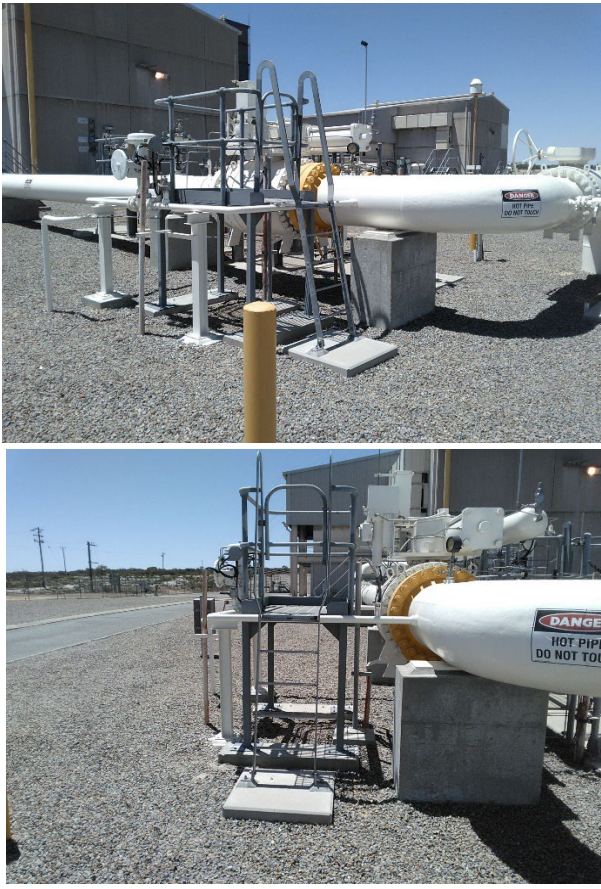
CS08-31	13/02/2024	Anti-Surge Valves (ZSL1311 / UCV1351) - 2 x Platforms	<p>1) Chain has been used in lieu of a handrail. The chain will likely break in the event of a fall (~1.5m).</p>	C. Unlikely	3. Severe	Medium	<p>1) Replace the chains with handrails.</p>

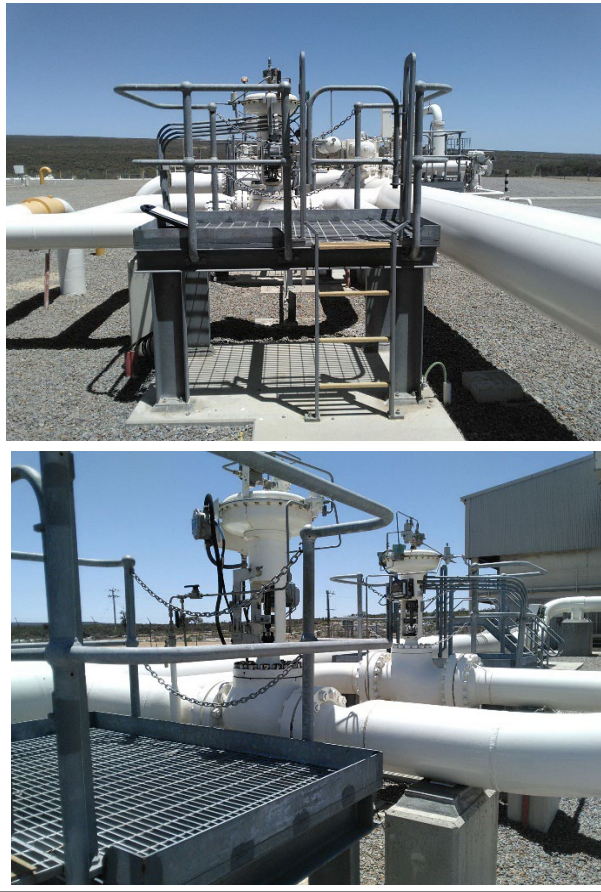
CS08-32	13/02/2024	Unit 1 - South Platform for Actuated Valve (1315)	<p>1) Mid and top handrail has been cut, leaving a gap of 260mm which exceeds AS requirements (max 100mm).</p> <p>2) The landing does not meet AS requirements (actual 700mm, required minimum 900mm).</p> <p>3) No hi vis (yellow) tread installed onto the ladder rungs or nosing of platform.</p>	B. Remote	3. Severe	Low	<p>1) Modify the handrail to eliminate the gap.</p> <p>2) Pour a new landing.</p> <p>3) Install hi vis (yellow) tread onto each ladder rungs and nosing of platform.</p>

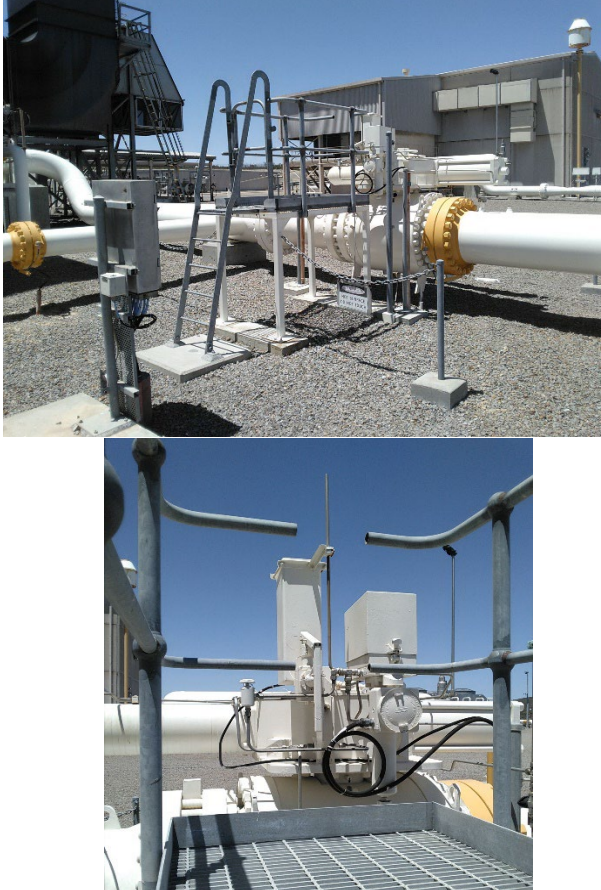
CS08-33	13/02/2024	Unit 1 - PSV1316A	<p>1) Access to PSV for maintenance tasks currently completed using a platform ladder on blue metal. This creates the potential for the ladder to be unstable and cause a fall from height (~2m).</p>	C. Unlikely	3. Severe	Medium	<p>1) Option A: Install concrete landing for platform ladder to be set up on.</p> <p>Option B: Install a purpose built platform and access stairs or ladder that is AS compliant.</p>

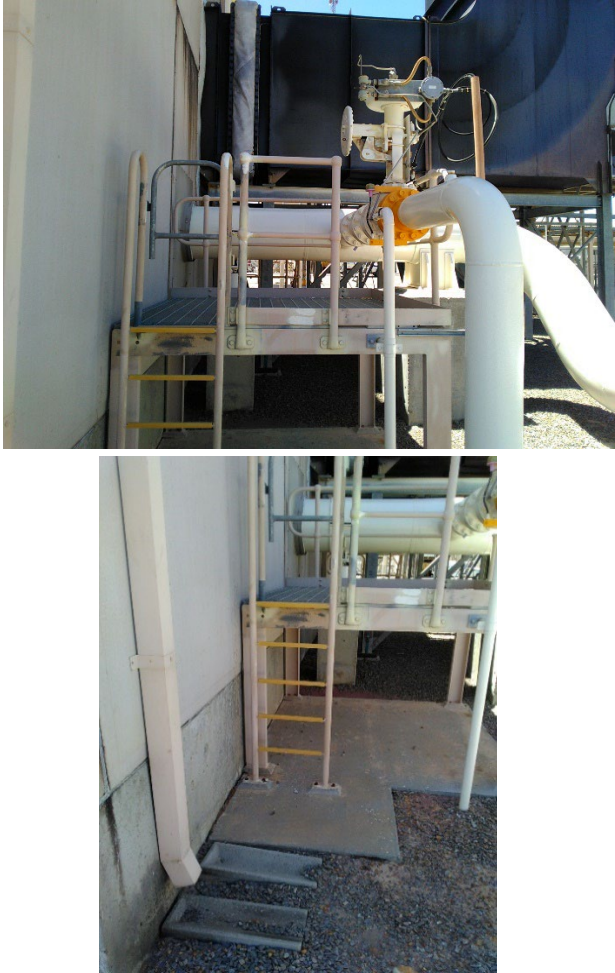
CS08-35	13/02/2024	Unit 1 Pressure Skid - 2 x Stairway Platforms	1) Landings are too small and do not meet AS requirements. They also pose a slip / trip / fall (same level) hazard. 2) No hi vis (yellow) tread installed on the nosing of the stairs and platform.	C. Unlikely	2. Minor	Low	1) Pour a new landing. 2) Install hi vis (yellow) tread onto the nosing of the platform and each stair (400mm width).

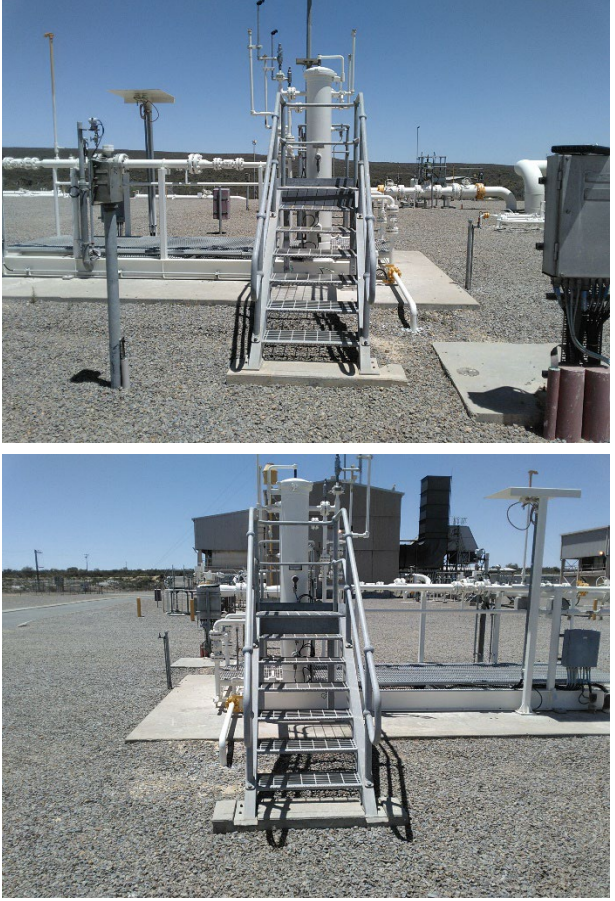
CS08-36	13/02/2024	Unit 1 Pressure Skid - Access / Work Platform	1) The step up / down onto the platform exceeds AS requirements (=<300mm, actual 400mm). 2) Existing pipework at the end of the platform poses a trip hazard. 3) No kick plate or handrails are install on the platform. Potential to stair off.	C. Unlikely	2. Minor	Low	1) Install a platform with stair access, with hi vis (yellow tread) on the nosing of each stair and platform. Note: If 3 stairs or stairs are <=1m wide, then handrails will also be required. 2) Incorporate a hopover into the access stair design. 3) Install kick plates and handrail along the platform edges where practical.

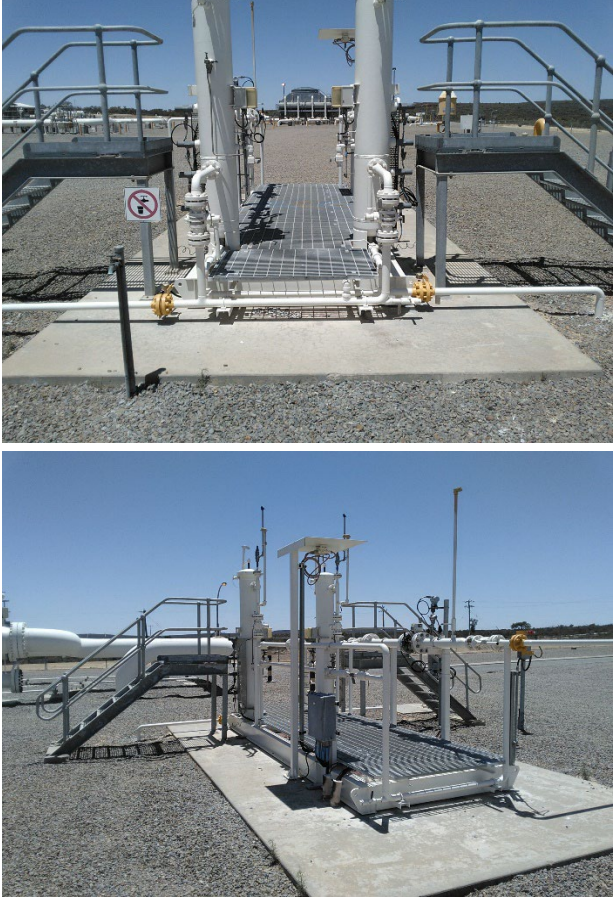
CS08-37	13/02/2024	Platform for Scrubber and adjacent Pipework	1) No access to Riser / Vent from platform without having to use a ladder on the platform. This will expose personnel to a fall over the existing handrail. 2) No access to the valves onto the top of the pipework.	C. Unlikely	2. Minor	Low	1) Modify platform and handrails to provide access to vent. 2) Install a access platform that complies with AS1567 requirements. Note: Discuss with FMOs on frequency to access both locations and methodology. This will help determine priority and suitability.

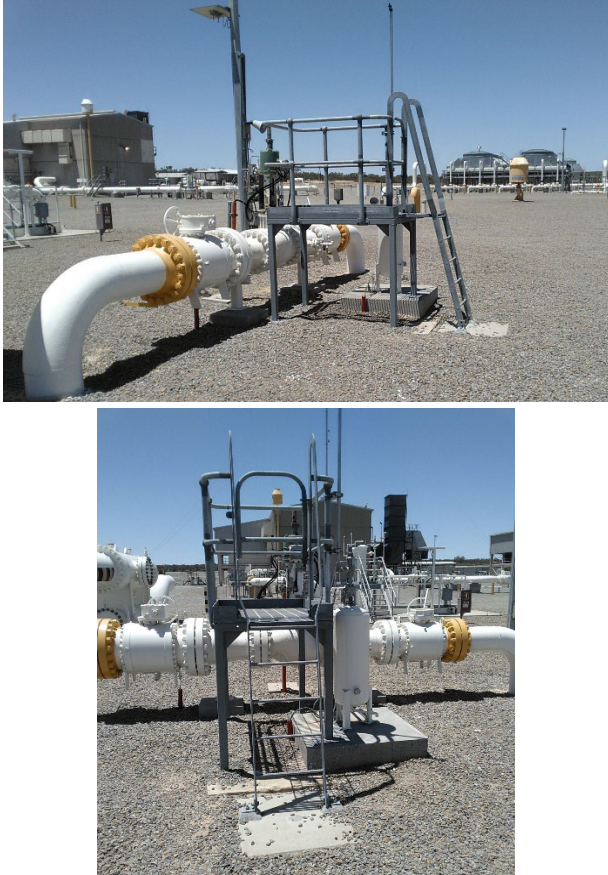
CS08-39	13/02/2024	PIC-181 / PIC-182 Skid - Access Platforms	<p>1) Landings are too small and do not meet AS requirements. They also pose a slip / trip / fall (same level) hazard.</p> <p>2) No hi vis (yellow) tread installed on the nosing of the stairs and</p>	C. Unlikely	2. Minor	Low	<p>1) Pour a new landing.</p> <p>2) Install hi vis (yellow) tread onto the nosing of the platform and each stair (750mm width).</p>

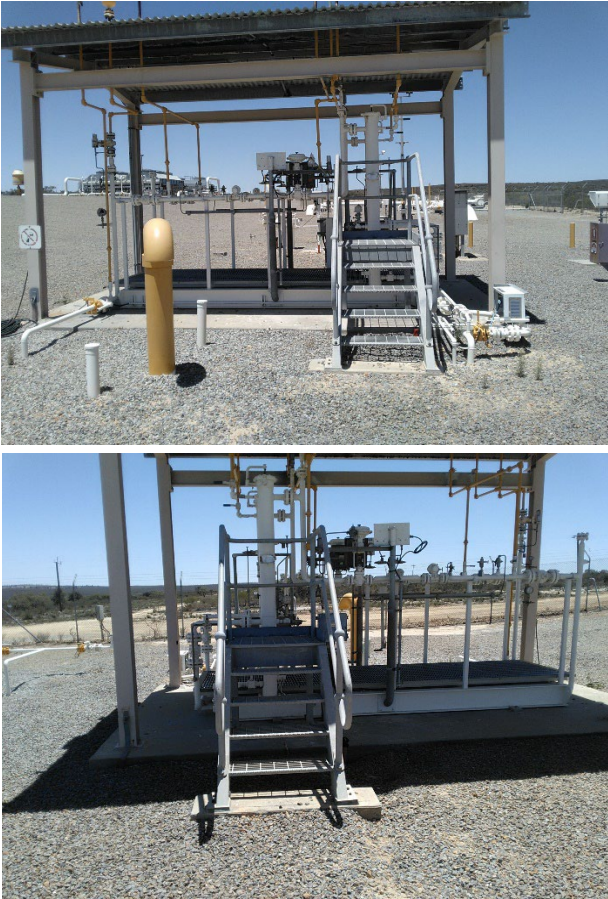
CS08-40	13/02/2024	PIC-181 / PIC-182 Skid	<p>1) Step up is 380mm which exceeds AS requirements (300mm-450mm requires minimum of 1 stair).</p>	C. Unlikely	2. Minor	Low	<p>1.1) Install a interim stair to assist with access and meet AS1657 requirements. Note: If 3 stairs or stairs are <=1m wide, then handrails will also be required.</p> <p>1.2) Install hi vis (yellow) tread onto each stair.</p>

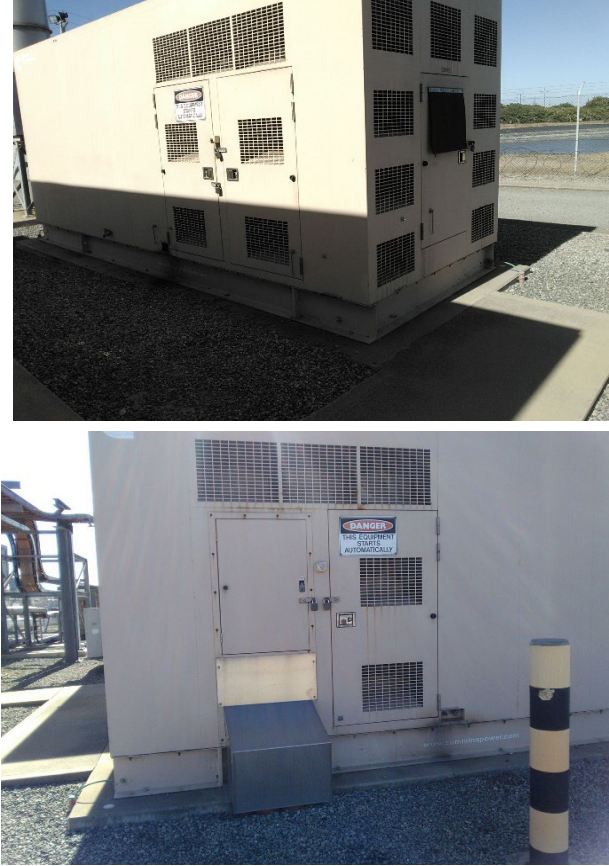
CS10-07	15/12/2023	Load Bank	1) No landing installed for personnel to stand on.	C. Unlikely	2. Minor	Low	1) Pour a new landing.

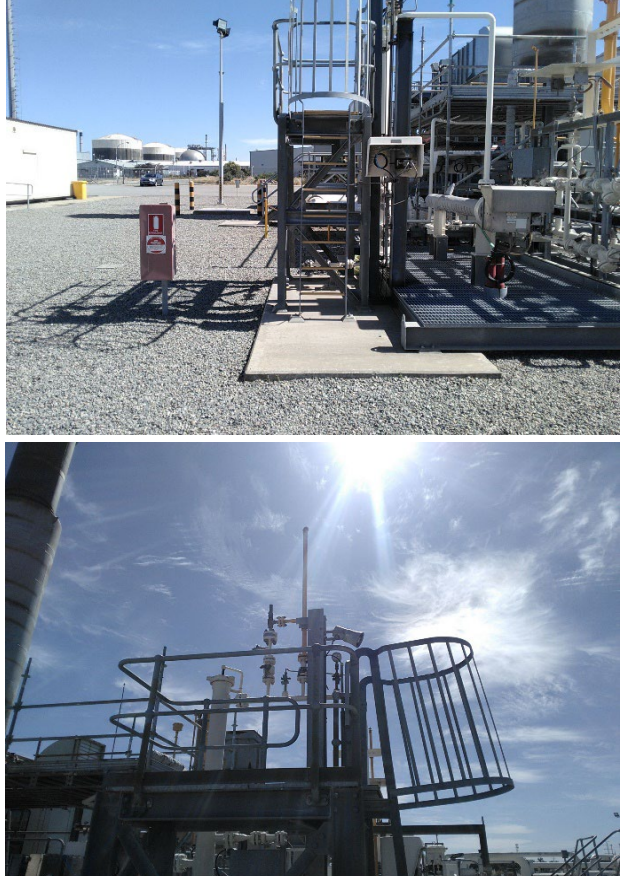
CS10-29	15/12/2023	Unit 3 Fuel Gas Skid - East and West Sides	<p>1) No hi vis tread installed on the edge of skid.</p> <p>2) No hi vis (yellow) tread installed on the nosing of the stairs.</p> <p>3) Work platform on the East side does not meet AS requirements for depth (actual 430mm, AS requires >=600mm) and step up (actual 330mm, AS requires 1 stair for 300-450mm).</p> <p>4) Concrete footings pose a trip hazard.</p>	C. Unlikely	3. Severe	Medium	<p>1) Install hi vis (yellow) non-slip tread installed on the nosing of the skid.</p> <p>2) Install hi vis (yellow) non-slip tread installed on the nosing of the stairs.</p> <p>3) Modify the work platform to meet AS requirements (i.e. step up, depth).</p> <p>4) Option A: Extend the concrete landing to incorporate the whole of the walkway.</p> <p>Option B: Install additional blue metal until level with the concrete footing.</p>
