Revised Final Plan
Attachment 9.12

Structures & Operational Sites - Working at Heights - Appendix B

August 2025

**Dampier Bunbury
Pipeline**

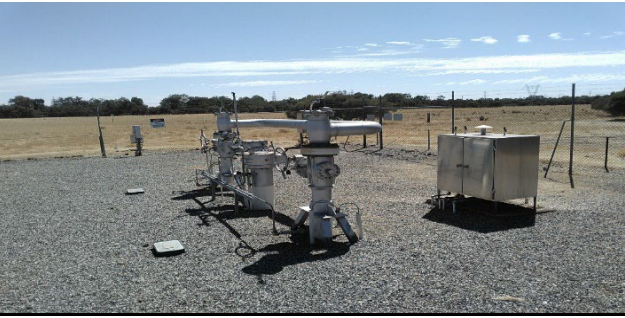
Reference	Date Added	Site	Issue	Likelihood	Consequence	Risk Score	Suggestions	Evidence	Date Planned For Completion	Date Completed	Comments
MLV010-1	19/03/2024	All Areas	No design risks identified. Situational/task based risk may exist.				No Action Required.	No reference photo taken.			
MLV144-1	5/03/2024	MLV144 - All Areas	1) Access to Risers and vents ~1200mm for maintenance tasks currently completed using a platform ladder on blue metal. This creates the potential for the ladder to be unstable and cause a fall from height. 2) Cable markers / inspection pits pose a trip hazard.	C. Unlikely	2. Minor	Low	1) Option A: Install concrete landing for platform ladder to be set up on. Option B: Install a purpose built platform and access stairs or ladder that is AS compliant. 2) Relocate, accommodation into above works or build up blue

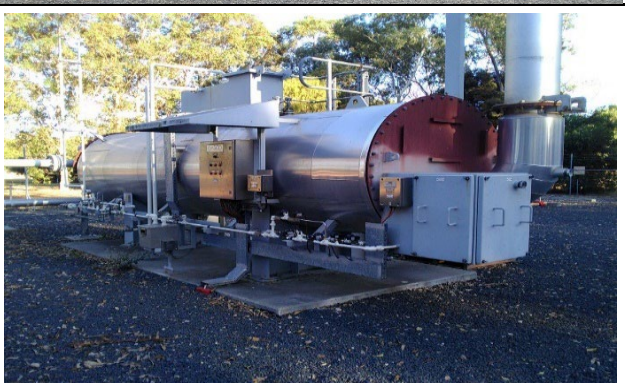
MLV156 / MLV157-1	1/03/2024	MLV156 / MLV157 - Water Bath Heater	1) Access to Risers and Vents ~2000mm for maintenance tasks currently completed using a platform ladder on blue metal. This creates the potential for the ladder to be unstable and cause a fall from height. 2) The landing for the platform ladder does not meet AS1657 requirements (actual 560mm, requirement min	C. Unlikely	3. Severe	Medium	1) Option A: Install concrete landing for platform ladder to be set up on. Option B: Install a purpose built platform and access stairs or ladder that is AS compliant. 2) Pour a new landing or extend the existing landing.

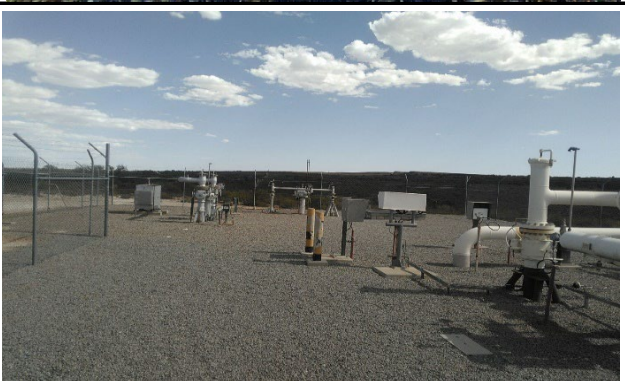
MLV102-1	12/02/2024	MLV102 - All Areas (except CS Pits)	1) Access to Risers and Vents for maintenance tasks currently completed using a platform ladder on blue metal. This creates the potential for the ladder to be unstable and cause a fall from height.	C. Unlikely	3. Severe	Medium	1) Option A: Install concrete landing for platform ladder to be set up on. Option B: Install a purpose built platform and access stairs or ladder that is AS compliant.

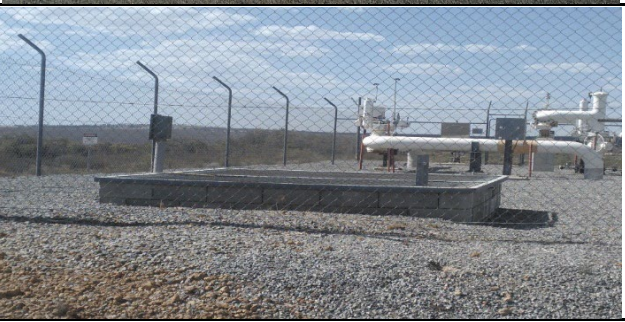
MLV102-2	12/02/2024	MLV102 - 2 x CS Pits (1 inside fenced compound, 1 outside adjacent to compound)	1) Ladder does not extend 1m past the landing at the top of the ladder and does not have sufficient locations to hold onto when mounting / dismounting. 2) No non-slip tread on ladder rungs.	B. Remote	3. Severe	Medium	1) Woody or replace the ladder, ensuring it extends 1m past the top landing, with sufficient locations to hold onto when mounting / dismantling the ladder. 2) Modified or replacement ladder to have hi vis (yellow) nos

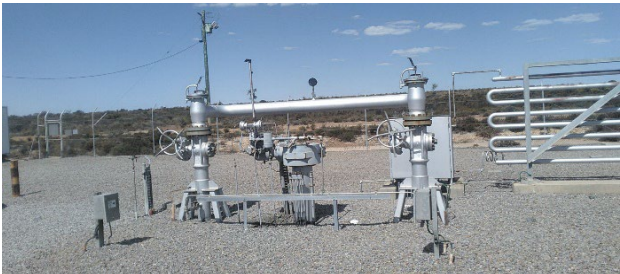
Reference	Date Added	Site	Issue	Likelihood	Consequence	Risk Score	Suggestions	Evidence	Date Planned For Completion	Date Completed	Comments
MLV095-1	6/02/2024	MLV095 and Eneabba Meter Station - Multiple Risers	1) Access to Risers and Vents for maintenance tasks currently completed using a platform ladder on blue metal. This creates the potential for the ladder to be unstable and cause a fall from height.	C. Unlikely	3. Severe	Medium	1) Option A: Install concrete landing for platform ladder to be set up on. Option B: Install a purpose built platform and access stairs or ladder that is AS compliant.

23/04/2024 Raised with Robert Van Der Wilk and requested the recommended actions are incorporated into the Eneabba Meter Station Re-Lifing Project, during the Design Review Meeting. 05/06/2024 Robert advised Paul Reilly he will address this action item.
MLV095-2	6/02/2024	MLV095 and Eneabba Meter Station - Inspection Pit	1) Ladder does not extend 1m past the landing at the top of the ladder and does not have sufficient locations to hold onto when mounting / dismounting. 2) No non-slip tread on ladder rungs.	B. Remote	3. Severe	Medium	1) Modify or replace the ladder, ensuring it extends 1m past the top landing, with sufficient locations to hold onto when mounting / dismounting the ladder. 2) Modified or replacement ladder to have hi vis (yellow) non-slip tread installed on the rungs.

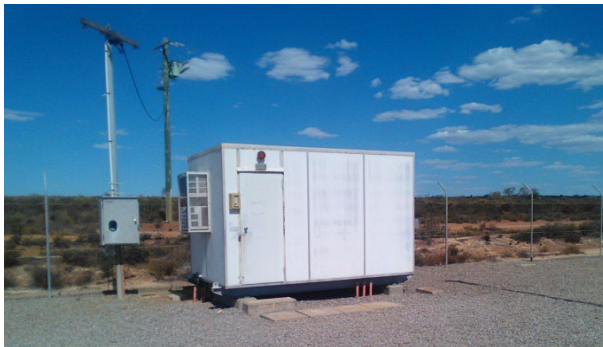
MLV095-3	6/02/2024	MLV095 and Eneabba Meter Station - Pav Hut	1) The landing for the stairs does not meet AS1657 requirements of 900mm. 2) Stair riser exceeds AS1657 requirement of 130-225mm (actual 300mmm). 3) No hi vis (yellow) tread installed onto the nosing of each stair.	C. Unlikely	2. Minor	Low	1) Pour a new landing. 2) Replace stair with AS1657 compliant stairs. 3) Install hi vis (yellow) tread onto the nosing of each stair.

23/04/2024 Raised with Robert Van Der Wilk and requested the recommended actions are incorporated into the Eneabba Meter Station Re-Lifing Project, during the Design Review Meeting. 05/06/2024 Robert has requested this item to be covered by Paul Reilly's W@H Improvement Project.
MLV095-4	6/02/2024	MLV095 and Eneabba Meter Station - Metering Skid	1) No non-slip tread on the edge of skid and nosing of stairs. 2) Requirement for handrail and stair risers in AS1657 not met. 3) Landing does not meet the AS1657 requirements and is currently blue metal.	C. Unlikely	2. Minor	Low	1) Install hi vis (yellow) non-slip tread installed on the edge of the skid and nosing of all stairs. 2) Replace stairs and install handrail that meets AS1657 requirements. 3) Pour a landing that meets AS requirements.

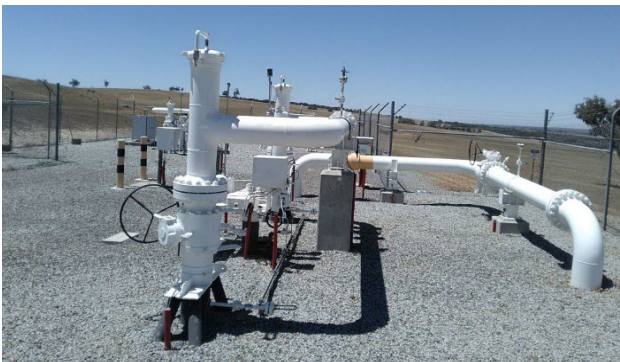
MLV114-1	13/12/2023	MLV114 - All Areas	1) Access to Risers and Vents ~2000mm for maintenance tasks currently completed using a platform ladder on blue metal. This creates the potential for the ladder to be unstable and cause a fall from height.	C. Unlikely	3. Severe	Medium	1) Option A: Install concrete landing for platform ladder to be set up on. Option B: Install a purpose built platform and access stairs or ladder that is AS compliant.

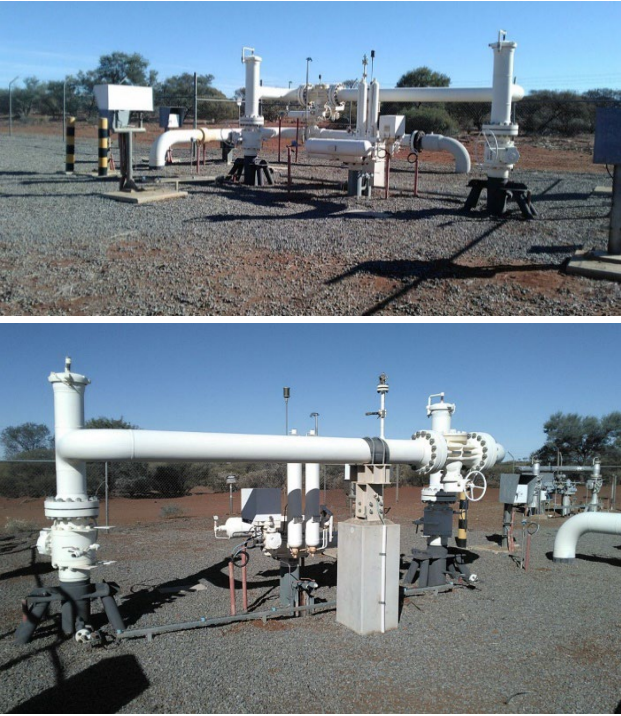
Reference	Date Added	Site	Issue	Likelihood	Consequence	Risk Score	Suggestions	Evidence	Date Planned For Completion	Date Completed	Comments
MLV009-1	26/07/2023	All Areas	No design risks identified. Situational/task based risk may exist.				No Action Required.	No reference photo taken.			
MLV066-1	22/05/2023	MLV066 - All Areas excluding the Inspection Pit	1) Access to Risers up to 2900mm and Vents up to 3340mm for maintenance tasks currently completed using a platform ladder on blue metal. This creates the potential for the ladder to be unstable and cause a fall from height.	C. Unlikely	3. Severe	Medium	1) Option A: Install concrete landing for platform ladder to be set up on. Option B: Install a purpose built platform and access stairs or ladder that is AS compliant.

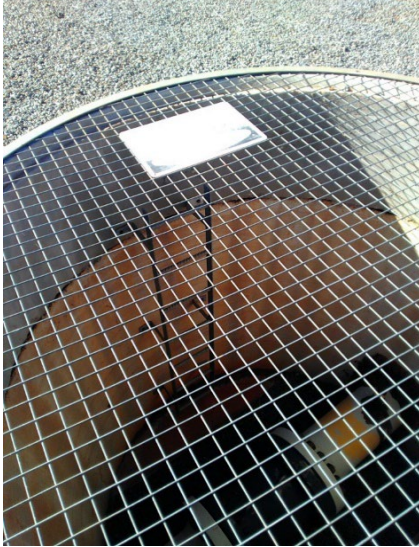
MLV066-2	22/05/2023	MLV066 - Inspection Pit	1) Ladder does not extend 1m past the landing at the top of the ladder and does not have sufficient locations to hold onto when mounting / dismantling. 2) No non-slip tread on ladder rungs.	B. Remote	3. Severe	Low	1) Modify or replace the ladder, ensuring it extends 1m past the top landing, with sufficient locations to hold onto when mounting / dismantling the ladder. 2) Modified or replacement ladder to have hi vis (yellow) non-slip tread installed on the rungs.

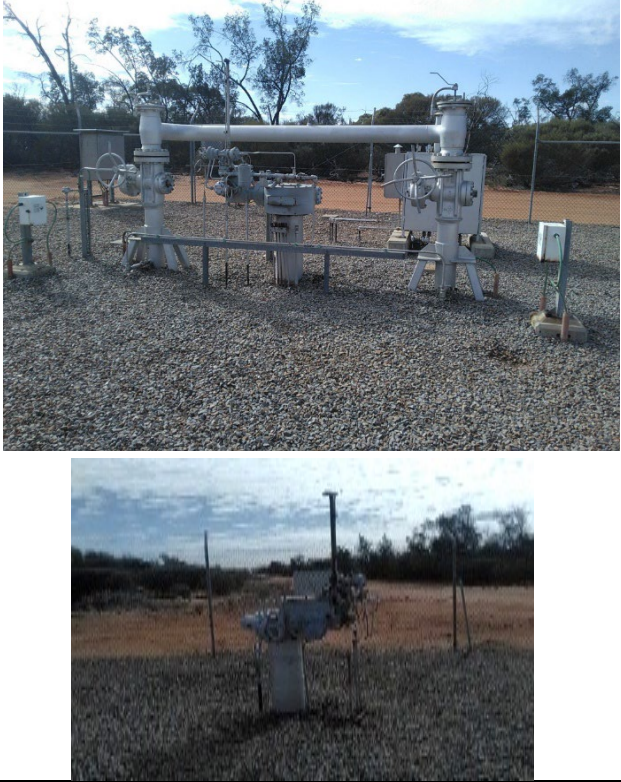
MLV071-1	22/05/2023	MLV071 - All Areas	1) Access to Risers up to 2200mm and Vents up to 2500mm for maintenance tasks currently completed using a platform ladder on blue metal. This creates the potential for the ladder to be unstable and cause a fall from height.	C. Unlikely	3. Severe	Medium	1) Option A: Install concrete landing for platform ladder to be set up on. Option B: Install a purpose built platform and access stairs or ladder that is AS compliant.

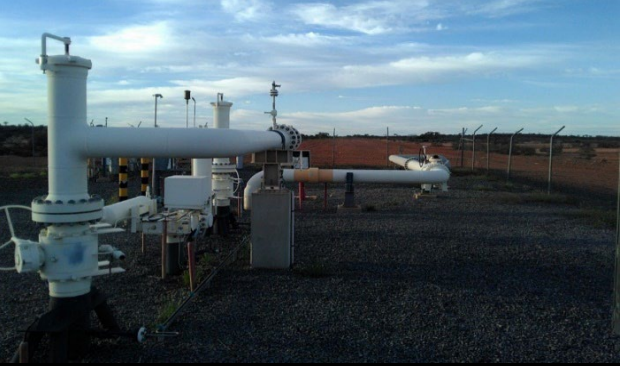
MLV042-1	21/04/2023	MLV042 - All Areas	1) Access to Risers and Vents for maintenance tasks currently completed using a platform ladder on blue metal. This creates the potential for the ladder to be unstable and cause a fall from height.	C. Unlikely	3. Severe	Medium	1) Option A: Install concrete landing for platform ladder to be set up on. Option B: Install a purpose built platform and access stairs or ladder that is AS compliant.

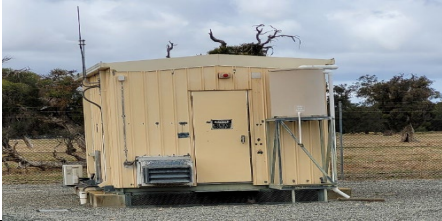
MLV142-1	13/04/2023	MLV142 - Pav Hut (Cream Colour) - North Side	1) The Step Up is 330mm and does not meet AS requirements (≤300mm) slightly. 2) No hi vis (yellow) strip on the nosing (ends) of the stairs.	C. Unlikely	2. Minor	Low	1) No action required as only minimum exceedance of AS requirements. 2) Install hi vis (yellow) non-slip strip on the nosing of each stair.

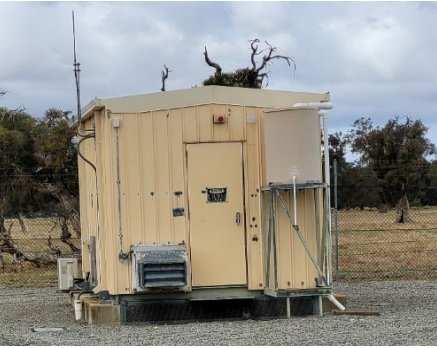
MLV142-2	13/04/2023	MLV142 - Pav Hut (Cream Colour) - West Side (north side pictured)	1) The Step Up is 310mm and does not meet AS requirements (≤300mm) slightly. 2) No hi vis (yellow) strip on the nosing (ends) of the stairs.	C. Unlikely	2. Minor	Low	1) No action required as only minimum exceedance of AS requirements. 2) Install hi vis (yellow) non-slip strip on the nosing of each stair.

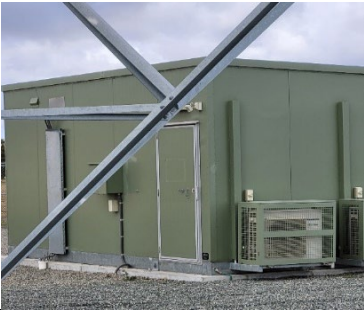
MLV142-3	13/04/2023	MLV142 - Green Hut - East Side	1.1) The stair risers are 100mm and 250mm and therefore do not meet the AS requirements (130-225mm). 1.2) The current state of the ground conditions has created a trip / fall hazard when using the door (e.g. concrete pad is not width to act as the landing).	C. Unlikely	2. Minor	Low	1) Install additional blue metal to create level ground and eliminate the trip / fall hazard when entering / exiting the hut.

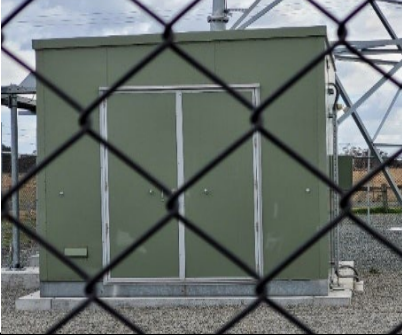
MLV142-4	13/04/2023	MLV142 - Green Hut - South Side	1.1) The stair risers are 100mm and 250mm and therefore do not meet the AS requirements (130-225mm). 1.2) The current state of the ground conditions has created a trip / fall hazard when using the door (e.g. concrete pad is not width to act as the landing).	C. Unlikely	2. Minor	Low	1) Install additional blue metal to create level ground and eliminate the trip / fall hazard when entering / exiting the hut.

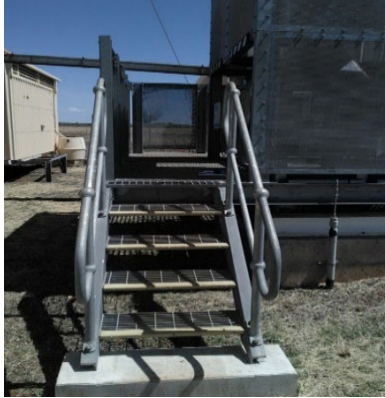
MLVXXX-1	2/02/2023	Example - TEG unit	1) Landing does not meet AS requirement of 900mm long			Low	1.1) Remove old landing and install new precast one 1.2) Pour new landing

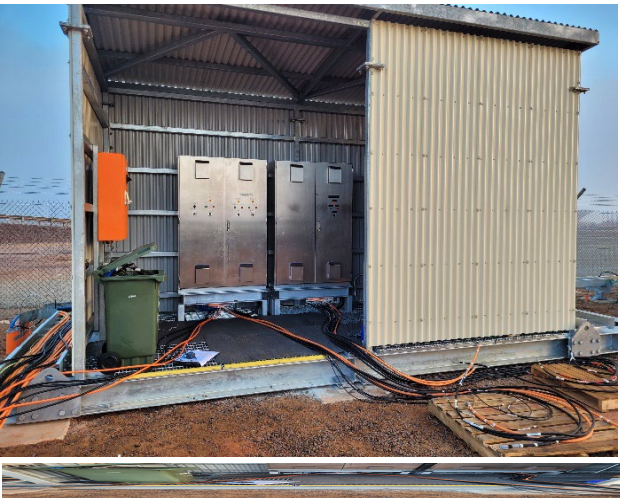
Reference	Date Added	Site	Issue	Likelihood	Consequence	Risk Score	Suggestions	Evidence	Date Planned For Completion	Date Completed	Comments
Ashburton Port Meter Station - 1	16/07/2024	Ashburton Port Meter Station - Controls Shelter	1) No landing has been installed beneath where the step and handrails will be (once installed). Notes: - Step pictured at the Solar Skid is actually for the Controls Shelter according to the Construction Crew. - Handrails are inside the Controls Shelter, awaiting installation. - 16/07/2024 Raised with Jeromie Gasper as construction project is still in progress.	C. Unlikely	2. Minor	Low	1) Pour a landing. Notes: - The landing needs to be at least the width of the stairs (step is 1800mm wide). - The depth of landing will need to be 600mm from the bottom stair.

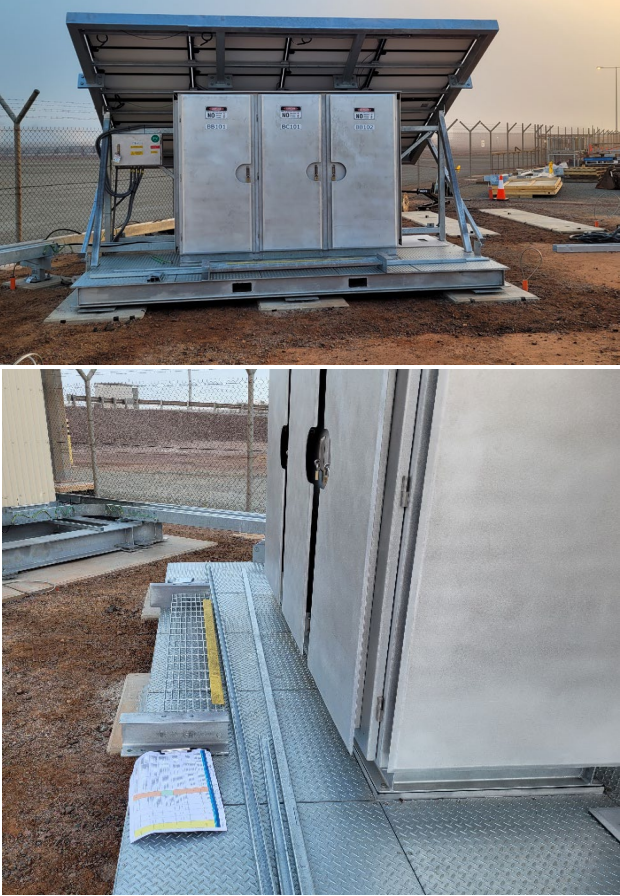
Ashburton Port Meter Station - 2	16/07/2024	Ashburton Port Meter Station - Solar Skid x 2	1) No concrete landing for personnel to step on / off when accessing the panel side of the solar skid. 2) Step up from ground onto the skid exceeds the step up requirements under AS1657 (actual 320mm, 200-449mm needs 1 step). 3) No handrails to stop personnel falling or stepping off the skid and insufficient room when opening the panel door. Potential fall is 320mm. Distance from the panel to edge of skid is 710mm (minimum distance for platform and walkway is 600mm). Notes: - Pictured step is for the Controls Shelter according to the Construction Crew. - Raised with Jeromie Gasper as construction project is still in progress.	C. Unlikely	2. Minor	Low	1) Pour a landing for access point(s). 2.1) Option A: Have the landing site 50mm above ground level to eliminate the need of a intermediate step for access. 2.2) Option B: Install a intermediate step. 3) Consider installing handrails around the skid, taking into account distance of panel door opening.

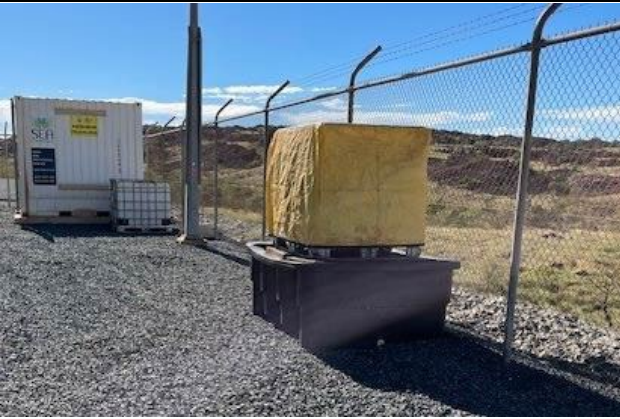
Pluto Interconnect Compressor / Metering Station - 15	8/07/2024	Oil IBC	1) If personnel stand on the bund, they are exposed to a fall. 2) If personnel use a ladder, they are exposed to a fall if the ladder slips on blue metal. Note: INX-19744 raised by Ben Riddle. The oil spear has to be put into the top of the oil pod, so you have to stand on the side of the bund or work from a ladder. Access frequency is every 15 days.	C. Unlikely	3. Severe	Medium	1) Redesign the job to use a pump permanently set up on the bund with a relief in it and feed the pump from the bottom of the IBC. This eliminates the risk of a fall from height and reduces the risk of oil spills on blue metal during transfer of oil. Suggestions from Ben Riddle in INX-19744.

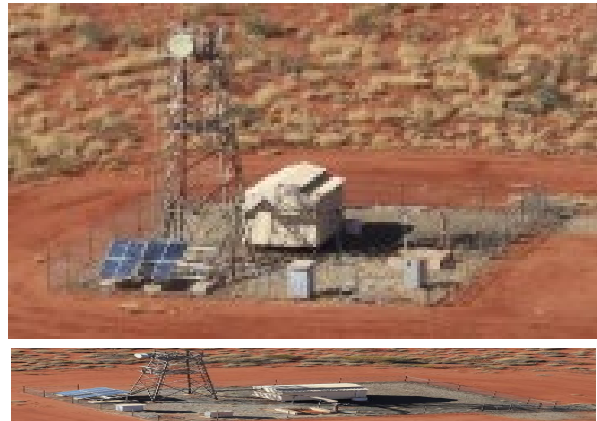
Spur 1 - 1	22/04/2024	Spur 1 - Hut	Assessed using surveillance photo. Additional photos requested to confirm accuracy of assessment. 1) No handrails are installed and therefore the AS requirement (2 or more stairs) is not being met. 2) The stairs do not run the full length until the landing and entrance of hut. However the Step Up does currently meet the AS requirement (200mm).	D. Occasional	3. Severe	Medium	1) Install handrails that run the full length of stairs and meet AS requirements. 2) Redesign the stairs to run from the landing to the entrance to the hut and meet the AS requirements and provide safe access. 3) Ensure hi vis (yellow) anti-slip tread is installed on the entire of

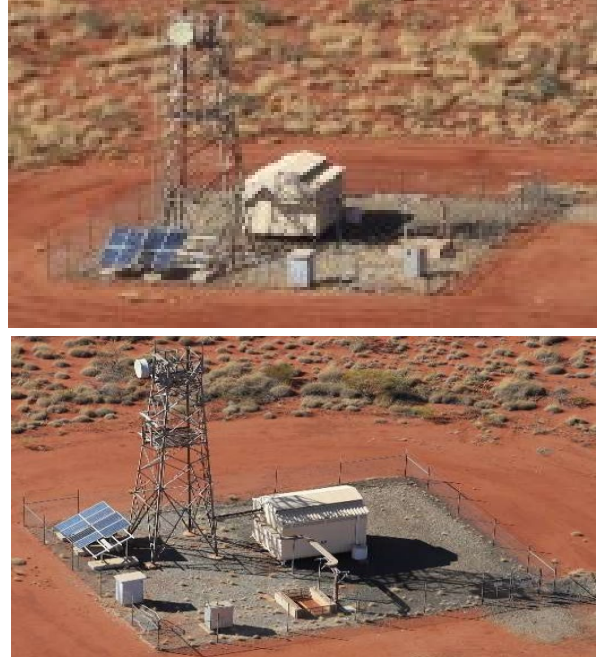
Spur 1 - 2	22/04/2024	Spur 1 - Tower	No ladder access on tower is visible from surveillance photos. Scaffolding, EWP or other means of access would be required.				N.A.

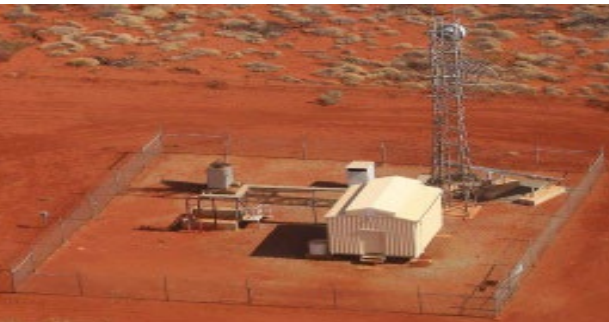
Reference	Date Added	Site	Issue	Likelihood	Consequence	Risk Score	Suggestions	Evidence	Date Planned For Completion	Date Completed	Comments
Spur 2 - 1	22/04/2024	Spur 2 - Hut	1) No handrails are installed and therefore the AS requirement (2 or more stairs) is not being met. 2) The stairs do not run the full length until the landing and entrance of hut. However the Step Up does currently meet the AS requirement (300mm)	D. Occasional	3. Severe	Medium	1) Install handrails that run the full length of stairs and meet AS requirements. 2) Redesign the stairs to run from the landing to the entrance to the hut and meet the AS requirements and provide safe access.

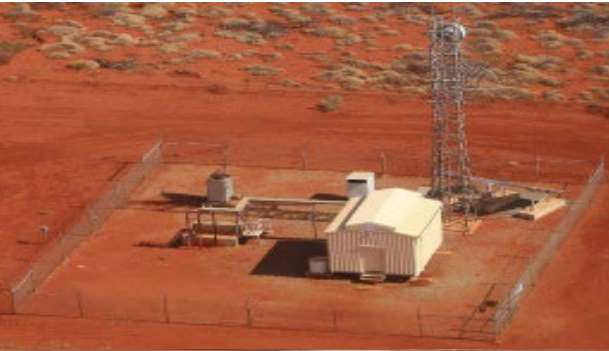
Spur 2 - 2	22/04/2024	Spur 2 - Tower	No ladder access on tower is visible from surveillance photos. Scaffolding, EWP or other means of access would be required.				N.A.

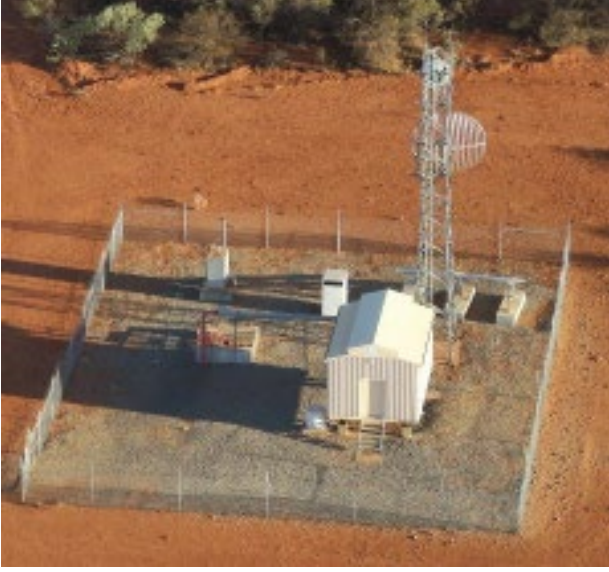
Spur 3 - 1	22/04/2024	Spur 3 - Hut	1) No handrails are installed and therefore the AS requirement (2 or more stairs) is not being met. 2) The stairs do not run the full length until the landing and entrance of hut. However the Step Up does currently meet the AS requirement (300mm) 3) No hi vis (yellow) anti-slip tread installed on the nosing of the stairs. 4) The landing is smaller then the size required in the AS (minimum 600mm depth from bottom stair). <i>Note: Assessed using surveillance photos. Onsite verification and measures required.</i>	D. Occasional	3. Severe	Medium	1) Install handrails that run the full length of stairs and meet AS requirements. 2) Redesign the stairs to run from the landing to the entrance to the hut and meet the AS requirements and provide safe access. 3) Ensure hi vis (yellow) anti-slip tread is installed on the nosing of all stairs (width 840mm). 4) Remove the existing landing and pour a new landing that meets AS requirements.

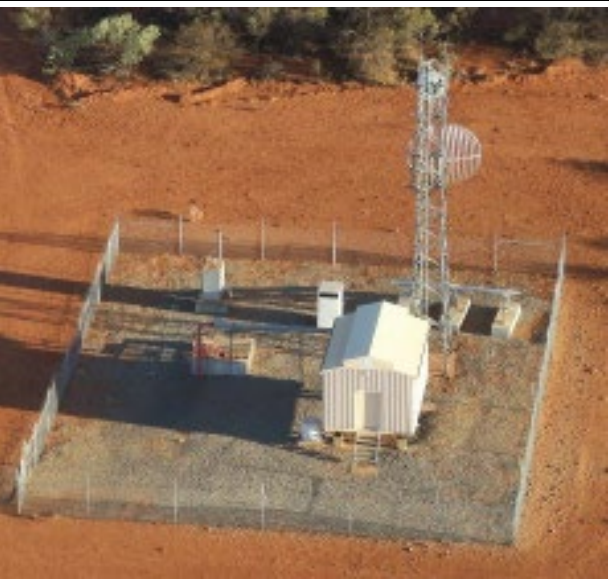
Spur 3 - 2	22/04/2024	Spur 3 - Tower	No ladder access on tower is visible from surveillance photos. Scaffolding, EWP or other means of access would be required.				N.A.

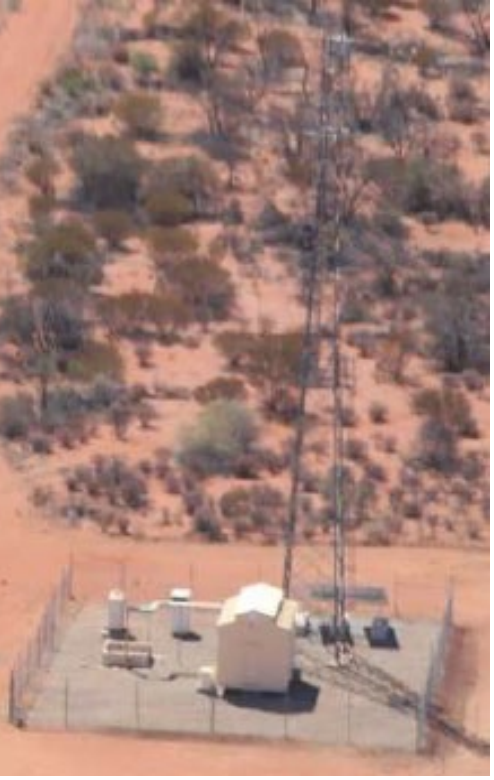
Spur 4 - 1	22/04/2024	Spur 4 - Hut	1) No handrails are installed and therefore the AS requirement (2 or more stairs) is not being met. 2) The stairs do not run the full length until the landing and entrance of hut. However the Step Up does currently meet the AS requirement (300mm) 3) No hi vis (yellow) anti-slip tread installed on the nosing of the stairs. 4) The landing is smaller then the size required in the AS (minimum 600mm depth from bottom stair). <i>Note: Assessed using surveillance photos. Onsite verification and measures required.</i>	D. Occasional	3. Severe	Medium	1) Install handrails that run the full length of stairs and meet AS requirements. 2) Redesign the stairs to run from the landing to the entrance to the hut and meet the AS requirements and provide safe access. 3) Ensure hi vis (yellow) anti-slip tread is installed on the nosing of all stairs (width 840mm). 4) Remove the existing landing and pour a new landing that meets AS requirements.

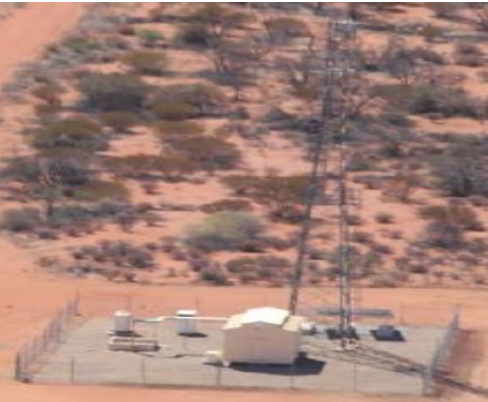
Reference	Date Added	Site	Issue	Likelihood	Consequence	Risk Score	Suggestions	Evidence	Date Planned For Completion	Date Completed	Comments
Spur 4 - 2	22/04/2024	Spur 4 - Tower	1) No access platform provided for ease of access to the ladder. Note: This may have not be provided for the purpose of preventing unauthorised access. 2) No fall restraint/arrest system in place for personnel using the ladder. This exposes personnel to a significant fall that would likely result in a fatality or serious injury.	C. Unlikely	4. Major	High	1) Install a access stairs/ladder and platform to enable access to the ladder. Ensure a lockable gate or similar and signage is provided to prevent unauthorised access. 2) Install a certified fall restraint/arrest system that is suitable for the end users. 3) Assess if the installation a side

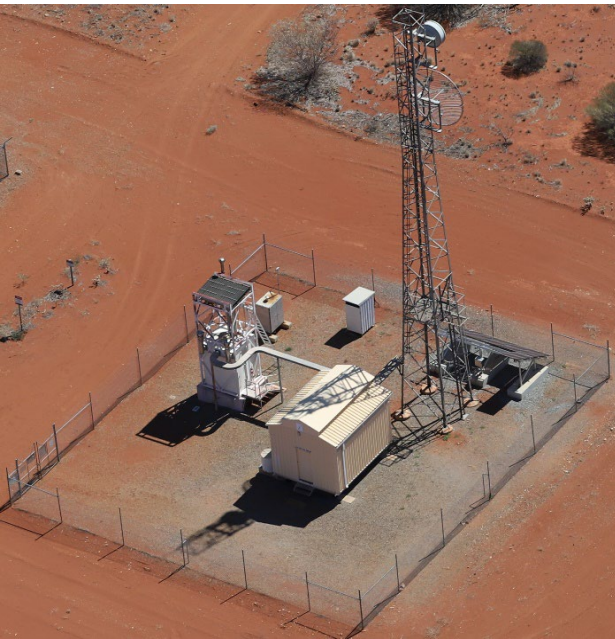
Spur 5 - 1	22/04/2024	Spur 5 - Hut	1) No handrails are installed and therefore the AS requirement (2 or more stairs) is not being met. 2) The stairs do not run the full length until the landing and entrance of hut. However the Step Up does currently meet the AS requirement (300mm) 3) No hi vis (yellow) anti-slip tread installed on the nosing of the stairs. 4) The landing is smaller then the size required in the AS (minimum 600mm depth from bottom stair). Note: Assessed using surveillance photos. Onsite verification and measures required.	D. Occasional	3. Severe	Medium	1) Install handrails that run the full length of stairs and meet AS requirements. 2) Redesign the stairs to run from the landing to the entrance to the hut and meet the AS requirements and provide safe access. 3) Ensure hi vis (yellow) anti-slip tread is installed on the nosing of all stairs (width 840mm). 4) Remove the existing landing and pour a new landing that meets AS requirements.

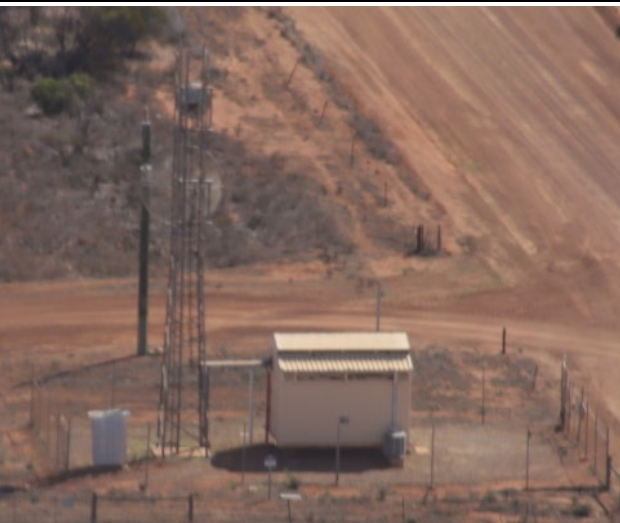
Reference	Date Added	Site	Issue	Likelihood	Consequence	Risk Score	Suggestions	Evidence	Date Planned For Completion	Date Completed	Comments
Spur 6 - 1	22/04/2024	Spur 5 - Hut	<p>1) No handrails are installed and therefore the AS requirement (2 or more stairs) is not being met.</p> <p>2) The stairs do not run the full length until the landing and entrance of hut. However the Step Up does currently meet the AS requirement (300mm)</p> <p>3) No hi vis (yellow) anti-slip tread installed on the nosing of the stairs.</p> <p>4) The landing is smaller then the size required in the AS (minimum 600mm depth from bottom stair).</p> <p>Note: Assessed using surveillance photos. Onsite verification and measures required.</p>	D. Occasional	3. Severe	Medium	<p>1) Install handrails that run the full length of stairs and meet AS requirements.</p> <p>2) Redesign the stairs to run from the landing to the entrance to the hut and meet the AS requirements and provide safe access.</p> <p>3) Ensure hi vis (yellow) anti-slip tread is installed on the nosing of all stairs (width 840mm).</p> <p>4) Remove the existing landing and pour a new landing that meets AS requirements.</p>

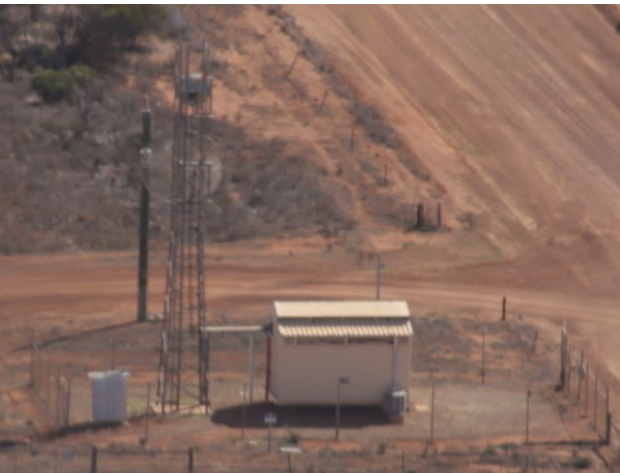
Spur 6 - 2	22/04/2024	Spur 5 - Tower	<p>1) Unlike some other Repeater Stations, the ladder at this location can be access from ground level. No gate or means of accessing the ladder on a platform at height to prevent unauthorised access, has been implemented.</p> <p>2) No fall restraint/arrest system in place for personnel using the ladder. This exposes personnel to a significant fall that would likely result in a fatality or serious injury.</p>	C. Unlikely	4. Major	High	<p>1) Consider installing a lockable gate or similar and signage is provided to prevent unauthorised access.</p> <p>2) Install a certified fall restraint/arrest system that is suitable for the end users.</p> <p>3) Replace the ladder with a AS compliant ladder.</p> <p>4) Install hi vis (yellow) anti-slin</p>

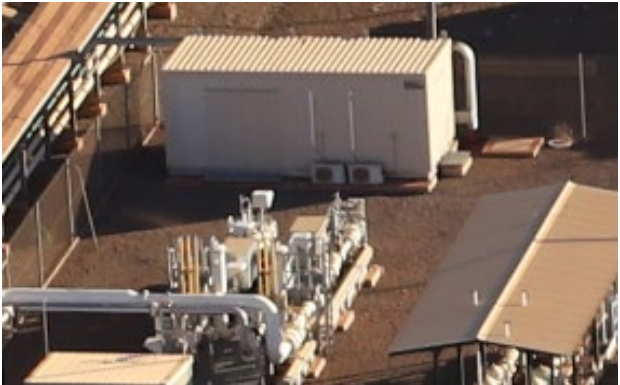
Solomon Meter Station - 1	8/04/2024	Hut	<p>Double Doors</p> <p>1) No landing installed and personnel are landing on dirt.</p> <p>Single Door</p> <p>2) Height for step up appears to exceed AS1657 requirements.</p> <p>Note: Assessed using surveillance photos. Onsite verification and measures required.</p>	C. Unlikely	2. Minor	Low	<p>Double Doors</p> <p>1.1) Pour a landing.</p> <p>Single Door</p> <p>2) Take measurements onsite to verify step up height. Install stairs and pour new landing if required.</p>

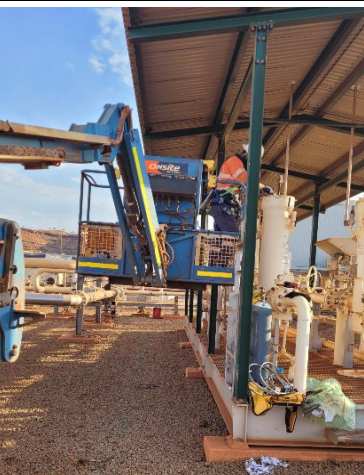
Solomon Meter Station - 2	8/04/2024	Risers / Vents	<p>1) Access to some risers / vents for maintenance activities either requires a platform ladder set up on blue metal (slip risk) or use of a EWP (crush risk).</p> <p>Note: Assessed using surveillance photos. Onsite verification and measures required.</p>	C. Unlikely	3. Severe	Medium	<p>1) Option A: Install concrete landing for platform ladder to be set up on.</p> <p>Option B: Install a purpose built platform and access stairs or ladder that is AS compliant.</p>

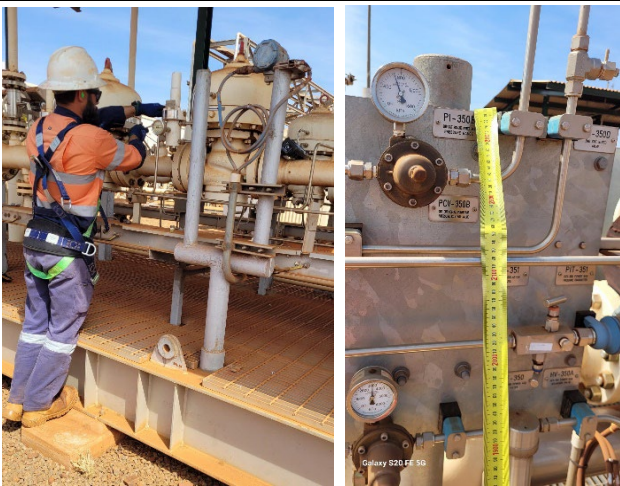
Solomon Meter Station - 3	8/04/2024	Passure Control Skid - External Edges with Equipment (e.g. Instrument Panels, Valves, PSV, Gauges)	<p>1) Personnel performing maintenance activities are required to stand on blue metal or concrete blocks and/or over stretch to access equipment on external sides of the skid.</p> <p>Height up to ~2200mm above ground level.</p> <p>Note: Photos and measurements provided by Kelvin Logan (FMO - Offline Crew).</p>	D. Occasional	2. Minor	Medium	<p>1.1) Install a purpose built platform and access stairs that is AS compliant.</p> <p>1.2) Pour a landing.</p>

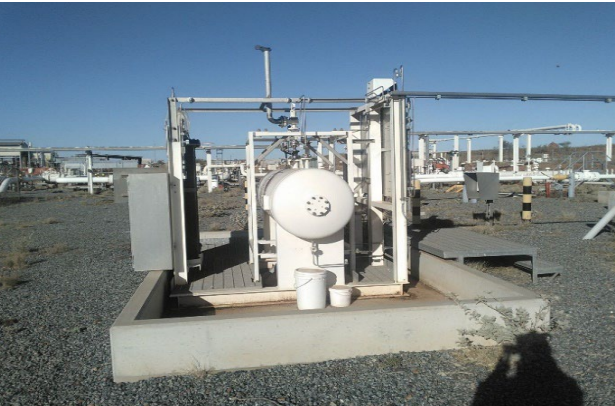
Ashburton West Facility - 2	27/03/2024	Mercaptain Tank, Injection Panel and Bund	1) No hop over on opposite side of the bund to where the concrete step is located. It is a common access path. 2) No hi vis nosing on stairs (width 1790mm). 3) No edge protection installed around platform. Potential fall of 400mm.	C. Unlikely	2. Minor	Low	1) Install a hop over. 2) Install hi vis (yellow) anti slip tread on the nosing of all stairs. 3) Consider installing handrails around the platform.

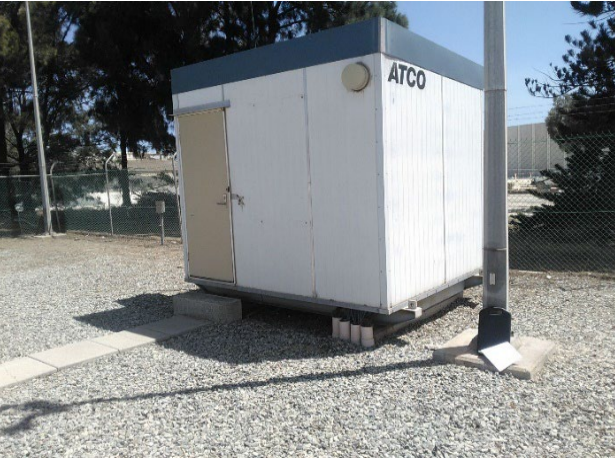
Kwinana Nickel Refinery - 1	5/03/2024	Kwinana Nickel Refinery (KNR) - Hut Access Door	1) No hi vis (yellow) anti-slip tread installed on the nosing of the stairs.	C. Unlikely	2. Minor	Low	1) Install hi vis (yellow) anti-slip tread on the nosing of all stairs.

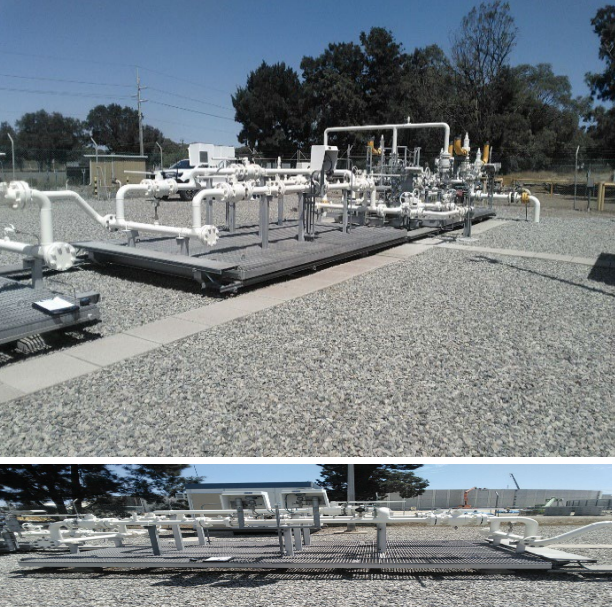
Kwinana Nickel Refinery - 2	5/03/2024	Kwinana Nickel Refinery (KNR) - Metering / Pressure Control Skid	1) East side of skid does not have a landing. Personnel land onto blue metal currently. 2) Step up from the blue metal to the east side of the skid (380mm), does not meet AS requirements (300mm requirements). 3) No handrails installed to provide edge protection and prevent a fall from skid (300-380mm).	C. Unlikely	3. Severe	Medium	1) Pour a landing. 2) Install a interim step between the new landing and skid, if required to meet AS1657 requirements. 3) Consider installing handrails around open edges of skid, with designated access points that meet AS1657 requirements.

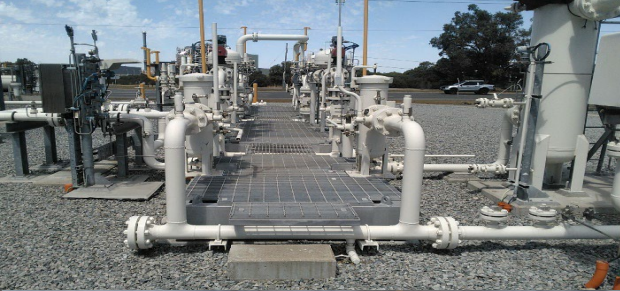
Rockingham Meter Station - 2	5/03/2024	Rockingham Meter Station - Pressure Control / Metering Skid - 2 x Access Points	<p><i>West Side (Smaller Step)</i></p> <p>1) No concrete landing. Currently stepping onto blue metal which was found to be slippery.</p> <p>2) No hi vis nosing on stairs (730mm width).</p> <p>3) Stair design does not meet AS1657</p>	C. Unlikely	2. Minor	Low	<p>1) Pour a landing for each set of access stairs.</p> <p>2) Install hi vis (yellow) anti slip tread on the nosing of all stairs.</p> <p>3) Replace step.</p>

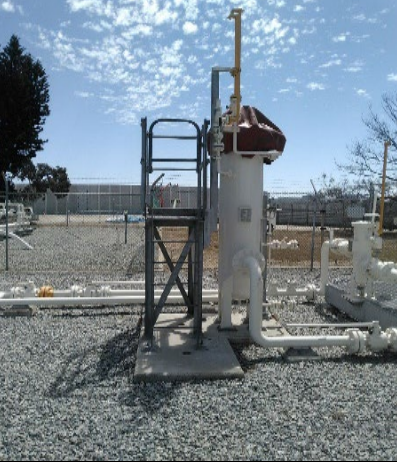
Rockingham Meter Station - 4	5/03/2024	Rockingham Meter Station -Access Platform	<p>1) Ladder rungs are smooth and does not have anti slip tread.</p> <p>2) Ladder is not install on centre of landing. The landing does not meet AS1657 requirements (e.g. actual 580mm vs required 900mm depth).</p>				<p>1) Install hi vis (yellow) anti slip tread onto all ladder rungs.</p> <p>2) Replace the landing.</p>

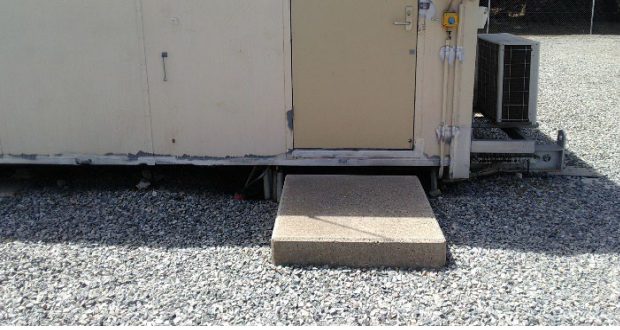
Reference	Date Added	Site	Issue	Likelihood	Consequence	Risk Score	Suggestions	Evidence	Date Planned For Completion	Date Completed	Comments
Rockingham Meter Station - 5	5/03/2024	Rockingham Meter Station - Hut	<p>1) Step up from stair into Hut exceeds AS1657 requirements (430mm requires at least 1 interim step).</p> <p>2) No hi vis nosing on stairs (730mm width).</p> <p>3) No concrete landing. Currently stepping onto blue metal which was found to be slippery.</p>				<p>1) Remove the existing concrete step and replace with AS1657 compliant stairs.</p> <p>2) Install hi vis (yellow) anti slip tread on the nosing of all stairs.</p> <p>3) Pour a landing.</p>

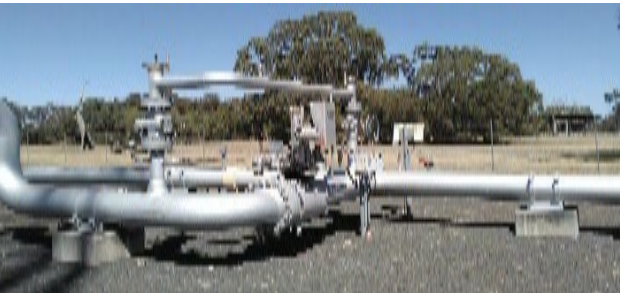
Wagerup West - 1	5/03/2024	All Areas	<p>1) Access to Risers and Vents ~2000mm for maintenance tasks currently completed using a platform ladder on blue metal. This creates the potential for the ladder to be unstable and cause a fall from height.</p>	C. Unlikely	3. Severe	Medium	<p>1) Option A: Install concrete landing for platform ladder to be set up on.</p> <p>Option B: Install a purpose built platform and access stairs or ladder that is AS compliant.</p>

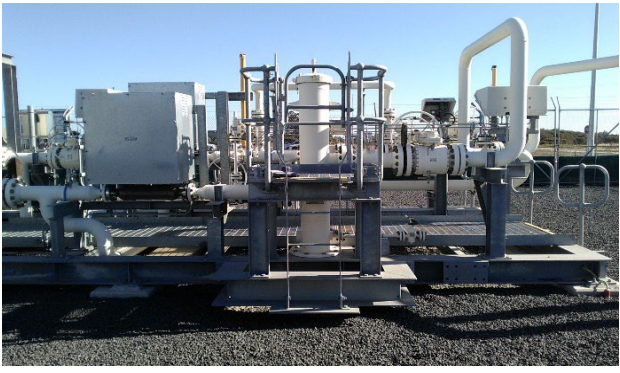
Wellesley Meter Station - 2	5/03/2024	Platform Adjacent to Metering / Pressure Control Skid	<p>1) No top handrail for section facing the riser.</p> <p>2) No hi vis (yellow) tread installed on of each ladder rung.</p> <p>3) No landing for the ladder and ladder is suspended above the ground.</p>	C. Unlikely	3. Severe	Medium	<p>1) Install the missing top handrail.</p> <p>2) Install hi vis (yellow) tread onto each ladder rung.</p> <p>3.1) Pour a landing.</p> <p>3.2) Extend the ladder to the landing, ensuring AS1657 requirements are met (e.g. step up).</p>

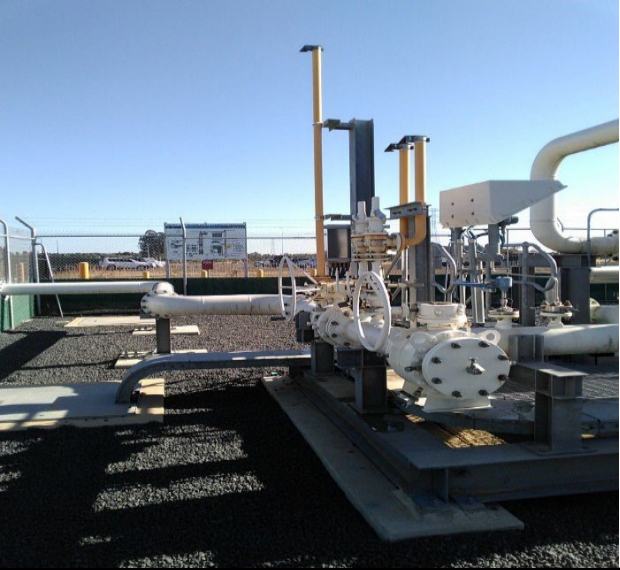
Wellesley Meter Station - 3	5/03/2024	Vents on the West Side of the Metering / Pressure Control Skid	<p>1.1) Access to Risers and Vents ~2500mm for maintenance tasks currently completed using a platform ladder on blue metal. This creates the potential for the ladder to be unstable and cause a fall from height.</p> <p>1.2) Existing landing impacts access to Vents and Hand Valves. Trip / slip off landing is possible with potential sprains / strain type injuries</p>	C. Unlikely	3. Severe	Medium	<p>1.1) Option A: Install concrete landing for platform ladder to be set up on.</p> <p>Option B: Install a purpose built platform and access stairs or ladder that is AS compliant.</p> <p>1.2) Extend the landing to accommodation the above and accessing hand valves.</p>

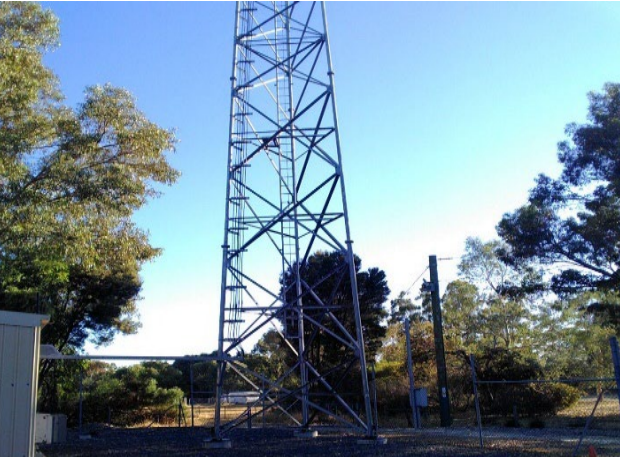
Clifton Road Meter Station-3	1/03/2024	Pav Hut - Roof	<p>1) Roof access periodically required for maintenance work. Currently performed with personnel working in FIPS.</p> <p>Note: Same Hazard / Design issue as raised for another Facilities Site by Andrew Hynes.</p>	C. Unlikely	4. Major	High	<p>1) Consider installing a platform and access stairs / ladder. This will prevent a fall and reliance on PPE.</p>	 			
Clifton Road Meter Station-4	1/03/2024	Repeater Tower	<p>1) No access platform provided for ease of access to the ladder.</p> <p>Note: This may have not be provided for the purpose of preventing unauthorised access.</p> <p>2) No fall restraint/arrest system in place for personnel using the ladder. This exposes personnel to a significant fall that would likely result in a fatality or serious injury.</p> <p>3) No ladder enclosure has been installed</p>	C. Unlikely	4. Major	High	<p>1) Install a access stairs/ladder and platform to enable access to the ladder. Ensure a lockable gate or similar and signage is provided to prevent unauthorised access.</p> <p>2) Install a certified fall restraint/arrest system that is suitable for the end users.</p> <p>3) Assess if the installation a side screen, ladder cage or other type of enclosure to prevent a</p>

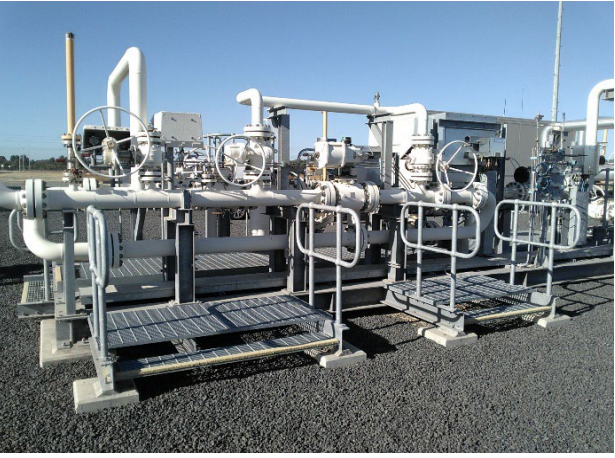
Reference	Date Added	Site	Issue	Likelihood	Consequence	Risk Score	Suggestions	Evidence	Date Planned For Completion	Date Completed	Comments
Wellesley Meter Station - 1	1/03/2024	Access Stairs for Metering / Pressure Control Skid and Hand Valves	1) No hi vis (yellow) anti-slip tread installed on the nosing of the several stairs or does not cover the full length of the stair. 2) No concrete landing. Currently stepping onto blue metal which was found to be slippery. 3) Several gaps where people can fall (250-300mm) or take shortcuts and potential knock into equipment (injury / equipment damage).	C. Unlikely	2. Minor	Low	1) Ensure hi vis (yellow) anti-slip tread is installed on the nosing of all stairs (full width). 2) Consider pouring a landing in line with the access stairs and that meets the AS requirements. 3) Consider installing handrail and kick plates to eliminate them from being used as a shortcut.

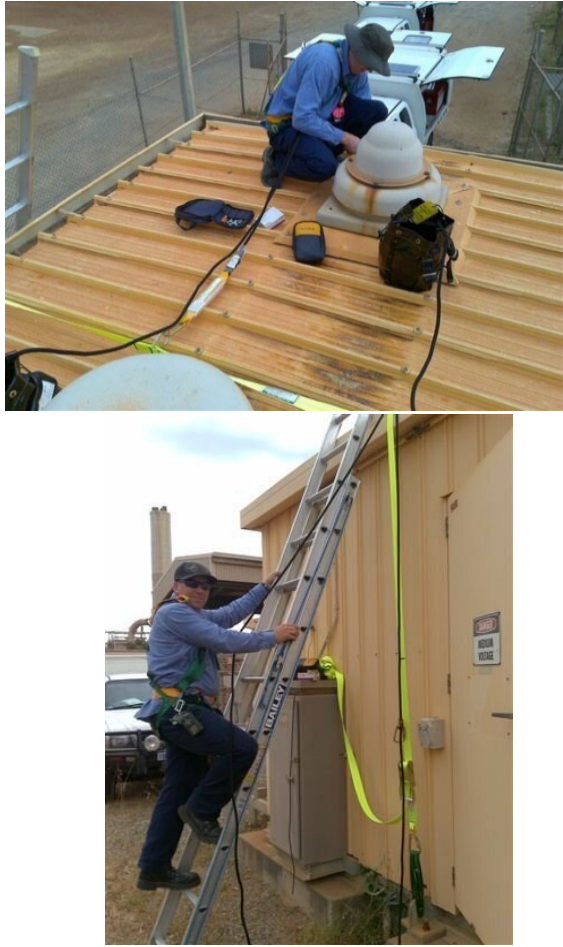
Worsley Meter Station - 1	19/12/2023	Pav Hut - Roof	1) Roof access periodically required for maintenance work. Currently performed with personnel working in FIPS. Note: Hazard / Design issue raised by Andrew Hynes. Advised this same issue appears on a number of other sites.	C. Unlikely	4. Major	High	1) Consider installing a platform and access stairs / ladder. This will prevent a fall and reliance on PPE.

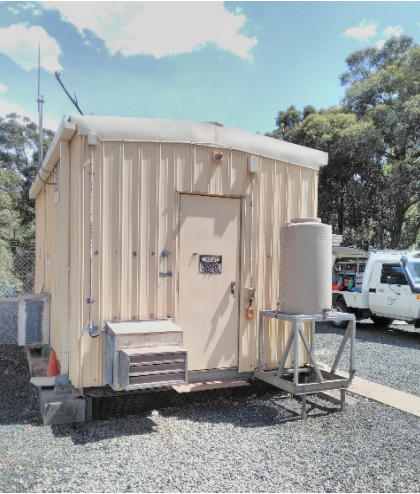
Reference	Date Added	Site	Issue	Likelihood	Consequence	Risk Score	Suggestions	Evidence	Date Planned For Completion	Date Completed	Comments
Worsley Meter Station - 2	19/12/2023	Pav Hut - Access Doors	<p>1) The stairs do not run the full length until the landing and entrance of hut. This has resulted in the Step Up not meeting the AS requirement.</p> <p>2) No hi vis (yellow) anti-slip tread installed on the nosing of the stairs.</p> <p>3) No landing available on South side. Personnel stepping onto / off blue metal which can be slippery</p> <p>4) Landing and Concrete Step on the East side do not meet AS requirements and poses a trip / slip fall.</p>	D. Occasional	3. Severe	Medium	<p>1) Redesign the stairs to run from the landing to the entrance to the hut and meet the AS requirements and provide safe access. This includes handrails if two steps or more are required.</p> <p>2) Ensure hi vis (yellow) anti-slip tread is installed on the nosing of all stairs (width 850mm).</p> <p>3) Pour a landing that meets AS requirements.</p> <p>4) Modify the step and landing to meet AS requirements.</p>

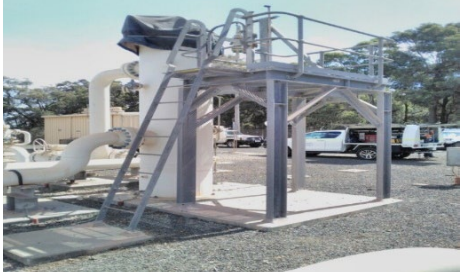
Worsley Meter Station - 3	19/12/2023	Riser - Filter	<p>1) No hi vis (yellow) anti-slip tread installed on the nosing of the stairs.</p> <p>Note: Hazard / Design issue raised by Andrew Hynes. Advised this same issue appears on a number of other sites.</p>	C. Unlikely	2. Minor	Low	<p>1) Ensure hi vis (yellow) anti-slip tread is installed on the nosing of all stairs.</p>

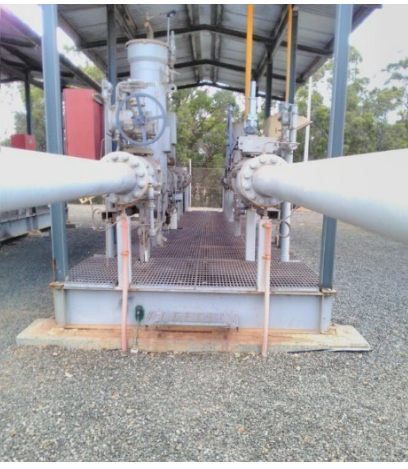
Worsley Meter Station - 4	19/12/2023	SWC Run 1 and Run 2	<p>1.1) Step up appears to exceed AS requirements. Measurements required to confirm.</p> <p>1.2) No hi vis (yellow) anti-slip tread installed on the nosing of the stairs.</p> <p>2) No concrete landing. Currently stepping onto blue metal which was found to be slippery.</p> <p>Note: Hazard / Design issue raised by Andrew Hynes. Advised this same issue appears on a number of other sites.</p>	C. Unlikely	3. Severe	Medium	<p>1.1) If measurements confirm step up / riser heights exceed AS requirements, then modify the stair(s) to meet them.</p> <p>1.2) Ensure hi vis (yellow) anti-slip tread is installed on the nosing of all stairs.</p> <p>2) Consider pouring a landing in line with the access stairs and that meets the AS requirements.</p>

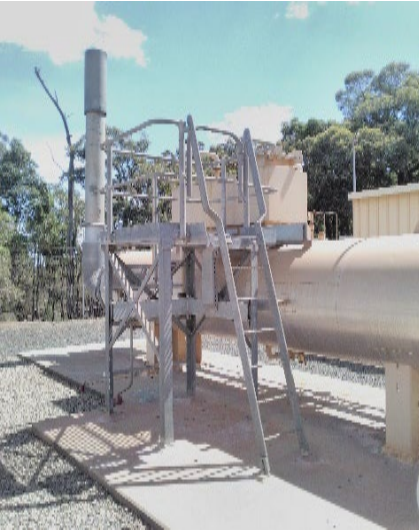
Worsley Meter Station - 5	19/12/2023	Heater Platform	<p>1) No hi vis anti-slip tread has been installed on ladder rungs.</p>	C. Unlikely	2. Minor	Low	<p>1) Replacement ladder to have hi vis (yellow) non-slip tread installed on the rungs.</p>

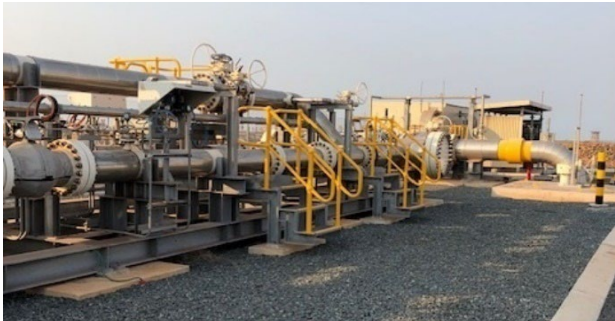
Pluto Interconnect Compressor / Metering Station - 14	27/11/2023	Platforms for Hand Valves	<p>1) The step up from the ground to the first stair exceeds AS requirements.</p> <p>2) No concrete landing. Currently stepping onto blue metal which was found to be slippery.</p> <p>Note: Raised by FMOs during Monthly Workgroup Meeting.</p>	C. Unlikely	2. Minor	Low	<p>1) Modify the stairs to include 1 or more stairs and associated handrails, to ensure AS requirements are met.</p> <p>2) Pour a landing for each set of access stairs.</p>
