Revised Final Plan
Attachment 9.12

Structures & Operational Sites - Working at Heights - Appendix B

August 2025

**Dampier Bunbury
Pipeline**

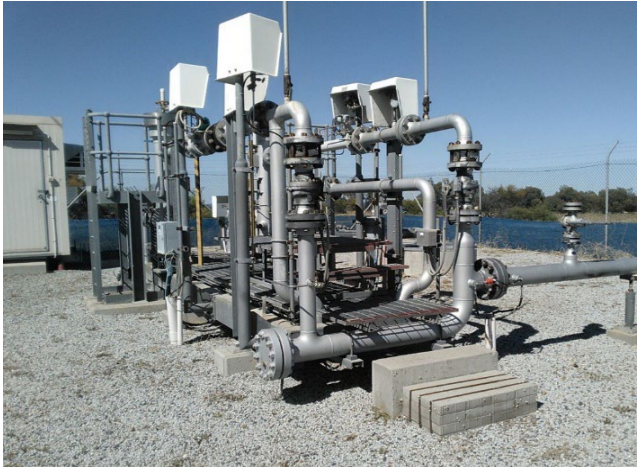
Mondarra Meter Station - 1	5/10/2023	Mondarra Meter Station - Metering Skid	<p>1) Concrete slab used for stairs but do not meet AS requirements.</p> <p>2) Landing on one side does not meet AS requirements. The other side has blue metal as landing which can be slippery.</p> <p>3) No hi vis nosing on stairs and edge of platform.</p> <p>Note: Height of fall 600mm.</p>	C. Unlikely	3. Severe	Medium	<p>1) Redesign the stairs to meet AS requirements (e.g. implement a 3rd step). If 2 or more steps are in place, then handrails are required.</p> <p>2) Landing to be poured to suit new stair design and AS requirements.</p> <p>3) Install hi vis (yellow) non-slip tread installed on the nosing of all stairs.</p>

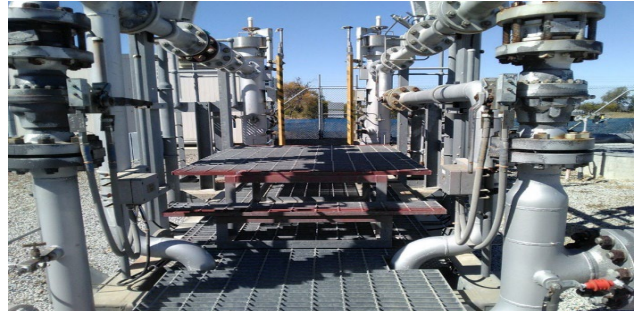
Mondarra Meter Station - 2	5/10/2023	Mondarra Meter Station - Metering Skid - Platform Landed on Skid	<p>1) No hi vis nosing on stairs and edge of platform.</p> <p>2) No edge protection on the platform. Depending on the side, there is potential for a fall through the pipework onto ground below or grid mesh deck.</p>	C. Unlikely	3. Severe	Medium	<p>1) Install hi vis (yellow) non-slip tread installed on the nosing of all stairs.</p> <p>2) Install edge protection on platform.</p>

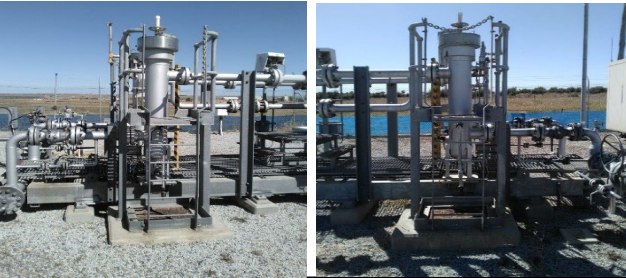
Reference	Date Added	Site	Issue	Likelihood	Consequence	Risk Score	Suggestions	Evidence	Date Planned For Completion	Date Completed	Comments
Mondarra Meter Station - 3	5/10/2023	Mondarra Meter Station - Metering Skid - 2 x Platforms For Risers	1) Chain has been used in lieu of a self closing gate at the entrance of the two platforms. Chain will break in the event of a fall and self closing gates are a AS requirement. 2) No hi vis (yellow) anti-slip tread installed on the ladder rungs.	C. Unlikely	3. Severe	Medium	1) Replace the chains with a self closing gate. 2) Install hi vis (yellow) anti-slip tread to all ladder rungs. 3) Pour a new landing for each platform.

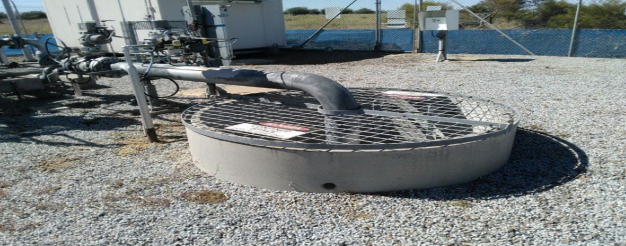
Mondarra Meter Station - 4	5/10/2023	Mondarra Meter Station - Confined Space Pit - Access Ladder For Hand Valve	1) Ladder does not extend 1m (~800mm) past the landing at the top of the ladder and does not have sufficient locations to hold onto when mounting / dismantling. 2) No non-slip tread on ladder rungs.	B. Remote	3. Severe	Medium	1) Modify or replace the ladder, ensuring it extends 1m past the top landing, with sufficient locations to hold onto when mounting / dismantling the ladder.

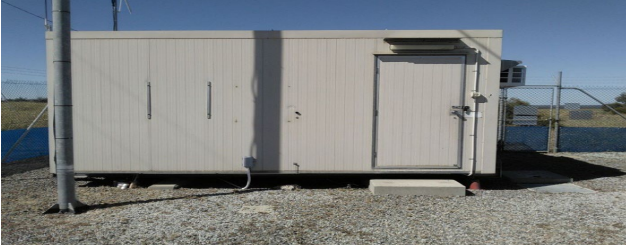
Mondarra Meter Station - 5	5/10/2023	Mondarra Meter Station - Pav Hut	1) Landing does not meet the AS requirements and is currently blue metal.	B. Remote	2. Minor	Low	1) Pour a landing that meets AS requirements.

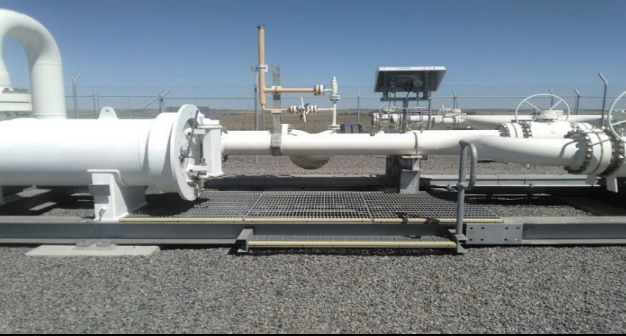
Waitsia Inlet Meter Station - 1	5/10/2023	Waitsia Inlet Meter Station - Filter Skid	1) Access stairs for platform used to access HV-106D is missing one handrail (left hand side). Holes already drilled into support. 2) No concrete landing. Currently stepping onto blue metal which was found to be slippery.	C. Unlikely	2. Minor	Low	1) Consider installing a handrail on the left hand side of the stairs, that matches the existing handrail on the right hand side. 2) Consider pouring a landing in line with the access stairs and that meets the AS requirements.

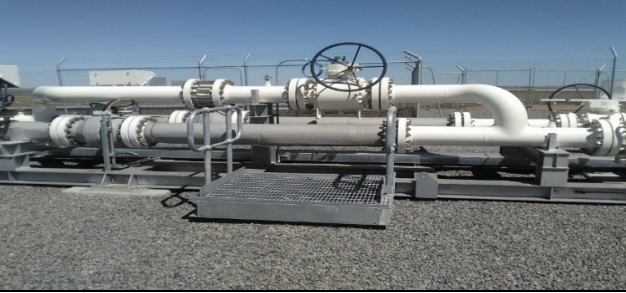
Waitsia Inlet Meter Station - 2	5/10/2023	Waitsia Inlet Meter Station - Metering Skid	1) No hi vis (yellow) anti-slip tread installed on the nosing of the stairs. 2) No concrete landing. Currently stepping onto blue metal which was found to be slippery.	C. Unlikely	2. Minor	Low	1) Ensure hi vis (yellow) anti-slip tread is installed on the nosing of all stairs. 2) Consider pouring a landing in line with the access stairs and that meets the AS requirements.

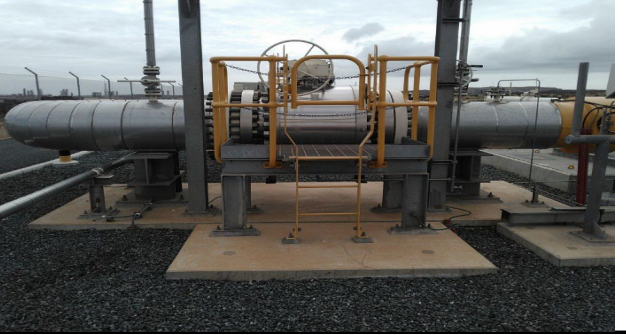
Dampier Facilities - 2	29/08/2023	Platforms for HV211 and HV237	1) Chain has been used in lieu of a handrail at the top of the platform, adjacent to the Bettic Equipment or Valves Chain will break in the event of a fall and therefore will not meet AS 1657 requirements for guardrails. 2) No hi vis (yellow) tread installed onto each ladder rung (450mm).	C. Unlikely	3. Severe	Medium	1) Replace the chain with a handrail that meets AS 1657 requirement. 2) Hi vis (yellow) non-slip tread to be installed on the ladder rungs.

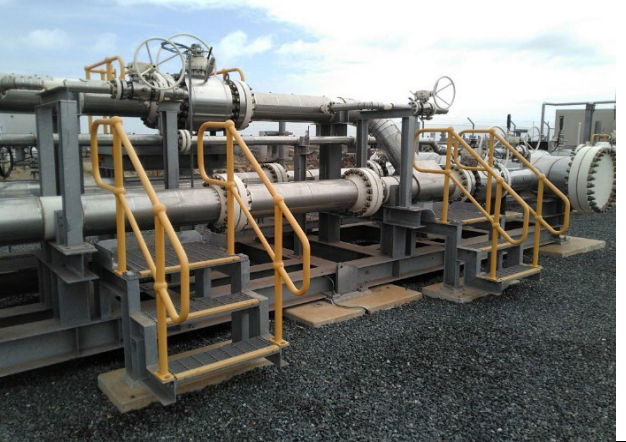
Review of Gorgon Meter Station identified that Chevron has similar platforms with a different design for the handrail that enables access to equipment. They curve the handrail below or above the equipment so you have unrestricted access but still have edge protection to protect against a fall. Photos are available for reference.
Dampier Facilities - 3	29/08/2023	Platforms for HV242 and HV243	1) The landing for the stairs does not meet AS1657 requirements of 900mm. 2) No hi vis (yellow) tread installed onto the nosing of each stair (1000mm). 3) No edge protection to prevent a fall from platform. Note: Step up from landing (currently blue metal) is 300mm so no intermediate step is required.	C. Unlikely	2. Minor	Low	1) Pour a new landing. 2) Install hi vis (yellow) tread onto the nosing of each stair. 3) Install edge protection for platform.

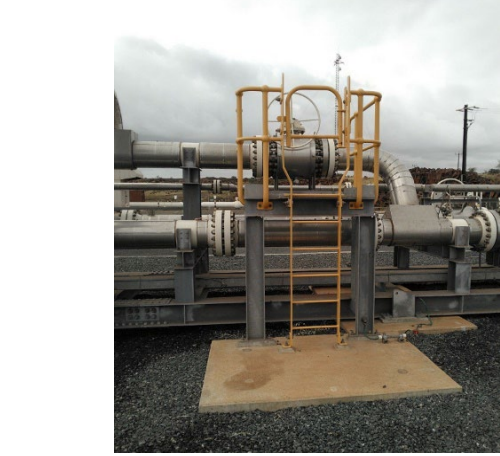
Dampier Facilities - 4	29/08/2023	Platforms for HV220 and HV241	1) No hi vis (yellow) tread installed onto each ladder rung (450mm).	C. Unlikely	2. Minor	Low	1) Hi vis (yellow) non-slip tread to be installed on the ladder rungs.

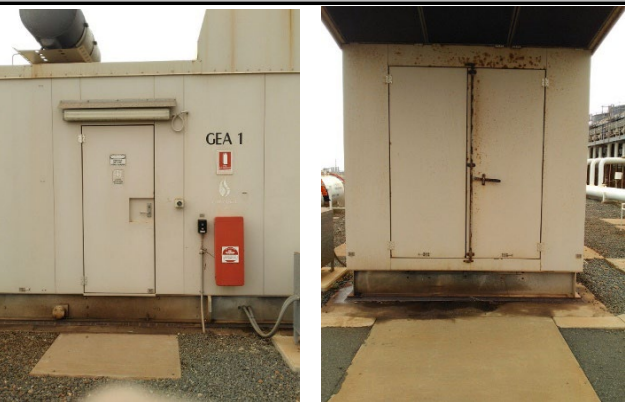
Reference	Date Added	Site	Issue	Likelihood	Consequence	Risk Score	Suggestions	Evidence	Date Planned For Completion	Date Completed	Comments
Dampier Facilities - 5	29/08/2023	GEA 1	<p>1) The Step Up from the ground to the step / door is 410mm which exceeds AS1657 requirements.</p> <p>2) No hi vis (yellow) anti-slip tread installed on the nosing of the lip of the stair at one access door.</p>	D. Occasional	3. Severe	Medium	<p>1) Install 1 intermediate step between the landing and doorway at each of the 3 doors.</p> <p>2) Ensure hi vis (yellow) anti-slip tread is installed on the nosing of stairs.</p>

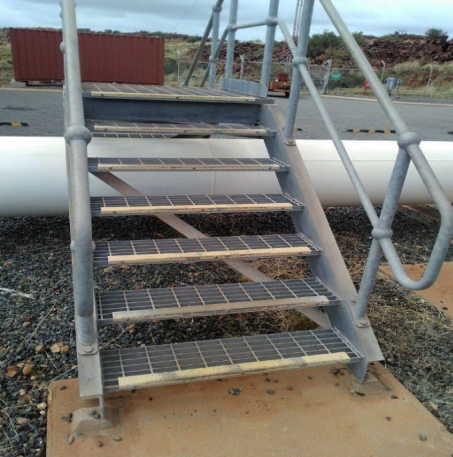
Dampier Facilities - 7	29/08/2023	Access Stairs Between GEA 1 and After Cooler Fans	1) The existing hi vis (yellow) anti-slip tread installed on some of the stairs are significantly worn and may impact their effectiveness.	C. Unlikely	2. Minor	Low	1) Replace the hi vis (yellow) non-slip tread on each stair (1000mm width).

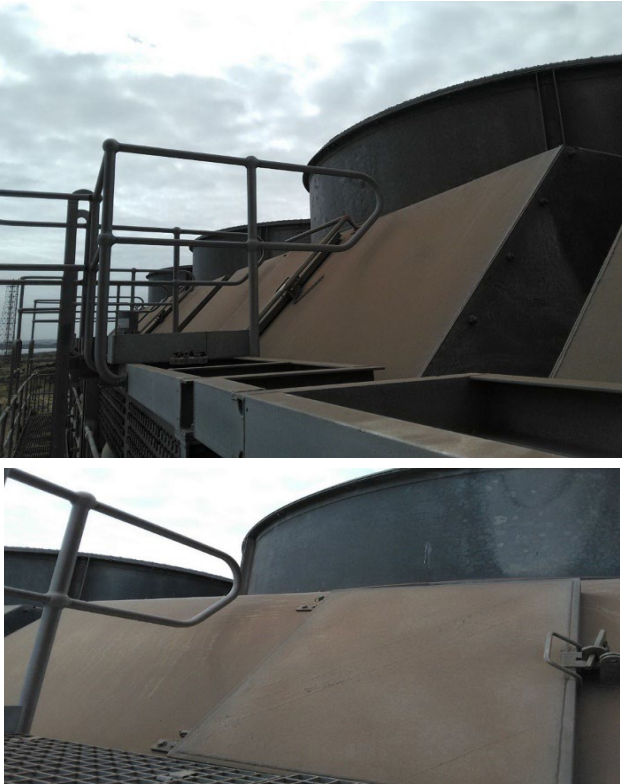
Dampier Facilities - 9	29/08/2023	Top Platform for each After Cooler Fan	<p>1.1) There is no method for accessing this platform from the below walkway without climbing onto structural steel and being exposed to a fall.</p> <p>1.2) Gap between the existing handrail and the structure on both sides of the platform. This poses a potential of a slip / trip.</p>	C. Unlikely	4. Major	High	<p>1.1) Install signage to highlight the fall from height risk until a suitable means of access is installed.</p> <p>1.2) Modify the platform to - allow for safe access to the top of the fans; - eliminate or reduce the gap between the existing handrail and floor / structure.</p>

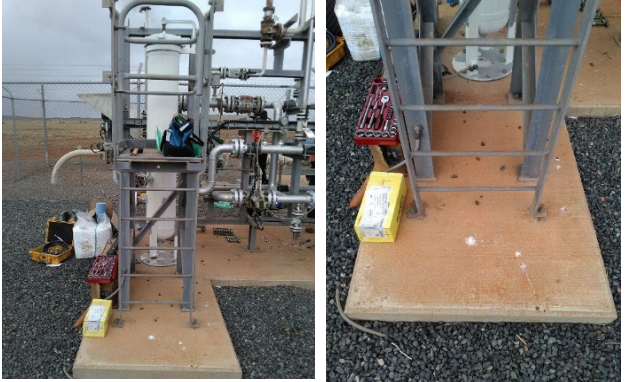
Maitland Estate Meter Station - 1	29/08/2023	Access Ladder / Platform For Riser	<p>1) The depth landing (e.g. 460mm) does not meet AS requirement (e.g. 600mm).</p> <p>2) No hi vis (yellow) anti-slip tread installed on the ladder rungs.</p>	C. Unlikely	2. Minor	Low	<p>1) Pour a new landing.</p> <p>2) Ensure hi vis (yellow) anti-slip tread is installed on the rungs.</p>

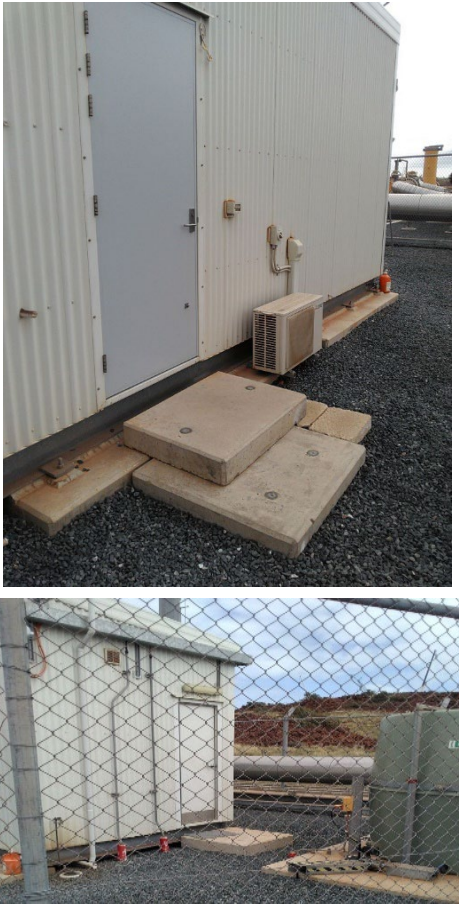
Reference	Date Added	Site	Issue	Likelihood	Consequence	Risk Score	Suggestions	Evidence	Date Planned For Completion	Date Completed	Comments
Pluto Interconnect Compressor / Metering Station - 11	25/08/2023	Battery Room / Hut - 3 x Access Doors	1) 1 Set of Stairs (centre are not centred and small concrete blocks have potential to move.	C. Unlikely	2. Minor	Low	1) Remove the existing steps and landing. Pour a new landing and install a new step that are centred with the access door.

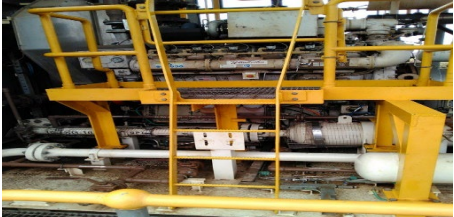
Pluto Interconnect Compressor / Metering Station - 8	25/08/2023	Access Platform For Compressor Package	1) No hi vis (yellow) anti-slip tread installed on the ladder rungs.	C. Unlikely	2. Minor	Low	1) Install hi vis (yellow) anti-slip tread to all ladder rungs.

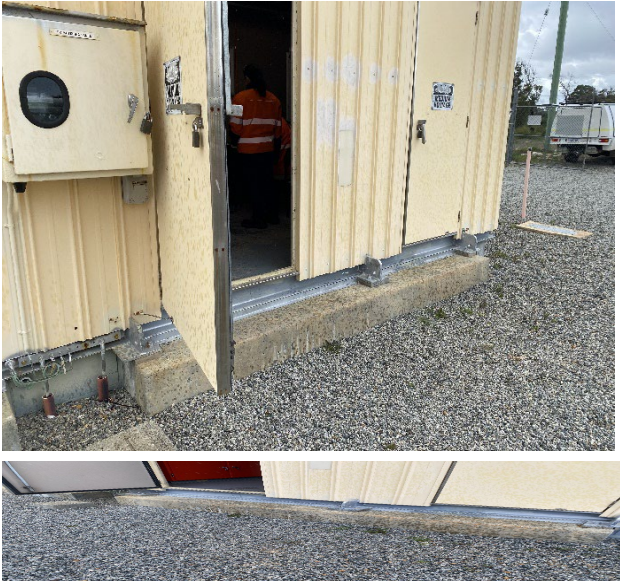
Della Road Meter Station	11/08/2023	Pav Huts	1) The landing does meet AS requirements (e.g. 600mm depth). Employees also reported historical events where personnel have tripped over / on the landing when entering / exiting Pav Huts. Note: FMOs - Facilities reported this same hazard / design issue exists on multiple sites including Forestdale and Whelshpool Meter Stations. 2) Cable Pit adjacent to Pav Hut entrance, posing a trip hazard to personnel.	D. Occasional	2. Minor	Medium	1.1) Extend the landing. 1.2) Install a step to assist with access and a grab, if the AS requirement for step ups requires it (300mm to 400mm requires 1 step). 2) Relocate the Cable Pits to locations outside of access paths, where it is practical to do so. The remaining pits are to be painted with hi vis colour or have hi vis tape applied to highlight them.

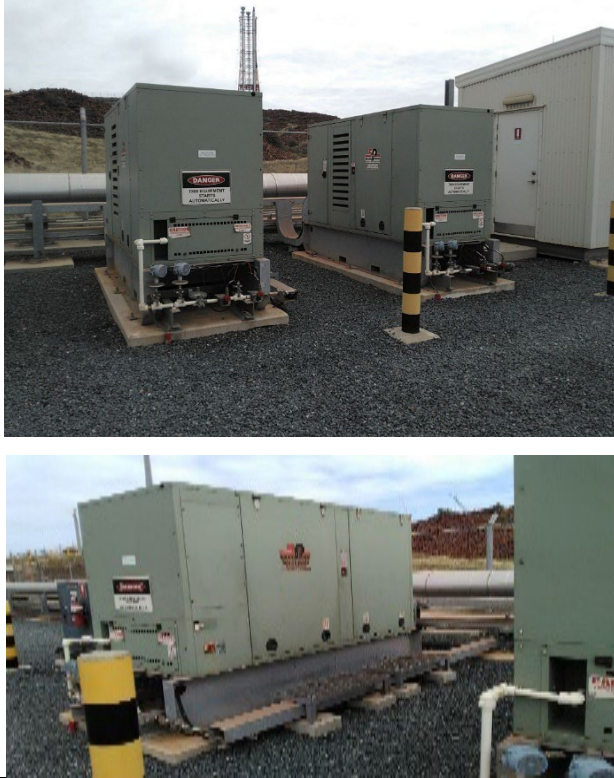
Pluto Interconnect Compressor / Metering Station - 12	11/08/2023	Shelby Power Gas Engine Alternators (x 2)	Non-Grid Mesh Steps Side 1) The landing on this side of both alternators does not meet AS1657 requirements, nor does it provide a stable platform to work from. It also poses a trip hazard when accessing the emergency stop button and cabinets. Grid Mesh Steps Side 2) Step up from ground level to grid mesh steps does not meet AS1657 requirements. Step up is 360mm and therefore an additional step is required. 3) The Grid Mesh Steps are being used as a work platform but their design pose a risk (e.g. small size, no handrails). 4) No hi vis tread on the nosing of the stairs.	C. Unlikely	2. Minor	Low	Non-Grid Mesh Steps Side 1) Pour a new landing. Grid Mesh Steps Side 2) 3.1) Option A: Replace the access step with a purpose build access stairs and platform, with edge protection. 3.2) Option B: Install additional step and retrofit handrails. 4) Install hi vis tread on the nosing of all stairs.

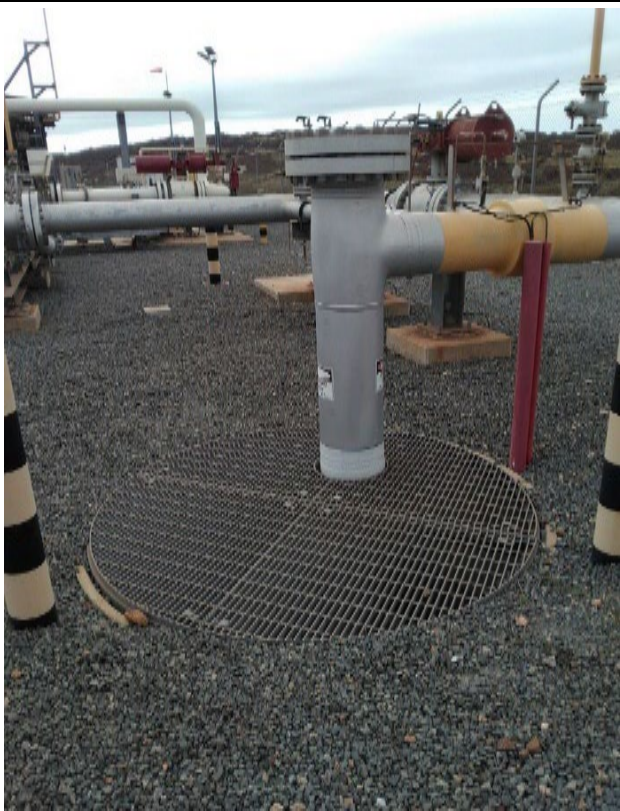
Reference	Date Added	Site	Issue	Likelihood	Consequence	Risk Score	Suggestions	Evidence	Date Planned For Completion	Date Completed	Comments
Pluto Interconnect Compressor / Metering Station - 13	11/08/2023	Inspection Pit For Main Tapping - DBNGP	1) No access ladder has been installed.	B. Remote	3. Severe	Low	1) Install a ladder that is AS1657 compliant.

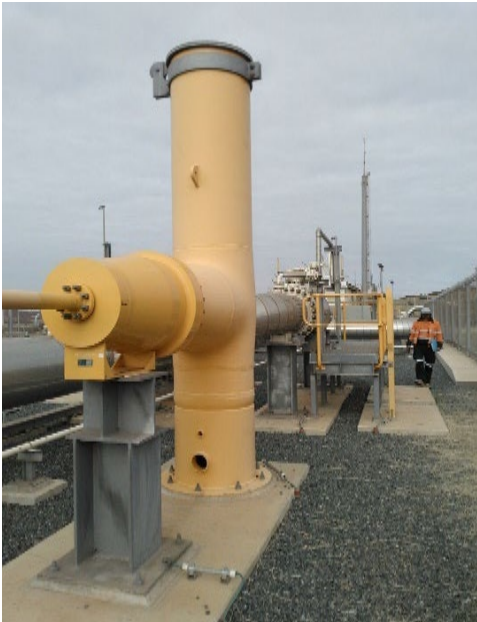
Pluto Interconnect Compressor / Metering Station - 3	11/08/2023	Vent Stack	1) No method for accessing could be identified. Note: Potential fall of ~5m.	C. Unlikely	3. Severe	Medium	1) Install a purpose built platform and access stairs or ladder that is AS compliant.

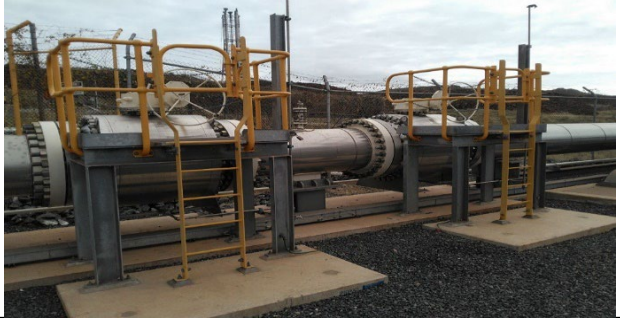
Pluto Interconnect Compressor / Metering Station - 4	11/08/2023	Multiple Platforms to Access Hand Valves, including - HV100A - HV100B - HV124 - HV125 - HV127	1) Chain has been used in lieu of a handrail for two sides of this platform. Chain will break in the event of a fall. 2) No hi vis (yellow) anti-slip tread installed on the ladder rungs.	C. Unlikely	2. Minor	Low	1) Replace the chains with a handrail with a lockable gate for access. 2) Install hi vis (yellow) anti-slip tread to all ladder rungs.

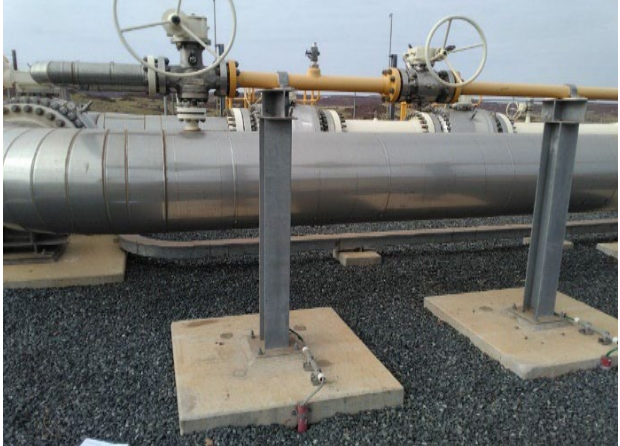
Pluto Interconnect Compressor / Metering Station - 5	11/08/2023	Multiple Hand Valves	1) Existing landings are off centre and insufficient size to position a platform ladder or safety step, to access the hand valves. This creates the risk off a fall.	C. Unlikely	3. Severe	Medium	Option A: Install concrete landing for platform ladder to be set up on. Option B: Install a purpose built platform and access stairs or ladder that is AS compliant.

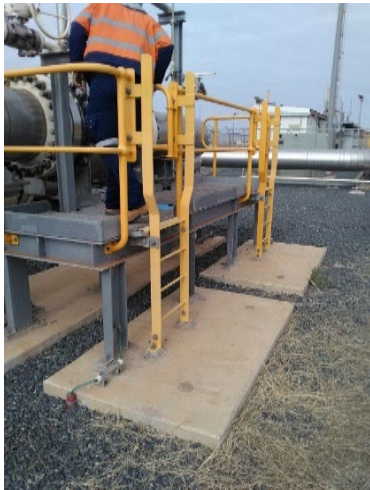
Reference	Date Added	Site	Issue	Likelihood	Consequence	Risk Score	Suggestions	Evidence	Date Planned For Completion	Date Completed	Comments
Pluto Interconnect Compressor / Metering Station - 6	11/08/2023	Hand Valve 107 Platform	1) No hi vis (yellow) anti-slip tread installed on the ladder rungs.	C. Unlikely	2. Minor	Low	1) Install hi vis (yellow) anti-slip tread to all ladder rungs

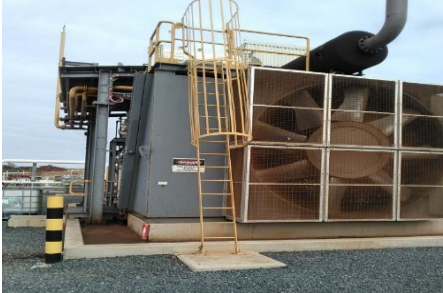
Pluto Interconnect Compressor / Metering Station - 7	11/08/2023	Compressor North Ladder	1) No hi vis (yellow) anti-slip tread installed on the ladder rungs.	C. Unlikely	2. Minor	Low	1) Install hi vis (yellow) anti-slip tread to all ladder rungs

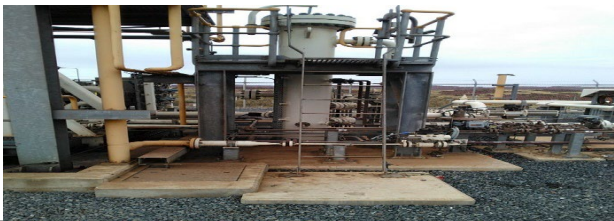
Pluto Interconnect Compressor / Metering Station - 9	11/08/2023	Access Platform for Flange	1) No hi vis (yellow) anti-slip tread installed on the ladder rungs. 2) Self closing gate is no longer self closing and therefore does not meet AS1657 requirements.	C. Unlikely	2. Minor	Low	1) Install hi vis (yellow) anti-slip tread to all ladder rungs. 2) Repair or replace the gate to ensure it is self closing using gravity, spring or other means.

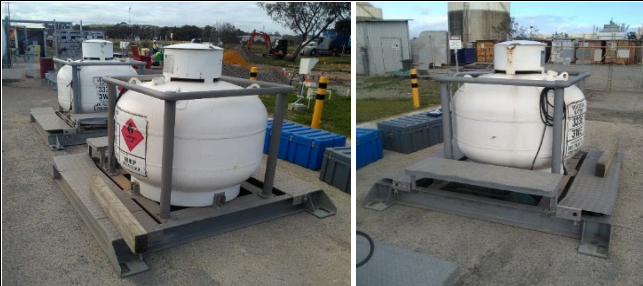
Cape Preston Meter Station - 1	26/07/2023	All Areas	No design risks identified. Situational/task based risk may exist.				No Action Required.	No reference photo taken.			
AGR Meter Station - 1	25/07/2023	Mercaptain Tanks (Style 1 x 2)	1.1) The Step Up from the ground to the higher stair is 440mm and therefore the AS requirement requires a minimum of 1 step be provided. 1.2) The upper stair is being utilised as a landing to work from. This upper stair does not meet the AS requirements for a landing (e.g. depth is 400mm, requirement is 600mm minimum, no handrail). 2) No hi vis (yellow) anti-slip tread installed on the nosing of the stairs.	C. Unlikely	3. Severe	Medium	1) Redesign the access method and landing / work platform to meet AS requirements (including edge protection). 2) Ensure hi vis (yellow) anti-slip tread is installed on the nosing of stairs (2 sides' width >1000mm, 1 side's width x >1900mm) or ladder rungs (if replaced).

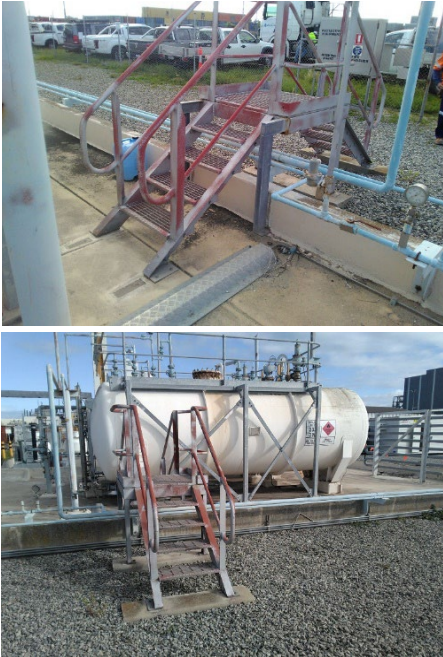
AGR Meter Station - 3	25/07/2023	Access Stairs from Side Gate to Mercaptain Vessels Bund	1) The depth landing (e.g. 300mm) does not meet AS requirement (e.g. 600mm). The edge of the landing (blue metal side) also has a curved edge posing an additional risk of a rolled ankle. 2) No hi vis (yellow) anti-slip tread installed on the nosing of the stairs.	C. Unlikely	2. Minor	Low	1) Pour a new landing. 2) Ensure hi vis (yellow) anti-slip tread is installed on the nosing of stairs.

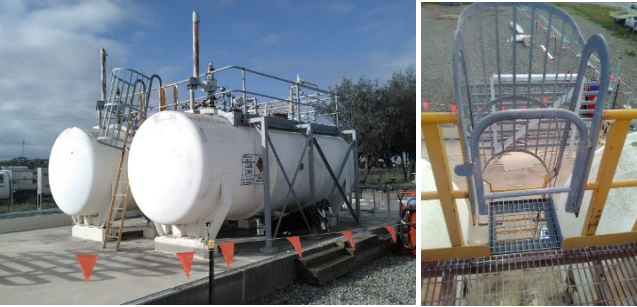
Reference	Date Added	Site	Issue	Likelihood	Consequence	Risk Score	Suggestions	Evidence	Date Planned For Completion	Date Completed	Comments
AGR Meter Station - 4	25/07/2023	2 x Mercaptain Vessels	1) Gate no longer self closes. 2) No non-slip tread on the access ladder rungs.	B. Remote	2. Minor	Low	1) Repair or replace the gate to ensure it is self closing and meets AS requirements. 2) Install hi vis (yellow) non-slip tread on the ladder rungs.

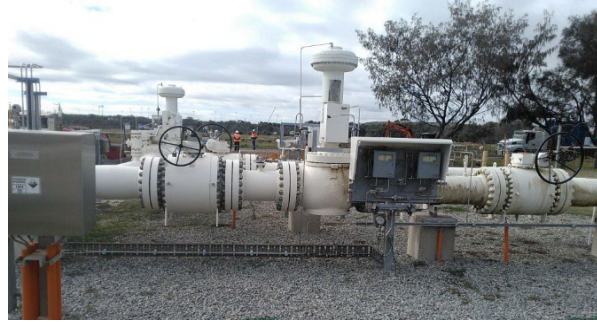
AGR Meter Station - 5	25/07/2023	Multiple Risers	1) Access to Risers and Vents up to 2800mm for maintenance tasks currently completed using a platform ladder on blue metal. This creates the potential for the ladder to be unstable and cause a fall from height.	C. Unlikely	3. Severe	Medium	1. 1) Option 1: Install a access ladder and platform that meets AS requirements (preferred option). 1.2) Option 2: Implement a 1500 x 1500 precast concrete for ladder to sit on to access the risers.

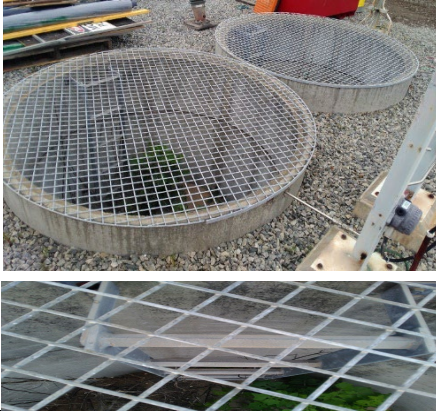
AGR Meter Station - 6	25/07/2023	2 x Inspection Pits	1) Ladder does not extend 1m past the landing at the top of the ladder and does not have sufficient locations to hold onto when mounting / dismantling. 2) No non-slip tread on ladder rungs.	B. Remote	3. Severe	Medium	1) Modify or replace the ladder, ensuring it extends 1m past the top landing, with sufficient locations to hold onto when mounting / dismantling the ladder. 2) Modified or replacement ladder to have hi vis (yellow) non-slip tread installed on the rungs.

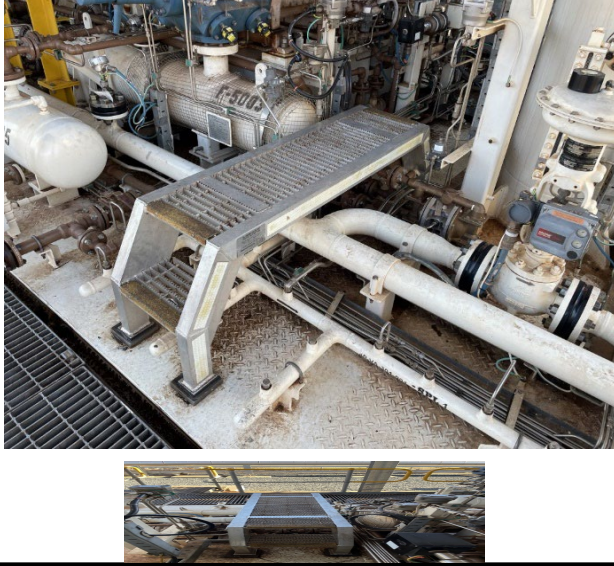
Pluto Interconnect Compressor / Metering Station - 1	23/06/2023	Pluto Compressor Package - Step Over Platform	1.1) The platform feet have been fastened with silicone adhesive only, which has failed and the platform is therefore free to move. 1.2) The only thing restraint movement of the platform is a loop of instrument tubing which is live. This tubing also obstructs the landing (trip hazard). 2) There is no handrails or kickboards fitted. Note: Raised by Andrew Stanwix.	C. Unlikely	3. Severe	Medium	1.1) Temporary solution - Install a information tag to raise awareness and then install ratchet strap(s) to hold the platform in place. Done. 1.2) Permanent solution - Fabricate and install a permanent solution that meets AS requirements. 2) Ensure handrails and kick plates are installed in line with the AS requirements applicable to the permanent solution.

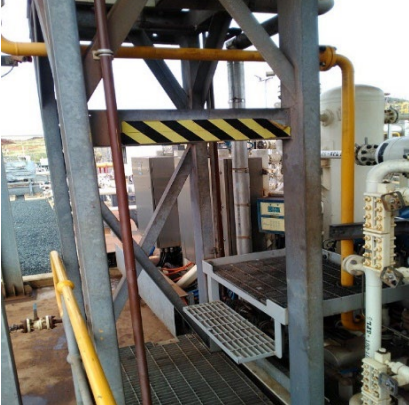
Pluto Interconnect Compressor / Metering Station - 2	23/06/2023	Reofitted Platform On The South Side of the Compressor Package (Package Exhaust)	1) No edge protection for platform. Potential for fall ~1m and onto potentially hot equipment. 2) Structural cross beam adjacent to walkway that personal must duck under to access this platform. These pose a hazard for bumping their head (previous MTI at TGS). Faded hi vis tape currently in place.	D. Occasional	3. Severe	Medium	1) Install handrails and gate to provide 360 edge protection. 2.1) Option A: Eliminate the cross beams if engineering allows for it. 2.2) Option B: Install padding to protect people if contact is made. Example product is Scaff Pads.

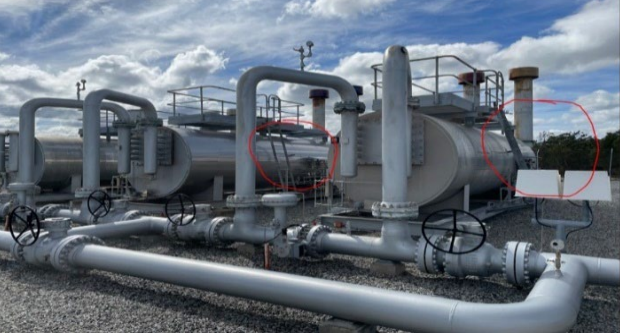
Pinjar Metering Station (Power Station) - 1	20/06/2023	Heaters - Top Platform	1) No non-slip tread on ladder runs. 2) Landing does not meet the AS requirements and is currently blue metal. Note: - Findings are based on photo and feedback from Adrian Taylor.	B. Remote	2. Minor	Low	1) Install hi vis (yellow) non-slip tread installed on the rungs. 2) Pour a landing that meets AS requirements.

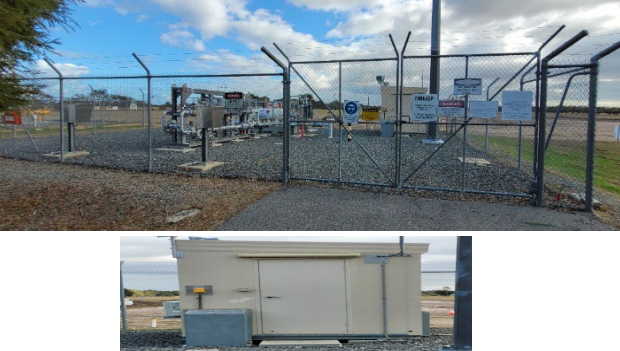
Mandurah Gate Meter Station - 1	13/04/2023	Pav Hut	1) The step up (riser) does not meet the AS requirements (130-225mm).			Low	1.1) Implement a interim step to assist with access and egress. 1.2) Modify the landing to accommodate the new step.

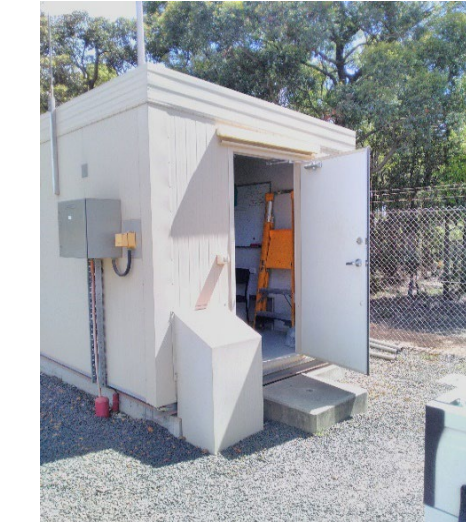
Worsley Meter Station - 6		Meter Hut	1.1) Step up appears to exceed AS requirements. Measurements required to confirm. 1.2) No hi vis (yellow) anti-slip tread installed on the nosing of the stairs. 2) Concrete landing may need modification to suit any installation of stairs. Note: Hazard / Design issue raised by Andrew Hynes. Advised this same issue appears on a number of other sites.	C. Unlikely	2. Minor	Low	1.1) If measurements confirm step up / riser heights exceed AS requirements, then modify the stair(s) to meet them. 1.2) Ensure hi vis (yellow) anti-slip tread is installed on the nosing of all stairs. 2) Consider modifying the landing to meet the AS requirements.

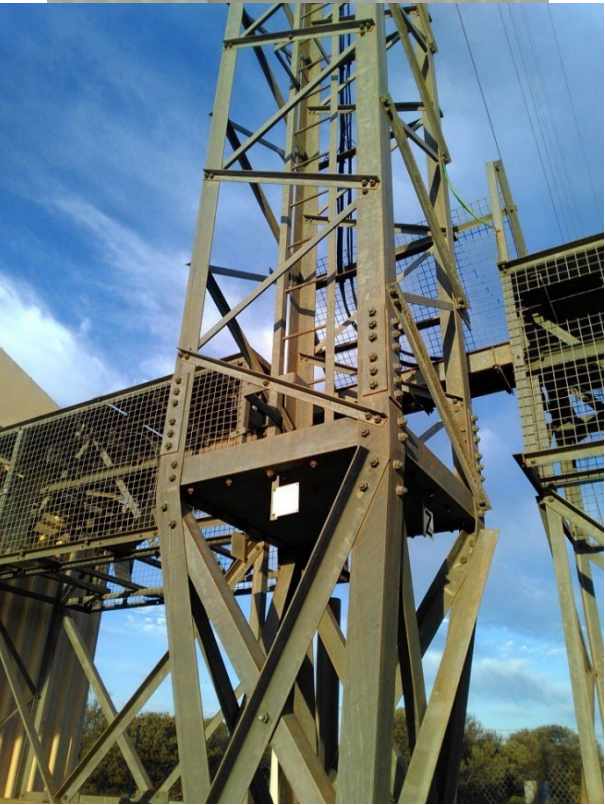
Reference	Date added	Location on Site	Issue	Likelihood	Consequence	Risk Score	Suggestions	Evidence	What is being completed	Date planned for completion	Date completed	Comments
R013-4	21/04/2023	Repeater Station 13 - Communications Tower	<p>1) No access platform provided for ease of access to the ladder. Note: This may have not be provided for the purpose of preventing unauthorised access.</p> <p>2) No fall restraint/arrest system in place for personnel using the ladder. This exposes personnel to a significant fall that would likely result in a fatality or serious injury.</p> <p>3) No ladder enclosure has been installed for the ladder to meet AS requirements (where a fall of more than 6m).</p> <p>4) No hi vis (yellow) anti-slip tread installed on the ladder rungs.</p> <p>Findings on hold pending discussion with Dane. Refer to comments.</p>	C. Unlikely	3. Severe	High	<p>1) Install a access stairs/ladder and platform to enable access to the ladder. Ensure a lockable gate or similar and signage is provided to prevent unauthorised access.</p> <p>2) Install a certified fall restraint/arrest system that is suitable for the end users.</p> <p>3) Assess if the installation a side screen, ladder cage or other type of enclosure to prevent a sideways fall from the ladder, if practical for the end users.</p> <p>4) Install hi vis (yellow) anti-slip tread on the ladder rungs.</p>

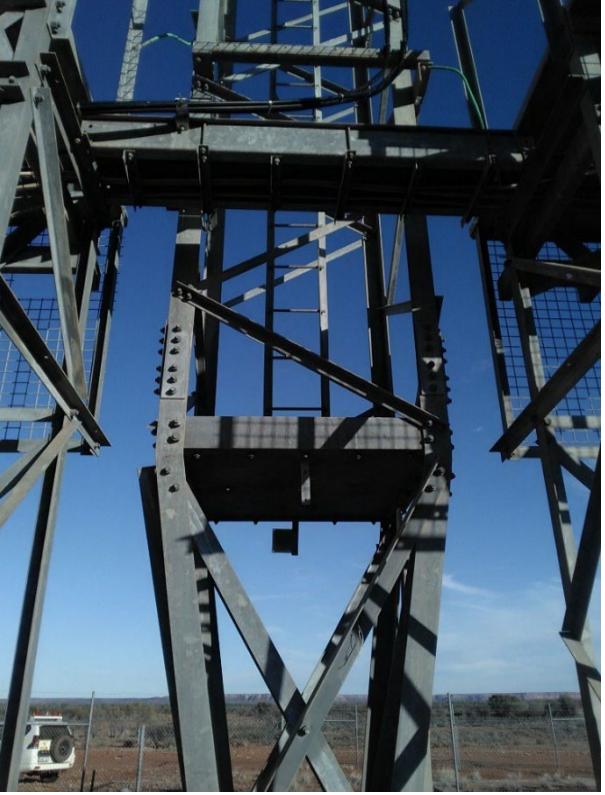
R017-4	21/04/2023	Repeater Station 17 - Communications Tower	<p>1) No access platform provided for ease of access to the ladder. Note: This may have not be provided for the purpose of preventing unauthorised access.</p> <p>2) No fall restraint/arrest system in place for personnel using the ladder. This exposes personnel to a significant fall that would likely result in a fatality or serious injury.</p> <p>3) No ladder enclosure has been installed for the ladder to meet AS requirements (where a fall of more than 6m).</p> <p>4) No hi vis (yellow) anti-slip tread installed on the ladder rungs.</p> <p>Findings on hold pending discussion with Dane. Refer to comments.</p>	C. Unlikely	4. Major	High	<p>1) Install a access stairs/ladder and platform to enable access to the ladder. Ensure a lockable gate or similar and signage is provided to prevent unauthorised access.</p> <p>2) Install a certified fall restraint/arrest system that is suitable for the end users.</p> <p>3) Assess if the installation a side screen, ladder cage or other type of enclosure to prevent a sideways fall from the ladder, if practical for the end users.</p> <p>4) Install hi vis (yellow) anti-slip tread on the ladder rungs.</p>

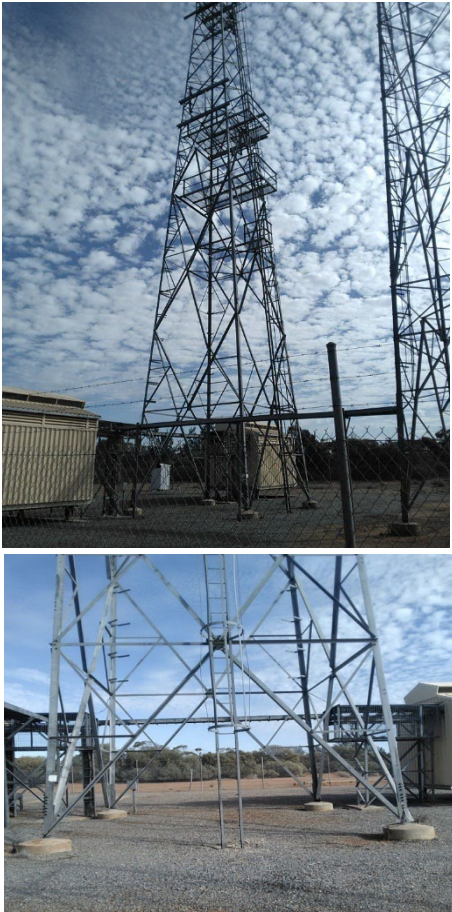
R025-4	22/05/2023	Repeater Station 25 - Smaller Communications Tower	<p>1) Unlike some other Repeater Stations, the ladder at this location can be access from ground level. No gate or means of accessing the ladder on a platform at height to prevent unauthorised access, has been implemented.</p> <p>2) No fall restraint/arrest system in place for personnel using the ladder. This exposes personnel to a significant fall that would likely result in a fatality or serious injury.</p> <p>3) The width of the ladder (250mm) does not meet the AS requirements (375mm to 525mm) and may create a hazard to personnel using the ladder.</p> <p>4) No hi vis (yellow) anti-slip tread installed on the ladder rungs. They are currently smooth metal rungs.</p> <p>Note: Discuss findings and actions with Dane.</p>	C. Unlikely	4. Major	High	<p>1) Consider installing a lockable gate or similar and signage is provided to prevent unauthorised access.</p> <p>2) Install a certified fall restraint/arrest system that is suitable for the end users.</p> <p>3) Replace the ladder with a AS compliant ladder.</p> <p>4) Install hi vis (yellow) anti-slip tread on the ladder rungs.</p>

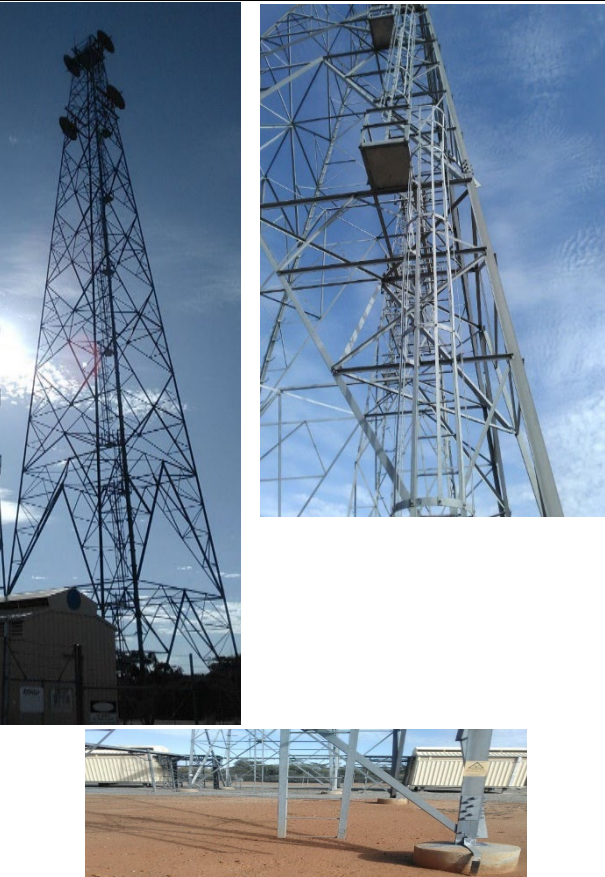
R025-5	22/05/2023	Repeater Station 25 - Larger Communications Tower	<p>1) Unlike some other Repeater Stations, the ladder at this location can be access from ground level. No gate or means of accessing the ladder on a platform at height to prevent unauthorised access, has been implemented.</p> <p>2) The Step Up to access the first ladder rung (520mm) exceeds the AS requirements (≈150mm).</p> <p>3) No fall restraint/arrest system in place for personnel using the ladder. This exposes personnel to a significant fall that would likely result in a fatality or serious injury.</p> <p>4) No hi vis (yellow) anti-slip tread installed on the ladder rungs. They are currently smooth metal rungs.</p> <p>Note: Discuss findings and actions with Dane.</p>	C. Unlikely	4. Major	High	<p>1) Consider installing a lockable gate or similar and signage is provided to prevent unauthorised access.</p> <p>2) Extend the ladder to the landing.</p> <p>3) Install a certified fall restraint/arrest system that is suitable for the end users.</p> <p>4) Install hi vis (yellow) anti-slip tread on the ladder rungs.</p>

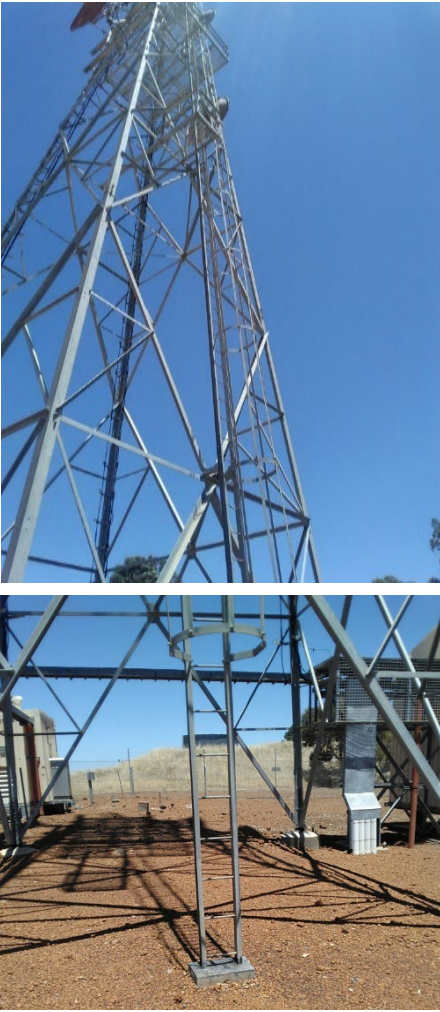
R039-5	13/12/2023	Repeater Station 39 - Communications Tower	<p>1) Unlike some other Repeater Stations, the ladder at this location can be access from ground level. No gate or means of accessing the ladder on a platform at height to prevent unauthorised access, has been implemented.</p> <p>2) The Step Up to access the first ladder rung (520mm) exceeds the AS requirements (= <150mm).</p> <p>3) No fall restraint/arrest system in place for personnel using the ladder. This exposes personnel to a significant fall that would likely result in a fatality or serious injury.</p> <p>4) No hi vis (yellow) anti-slip tread installed on the ladder rungs. They are currently smooth metal rungs.</p> <p>5) The landing for the ladder does not meet AS1657 requirements of 900mm from the bottom lung.</p> <p>Note: Discuss findings and actions with Dane.</p>	C. Unlikely	4. Major	High	<p>1) Consider installing a lockable gate or similar and signage is provided to prevent unauthorised access.</p> <p>2) Extend the ladder to the landing.</p> <p>3) Install a certified fall restraint/arrest system that is suitable for the end users.</p> <p>4) Install hi vis (yellow) anti-slip tread on the ladder rungs.</p> <p>5) Pour a new landing.</p>

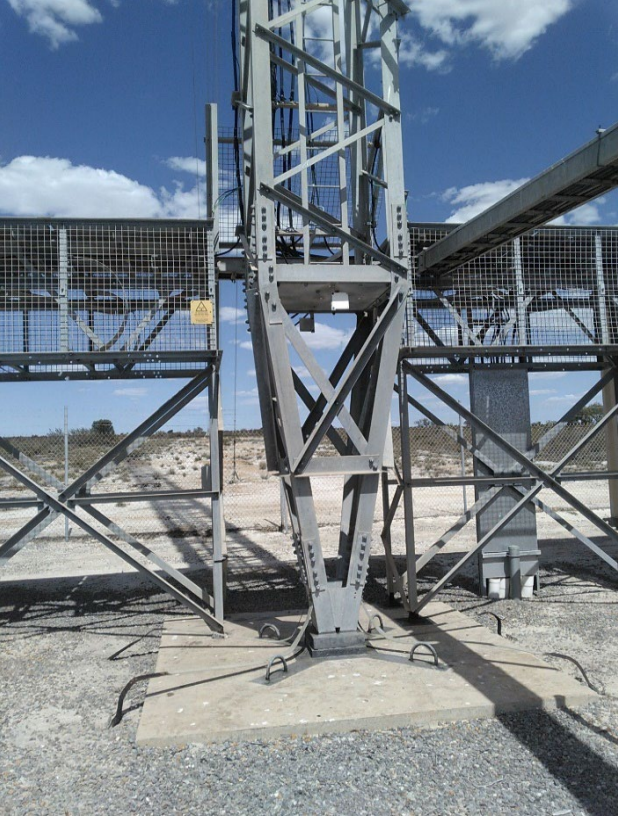
R034-5	12/02/2024	Repeater Station 34 - Communications Tower	<p>1) No access platform provided for ease of access to the ladder. Note: This may have not be provided for the purpose of preventing unauthorised access.</p> <p>2) No fall restraint/arrest system in place for personnel using the ladder. This exposes personnel to a significant fall that would likely result in a fatality or serious injury.</p> <p>3) No ladder enclosure has been installed for the ladder to meet AS requirements (where a fall of more than 6m).</p> <p>4) No hi vis (yellow) anti-slip tread installed on the ladder rungs.</p> <p>Findings on hold pending discussion with Dane. Refer to comments.</p>	C. Unlikely	4. Major	High	<p>1) Install a access stairs/ladder and platform to enable access to the ladder. Ensure a lockable gate or similar and signage is provided to prevent unauthorised access.</p> <p>2) Install a certified fall restraint/arrest system that is suitable for the end users.</p> <p>3) Assess if the installation a side screen, ladder cage or other type of enclosure to prevent a sideways fall from the ladder, if practical for the end users.</p> <p>4) Install hi vis (yellow) anti-slip tread on the ladder rungs.</p>

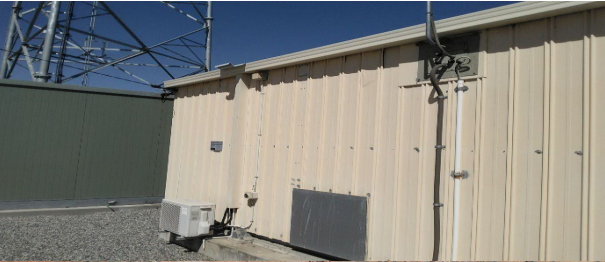
Wagerup Repeater Station - 3	5/03/2024	Wagerup Repeater Station - Yellow Hut Roof Access	<p>1) Roof access periodically required for maintenance work. Currently performed with personnel working in FIPS.</p> <p>Note: Same Hazard / Design issue as raised for another Facilities Site by Andrew Hynes.</p> <p>Assessed using surveillance photo. Site visit required to obtain additional photos and measurements.</p>	C. Unlikely	4. Major	High	<p>1) Consider installing a platform and access stairs / ladder. This will prevent a fall and reliance on PPE.</p>

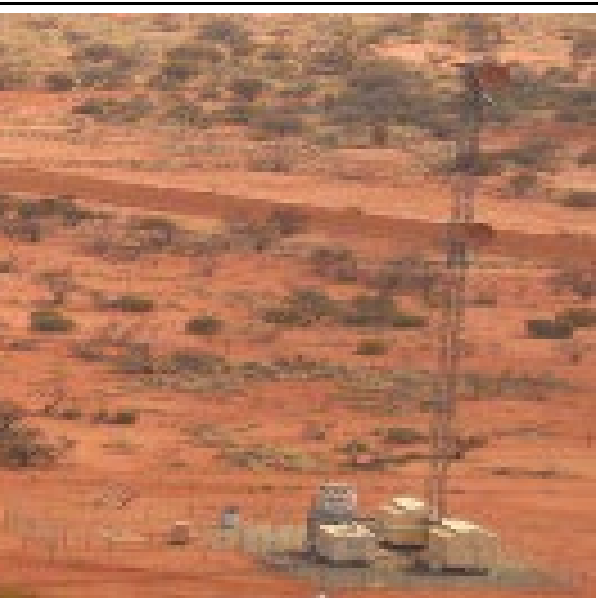
R011-7	4/04/2024	Repeater Station 11 - Communications Tower	<p>Assessed using surveillance photo. Site visit required to obtain additional photos and measurements.</p> <p>1) No access platform provided for ease of access to the ladder. Note: This may have not be provided for the purpose of preventing unauthorised access.</p> <p>2) No fall restraint/arrest system in place for personnel using the ladder. This exposes personnel to a significant fall that would likely result in a fatality or serious injury.</p>	C. Unlikely	3. Severe	High	<p>1) Install a access stairs/ladder and platform to enable access to the ladder. Ensure a lockable gate or similar and signage is provided to prevent unauthorised access.</p> <p>2) Install a certified fall restraint/arrest system that is suitable for the end users.</p> <p>3) Assess if the installation a side screen, ladder cage or other type of enclosure to prevent a sideways fall from the ladder, if practical for the end users.</p>

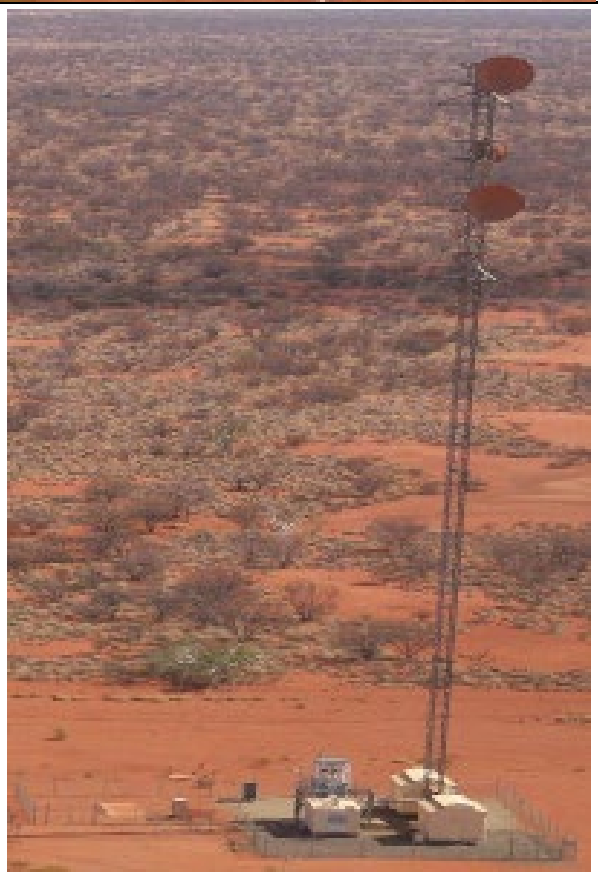
R012-7	4/04/2024	Repeater Station 12 - Communications Tower	<p>Assessed using surveillance photo. Site visit required to obtain additional photos and measurements.</p> <p>1) No access platform provided for ease of access to the ladder. Note: This may have not be provided for the purpose of preventing unauthorised access.</p> <p>2) No fall restraint/arrest system in place for personnel using the ladder. This exposes personnel to a significant fall that would likely result in a fatality or serious injury.</p> <p>3) No ladder enclosure has been installed for the ladder to meet AS requirements (where a fall of more than 6m).</p> <p>4) No hi vis (yellow) anti-slip tread installed on the ladder rungs.</p> <p>Findings on hold pending discussion with Dane. Refer to comments.</p>	C. Unlikely	3. Severe	High	<p>1) Install a access stairs/ladder and platform to enable access to the ladder. Ensure a lockable gate or similar and signage is provided to prevent unauthorised access.</p> <p>2) Install a certified fall restraint/arrest system that is suitable for the end users.</p> <p>3) Assess if the installation a side screen, ladder cage or other type of enclosure to prevent a sideways fall from the ladder, if practical for the end users.</p> <p>4) Install hi vis (yellow) anti-slip tread on the ladder rungs.</p>

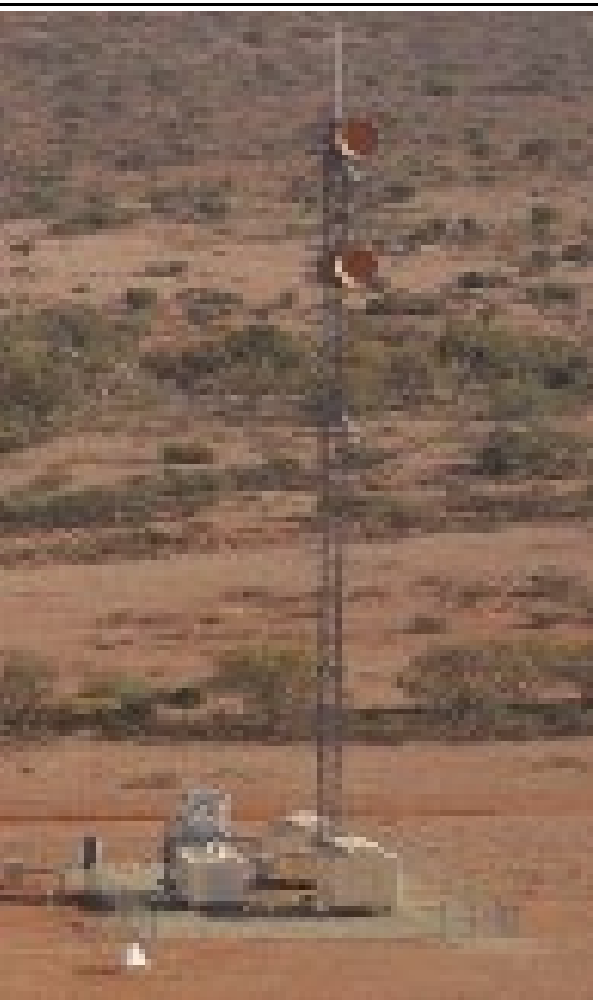
R014-7	4/04/2024	Repeater Station 14 - Communications Tower	<p>Assessed using surveillance photo. Site visit required to obtain additional photos and measurements.</p> <p>1) No access platform provided for ease of access to the ladder. Note: This may have not be provided for the purpose of preventing unauthorised access.</p> <p>2) No fall restraint/arrest system in place for personnel using the ladder. This exposes personnel to a significant fall that would likely result in a fatality or serious injury.</p> <p>3) No ladder enclosure has been installed for the ladder to meet AS requirements (where a fall of more than 6m).</p> <p>4) No hi vis (yellow) anti-slip tread installed on the ladder rungs.</p> <p>Findings on hold pending discussion with Dane. Refer to comments.</p>	C. Unlikely	3. Severe	High	<p>1) Install a access stairs/ladder and platform to enable access to the ladder. Ensure a lockable gate or similar and signage is provided to prevent unauthorised access.</p> <p>2) Install a certified fall restraint/arrest system that is suitable for the end users.</p> <p>3) Assess if the installation a side screen, ladder cage or other type of enclosure to prevent a sideways fall from the ladder, if practical for the end users.</p> <p>4) Install hi vis (yellow) anti-slip tread on the ladder rungs.</p>

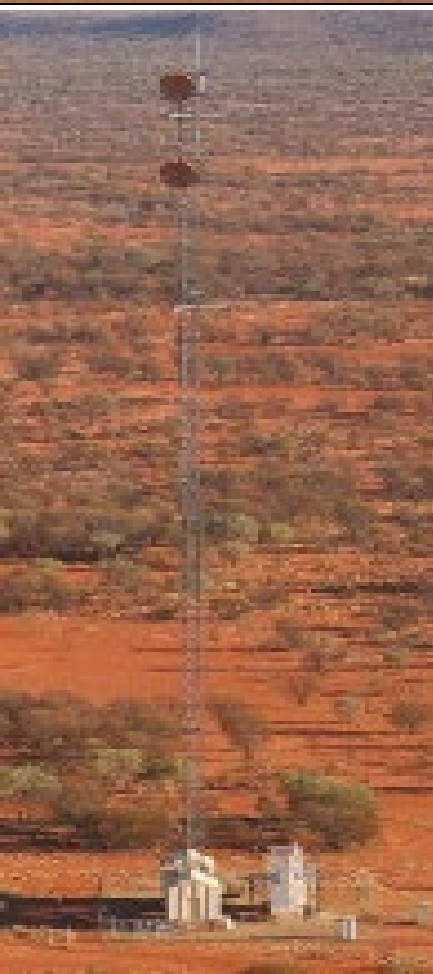
R015-5	4/04/2024	Repeater Station 15 - Communications Tower	<p>Assessed using surveillance photo. Site visit required to obtain additional photos and measurements.</p> <p>1) No access platform provided for ease of access to the ladder. Note: This may have not be provided for the purpose of preventing unauthorised access.</p> <p>2) No fall restraint/arrest system in place for personnel using the ladder. This exposes personnel to a significant fall that would likely result in a fatality or serious injury.</p> <p>3) No ladder enclosure has been installed for the ladder to meet AS requirements (where a fall of more than 6m).</p> <p>4) No hi vis (yellow) anti-slip tread installed on the ladder rungs.</p> <p>Findings on hold pending discussion with Dane. Refer to comments.</p>	C. Unlikely	3. Severe	High	<p>1) Install a access stairs/ladder and platform to enable access to the ladder. Ensure a lockable gate or similar and signage is provided to prevent unauthorised access.</p> <p>2) Install a certified fall restraint/arrest system that is suitable for the end users.</p> <p>3) Assess if the installation a side screen, ladder cage or other type of enclosure to prevent a sideways fall from the ladder, if practical for the end users.</p> <p>4) Install hi vis (yellow) anti-slip tread on the ladder rungs.</p>
