Revised Final Plan
Attachment 9.12

Structures & Operational Sites - Working at Heights - Appendix B

August 2025

**Dampier Bunbury
Pipeline**

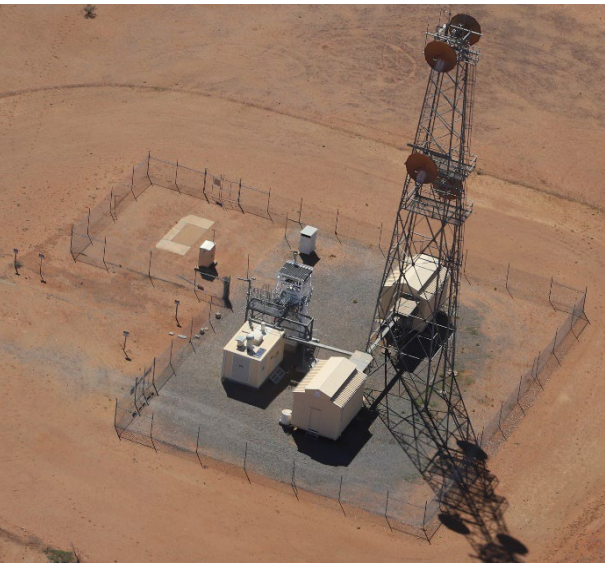
R018-8	4/04/2024	Repeater Station 18 - Communications Tower	Assessed using surveillance photo. Site visit required to obtain additional photos and measurements. 1) No access platform provided for ease of access to the ladder. Note: This may have not be provided for the purpose of preventing unauthorised access. 2) No fall restraint/arrest system in place for personnel using the ladder. This exposes personnel to a significant fall that would likely result in a fatality or serious injury.	C. Unlikely	4. Major	High	1) Install a access stairs/ladder and platform to enable access to the ladder. Ensure a lockable gate or similar and signage is provided to prevent unauthorised access. 2) Install a certified fall restraint/arrest system that is suitable for the end users. 3) Assess if the installation a side screen, ladder cage or other type of enclosure to prevent a sideways fall from the ladder, if practical for the end users.

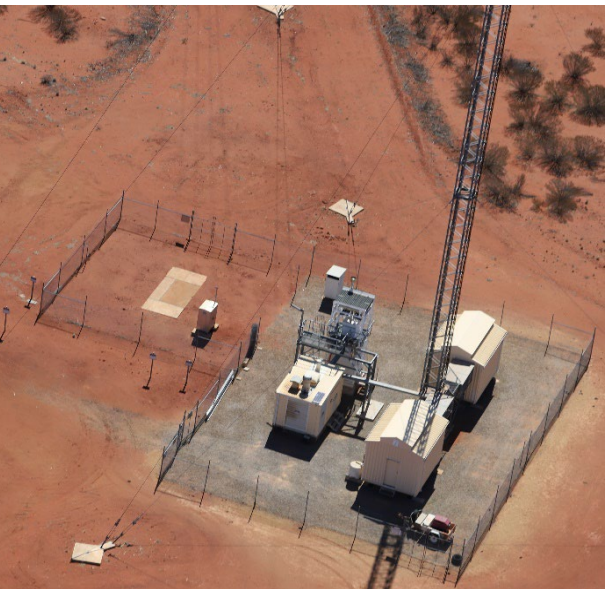
R019-8	4/04/2024	Repeater Station 19 - Communications Tower	Assessed using surveillance photo. Site visit required to obtain additional photos and measurements. 1) No access platform provided for ease of access to the ladder. Note: This may have not be provided for the purpose of preventing unauthorised access. 2) No fall restraint/arrest system in place for personnel using the ladder. This exposes personnel to a significant fall that would likely result in a fatality or serious injury.	C. Unlikely	4. Major	High	1) Install a access stairs/ladder and platform to enable access to the ladder. Ensure a lockable gate or similar and signage is provided to prevent unauthorised access. 2) Install a certified fall restraint/arrest system that is suitable for the end users. 3) Assess if the installation a side screen, ladder cage or other type of enclosure to prevent a sideways fall from the ladder, if practical for the end users.

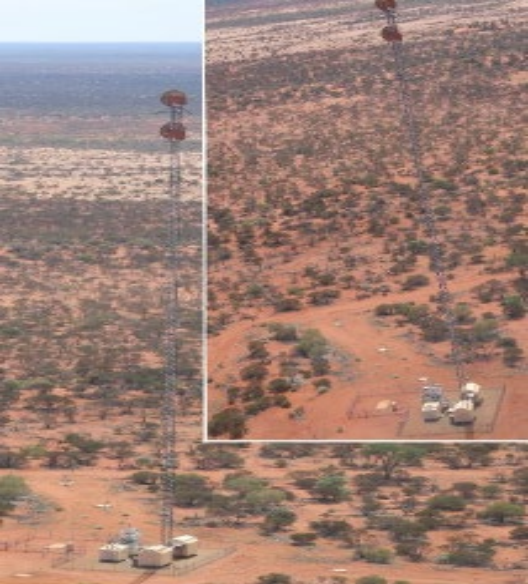
R020-8	4/04/2024	Repeater Station 20 - Communications Tower	Assessed using surveillance photo. Site visit required to obtain additional photos and measurements. 1) No access platform provided for ease of access to the ladder. Note: This may have not be provided for the purpose of preventing unauthorised access. 2) No fall restraint/arrest system in place for personnel using the ladder. This exposes personnel to a significant fall that would likely result in a fatality or serious injury.	C. Unlikely	4. Major	High	1) Install a access stairs/ladder and platform to enable access to the ladder. Ensure a lockable gate or similar and signage is provided to prevent unauthorised access. 2) Install a certified fall restraint/arrest system that is suitable for the end users. 3) Assess if the installation a side screen, ladder cage or other type of enclosure to prevent a sideways fall from the ladder, if practical for the end users.

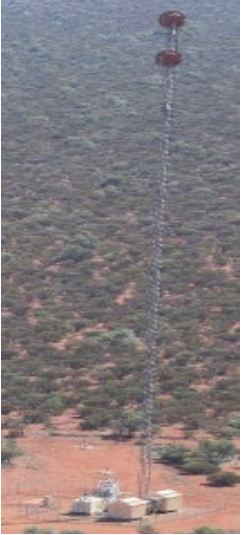
R022-8	4/04/2024	Repeater Station 22 - Communications Tower	Assessed using surveillance photo. Site visit required to obtain additional photos and measurements. 1) No access platform provided for ease of access to the ladder. Note: This may have not be provided for the purpose of preventing unauthorised access. 2) No fall restraint/arrest system in place for personnel using the ladder. This exposes personnel to a significant fall that would likely result in a fatality or serious injury. 3) No ladder enclosure has been installed for the ladder to meet AS requirements (where a fall of more than 6m). 4) No hi vis (yellow) anti-slip tread installed on the ladder rungs.	C. Unlikely	4. Major	High	1) Install a access stairs/ladder and platform to enable access to the ladder. Ensure a lockable gate or similar and signage is provided to prevent unauthorised access. 2) Install a certified fall restraint/arrest system that is suitable for the end users. 3) Assess if the installation a side screen, ladder cage or other type of enclosure to prevent a sideways fall from the ladder, if practical for the end users. 4) Install hi vis (yellow) anti-slip tread on the ladder rungs.

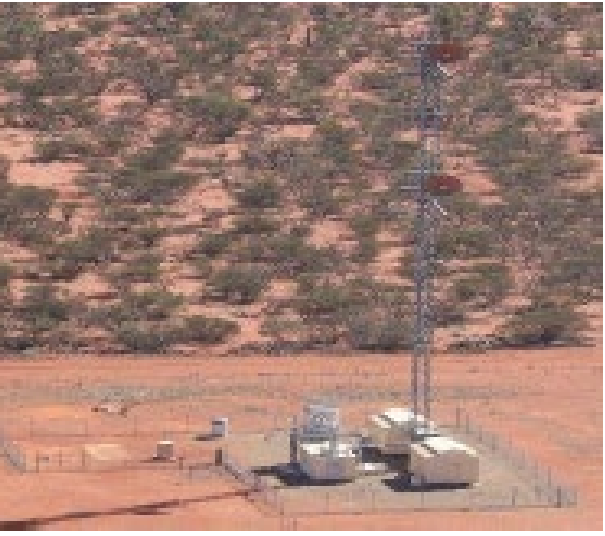
R023-8	4/04/2024	Repeater Station 23 - Communications Tower	Assessed using surveillance photo. Site visit required to obtain additional photos and measurements. 1) No access platform provided for ease of access to the ladder. Note: This may have not be provided for the purpose of preventing unauthorised access. 2) No fall restraint/arrest system in place for personnel using the ladder. This exposes personnel to a significant fall that would likely result in a fatality or serious injury.	C. Unlikely	4. Major	High	1) Install a access stairs/ladder and platform to enable access to the ladder. Ensure a lockable gate or similar and signage is provided to prevent unauthorised access. 2) Install a certified fall restraint/arrest system that is suitable for the end users. 3) Assess if the installation a side screen, ladder cage or other type of enclosure to prevent a sideways fall from the ladder, if practical for the end users.

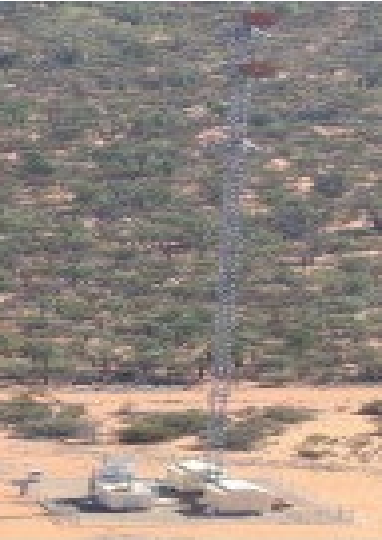
R024-8	4/04/2024	Repeater Station 24 - Communications Tower	Assessed using surveillance photo. Site visit required to obtain additional photos and measurements. 1) No access platform provided for ease of access to the ladder. Note: This may have not be provided for the purpose of preventing unauthorised access. 2) No fall restraint/arrest system in place for personnel using the ladder. This exposes personnel to a significant fall that would likely result in a fatality or serious injury.	C. Unlikely	4. Major	High	1) Install a access stairs/ladder and platform to enable access to the ladder. Ensure a lockable gate or similar and signage is provided to prevent unauthorised access. 2) Install a certified fall restraint/arrest system that is suitable for the end users. 3) Assess if the installation a side screen, ladder cage or other type of enclosure to prevent a sideways fall from the ladder, if practical for the end users.

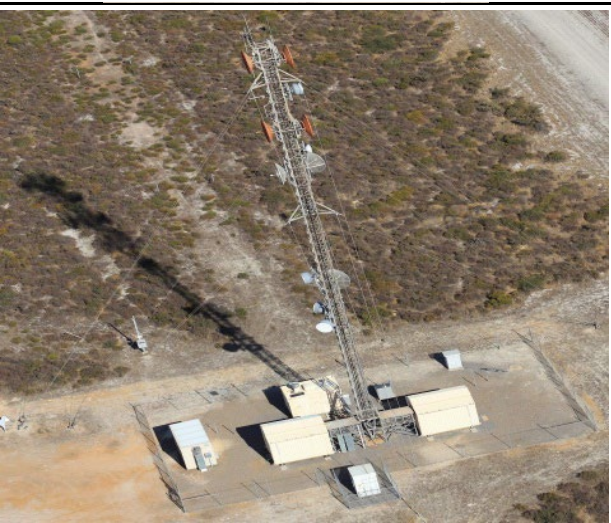
R031-5	4/04/2024	Repeater Station 32 - Communications Tower	<p>Assessed using surveillance photo. Site visit required to obtain additional photos and measurements.</p> <p>1) No access platform provided for ease of access to the ladder. Note: This may have not be provided for the purpose of preventing unauthorised access.</p> <p>2) No fall restraint/arrest system in place for personnel using the ladder. This exposes personnel to a significant fall that would likely result in a fatality or serious injury.</p> <p>3) No ladder enclosure has been installed for the ladder to meet AS requirements (where a fall of more than 6m).</p> <p>4) No hi vis (yellow) anti-slip tread installed on the ladder rungs.</p> <p>Findings on hold pending discussion with Dane. Refer to comments.</p>	C. Unlikely	4. Major	High	<p>1) Install a access stairs/ladder and platform to enable access to the ladder. Ensure a lockable gate or similar and signage is provided to prevent unauthorised access.</p> <p>2) Install a certified fall restraint/arrest system that is suitable for the end users.</p> <p>3) Assess if the installation a side screen, ladder cage or other type of enclosure to prevent a sideways fall from the ladder, if practical for the end users.</p> <p>4) Install hi vis (yellow) anti-slip tread on the ladder rungs.</p>

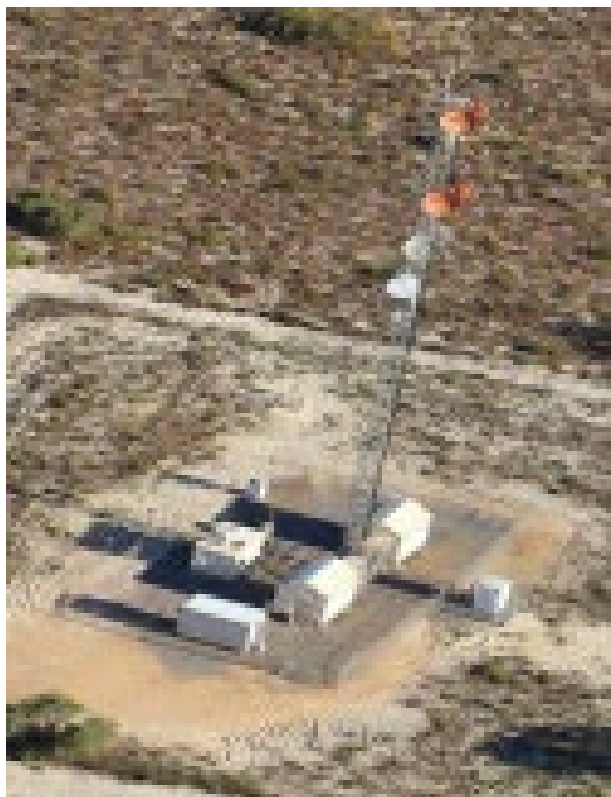
R032-5	4/04/2024	Repeater Station 32 - Communications Tower	<p>Assessed using surveillance photo. Site visit required to obtain additional photos and measurements.</p> <p>1) No access platform provided for ease of access to the ladder. Note: This may have not be provided for the purpose of preventing unauthorised access.</p> <p>2) No fall restraint/arrest system in place for personnel using the ladder. This exposes personnel to a significant fall that would likely result in a fatality or serious injury.</p> <p>3) No ladder enclosure has been installed for the ladder to meet AS requirements (where a fall of more than 6m).</p> <p>4) No hi vis (yellow) anti-slip tread installed on the ladder rungs.</p> <p>Findings on hold pending discussion with Dane. Refer to comments.</p>	C. Unlikely	4. Major	High	<p>1) Install a access stairs/ladder and platform to enable access to the ladder. Ensure a lockable gate or similar and signage is provided to prevent unauthorised access.</p> <p>2) Install a certified fall restraint/arrest system that is suitable for the end users.</p> <p>3) Assess if the installation a side screen, ladder cage or other type of enclosure to prevent a sideways fall from the ladder, if practical for the end users.</p> <p>4) Install hi vis (yellow) anti-slip tread on the ladder rungs.</p>

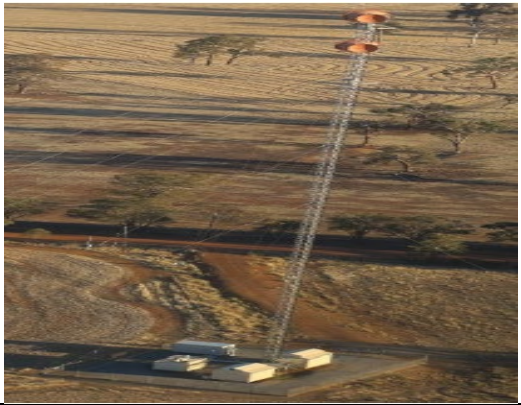
R038-5	4/04/2024	Repeater Station 38 - Communications Tower	<p>Assessed using surveillance photo. Site visit required to obtain additional photos and measurements.</p> <p>1) No access platform provided for ease of access to the ladder. Note: This may have not be provided for the purpose of preventing unauthorised access.</p> <p>2) No fall restraint/arrest system in place for personnel using the ladder. This exposes personnel to a significant fall that would likely result in a fatality or serious injury.</p>	C. Unlikely	4. Major	High	<p>1) Install a access stairs/ladder and platform to enable access to the ladder. Ensure a lockable gate or similar and signage is provided to prevent unauthorised access.</p> <p>2) Install a certified fall restraint/arrest system that is suitable for the end users.</p>

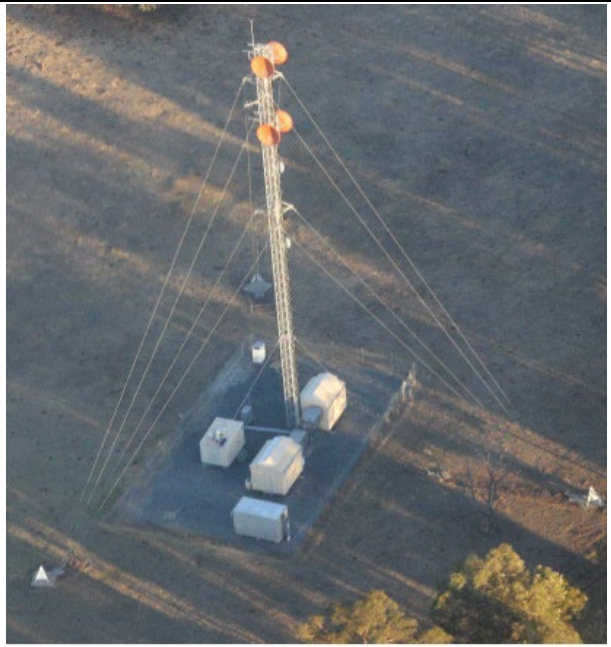
R040-5	4/04/2024	Repeater Station 40 - Communications Tower	<p>Assessed using surveillance photo. Site visit required to obtain additional photos and measurements.</p> <p>1) No access platform provided for ease of access to the ladder. Note: This may have not be provided for the purpose of preventing unauthorised access.</p> <p>2) No fall restraint/arrest system in place for personnel using the ladder. This exposes personnel to a significant fall that would likely result in a fatality or serious injury.</p> <p>3) No ladder enclosure has been installed for the ladder to meet AS requirements (where a fall of more than 6m).</p> <p>4) No hi vis (yellow) anti-slip tread installed on the ladder rungs.</p> <p>Findings on hold pending discussion with Dane. Refer to comments.</p>	C. Unlikely	4. Major	High	<p>1) Install a access stairs/ladder and platform to enable access to the ladder. Ensure a lockable gate or similar and signage is provided to prevent unauthorised access.</p> <p>2) Install a certified fall restraint/arrest system that is suitable for the end users.</p> <p>3) Assess if the installation a side screen, ladder cage or other type of enclosure to prevent a sideways fall from the ladder, if practical for the end users.</p> <p>4) Install hi vis (yellow) anti-slip tread on the ladder rungs.</p>

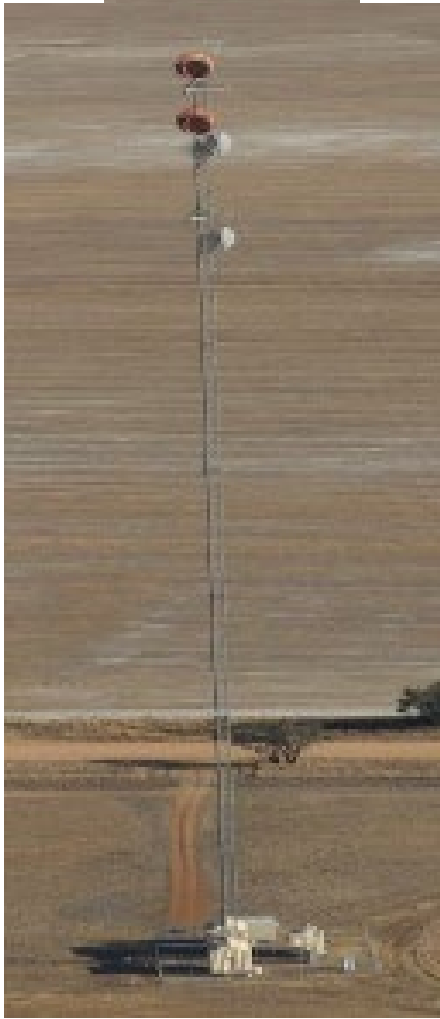
R033-5	8/04/2024	Repeater Station 33 - Communications Tower	<p>Assessed using surveillance photo. Site visit required to obtain additional photos and measurements.</p> <p>1) No access platform provided for ease of access to the ladder. Note: This may have not be provided for the purpose of preventing unauthorised access.</p> <p>2) No fall restraint/arrest system in place for personnel using the ladder. This exposes personnel to a significant fall that would likely result in a fatality or serious injury.</p> <p>3) No ladder enclosure has been installed for the ladder to meet AS requirements (where a fall of more than 6m).</p> <p>4) No hi vis (yellow) anti-slip tread installed on the ladder rungs.</p> <p>Findings on hold pending discussion with Dane. Refer to comments.</p>	C. Unlikely	4. Major	High	<p>1) Install a access stairs/ladder and platform to enable access to the ladder. Ensure a lockable gate or similar and signage is provided to prevent unauthorised access.</p> <p>2) Install a certified fall restraint/arrest system that is suitable for the end users.</p> <p>3) Assess if the installation a side screen, ladder cage or other type of enclosure to prevent a sideways fall from the ladder, if practical for the end users.</p> <p>4) Install hi vis (yellow) anti-slip tread on the ladder rungs.</p>

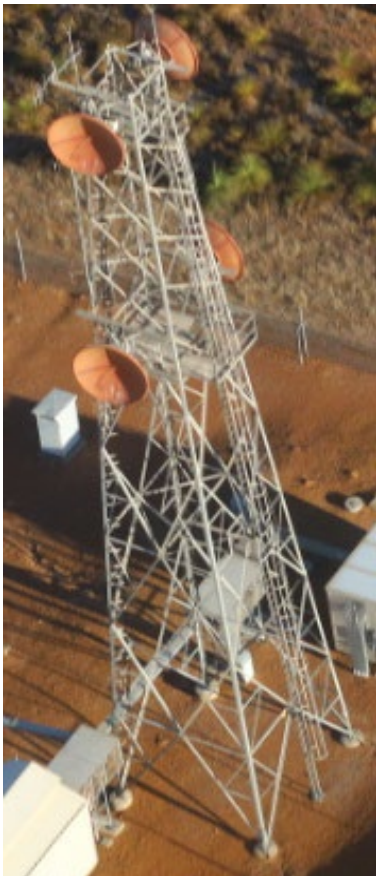
R035-5	8/04/2024	Repeater Station 35 - Telecommunications Tower	<p>Assessed using surveillance photo. Site visit required to obtain additional photos and measurements.</p> <p>1) No access platform provided for ease of access to the ladder. Note: This may have not be provided for the purpose of preventing unauthorised access.</p> <p>2) No fall restraint/arrest system in place for personnel using the ladder. This exposes personnel to a significant fall that would likely result in a fatality or serious injury.</p> <p>3) No ladder enclosure has been installed for the ladder to meet AS requirements (where a fall of more than 6m).</p> <p>4) No hi vis (yellow) anti-slip tread installed on the ladder rungs.</p> <p>Findings on hold pending discussion with Dane. Refer to comments.</p>	C. Unlikely	4. Major	High	<p>1) Install a access stairs/ladder and platform to enable access to the ladder. Ensure a lockable gate or similar and signage is provided to prevent unauthorised access.</p> <p>2) Install a certified fall restraint/arrest system that is suitable for the end users.</p> <p>3) Assess if the installation a side screen, ladder cage or other type of enclosure to prevent a sideways fall from the ladder, if practical for the end users.</p> <p>4) Install hi vis (yellow) anti-slip tread on the ladder rungs.</p>

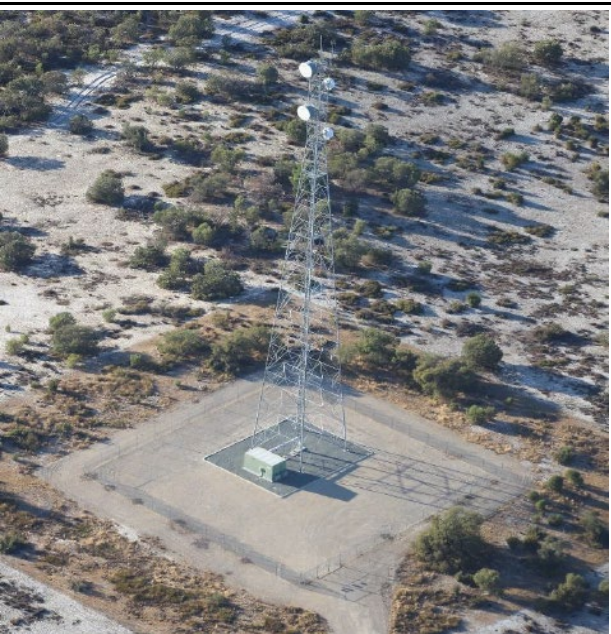
R042-2	8/04/2024	Repeater Station 42 - Communications Tower	<p>Assessed using surveillance photo. Site visit required to obtain additional photos and measurements.</p> <p>1) No access platform provided for ease of access to the ladder. Note: This may have not be provided for the purpose of preventing unauthorised access.</p> <p>2) No fall restraint/arrest system in place for personnel using the ladder. This exposes personnel to a significant fall that would likely result in a fatality or serious injury.</p> <p>3) No ladder enclosure has been installed for the ladder to meet AS requirements (where a fall of more than 6m).</p> <p>4) No hi vis (yellow) anti-slip tread installed on the ladder rungs.</p> <p>Findings on hold pending discussion with Dane. Refer to comments.</p>	C. Unlikely	4. Major	High	<p>1) Consider installing a lockable gate or similar and signage is provided to prevent unauthorised access.</p> <p>2) Extend the ladder to the landing.</p> <p>3) Install a certified fall restraint/arrest system that is suitable for the end users.</p> <p>4) Install hi vis (yellow) anti-slip tread on the ladder rungs.</p> <p>5) Pour a new landing.</p>

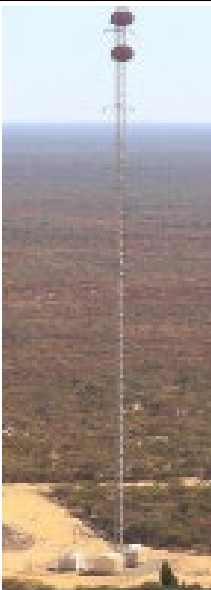
R027-4	12/04/2024	Repeater Station 27 - Communications Tower	<p>Assessed using surveillance photo. Site visit required to obtain additional photos and measurements.</p> <p>1) No access platform provided for ease of access to the ladder. Note: This may have not be provided for the purpose of preventing unauthorised access.</p> <p>2) No fall restraint/arrest system in place for personnel using the ladder. This exposes personnel to a significant fall that would likely result in a fatality or serious injury.</p>	C. Unlikely	4. Major	High	<p>1) Install a access stairs/ladder and platform to enable access to the ladder. Ensure a lockable gate or similar and signage is provided to prevent unauthorised access.</p> <p>2) Install a certified fall restraint/arrest system that is suitable for the end users.</p> <p>3) Assess if the installation a side screen, ladder cage or other type of enclosure to prevent a sideways fall from the ladder, if practical for the end users.</p>

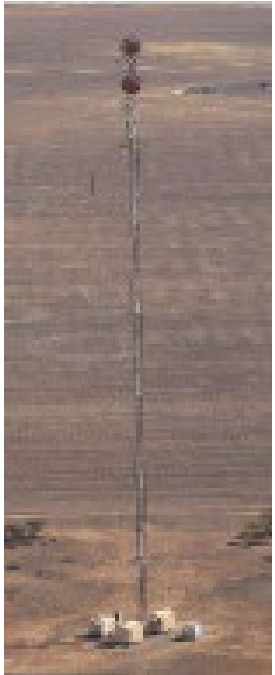
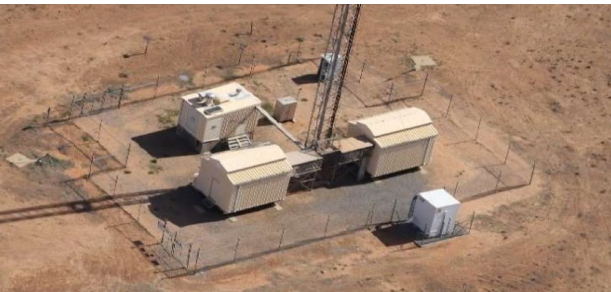
R028-4	12/04/2024	Repeater Station 28 - Communications Tower	<p>Assessed using surveillance photo.</p> <p>1) No access platform provided for ease of access to the ladder. Note: This may have not be provided for the purpose of preventing unauthorised access.</p> <p>2) No fall restraint/arrest system in place for personnel using the ladder. This exposes personnel to a significant fall that would likely result in a fatality or serious injury.</p> <p>3) No ladder enclosure has been installed for the ladder to meet AS requirements (where a fall of more than 6m).</p> <p>4) No hi vis (yellow) anti-slip tread installed on the ladder rungs.</p> <p>Findings on hold pending discussion with Dane. Refer to comments.</p>	C. Unlikely	4. Major	High	<p>1) Install a access stairs/ladder and platform to enable access to the ladder. Ensure a lockable gate or similar and signage is provided to prevent unauthorised access.</p> <p>2) Install a certified fall restraint/arrest system that is suitable for the end users.</p> <p>3) Assess if the installation a side screen, ladder cage or other type of enclosure to prevent a sideways fall from the ladder, if practical for the end users.</p> <p>4) Install hi vis (yellow) anti-slip tread on the ladder rungs.</p>

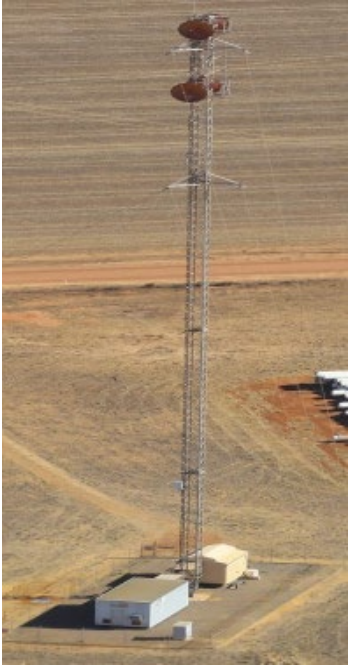
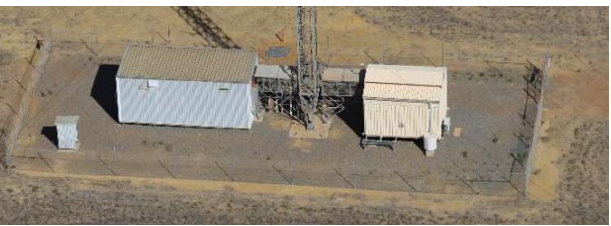
R029-3	12/04/2024	Repeater Station 29 - Communications Tower	<p>Assessed using surveillance photo. Site visit required to obtain additional photos and measurements.</p> <p>1) No access platform provided for ease of access to the ladder. Note: This may have not be provided for the purpose of preventing unauthorised access.</p> <p>2) No fall restraint/arrest system in place for personnel using the ladder. This exposes personnel to a significant fall that would likely result in a fatality or serious injury.</p> <p>3) No ladder enclosure has been installed for the ladder to meet AS requirements (where a fall of more than 6m).</p> <p>4) No hi vis (yellow) anti-slip tread installed on the ladder rungs.</p> <p>Findings on hold pending discussion with Dane. Refer to comments.</p>	C. Unlikely	4. Major	High	<p>1) Install a access stairs/ladder and platform to enable access to the ladder. Ensure a lockable gate or similar and signage is provided to prevent unauthorised access.</p> <p>2) Install a certified fall restraint/arrest system that is suitable for the end users.</p> <p>3) Assess if the installation a side screen, ladder cage or other type of enclosure to prevent a sideways fall from the ladder, if practical for the end users.</p> <p>4) Install hi vis (yellow) anti-slip tread on the ladder rungs.</p>

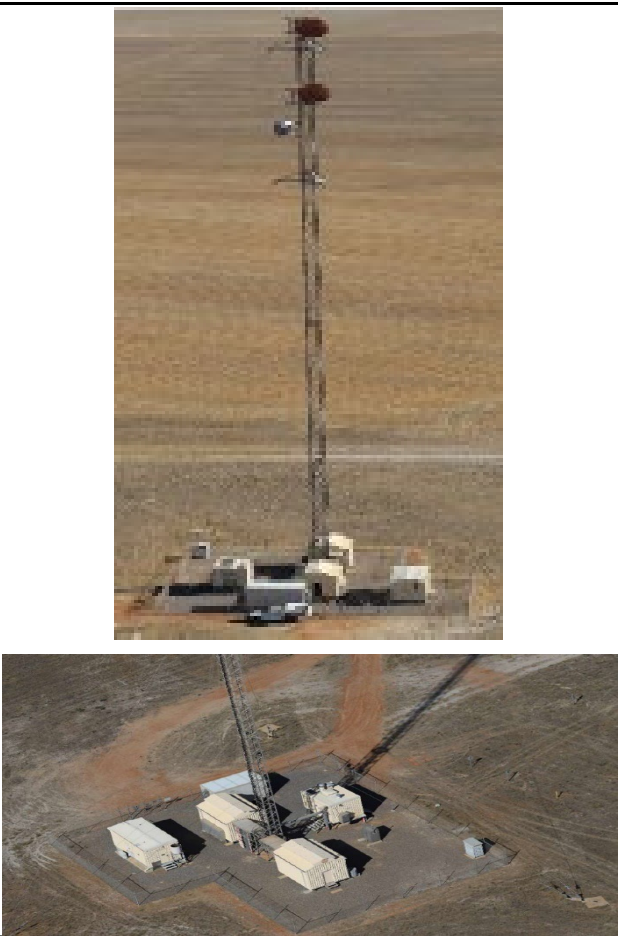
R030-5	12/04/2024	Repeater Station 30 - Communications Tower	<p>Assessed using surveillance photo. Site visit required to obtain additional photos and measurements.</p> <p>1) No access platform provided for ease of access to the ladder. Note: This may have not be provided for the purpose of preventing unauthorised access.</p> <p>2) No fall restraint/arrest system in place for personnel using the ladder. This exposes personnel to a significant fall that would likely result in a fatality or serious injury.</p> <p>3) No ladder enclosure has been installed for the ladder to meet AS requirements (where a fall of more than 6m).</p> <p>4) No hi vis (yellow) anti-slip tread installed on the ladder rungs.</p> <p>Findings on hold pending discussion with Dane. Refer to comments.</p>	C. Unlikely	4. Major	High	<p>1) Install a access stairs/ladder and platform to enable access to the ladder. Ensure a lockable gate or similar and signage is provided to prevent unauthorised access.</p> <p>2) Install a certified fall restraint/arrest system that is suitable for the end users.</p> <p>3) Assess if the installation a side screen, ladder cage or other type of enclosure to prevent a sideways fall from the ladder, if practical for the end users.</p> <p>4) Install hi vis (yellow) anti-slip tread on the ladder rungs.</p>

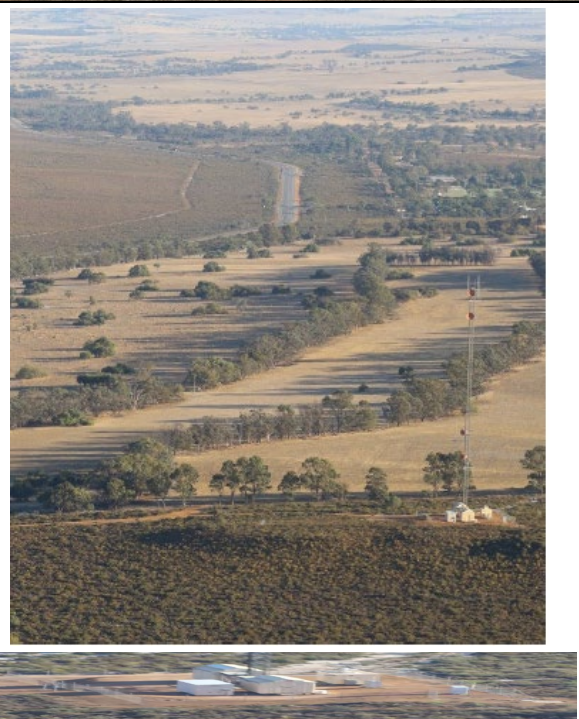
R036-5	12/04/2024	Repeater Station 36 - Communications Tower	<p>Assessed using surveillance photo. Site visit required to obtain additional photos and measurements.</p> <p>1) No access platform provided for ease of access to the ladder. Note: This may have not be provided for the purpose of preventing unauthorised access.</p> <p>2) No fall restraint/arrest system in place for personnel using the ladder. This exposes personnel to a significant fall that would likely result in a fatality or serious injury.</p> <p>3) No ladder enclosure has been installed for the ladder to meet AS requirements (where a fall of more than 6m).</p>	C. Unlikely	4. Major	High	<p>1) Install a access stairs/ladder and platform to enable access to the ladder. Ensure a lockable gate or similar and signage is provided to prevent unauthorised access.</p> <p>2) Install a certified fall restraint/arrest system that is suitable for the end users.</p> <p>3) Assess if the installation a side screen, ladder cage or other type of enclosure to prevent a sideways fall from the ladder, if practical for the end users.</p> <p>4) Install hi vis (yellow) anti-slip tread on the ladder rungs.</p>

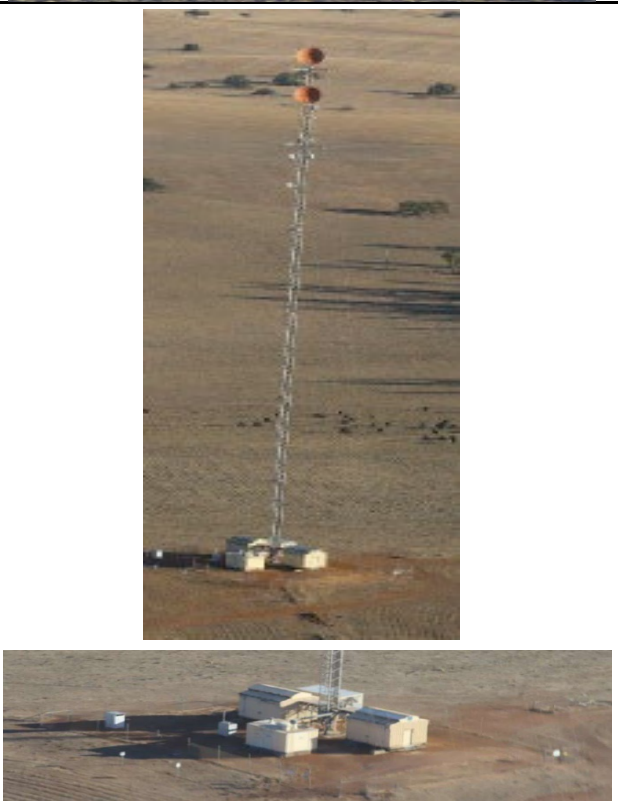
R037-5	12/04/2024	Repeater Station 37 - Communications Tower	<p>Assessed using surveillance photo. Site visit required to obtain additional photos and measurements.</p> <p>1) No access platform provided for ease of access to the ladder. Note: This may have not be provided for the purpose of preventing unauthorised access.</p> <p>2) No fall restraint/arrest system in place for personnel using the ladder. This exposes personnel to a significant fall that would likely result in a fatality or serious injury.</p> <p>3) No ladder enclosure has been installed for the ladder to meet AS requirements (where a fall of more than 6m).</p> <p>4) No hi vis (yellow) anti-slip tread</p>	C. Unlikely	4. Major	High	<p>1) Install a access stairs/ladder and platform to enable access to the ladder. Ensure a lockable gate or similar and signage is provided to prevent unauthorised access.</p> <p>2) Install a certified fall restraint/arrest system that is suitable for the end users.</p> <p>3) Assess if the installation a side screen, ladder cage or other type of enclosure to prevent a sideways fall from the ladder, if practical for the end users.</p> <p>4) Install hi vis (yellow) anti-slip tread on the ladder rungs.</p>

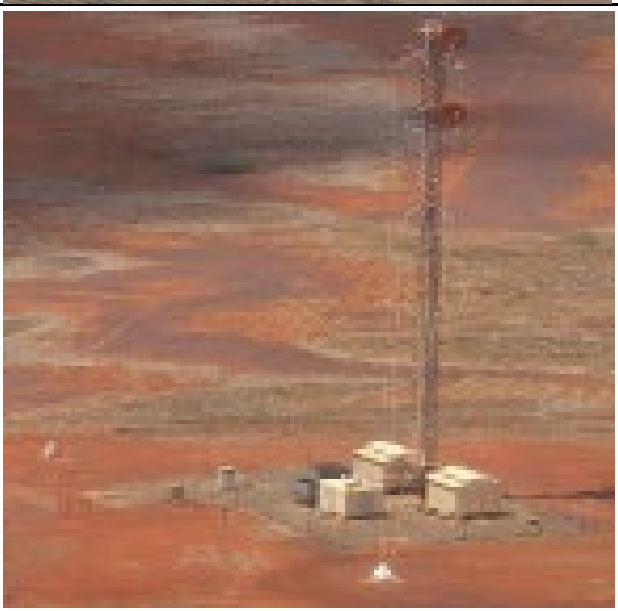
R002-7	22/04/2024	Repeater Station 2 - Communications Tower	<p>Assessed using surveillance photo. Site visit required to obtain additional photos and measurements.</p> <p>1) No access platform provided for ease of access to the ladder. Note: This may have not be provided for the purpose of preventing unauthorised access.</p> <p>2) No fall restraint/arrest system in place for personnel using the ladder. This exposes personnel to a significant fall that would likely result in a fatality or serious injury.</p> <p>3) No ladder enclosure has been installed for the ladder to meet AS requirements (where a fall of more than 6m).</p> <p>4) No hi vis (yellow) anti-slip tread installed on the ladder rungs.</p> <p>Findings on hold pending discussion with Dane. Refer to comments.</p>	C. Unlikely	3. Severe	High	<p>1) Install a access stairs/ladder and platform to enable access to the ladder. Ensure a lockable gate or similar and signage is provided to prevent unauthorised access.</p> <p>2) Install a certified fall restraint/arrest system that is suitable for the end users.</p> <p>3) Assess if the installation a side screen, ladder cage or other type of enclosure to prevent a sideways fall from the ladder, if practical for the end users.</p> <p>4) Install hi vis (yellow) anti-slip tread on the ladder rungs.</p>

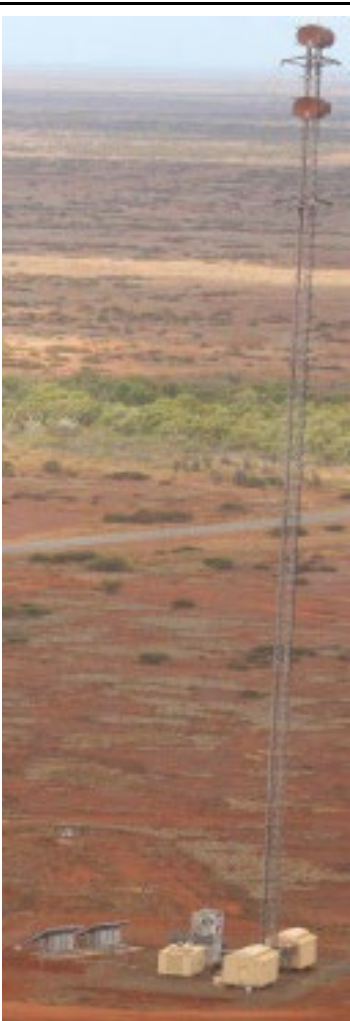
R003-7	22/04/2024	Repeater Station 3 - Communications Tower	<p>Assessed using surveillance photo. Site visit required to obtain additional photos and measurements.</p> <p>1) No access platform provided for ease of access to the ladder. Note: This may have not be provided for the purpose of preventing unauthorised access.</p> <p>2) No fall restraint/arrest system in place for personnel using the ladder. This exposes personnel to a significant fall that would likely result in a fatality or serious injury.</p> <p>3) No ladder enclosure has been installed for the ladder to meet AS requirements (where a fall of more than 6m).</p> <p>4) No hi vis (yellow) anti-slip tread installed on the ladder rungs.</p> <p>Findings on hold pending discussion with Dane. Refer to comments.</p>	C. Unlikely	3. Severe	High	<p>1) Install a access stairs/ladder and platform to enable access to the ladder. Ensure a lockable gate or similar and signage is provided to prevent unauthorised access.</p> <p>2) Install a certified fall restraint/arrest system that is suitable for the end users.</p> <p>3) Assess if the installation a side screen, ladder cage or other type of enclosure to prevent a sideways fall from the ladder, if practical for the end users.</p> <p>4) Install hi vis (yellow) anti-slip tread on the ladder rungs.</p>

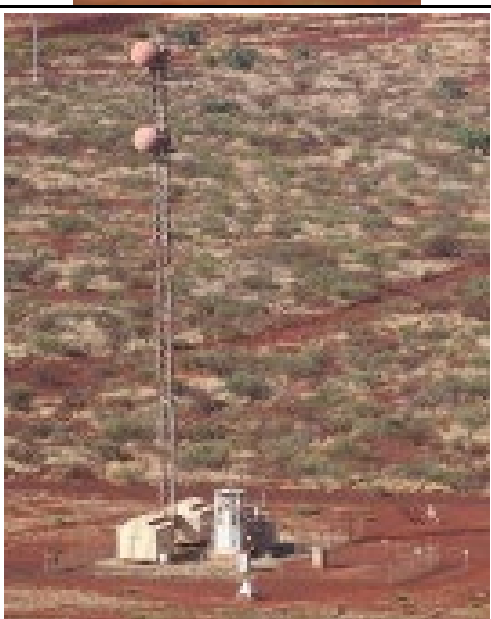
R006-7	22/04/2024	Repeater Station 6 - Communications Tower	<p>Assessed using surveillance photo. Site visit required to obtain additional photos and measurements.</p> <p>1) No access platform provided for ease of access to the ladder. Note: This may have not be provided for the purpose of preventing unauthorised access.</p> <p>2) No fall restraint/arrest system in place for personnel using the ladder. This exposes personnel to a significant fall that would likely result in a fatality or serious injury.</p> <p>3) No ladder enclosure has been installed for the ladder to meet AS requirements (where a fall of more than 6m).</p> <p>4) No hi vis (yellow) anti-slip tread installed on the ladder rungs.</p> <p>Findings on hold pending discussion with Dane. Refer to comments.</p>	C. Unlikely	3. Severe	High	<p>1) Install a access stairs/ladder and platform to enable access to the ladder. Ensure a lockable gate or similar and signage is provided to prevent unauthorised access.</p> <p>2) Install a certified fall restraint/arrest system that is suitable for the end users.</p> <p>3) Assess if the installation a side screen, ladder cage or other type of enclosure to prevent a sideways fall from the ladder, if practical for the end users.</p> <p>4) Install hi vis (yellow) anti-slip tread on the ladder rungs.</p>

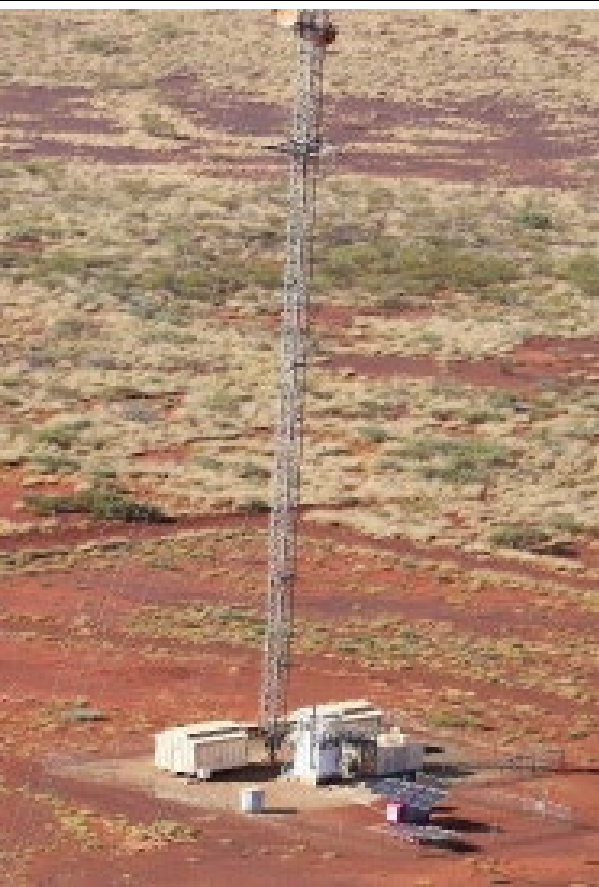
R007-7	22/04/2024	Repeater Station 7 - Communications Tower	<p>Assessed using surveillance photo. Site visit required to obtain additional photos and measurements.</p> <p>1) No access platform provided for ease of access to the ladder. Note: This may have not be provided for the purpose of preventing unauthorised access.</p> <p>2) No fall restraint/arrest system in place for personnel using the ladder. This exposes personnel to a significant fall that would likely result in a fatality or serious injury.</p> <p>3) No ladder enclosure has been installed for the ladder to meet AS requirements (where a fall of more than 6m).</p> <p>4) No hi vis (yellow) anti-slip tread installed on the ladder rungs.</p> <p>Findings on hold pending discussion with Dane. Refer to comments.</p>	C. Unlikely	3. Severe	High	<p>1) Install a access stairs/ladder and platform to enable access to the ladder. Ensure a lockable gate or similar and signage is provided to prevent unauthorised access.</p> <p>2) Install a certified fall restraint/arrest system that is suitable for the end users.</p> <p>3) Assess if the installation a side screen, ladder cage or other type of enclosure to prevent a sideways fall from the ladder, if practical for the end users.</p> <p>4) Install hi vis (yellow) anti-slip tread on the ladder rungs.</p>

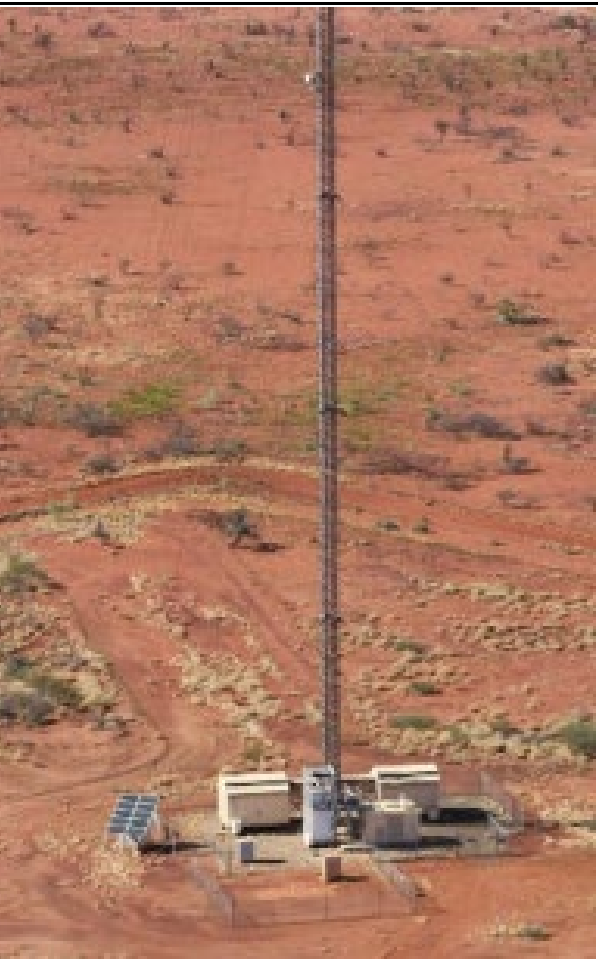
R008-7	22/04/2024	Repeater Station 8 - Communications Tower	<p>Assessed using surveillance photo. Site visit required to obtain additional photos and measurements.</p> <p>1) No access platform provided for ease of access to the ladder. Note: This may have not be provided for the purpose of preventing unauthorised access.</p> <p>2) No fall restraint/arrest system in place for personnel using the ladder. This exposes personnel to a significant fall that would likely result in a fatality or serious injury.</p> <p>3) No ladder enclosure has been installed for the ladder to meet AS requirements (where a fall of more than 6m).</p> <p>4) No hi vis (yellow) anti-slip tread installed on the ladder rungs.</p> <p>Findings on hold pending discussion with Dane. Refer to comments.</p>	C. Unlikely	3. Severe	High	<p>1) Install a access stairs/ladder and platform to enable access to the ladder. Ensure a lockable gate or similar and signage is provided to prevent unauthorised access.</p> <p>2) Install a certified fall restraint/arrest system that is suitable for the end users.</p> <p>3) Assess if the installation a side screen, ladder cage or other type of enclosure to prevent a sideways fall from the ladder, if practical for the end users.</p> <p>4) Install hi vis (yellow) anti-slip tread on the ladder rungs.</p>

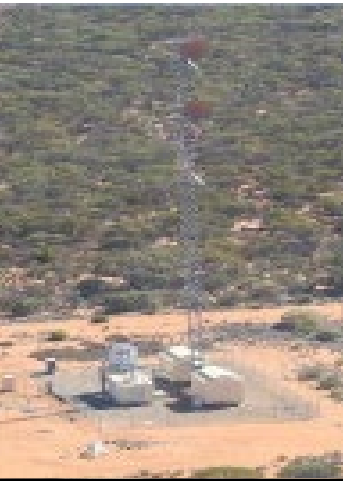
R026-4	12/04/2026	Repeater Station 26 - Communications Tower	<p>Assessed using surveillance photo. Site visit required to obtain additional photos and measurements.</p> <p>1) No access platform provided for ease of access to the ladder. Note: This may have not be provided for the purpose of preventing unauthorised access.</p> <p>2) No fall restraint/arrest system in place for personnel using the ladder. This exposes personnel to a significant fall that</p>	C. Unlikely	4. Major	High	<p>1) Install a access stairs/ladder and platform to enable access to the ladder. Ensure a lockable gate or similar and signage is provided to prevent unauthorised access.</p> <p>2) Install a certified fall restraint/arrest system that is suitable for the end users.</p> <p>3) Assess if the installation a side screen, ladder cage or other type</p>

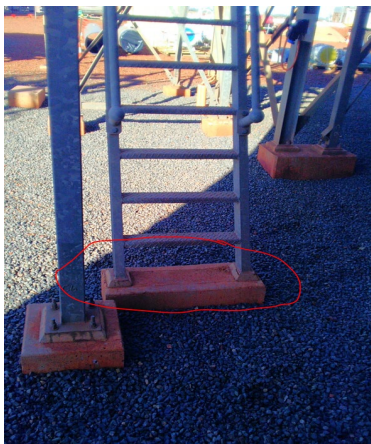
c	Date Added	Location on Site	Issue	Likelihood	Consequence	Risk Score	Suggestions	Evidence	What is being completed	Date Planned for Completion	Date Completed	Comments
CS01-1	2/02/2023	Example - Lube oil cooler unit 1	1) Landing does not meet AS requirement of 900mm 2) Stair treads too narrow and no non-slip				1.1) Remove old landing and install new precast one 1.2) Pour new landing 2.1) Replace ladder with new treads and non-slip

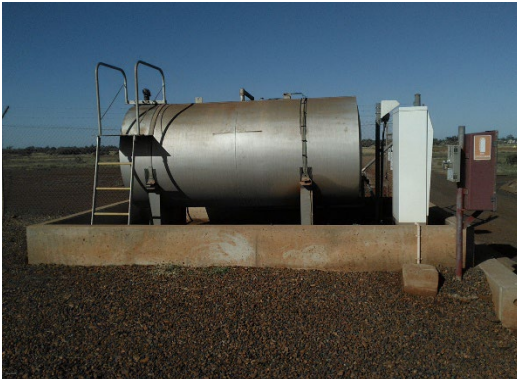
CS01-2	22/02/2023	Diesel Fuel Tank / Bowser	1) Handrail does not meet AS1657 requirement of 900mm (~600mm actual recorded). 2) No gate at the top of the work platform. Potential fall of 1.9m	D. Occasional	3. Severe	Medium	1.1) Replace the access ladder and platform with access stairs and platform, with handrails. 1.2) Modify the bund if required to accommodate the new platform and access stairs / ladder. 2) Self closing gate to be installed at the top of the platform.

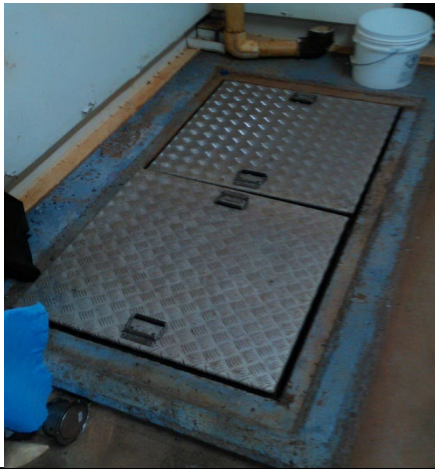
CS01-3	22/02/2023	Water Treatment Plant - Pit Inside Building	1) Poor access / egress from ladder. 2) The foot of the ladder does not rest on or terminate above the landing. There is also no clear handgrips to assist the person using the ladder. Therefore it does not meet AS 1657 requirements. 3) No non-slip tread on ladder rungs.	C. Unlikely	3. Severe	Medium	1) Consider the position of the ladder when being redesigned, to allow for safe access / egress. 2) Redesign the ladder and hand grips to provide suitable access and meet AS1657 requirements. 3) Replacement ladder to have hi vis (yellow) non-slip tread installed on the rungs.

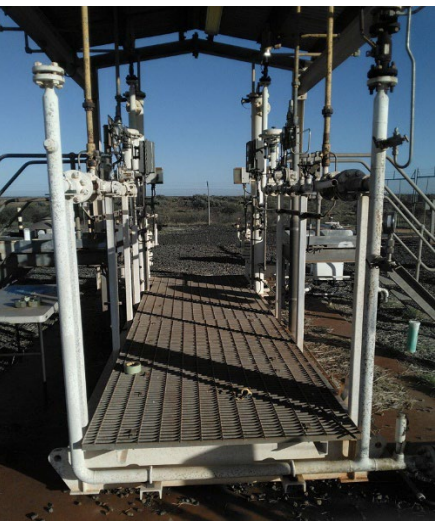
CS01-4	22/02/2023	GEA Fuel Gas Skid	1) Step up / down from grid mesh platform is 450mm and the current design is not compliant with AS 1657 (300-450mm requires a minimum of 1 step). 4 locations of this identified. 2) No hi vis (yellow) strip on the nosing (ends) of the grid mesh platform. 4 locations of this identified.	C. Unlikely	2. Minor	Low	1) Install a step between the landing and grid mesh platform to provide safe access at each location. 2) Install hi vis (yellow) non-slip strip on the nosing of each grid mesh platform (4 locations) as well as stairs installed under Action 1.

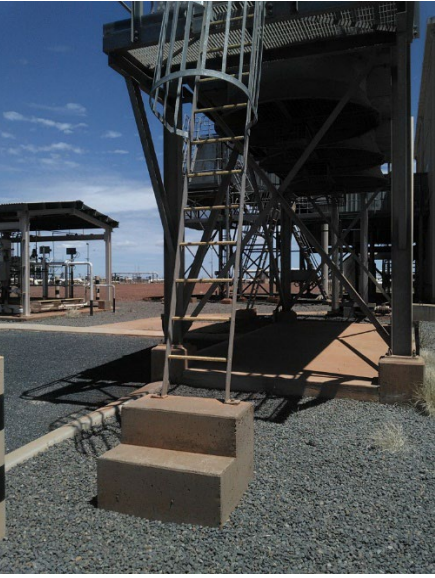
CS01-5	22/02/2023	ACS Lube Oil Cooler	1) Two ladders have landings that does not meet the AS1657 requirements. 2) Two ladders are currently installed on top of concrete steps due to being the incorrect size.	C. Unlikely	3. Severe	Medium	1) Pour a new landing for each ladder. 2) Replace both ladders with the correct size, to ensure it runs from the landing to the platform.

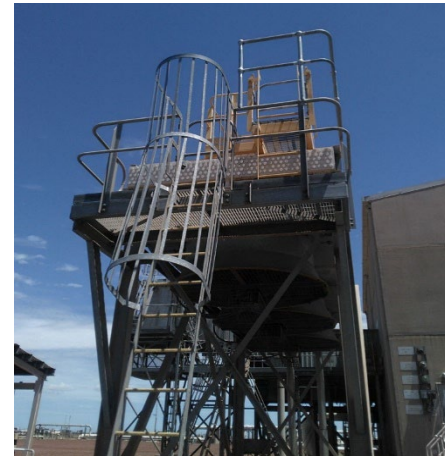
Date Added	Location on Site	Issue	Likelihood	Consequence	Risk Score	Suggestions	Evidence	What is being completed	Date Planned for Completion	Date Completed	Comments
CS01-6	22/02/2023	ACS Lube Oil Cooler - Platform (East Side)	1) On the middle platform, there is no mid rail between the existing handrail and the access ladder to the top platform. This has created the potential for a fall from height.	B. Remote	3. Severe	Medium	1) On the middle platform, install a handrail between the existing handrail and the ladder to the top platform.

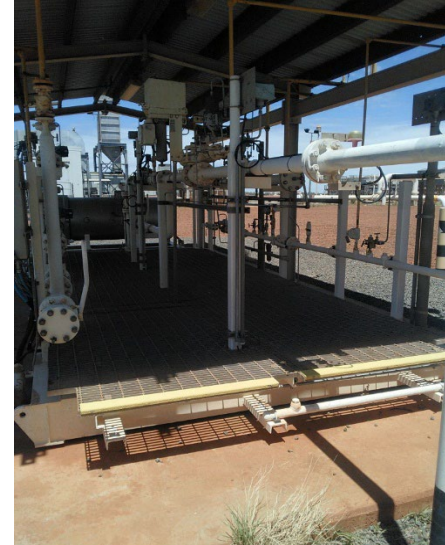
CS01-8	22/02/2023	ACS Fuel Gas Skid (South Side)	1) Step up / down from grid mesh platform is 450mm and the current design is not compliant with AS 1657 (300-450mm requires a minimum of 1 step). There is 2 locations of this.	C. Unlikely	2. Minor	Low	1) Install step(s) between the landing and grid mesh platform to provide safe access at each end.

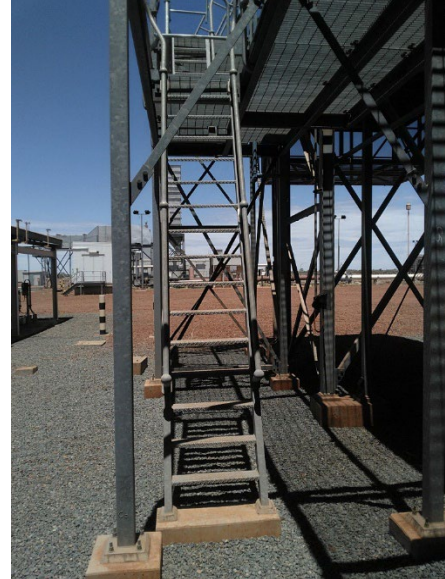
CS01-9	22/02/2023	ACS Inlet Duct	1) The landing for the ladder does not meet AS1657 requirements of 900mm from the bottom lung. 2) The angle of the slope (58.40 degrees) below the AS1657 requirements for step type ladders of Min 60 degrees and Max 70 degrees. Calculation Notes: 3.8m Rise (height), 2.2m Run (length), 16 Runs (steps). *To be verified by JW. 3) Handrail does not meet AS requirements by beginning within a max of 900mm of the landing. 4) Nosing of stairs does not have hi vis (yellow) tread installed. 5) Greater potential to fall if facing away from the stairs when descending.	B. Remote	3. Severe	Low	1) Pour a new landing. 2) Install a new staircase that complies with AS1657. The new stairwell will need to be installed with a different orientation to avoid head height hazards (e.g. cross beams). 3) Modify the handrail to meet the AS requirements. 4) Ensure the stairs have hi vis (yellow) tread installed on the nosing of each stair. 5) Install signage on both sides of the gate to instruct personnel to only descend the stairs whilst facing towards the stair.

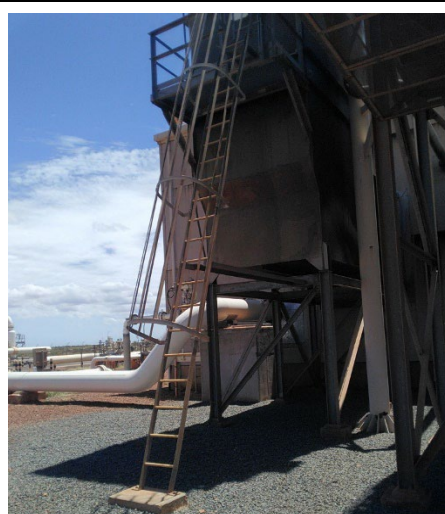
CS01-10	22/02/2023	ACS Exhaust Duct	1) The landing for the ladder does not meet the AS1657 requirements of 900mm from the bottom lung.	B. Remote	2. Minor	Low	1) Pour a new landing.

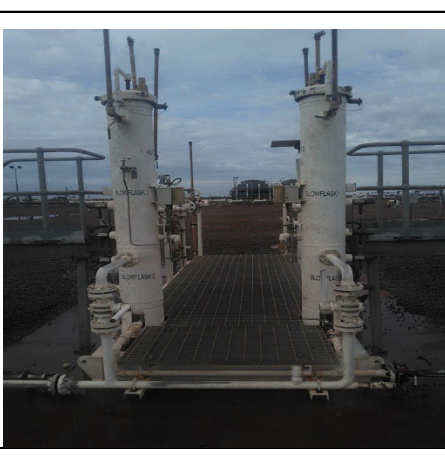
CS01-11	22/02/2023	Blow Flask Skid	1) Step up / down from grid mesh platform is 450mm and the current design is not compliant with AS 1657 (300-450mm requires a minimum of 1 step). There is 2 locations of this. 2) No hi vis (yellow) strip on the nosing (ends) of the grid mesh platform. There is 2 locations of this.	C. Unlikely	2. Minor	Low	1) Install a step between the landing and grid mesh platform to provide safe access at each end. 2) Install a hi vis (yellow) non-slip strip on the nosing of each end of the platform and installed stairs.

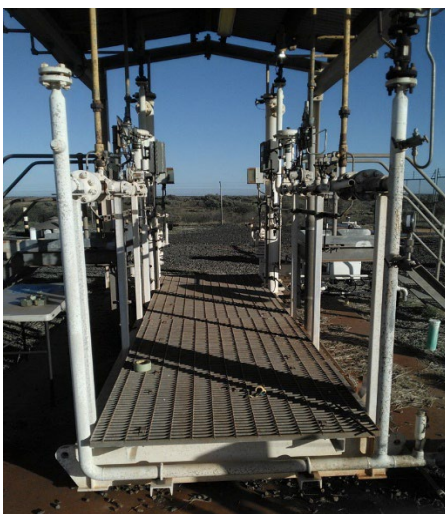
CS01-12	22/02/2023	Fuel Reduction Skid (West Side of Plant)	1) Step up / down from grid mesh platform is 450mm and the current design is not compliant with AS 1657 (300-450mm requires a minimum of 1 step). There is 2 locations of this. 2) No hi vis (yellow) strip on the nosing (ends) of the grid mesh platform. There is 2 locations of this.	C. Unlikely	2. Minor	Low	1) Install a step between the landing and grid mesh platform to provide safe access at each end. 2) Install hi vis (yellow) non-slip strip on the nosing of each end of the platform.

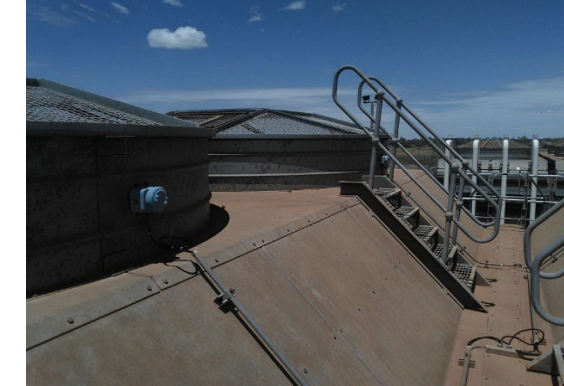
CS01-15	22/02/2023	After Cooler Fans - Top Platform	1) No handrails have been installed on the sloping edges adjacent to the 2 x grid mesh staircases. This is located on the top of the platform. 2) No hi vis (yellow) tread on the nosing of the stairs. 3) Cables installed in the access way between the after cooler fans, creating a trip hazard.	C. Unlikely	3. Severe	Medium	1) Install handrails to prevent access to the sloping edges. 2) Install hi vis (yellow) tread on the nosing of the stairs. 3) Re-route the cables to outside of the walkway.

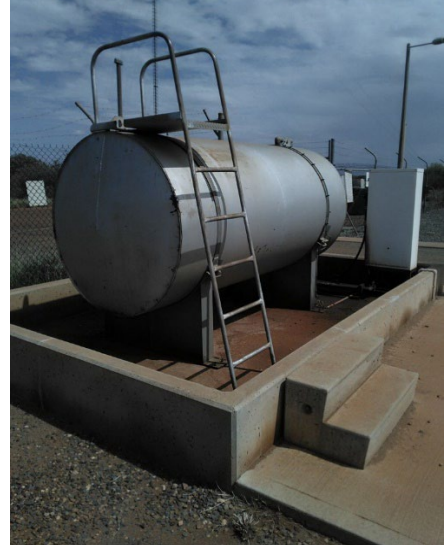
C502-2	21/02/2023	Diesel Fuel Tank / Bowser	1) Handrail does not meet AS 1657 requirement of 900mm (~900mm actual recorded). 2) No gate at the top of the work platform. Potential fall of 1.9m	D. Occasional	3. Severe	Medium	1.1) Replace the access ladder and platform with access stairs and platform, with handrails. 1.2) Modify the bund if required to accommodate the new platform and access stairs / ladder. 2) Self closing gate to be installed at the top of the platform.

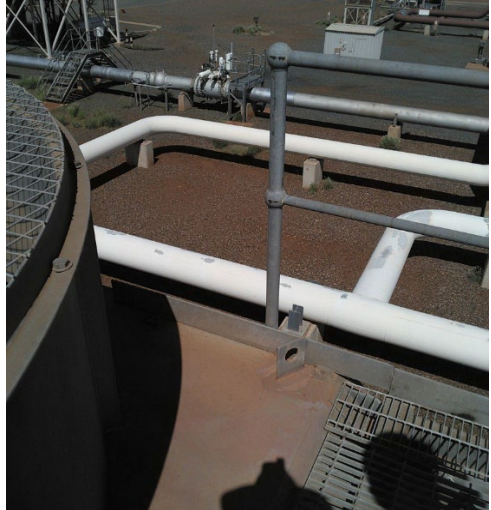
C502-3	21/02/2023	After Cooler Fans - Top Platforms	1) Several locations where there is a gap between the existing handrails and the fan enclosures exceeds the AS 1657 allowance (max 100mm). This creates the potential for a person to fall from height resulting in a fatality or significant injury due to the total fall distance.	C. Unlikely	4. Major	High	1) Extend the handrail to the fan enclosures to eliminate exposure to a unprotected edge.
