Revised Final Plan
Attachment 9.12

Structures & Operational Sites - Working at Heights - Appendix B

August 2025

**Dampier Bunbury
Pipeline**

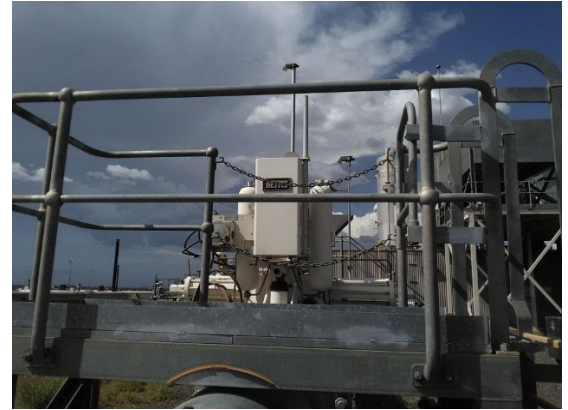
C502-6	21/02/2023	Unit 2 - Access Platform for Bettic Equipment	1) Chain has been used in lieu of a handrail at the top of the platform, adjacent to the Bettic Equipment. Chain will break in the event of a fall and therefore will not meet AS 1657 requirements for guardrails.	C. Unlikely	3. Severe	Medium	1) Replace the chains with handrails that meets AS 1657 requirement.

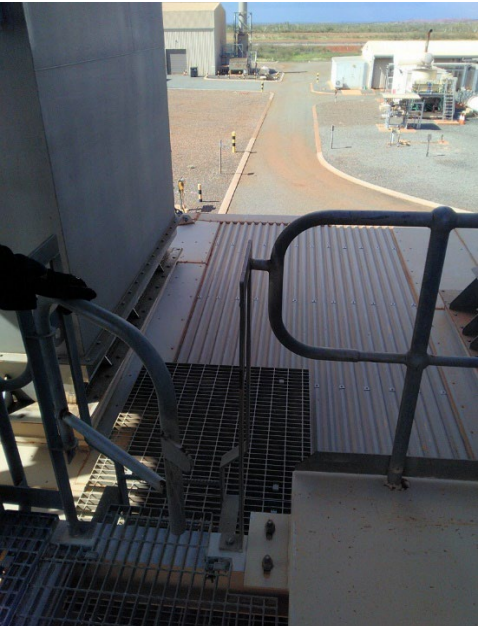
C502-7	21/02/2023	Unit 2 - Middle Platform (North Side)	1) Self closing gate leads onto a section of roof with no edge protection in place. This exposes personnel on the roof, to a potential for a fall from height resulting in a fatality or significant injury.	C. Unlikely	4. Major	High	1.1) Install edge protection along the exposed edges of the roof. 1.2) Install signage to highlight the fall from height risk until edge protection is installed.

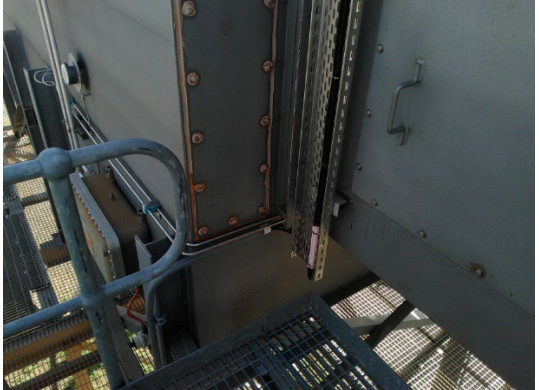
C502-8	21/02/2023	Unit 2 - Middle Platform (East Side)	1) There is a gap between the existing handrail and structure, which exceeds the AS 1657 requirements (<= 100mm).	B. Remote	3. Severe	Low	1) Extend the handrail towards the structure to reduce the gap. Ensure the hatch can still be operated without obstruction.

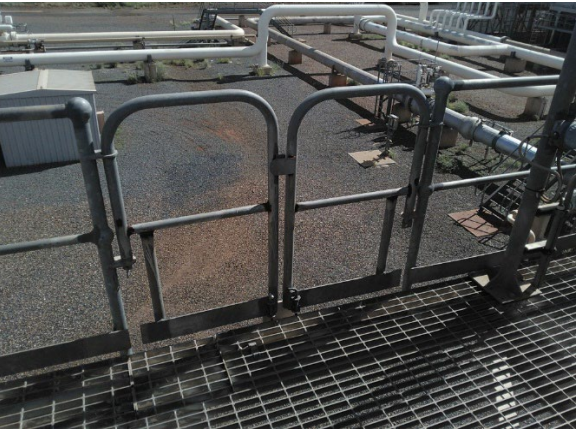
C502-10	21/02/2023	Unit 2 - Middle Platform (South Side)	1) When the existing gate is opened to allow mobile plant lifting loads onto/off the platform, it creates the potential for a person fall from height. A fall from this location would likely result in a fatality or significant injury.	C. Unlikely	4. Major	High	1.1) Recommend replacing the existing gate with a purpose built safety gate (i.e. UMZ18 Mezzanine Safety Gate). This type of gate eliminates the risk. It should be painted a hi vis colour (i.e. yellow) and have pinch point stickers or similar installed on the safety gate. 1.2) Install signage to highlight the fall from height risk until an alternative safety gate is installed.

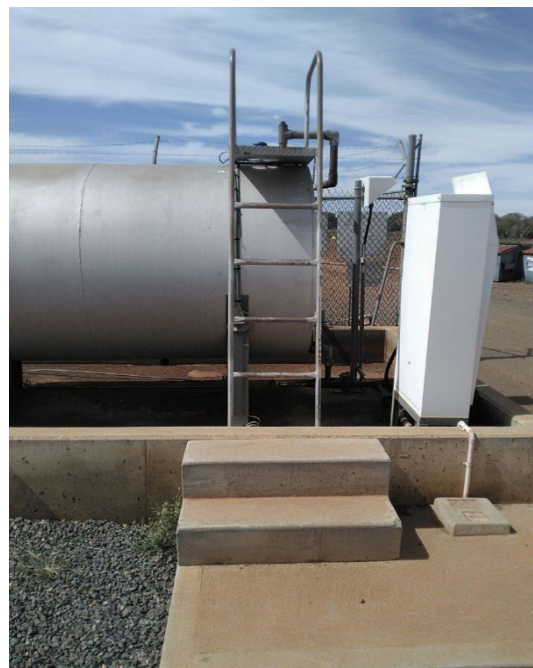
Replace ladder and landing. Pour new landing			
CS03-1	21/04/2023	Diesel Fuel Tank / Bowser	1) Handrail does not meet AS requirement of 900mm (~570mm). 2) No gate at the top of the work platform. 3) Landing does not meet AS requirements. Obstructed by bunding.	D. Occasional	3. Severe	Medium	1) Replace the access ladder and platform with access stairs and platform, with handrails and hi vis tread. 2) Self closing gate to be installed at the top of the platform. 3) Ensure the landing on the redesigned access stairs and platform meet the AS requirements. Modifying the bund if required.

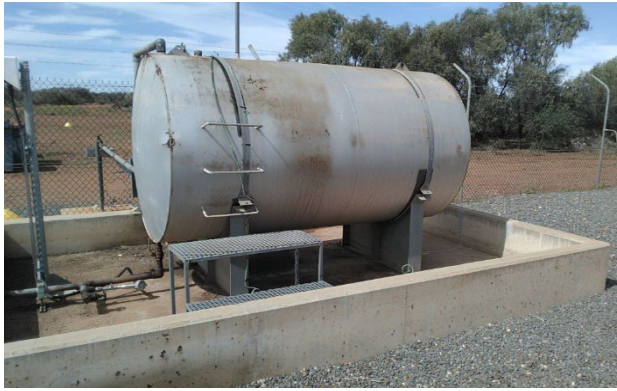
CS03-2	21/04/2023	Storage Tank Adjacent to Diesel Fuel Tank	1) Reo-bar used as ladder runs and this does not meet AS requirement. 2) No handrails have been installed. 3) Landing does not meet AS requirements. Obstructed by bunding. 4) Temporary step up does not meet AS requirement for Riser 130mm to 225mm (~300mm per step).	D. Occasional	3. Severe	Medium	1) Replace the access ladder and install an platform with access stairs and platform, with handrails and hi vis tread. 2) Self closing gate to be installed at the top of the platform. 3) Ensure the landing on the redesigned access stairs and platform meet the AS requirements. Modify the bund if required. 4) Remove the temporary stairs and tag out of service until they can be modified to meet AS requirements or is disposed of.

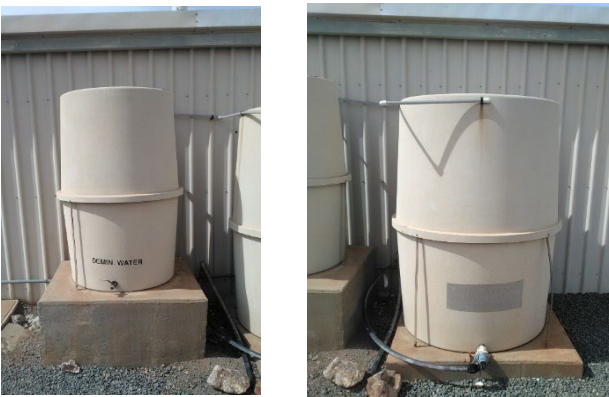
CS03-3	21/04/2023	Water Treatment Plant - 2 x Exterior Tanks	1) No platform available to access the inspection hatch on the top of the two tanks. Likely platform ladder on blue metal or standing on the concrete pad the tank sits on is used for access. Potential fall of 2080mm.	C. Unlikely	2. Minor	Low	1) Install a landing, step up and platform that complies with AS requirements. Ask a FMO or Dave Martin if we would perform a task to access the top. If no, hid the cell.

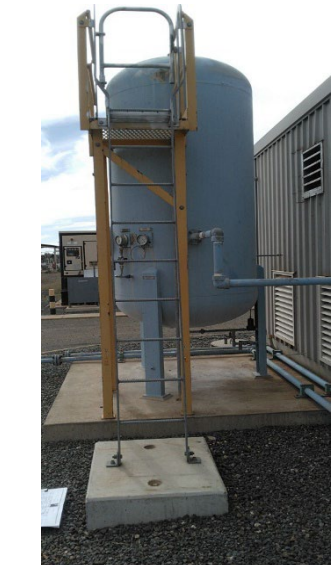
CS03-5	21/04/2023	Compressed Air Unit For Battery Rooms	1) No non-slip tread on ladder runs. 2) Landing does not meet the AS requirements. 3) ~200mm Gap between the vessel and the handrail is not compliant with AS requirements (max 100mm).	B. Remote	2. Minor	Low	1) Install hi vis (yellow) non-slip tread installed on the rungs. 2) Extend landing to meet AS requirements. 3) Extend the handrail to within 100mm of the vessel. Change to recommend the ladder is removed if it not required. Ask a FMO or David Martin from this work group.

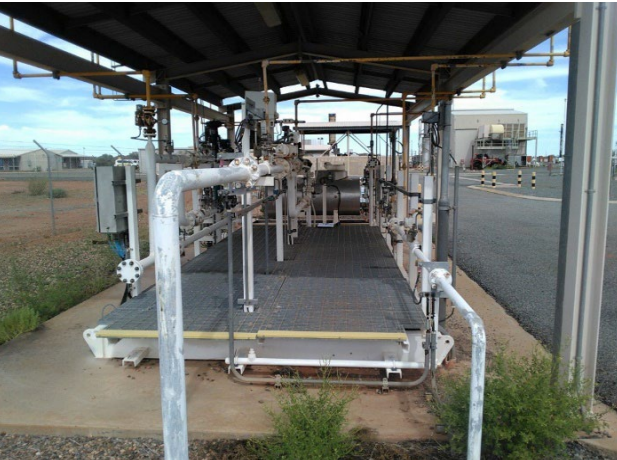
CS03-6	21/04/2023	Fuel Gas Skid For Stage 1 Unit	1) Step up / down from the grid mesh platform is 390mm and is therefore non-compliant with AS1657 (130-225mm). There is 2 locations of this.	C. Unlikely	2. Minor	Low	1) Install a step between the landing and grid mesh platform to provide safe access at each end.

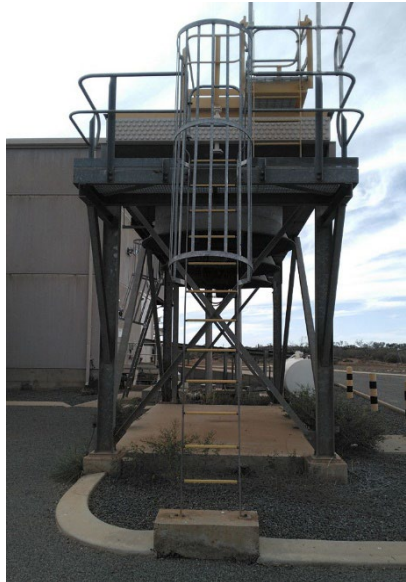
CS03-7	21/04/2023	Unit 1 After Coolers - South Access Ladder	1) Landing does not meet the AS requirements (size and step up from ground.	C. Unlikely	2. Minor	Low	1) Modify the size of the landing to meet AS requirements (including step up from ground to landing and size of landing).

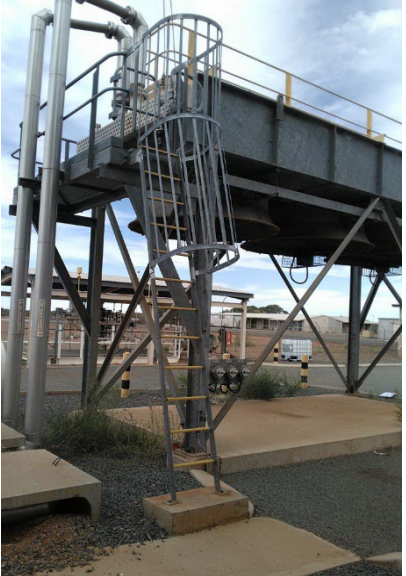
Reference	Date added	Location on Site	Issue	Likelihood	Consequence	Risk Score	Suggestions	Evidence	What is being completed	Date planned for completion	Date completed	Comments
CS03-8	21/04/2023	Unit 1 After Coolers - West Access Ladder	1) Landing does not meet the AS requirements (size and step up from ground.	C. Unlikely	2. Minor	Low	1) Modify the size of the landing to meet AS requirements (including step up from ground to landing and size of landing).

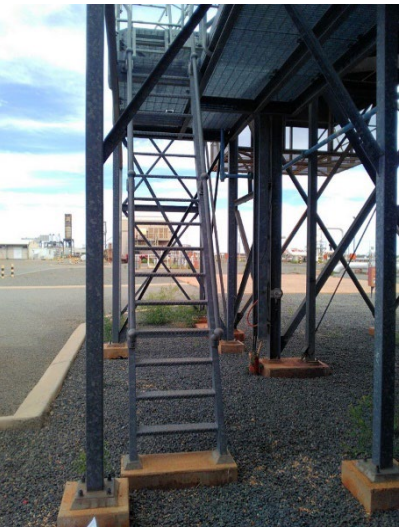
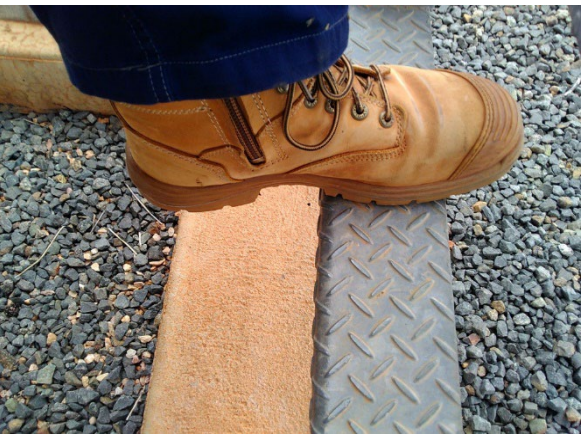
CS03-9	21/04/2023	Unit 1 After Cooler Fans - Top Platform	1) No handrail on the western end of the top platform. Personnel at risk of a fall ~5m when performing maintenance activities on the piping.	C. Unlikely	3. Severe	High	1) Modify the platform and handrails to provide access for maintenance tasks without being exposed to the risk of a fall.	No photos available. Refer to CS08.				
CS03-10	21/04/2023	ACS Inlet Duct	1) The landing for the ladder does not meet AS1657 requirements of 900mm. 2) The angle of the slope (58.40 degrees) exceeds AS1657 requirements of Min 20 degrees and Max 45 degrees. Calculation Notes: 3.8m Rise (height), 2.2m Run (length), 16 Runs (steps). 3) The steps nosing do not have no hi vis non-slip tread fitted and posings a slip/fall risk. 4) Handrail does not meet AS requirements by beginning within a max of 900mm of the landing. 5) Greater potential to fall if facing away from the stairs when descending.	C. Unlikely	3. Severe	Medium	1) Pour a new landing. 2) Install a new stairwell that complies with AS1657. The new stairwell will need to be installed with a different orientation to avoid head height hazards (e.g. cross beams). 3) Hi vis non-slip tread is also to be fitted to the nosing of each stair. 4) Modify the handrail to meet the AS requirements. 5) Install signage on both sides of the gate to instruct personnel to only descend the stairs whilst facing towards the stair. Check AS requirement for when the handrail can stop. Check AS requirement for the tread depth for this type of staircase. May differ.

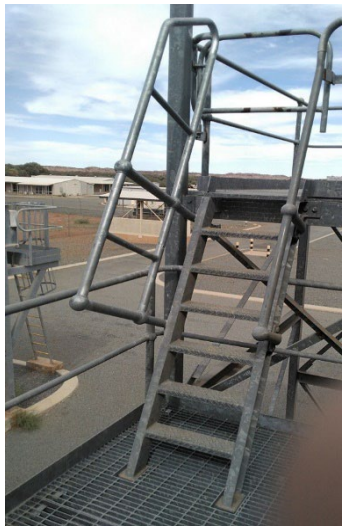
CS03-11	21/04/2023	ACS Inlet Duct - Middle Deck Access Ladder	1) The steps are small in size (~110mm), have no hi vis non-slip tread fitted, do not meet AS1657 requirements and posings a slip/fall risk. 2) Handrail does not meet AS requirements by not extending the full length of the stairs.	B. Remote	2. Minor	Low	1) Ensure the new stairwell has suitably sized steps that meet AS1657 requirements. Hi vis non-slip tread is also to be fitted to the nosing of each stair. 2) Extend the handrail the full length of the stairs. Check tread size in AS.

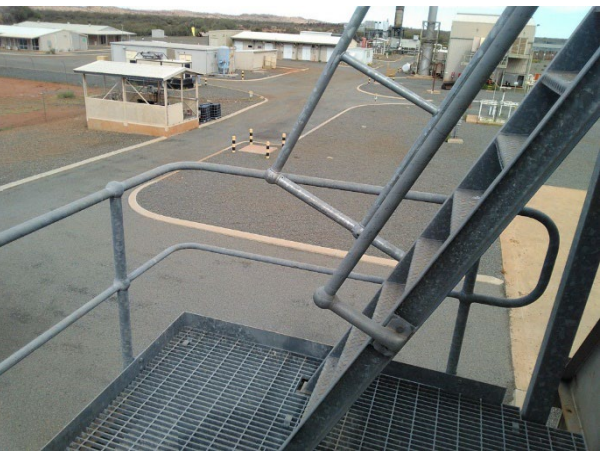
CS03-13	21/04/2023	ACS Inlet Duct - Top Deck	1) The landing for the ladder does not meet AS1657 requirements of 900mm. 2) The steps are small in size (~110mm), have no hi vis non-slip tread fitted, do not meet AS1657 requirements and posings a slip/fall risk. 3) Handrail does not meet AS requirements by not extending the full length of the stairs.	C. Unlikely	3. Severe	Medium	1) Modify the platform to provide adequate landing or modify the access method. 2) Ensure the new stairwell has suitably sized steps or a access ladder that meet AS1657 requirements. Hi vis non-slip tread is also to be fitted to the nosing of each stair. 3) Extend the handrail the full length of the stairs.

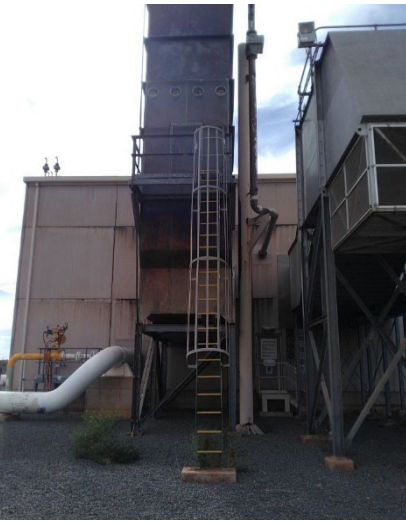
CS03-14	21/04/2023	ACS Exhaust Duct	1) The landing for the ladder does not meet AS1657 requirements of 900mm.	B. Remote	2. Minor	Low	1) Pour a new landing.

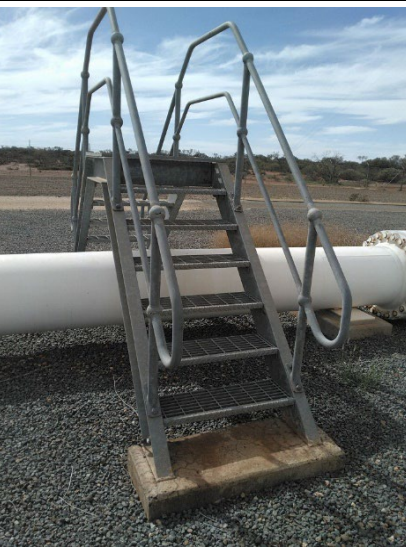
CS03-15	21/04/2023	Access Stairs Over Ground Level Pipework - Several Locations	1) The landing for the stairs does not meet AS1657 requirements of 900mm. 2) No hi vis (yellow) tread installed onto the nosing of each stair.	C. Unlikely	2. Minor	Low	1) Pour a new landing. 2) Install hi vis (yellow) tread onto the nosing of each stair.

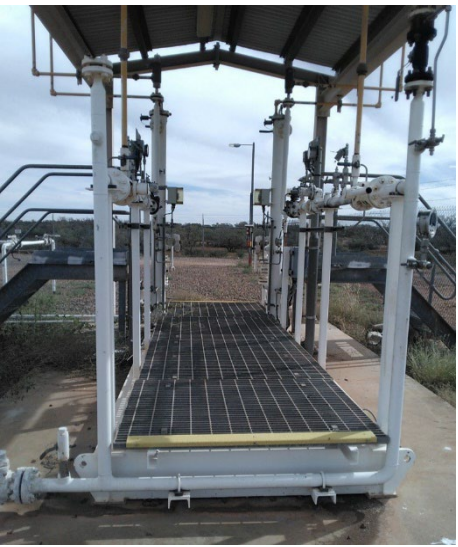
Reference	Date added	Location on Site	Issue	Likelihood	Consequence	Risk Score	Suggestions	Evidence	What is being completed	Date planned for completion	Date completed	Comments
CS03-16	21/04/2023	Fuel Reduction Skid (West Side of Plant)	1) Step up / down from the grid mesh platform is 370mm and is therefore non-compliant with AS1657 (130-225mm). There is 2 locations of this	B. Remote	2. Minor	Low	1) Install a step between the landing and grid mesh platform to provide safe access at each end.

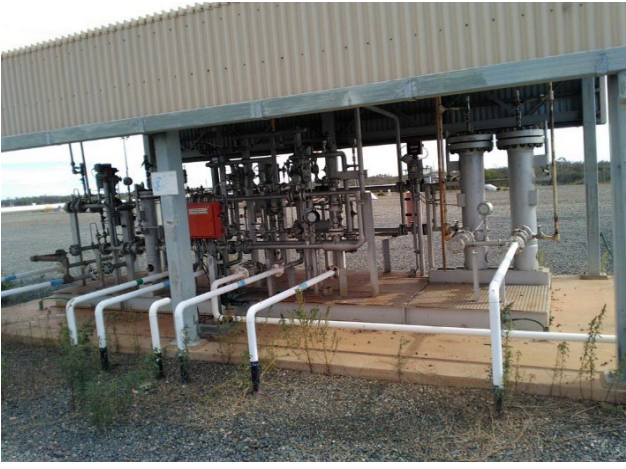
CS03-17	21/04/2023	Unit 1 Pressure Reduction Skid	1) No hi vis (yellow) strip on the nosing (ends) of the grid mesh platform.	B. Remote	2. Minor	Low	1) Install hi vis (yellow) non-slip strip on the nosing of the skid's access point.

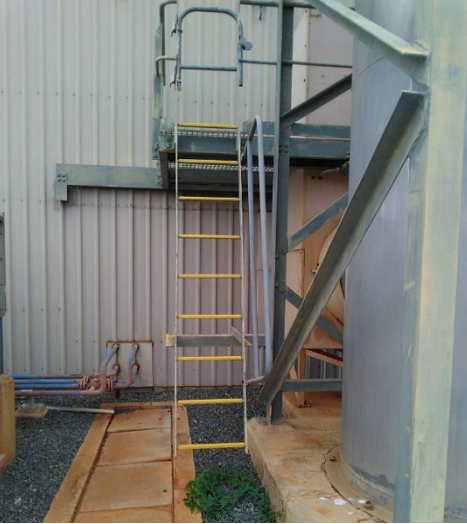
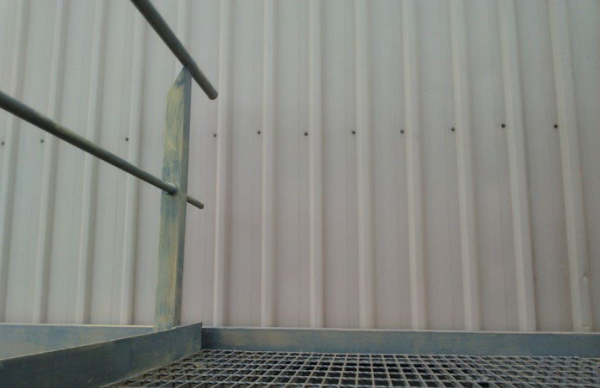
CS03-18	21/04/2023	Unit 1 Vessel - Access Platform	1) The ladder does not meet AS requirements (e.g. run full length to the landing, step up too great). 2) Gap between the handrail and structure 130mm and does not meet AS requirements (max 100mm). <i>Note: Comment only given the small difference above the AS requirement.</i>	C. Unlikely	3. Severe	Medium	1.1) Install a landing that meets AS requirements. 1.2) Modify the ladder so its runs to the new landing and the first step up meets AS requirements.

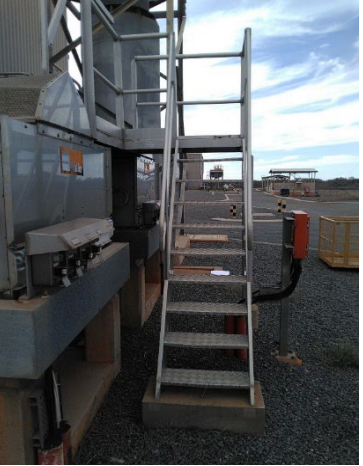
CS03-19	21/04/2023	Unit 1 Compressor Oil Cooler Fans Access Stairs	1) The landing for the stairs does not meet AS1657 requirements of 900mm. 2) The handrail does not run the full length of the stairs, increasing the potential of being unable to arrest a slip / fall. 3) No hi vis (yellow) tread installed onto each stair.	C. Unlikely	3. Severe	Medium	1) Pour a new landing. 2) Modify the handrail to run the full length of the stairs. 3) Install hi vis (yellow) tread onto each stair.

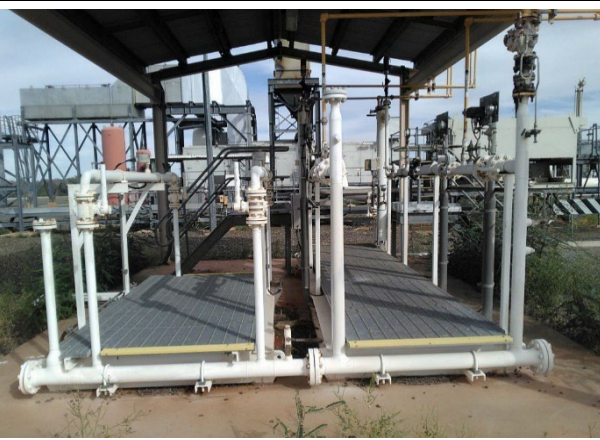
CS03-22	21/04/2023	GEA 1 and 2 - Fuel Gas Skid	1) The step up (370mm) from the ground to the grid mesh platform exceeds AS requirements (130-225mm).	C. Unlikely	2. Minor	Low	1) Install a step between the landing and grid mesh platform to provide safe access at the four access points.

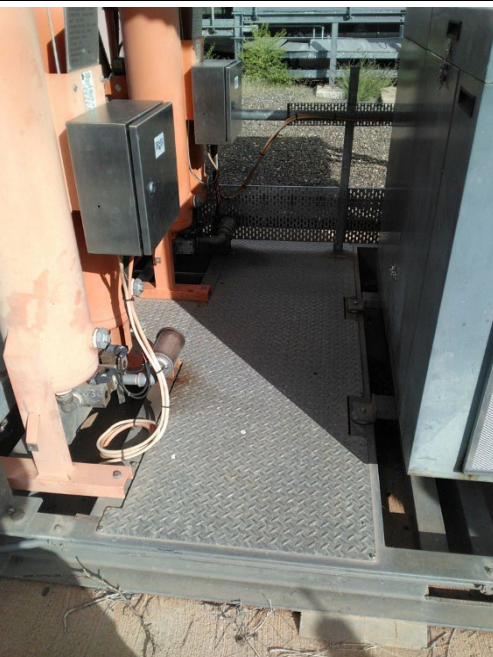
CS03-23	21/04/2023	Desiccant Dryers x 2	1) The landing (280mm) does not meet AS requirement of 600mm (Depth). 2) No hi vis (yellow) tread installed on the nosing of the platform. 3) Cable tray adjacent to step ups is a trip hazard and the hi vis tape has faded.	B. Remote	2. Minor	Low	1) Remove old landing and pour a new landing. 2) Install hi vis (yellow) tread onto the nosing of the two access points. 3.1) Relocate the cable tray to eliminate the trip hazard if practically possible. 3.2) If the cable tray can not be relocated then apply new hi vis tape.

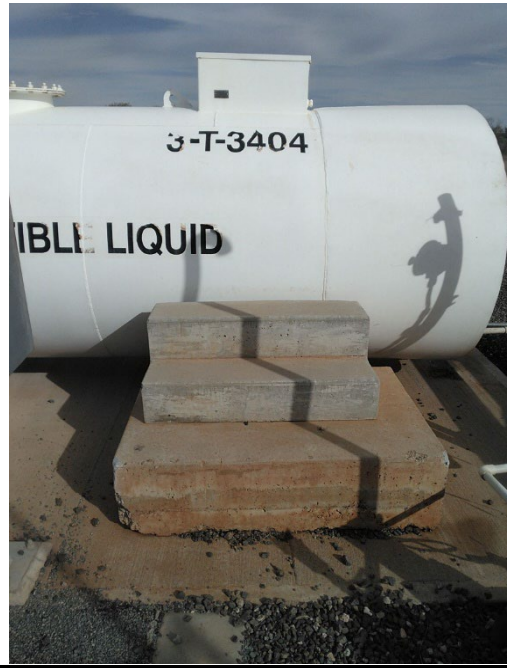
Reference	Date added	Location on Site	Issue	Likelihood	Consequence	Risk Score	Suggestions	Evidence	What is being completed	Date planned for completion	Date completed	Comments
CS03-24	21/04/2023	Unit 3 - Combustible Liquid Tank	<p>1) The stairs do not meet AS requirements (e.g. first step's riser is 360mm, no handrails, no hi vis nosing). The stairs are being used as a work platform</p> <p>Potential for a fall from the stop stair is 760mm.</p>	C. Unlikely	3. Severe	Medium	1) Replace the concrete stairs with a work platform and access stairs that is AS compliant.

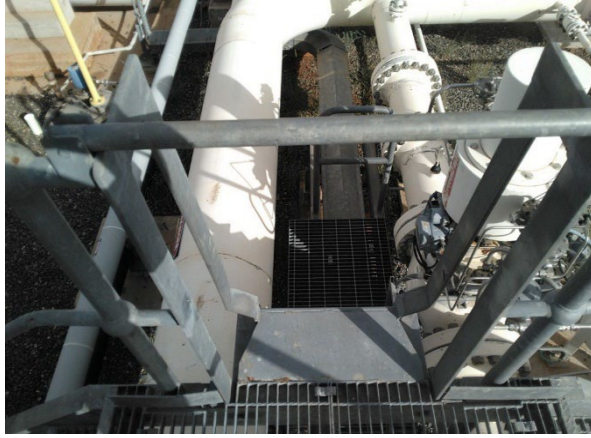
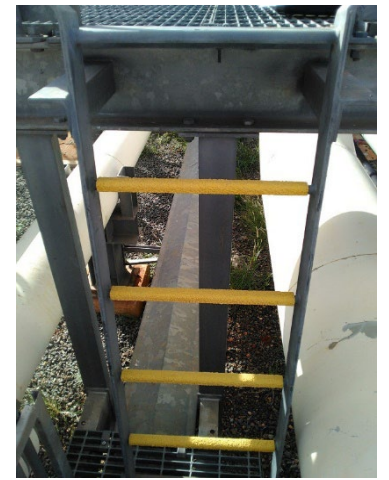
CS03-25	21/04/2023	Unit 3 Pipework (South Side) - Access Ladder	<p>1) Gate is not self closing (manual drop bar) and therefore is not AS compliant. It is also reliant on human behaviour to close the gate after each use.</p> <p>2) No hi vis (yellow) tread is installed on the nosing of top platform / top ladder rung.</p> <p>3) Ladder is not positioned in the centre of the landing (grid mesh platform) and landing is insufficient size.</p>	C. Unlikely	2. Minor	Low	<p>1) Replace the existing gate with a self closing gate.</p> <p>2) Install hi vis (yellow) tread on the nosing top platform / top ladder rung.</p> <p>3) Modify the grid mesh landing to meet AS requirements.</p>

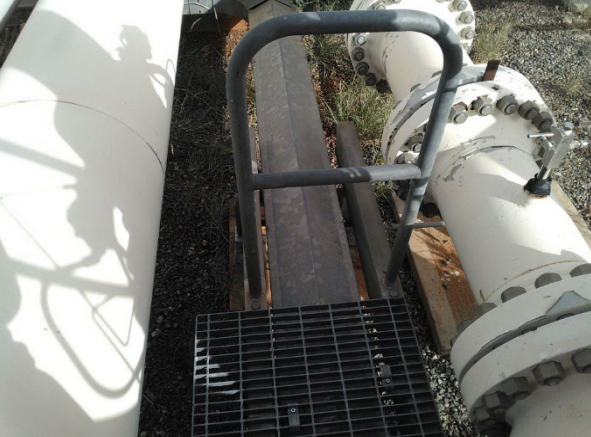
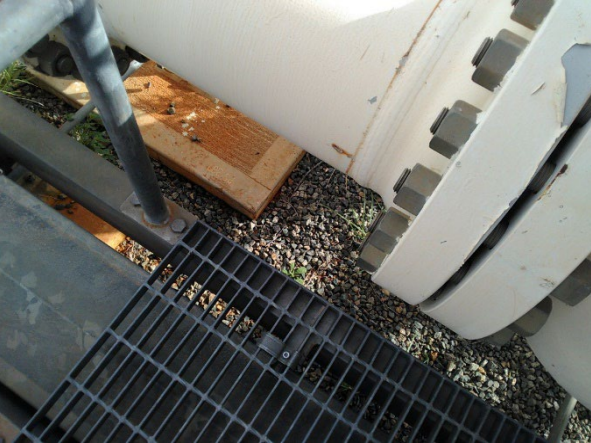
CS03-26	21/04/2023	Unit 3 Pipework (South Side) - Platform	<p>1) Gap (200mm) between the grid mesh and adjacent pipework does not meet AS requirements.</p> <p>2) Gap (260mm) between the handrails and adjacent pipework does not meet AS requirements.</p>	C. Unlikely	1. Trivial	Low	<p>1) Modify the platform and install kick plates to reduce the risk of a trip / fall through the open edges.</p> <p>2) Modify the handrail to eliminate or reduce the gap between the handrail and adjacent pipework.</p>

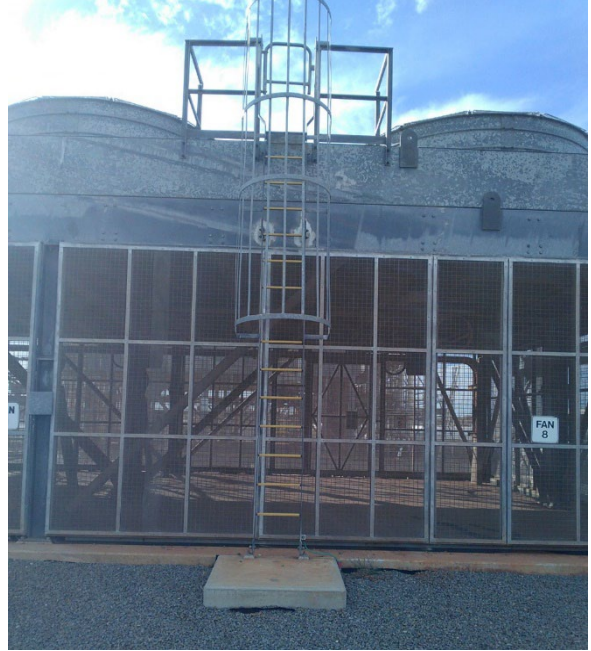
CS03-27	21/04/2023	After Cooler Fans - Fans 5-10 - 4 x Access Ladders For Top Platform	1) The ladder does not run the full length to the landing at ground level (ground to first rung is 440mm) and is therefore does not meet AS requirements.	C. Unlikely	2. Minor	Low	1) Modify the ladder to ensure it runs full length and risers meet AS requirements.

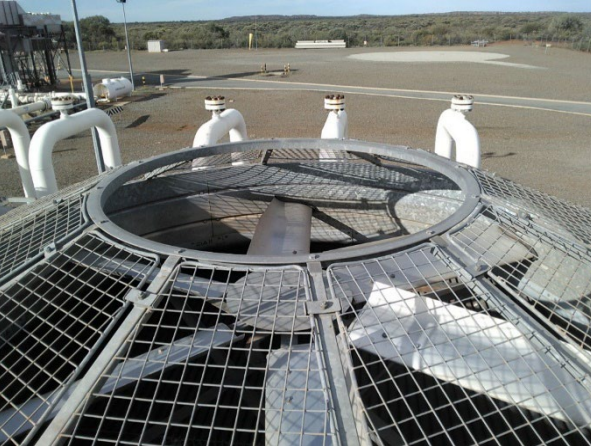
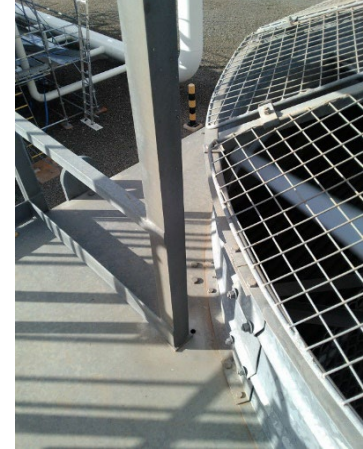
CS03-28	21/04/2023	After Cooler Fans - Fans 5-10 - Top Platform	<p>1) No hatches installed on the top of the 6 x after cooler fans. Exposure to a fall and contact with fan blades if not isolated.</p> <p>2) Some handrails have a gap (up to 140mm) between the handrail and adjacent structure (e.g. fan enclosures) which exceeds AS requirements.</p>	C. Unlikely	4. Major	High	<p>1) Install a hatch on each after cooler fan without one.</p> <p>2) Modify the handrail to eliminate gaps that exceed 100mm.</p>

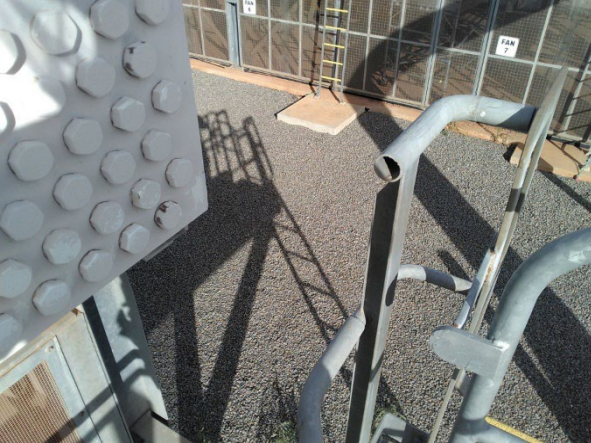
CS03-29	21/04/2023	After Cooler Fans - Fans 5-10 - Middle Platform	1) Gap between the handrail and structure exceeds AS requirements.	C. Unlikely	3. Severe	Medium	1) Modify the handrail to eliminate gaps that exceed 100mm.

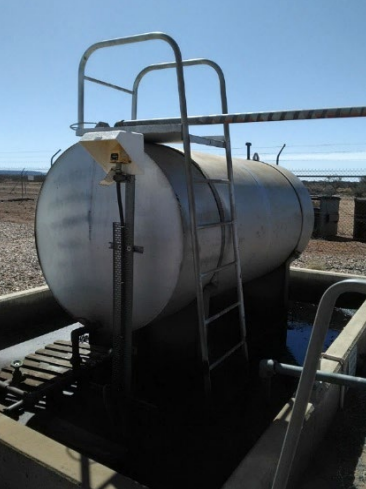
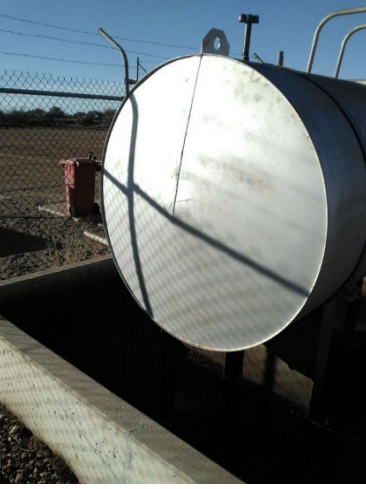
Replace ladder and landing. Pour new landing			
CS04-1	21/04/2023	Diesel Fuel Tank / Bowser	1) Handrail does not meet AS requirement of 900mm (~650mm). 2) No gate at the top of the work platform. 3) Landing does not meet AS requirements. Obstructed by bunding. 4) Personnel are standing on the top of the bunding to access the opposite end of the tank (e.g. to conduct dip stick check).	D. Occasional	3. Severe	Medium	1) Replace the access ladder and platform with access stairs and platform, with handrails and hi vis tread. This should be installed on the other side of the tank to support improvements to the land (3.) 2) Self closing gate to be installed at the top of the platform. 3) Ensure the landing on the redesigned access stairs and platform meet the AS requirements. 4.1) Implement a platform and access stairs or ladder. 4.2) Modify the bund to accommodate the access platform.

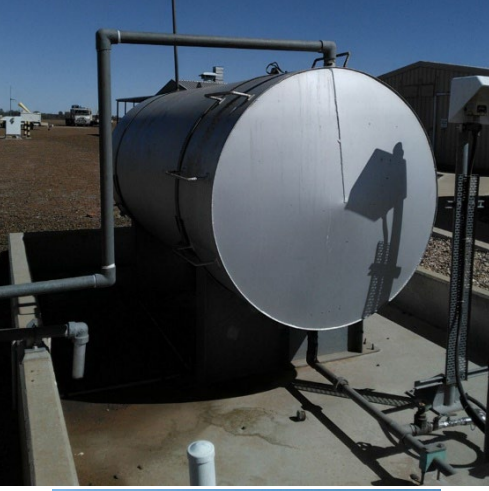
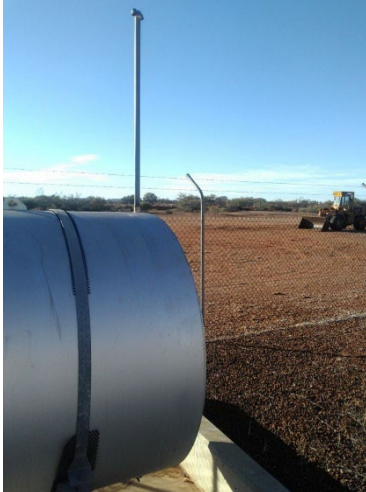
CS04-2	21/04/2023	Storage Tank Adjacent to Diesel Fuel Tank	1) Reo-bar used as ladder runs and this does not meet AS requirement. 2) No handrails have been installed. 3) Landing does not meet AS requirements. Obstructed by bunding. 4) Personnel are standing on the top of the bunding to access the opposite end of the tank (e.g. to conduct dip stick check).	D. Occasional	3. Severe	Medium	1) Replace the access ladder and install an platform with access stairs and platform, with handrails and hi vis tread. 2) Self closing gate to be installed at the top of the platform. 3) Ensure the landing on the redesigned access stairs and platform meet the AS requirements. 4.1) Implement a platform and access stairs or ladder. 4.2) Modify the bund to accommodate the access platform.

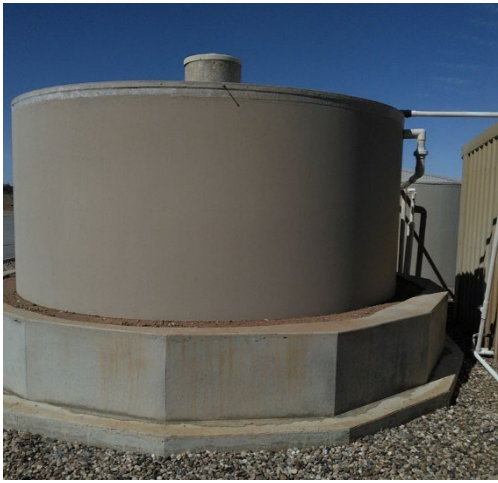
CS04-3	21/04/2023	Water Treatment Plant - 2 x Storage Tanks	1) No access stairs / ladder and platform to access the top hatch. Likely personnel use a ladder and existing concrete bund (on one tank only). This creates the risk of a fall during inspection of the tank and other related activities. Fall from the top of the tank ~2.5m or from top of concrete bund 750mm.	B. Remote	3. Severe	Low	1) Install access stairs or ladder and platform with self closing gate, hi vis (yellow) tread on rungs/stair nosing, handrails, etc. to be AS compliant.

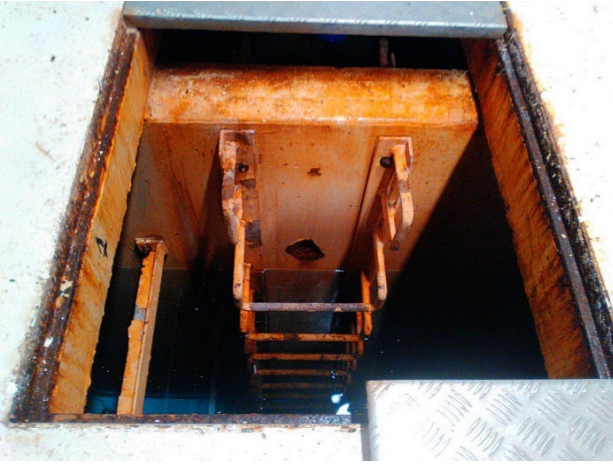
CS04-4	21/04/2023	Water Treatment Plant - 2 x Inspection Pits Inside Plant	1) Poor access / egress from ladder. 2) The foot of the ladder does not rest on or terminate above the landing. There is also no clear handgrips to assist the person when mounting and dismounting the ladder. Therefore it does not meet AS 1657 requirements. 3) No non-slip tread on ladder rungs.	B. Remote	4. Major	Medium	1) Replace and reposition to the ladder to allow safe access / egress. 2) Redesign the ladder and hand grips to provide suitable access and meet AS1657 requirements. 3) Replacement ladder to have hi vis (yellow) non-slip tread installed on the rungs.

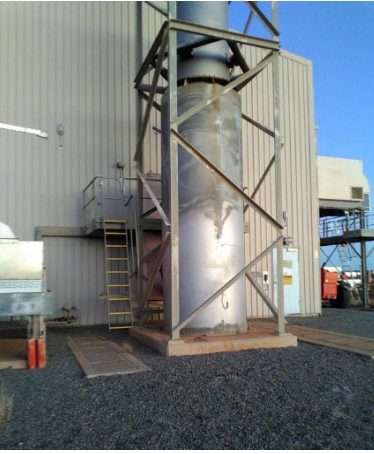
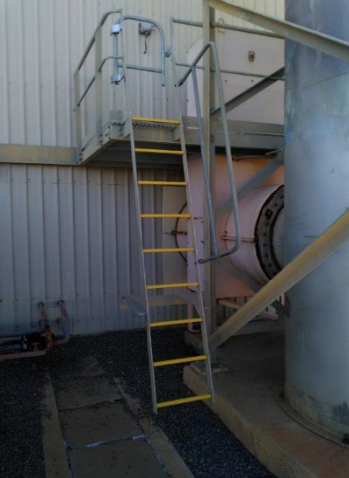
CS04-5	21/04/2023	Unit 1 Vessel - Access Platform	1) The ladder does not meet AS requirements, including the ladder does run full length to the landing and the step up is 220mm (AS <=150mm). 2) Gap between the handrail and structure (130mm) and does not meet AS requirements (max 100mm). Note: Comment only given the small difference above the AS requirement.	C. Unlikely	3. Severe	Medium	1.1) Install a landing that meets AS requirements. 1.2) Modify the ladder so its runs to the new landing and the first step up meets AS requirements. 2) No action required.

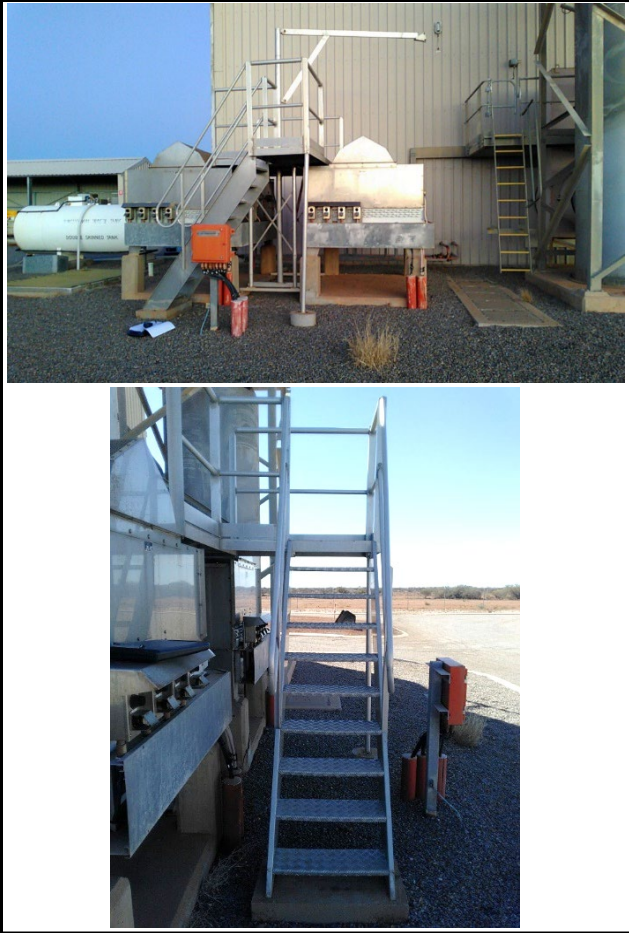
Reference	Date added	Location on Site	Issue	Likelihood	Consequence	Risk Score	Suggestions	Evidence	What is being completed	Date planned for completion	Date completed	Comments
CS04-6	21/04/2023	Unit 1 Compressor Oil Cooler Fans Access Stairs	<p>1) The landing for the stairs does not meet AS1657 requirements of 600mm minimum.</p> <p>2) The length of the handrail when compared to the full length of the stairs and landing, is not compliant with the AS requirements. The current design also increases the potential of being unable to arrest a slip / fall.</p> <p>3) No hi vis (yellow) tread installed onto each stair.</p>	C. Unlikely	3. Severe	Medium	<p>1) Pour a new landing.</p> <p>2) Modify the handrail to run the full length of the stairs.</p> <p>3) Install hi vis (yellow) tread onto each stair.</p>

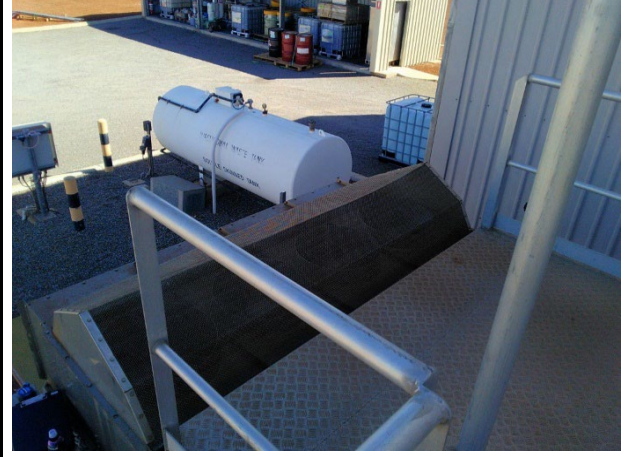
Module may be redundant.
CS04-7	21/04/2023	Unit 1 Compressor Oil Cooler Fans Platform	<p>1) The existing handrail does not extend around the outside of the fan enclosure on other side. This creates the risk of a fall of ~1.9m.</p>	C. Unlikely	3. Severe	Medium	<p>1) Install additional handrails and supporting structure around both fan enclosures.</p>

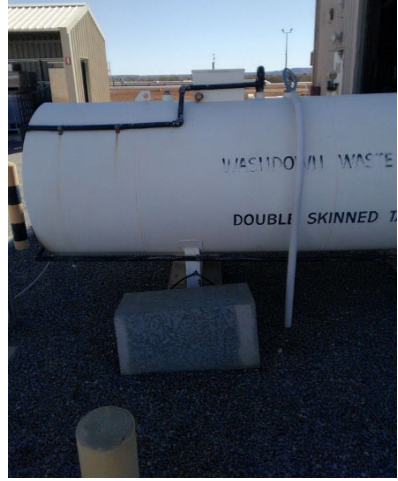
CS04-8	21/04/2023	Unit 1 Washdown Waste Tank	<p>1) Metal box currently being provided for access to the inspection hatch. Metal box is 400mm high and potentially slippery under some circumstances. Access provided does not meet AS requirements.</p> <p>Note: Feedback onsite was they believed this tank and therefore the metal box were redundant.</p>	B. Remote	2. Minor	Low	<p>1.1) If redundant, remove the metal box and dispose it.</p> <p>1.2) If not redundant, replace the metal box with access stairs and platform that meet AS requirements.</p>

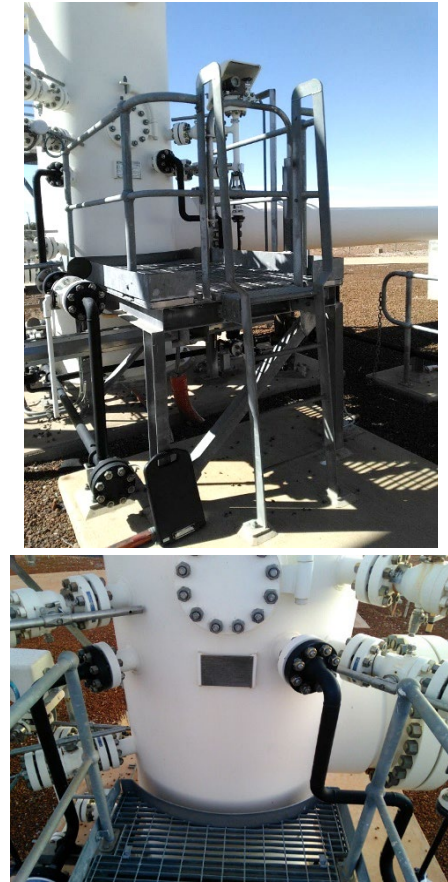
CS04-9	21/04/2023	Unit 1 Suction Scrubber	<p>1) The gap (450-500mm) between the handrail and structure exceeds the AS requirement (max 100mm). Note: The pipework reduces the potential to fall through the identified gaps, to ground level.</p> <p>2) The ladder rungs do not have hi vis (yellow) tread installed.</p>	C. Unlikely	2. Minor	Low	<p>1) Consider modifying the handrail to eliminate or reduce the gap to meet the AS requirement.</p> <p>2) Install hi vis (yellow) tread to all ladder rungs and the nosing of the platform / top rung.</p>

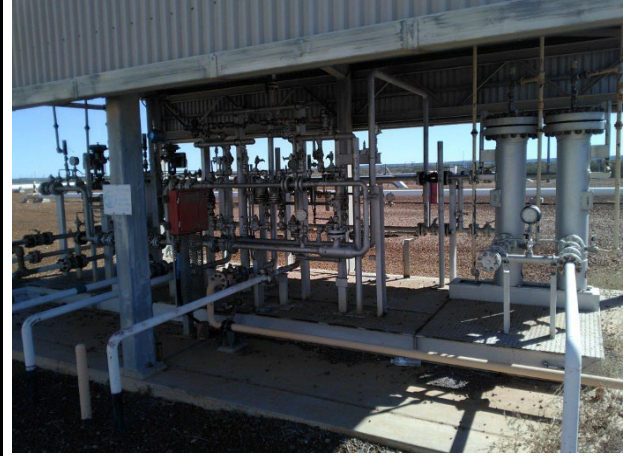
CS04-10	21/04/2023	Unit 1 Pressure Reduction Skid	<p>1) Landing and step up / down is impacted by a existing pipework. Therefore the AS requirements are not being met and a trip hazard is present.</p> <p>2) No hi vis (yellow) strip on the nosing (ends) of the grid mesh platform.</p>	B. Remote	2. Minor	Low	<p>1) Install a step and platform over the pipework, that meet AS requirements (e.g. hi vis nosing, step riser height).</p> <p>2) Install hi vis (yellow) non-slip strip on the nosing of the skid's access point.</p>

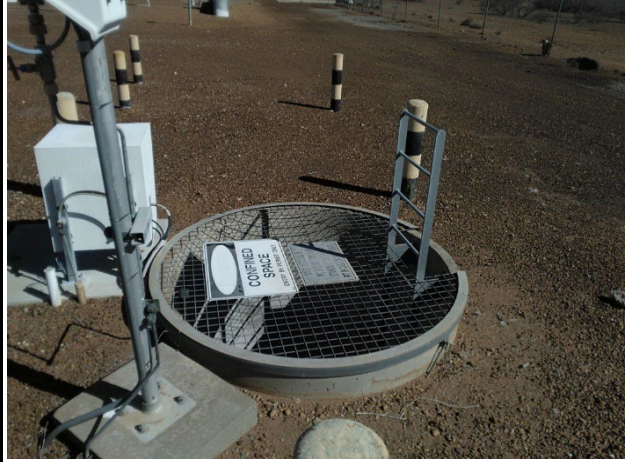
Module may be redundant.
CS04-11	21/04/2023	Confined Space - Access Ladder (West Side of Plant)	<p>1) Ladder does not extend 1m (~800mm) past the landing at the top of the ladder and does not have sufficient locations to hold onto when mounting / dismounting.</p> <p>2) No non-slip tread on ladder rungs.</p>	B. Remote	3. Severe	Medium	<p>1) Modify or replace the ladder, ensuring it extends 1m past the top landing, with sufficient locations to hold onto when mounting / dismounting the ladder.</p> <p>2) Modified or replacement ladder to have hi vis (yellow) non-slip tread installed on the rungs.</p>

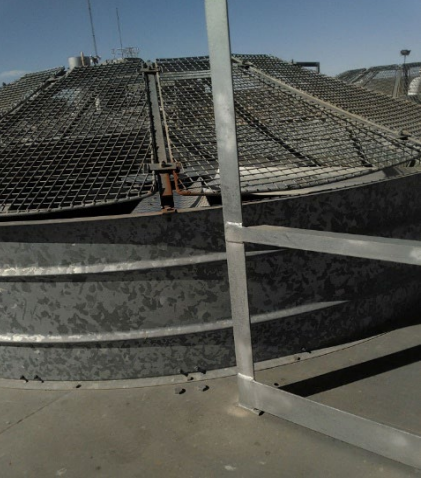
CS04-12	21/04/2023	After Cooler Fans - Fans 7-9 - Top Platform	<p>1) Gaps between some handrails and existing structures (e.g. fan enclosures) that exceed AS requirements (max 100mm) identified.</p>	B. Remote	3. Severe	Medium	<p>1) Modify the handrail to eliminate gaps that exceed 100mm.</p>

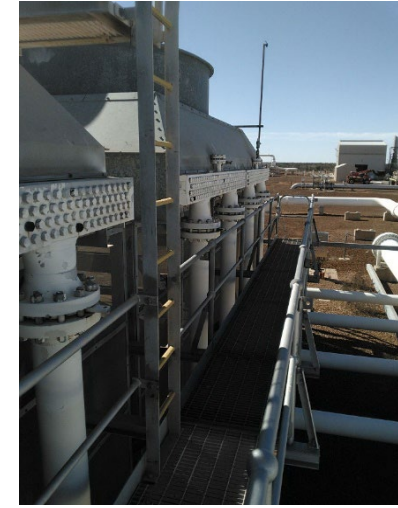
CS04-13	21/04/2023	After Cooler Fans - Fans 4-6 - Middle Platform	<p>1) Ladder to access the top platform doesn't not have guard rails behind it, to prevent a person who falls going over the middle platform's handrails.</p>	B. Remote	3. Severe	Medium	<p>1) Install additional handrails behind the ladder to prevent a fall from the ladder to over the handrail.</p>

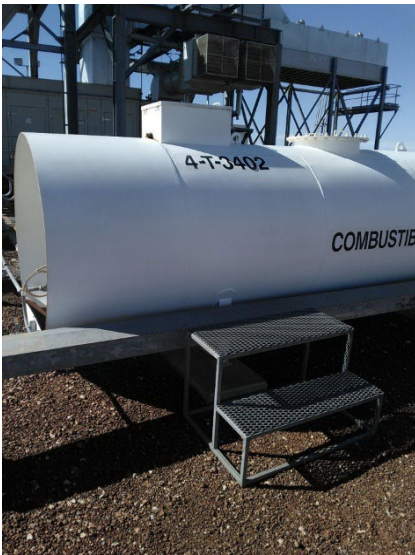
CS04-15	21/04/2023	Unit 3 Combustible Liquids Tank	1.1) The current temporary access stairs requires a person to stand on the cable tray to access the inspection hatch. It also creates the potential for someone to walk down the cable tray as a shortcut. The current design creates the potential for a 600mm fall and cause damage to property. 1.2) The temporary access stairs riser (300mm) do not meet the AS requirements (130-225mm). 2) No hi vis (yellow) tread installed on the nosing of the stairs. Stair width is 1020mm.	C. Unlikely	3. Severe	Medium	1) Replace the access stairs with a platform and access stairs that are AS compliant (e.g. handrails, hi vis tread on nosing) and allows access to the hatch and valve (if required). The existing unit is to be modified or disposed off. 2) Install hi vis (yellow) tread onto the nosing of the stairs.

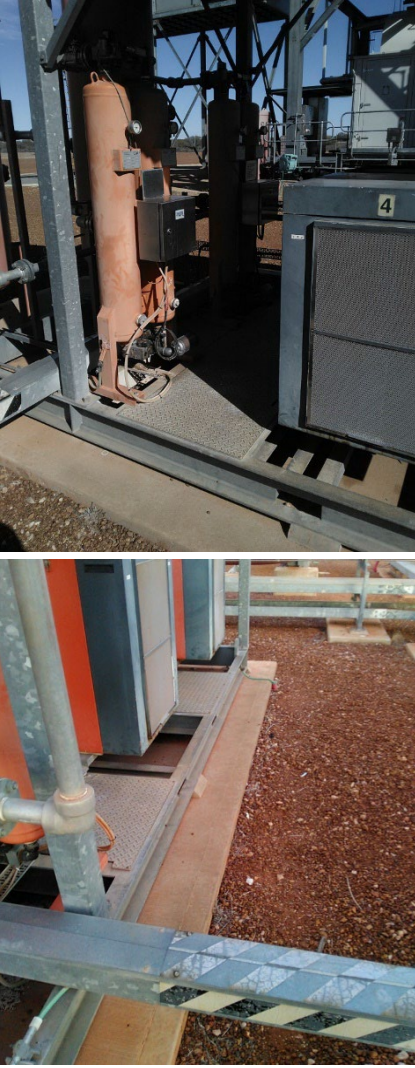
CS04-16	21/04/2023	Desiccant Dryers x 2	1) The landing (280mm) does not meet AS requirement of 600mm (Depth). 2) No hi vis (yellow) tread installed on the nosing of the platform. 3) Cable tray adjacent to step ups is a trip hazard and the hi vis tape has faded.	B. Remote	2. Minor	Low	1) Remove old landing and pour a new landing. 2) Install hi vis (yellow) tread onto the nosing of the two access points. 3.1) Relocate the cable tray to eliminate the trip hazard if practically possible. 3.2) If the cable tray can not be relocated then apply new hi vis tape.

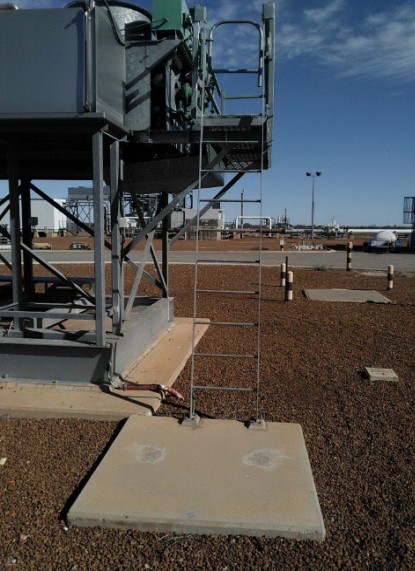
CS04-17	21/04/2023	GEA 1 Exhaust System	1) No hi vis (yellow) tread installed on the ladder rungs.	B. Remote	2. Minor	Low	1) Install hi vis (yellow) tread to all ladder rungs and the nosing of the platform / top rung.

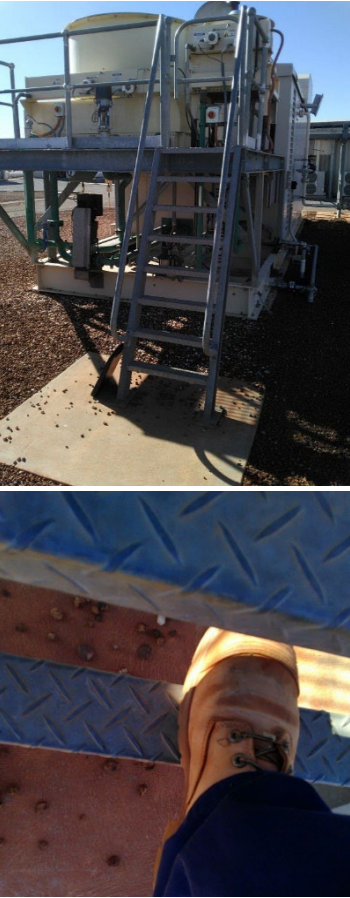
Reference	Date added	Location on Site	Issue	Likelihood	Consequence	Risk Score	Suggestions	Evidence	What is being completed	Date planned for completion	Date completed	Comments
CS04-21	21/04/2023	GEA 1 to 4 - Access / Egress Points	1) Some access stair(s) do not have hi vis (yellow) tread installed on the nosing of each stair. 2) The landing for some access points do not meet AS requirements. Note: Discussions with FMOs confirmed the access doors with no landings are used during tasks.	D. Occasional	2. Minor	Low	1) Install hi vis (yellow) tread on the nosing on the stairs. 2) Extend the landing.

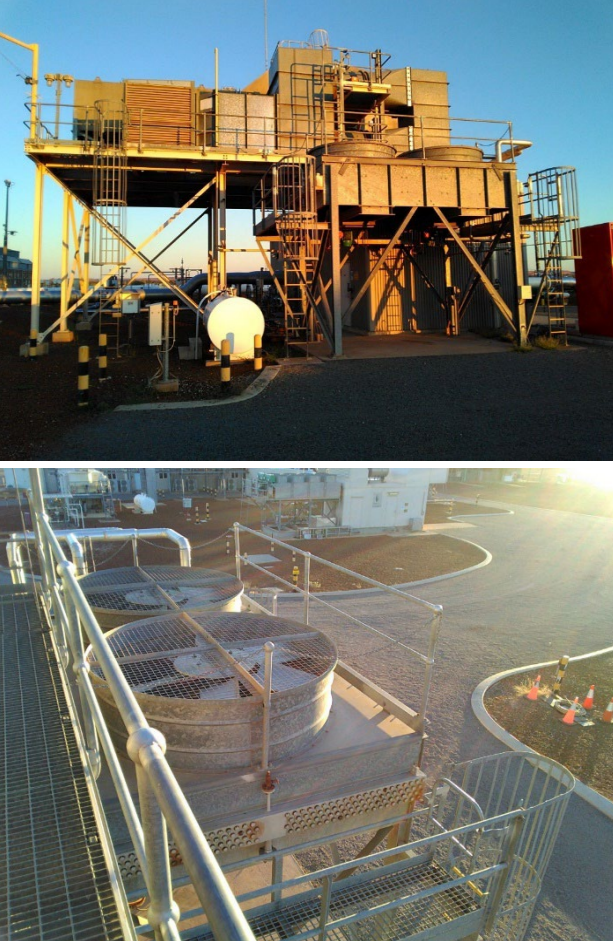
CS04-24	21/04/2023	Unit 2 - Middle Platform (North Side)	1) Self closing gate leads onto a section of roof with no edge protection in place. This exposes personnel on the roof, to a potential for a fall from height resulting in a fatality or significant injury. Note: GT Air Inlet System Replacement works was being undertaken at time of inspection. The construction materials are associated with these works and will be removed at the conclusion.	C. Unlikely	4. Major	High	1.1) Install edge protection along the exposed edges of the roof. 1.2) Install signage to highlight the fall from height risk until edge protection is installed.

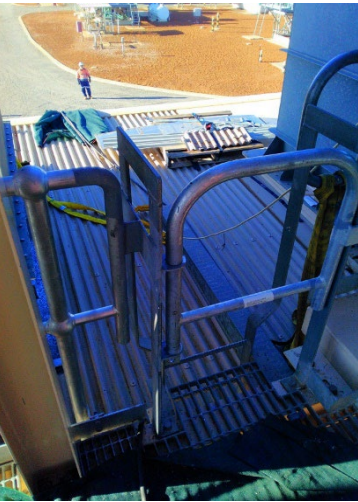
CS04-25	21/04/2023	Unit 2 - Middle Platform (South Side)	1) When the existing gate is opened to allow mobile plant lifting loads onto/off the platform, it creates the potential for a person fall from height. A fall from this location would likely result in a fatality or significant injury. Note: GT Air Inlet System Replacement works was being undertaken at time of inspection. The danger tape was associated with these works and will be removed at the conclusion.	C. Unlikely	4. Major	High	1.1) Recommend replacing the existing gate with a purpose built safety gate (i.e. UMZ18 Mezzanine Safety Gate). This type of gate eliminates the risk. It should be painted a hi vis colour (i.e. yellow) and have pinch point stickers or similar installed on the safety gate. 1.2) Install signage to highlight the fall from height risk until an alternative safety gate is installed.

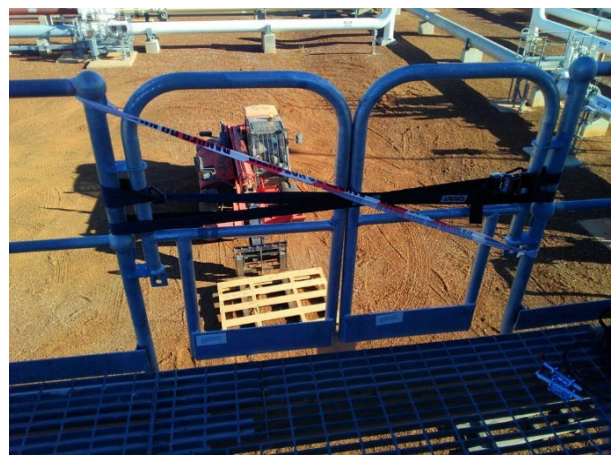
CS04-26	21/04/2023	Unit 2 - Second From The Top Platform (East Side)	1) No hi vis (yellow) tread installed on the ladder rungs.	C. Unlikely	2. Minor	Low	1) Install hi vis (yellow) tread to all ladder rungs and the nosing of the platform / top rung.

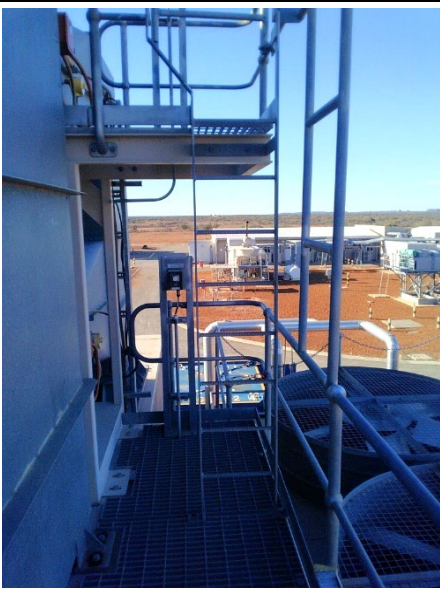
CS04-27	22/04/2023	Unit 2 - Second From The Top Platform (West Side)	1) Gap between the kickboard and the exhaust ducting is 410mm high and 2040mm wide. Potential for a person to fall if it was accessed.	B. Remote	3. Severe	Medium	1) Consider installing a handrail or similar, between the exhaust system and the kick plate.

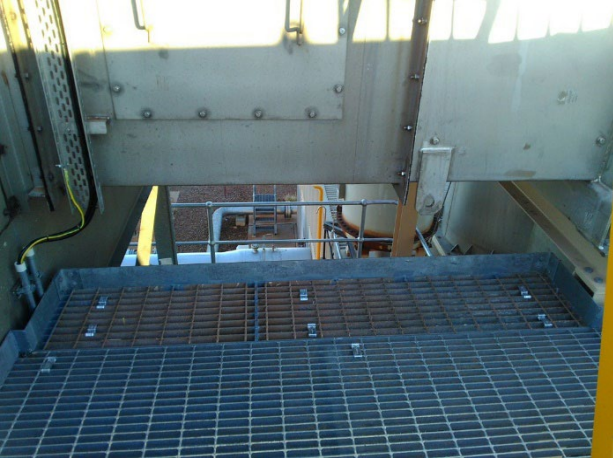
CS04-28	22/04/2023	Unit 2 - Second From The Top Platform (North Side)	1) No hi vis (yellow) tread installed on the ladder rungs.	C. Unlikely	2. Minor	Low	1) Install hi vis (yellow) tread to all ladder rungs and the nosing of the platform / top rung.
