Revised Final Plan
Attachment 9.12

Structures & Operational Sites - Working at Heights - Appendix B

August 2025

**Dampier Bunbury
Pipeline**

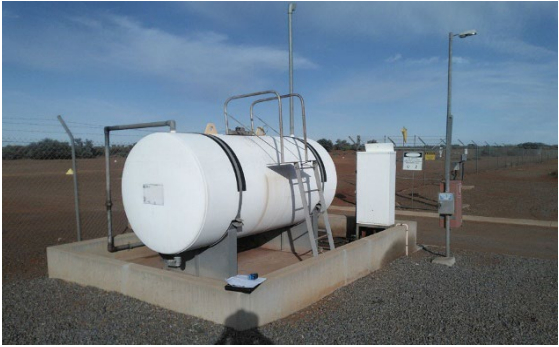
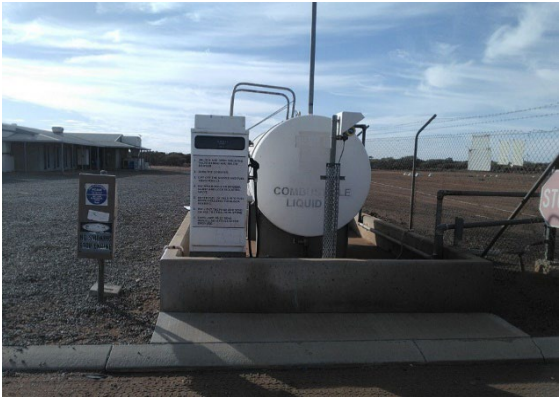
Replace ladder and landing. Pour new landing			
CS05-1	23/05/2023	Diesel Fuel Tank	<p>1.1) Handrail does not meet AS requirement of 900mm.</p> <p>2) No gate at the top of the work platform.</p> <p>3) Landing does not meet AS requirements. Obstructed by bunding.</p>	D. Occasional	3. Severe	Medium	<p>1) Replace the access ladder and platform with access stairs and platform, with handrails and hi vis tread.</p> <p>2) Self closing gate to be installed at the top of the platform.</p> <p>3) Ensure the landing on the redesigned access stairs and platform meet the AS requirements. Modifying the bund if required.</p>

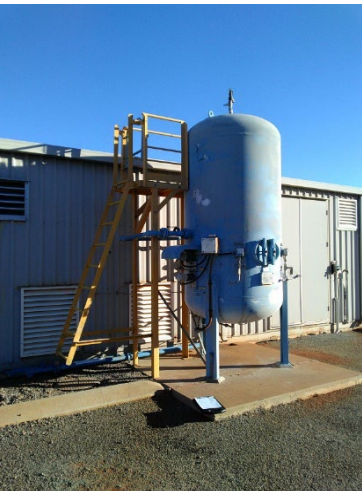
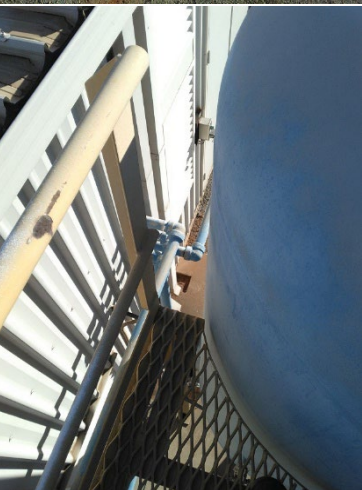
CS05-2	23/05/2023	Compressed Air Unit For Battery Rooms	<p>1) No non-slip tread on ladder runs.</p> <p>2) The ladder does not run to the landing and the step up exceeds the AS requirements (= <150mm).</p> <p>3) Landing does not meet the AS requirements and is current blue metal and a pit lid.</p> <p>4) ~200mm Gap between the vessel and the handrail is not compliant with AS requirements (max 100mm).</p>	B. Remote	2. Minor	Low	<p>1) Install hi vis (yellow) non-slip tread installed on the rungs.</p> <p>2) Extend the ladder to the landing.</p> <p>3) Pour a landing to meet AS requirements.</p> <p>4) Extend the handrail to within 100mm of the vessel.</p>

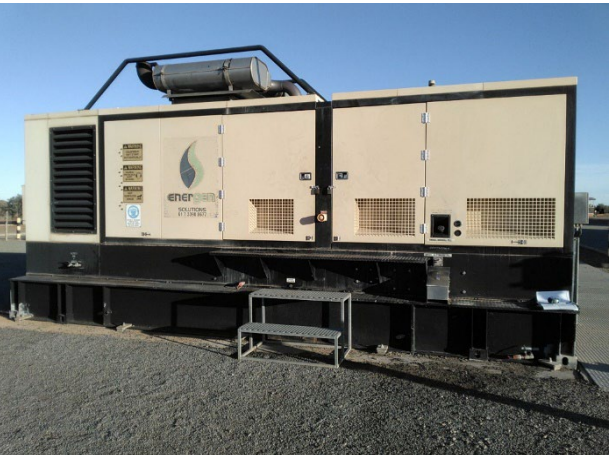
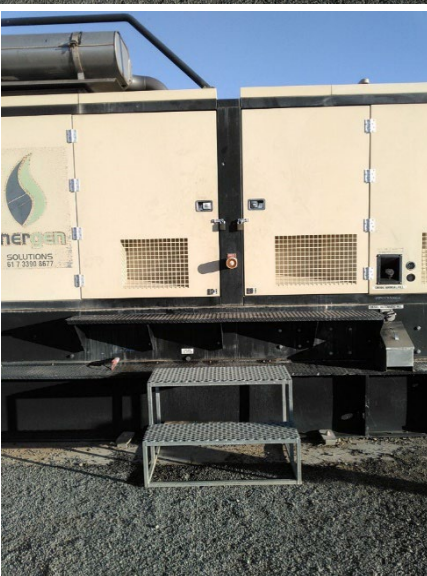
CS05-3	23/05/2023	Energen DEA - 2 x Sides	<p>1) Temporary steps (width 1000mm, depth 300mm) have been provided on both sides to enable access to the work platform. The temporary steps complies with the AS requirement with the exemption of: - Step up from the ground to first step (300mm) and from the last stair onto the work platform (380mm) (AS requirement is 300-450mm requires a minimum of 1 step be provided); - Riser is 300mm (AS requirement is 130-225mm).</p> <p>2) No handrails have been installed for the access stairs.</p> <p>3) The work platform has no edge protection installed (width 2500mm, depth 290mm). This creates a fall risk of 1000mm. Note: Conversations with FMOs confirmed that the black work platform is used during inspection and maintenance tasks and when refuelling.</p> <p>4) No hi vis (yellow) tread installed on the nosing of the stairs and work platform.</p>	D. Occasional	3. Severe	High	<p>1) Remove the temporary stairs with a purpose built access stairs that complies with the AS requirements.</p> <p>2) The replacement access stairs are designed and installed with both handrails in place.</p> <p>3) Redesign or replace the work platform with a purpose build platform that complies with the AS requirements including adequate edge protection.</p> <p>4) Install hi vis (yellow) non-slip tread installed on the nosing of the stairs and work platform.</p>

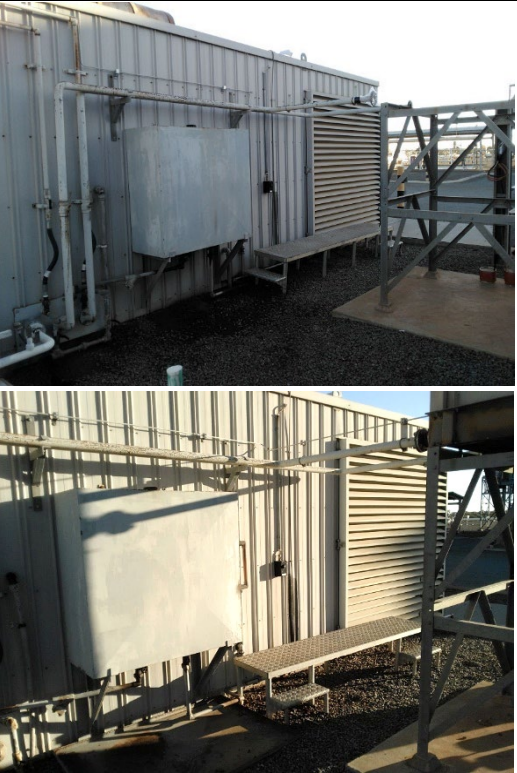
Reference	Date added	Location on Site	Issue	Likelihood	Consequence	Risk Score	Suggestions	Evidence	What is being completed	Date planned for completion	Date completed	Comments
CS05-4	23/05/2023	GEA Oil / Hydraulic Fluid Tank x 2	<p>1) The stairs are being used as a work platform. The dimensions (large stair width 2400mm, depth 520mm, riser 220mm, small stair width 570mm, depth 220mm, riser 220mm) suit stairs but not as a work platform and creates the risk of a fall.</p> <p>2) No hi vis (yellow) tread installed onto each stair.</p>	C. Unlikely	3. Severe	Medium	<p>1.1) Install a platform with stair access to replace the temporary stairs. Note: If 3 stairs will be required so handrails will also be required.</p> <p>2) Install hi vis (yellow) tread onto each stair.</p>

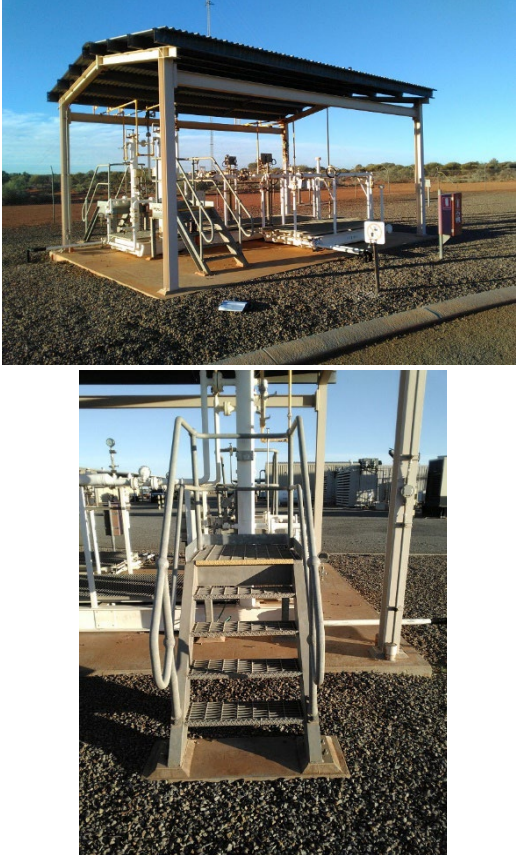
CS05-5	23/05/2023	GEA Fuel Gas Skid	<p>1) The nosings of the platforms and platform stairs do not have hi vis tread installed.</p> <p>2) The landing for the north platform stairs (depth 400mm) does not meet the AS requirements (min 600mm).</p> <p>3) Step up for the platform (400mm) exceeds the AS requirements (300-450mm requires a minimum of one step).</p>	C. Unlikely	2. Minor	Low	<p>1) Install hi vis (yellow) non-slip tread installed on the nosing of the platforms and access stairs.</p> <p>2) Pour a new landing.</p> <p>3) Implement a step for each of the 4 access points for the 2 platforms.</p>

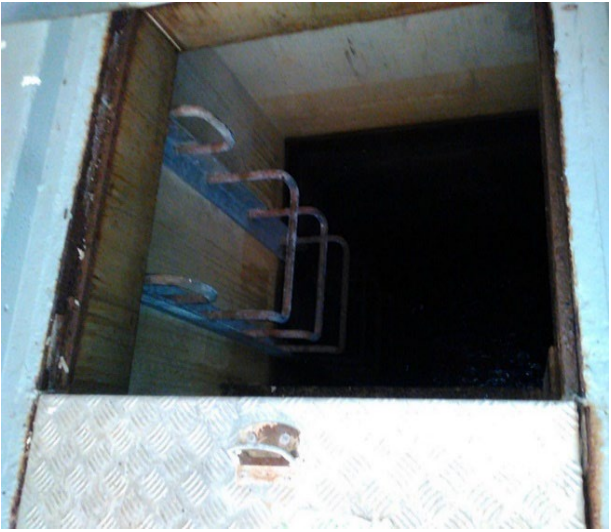
CS05-6	23/05/2023	Water Treatment Plant - Pit Inside Building	<p>1) Poor access / egress from ladder.</p> <p>2) The foot of the ladder does not rest on or terminate above the landing. There is also no clear handgrips to assist the person when mounting and dismounting the ladder. Therefore it does not meet AS 1657 requirements.</p> <p>3) No non-slip tread on ladder rungs.</p>	C. Unlikely	3. Severe	Medium	<p>1) Consider the position of the ladder when being redesigned, to allow for safe access / egress.</p> <p>2) Redesign the ladder and hand grips to provide suitable access and meet AS1657 requirements.</p> <p>3) Replacement ladder to have hi vis (yellow) non-slip tread installed on the rungs.</p>
