Revised Final Plan
Attachment 9.12

Structures & Operational Sites - Working at Heights - Appendix B

**Dampier Bunbury
Pipeline**

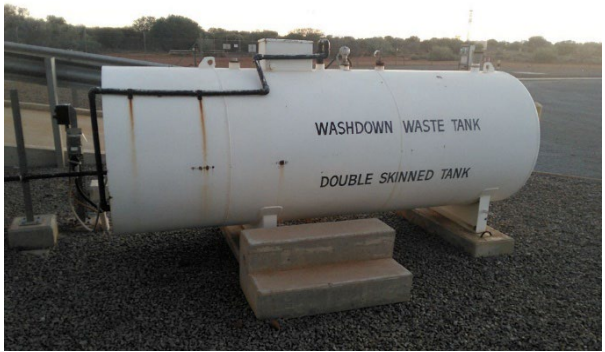
CS05-13	23/05/2023	Compressor Unit 1 Washdown Waste Tank	1) The existing stairs are not sufficiently sized to provide easy access to the inspection hatch. This will encourage personnel to over-reach to utilise the hatches.	C. Unlikely	3. Severe	Medium	1) Replace the stairs with purpose fit and AS compliant platform and access stairs.

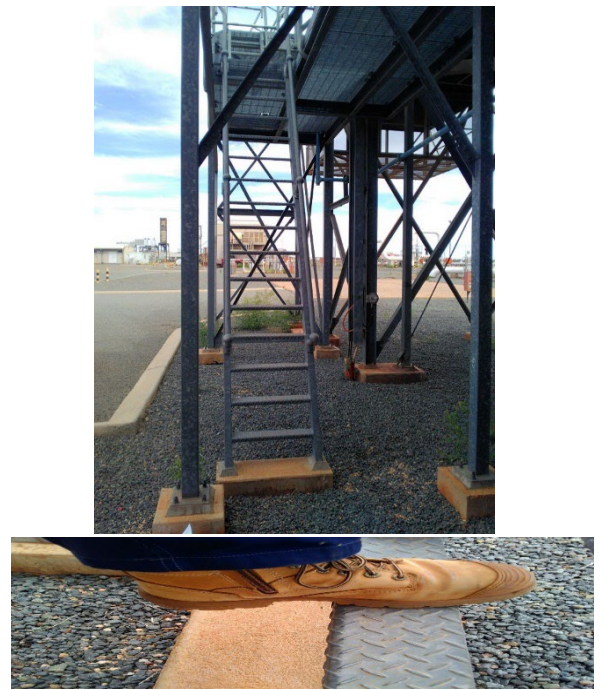
CS05-14	21/06/2023	Unit 1 Air Inlet System - Bottom Platform	<p>1) The landing for the ladder does not meet AS1657 requirements of 900mm.</p> <p>2) The angle of the slope (58.40 degrees) exceeds AS1657 requirements of Min 20 degrees and Max 45 degrees. Calculation Notes: 3.8m Rise (height), 2.2m Run (length), 16 Runs (steps).</p> <p>3) The steps nosing do not have no hi vis non-slip tread fitted and posings a slip/fall risk.</p> <p>4) Handrail does not meet AS requirements by beginning within a max of 900mm of the landing.</p> <p>5) Greater potential to fall if facing away from the stairs when descending.</p>	C. Unlikely	3. Severe	Medium	<p>1) Pour a new landing.</p> <p>2) Install a new stairwell that complies with AS1657. The new stairwell will need to be installed with a different orientation to avoid head height hazards (e.g. cross beams).</p> <p>3) Hi vis non-slip tread is also to be fitted to the nosing of each stair.</p> <p>4) Modify the handrail to meet the AS requirements.</p> <p>5) Install signage on both sides of the gate to instruct personnel to only descend the stairs whilst facing towards the stair.</p> <p>Check AS requirement for when the handrail can stop.</p> <p>Check AS requirement for the tread depth for this type of staircase. May differ.</p>

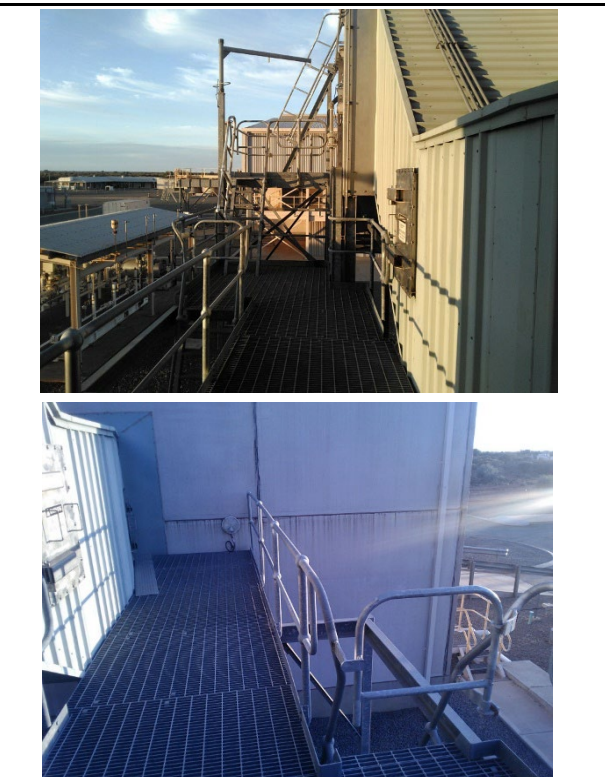
CS05-15	21/06/2023	Unit 1 Air Inlet System - Middle Platform	<p>1) The steps nosing do not have no hi vis non-slip tread fitted and posings a slip/fall risk.</p> <p>2) Handrail does not meet AS requirements by not extending the full length of the stairs.</p>	B. Remote	2. Minor	Low	<p>1) Hi vis non-slip tread is also to be fitted to the nosing of each stair.</p> <p>2) Extend the handrail the full length of the stairs.</p>

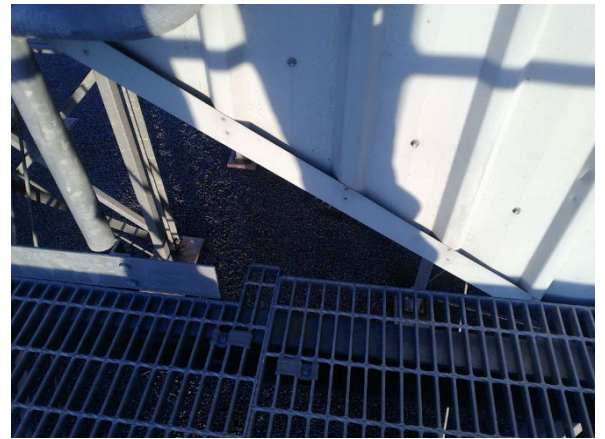
CS05-16	21/06/2023	Unit 1 Air Inlet System - Middle Platform	<p>1) ~230mm Gap between the structure and the handrail is not compliant with AS requirements (max 100mm).</p> <p>2) No kick plate installed on the end of the grid mesh facing the ducting. This creates a slip/fall and dropped object risk.</p>	B. Remote	2. Minor	Low	<p>1) Modify the handrail to extend within 100mm of the structure.</p> <p>2) Install a kick plate along the open edge of the grid mesh.</p>

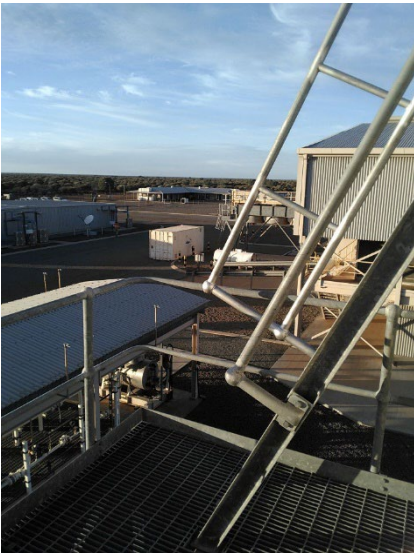
Reference	Date added	Location on Site	Issue	Likelihood	Consequence	Risk Score	Suggestions	Evidence	What is being completed	Date planned for completion	Date completed	Comments
CS05-17	21/06/2023	Unit 1 Air Inlet System - Top Platform	<p>1) The landing for the ladder does not meet AS1657 requirements of 900mm.</p> <p>2) The steps are small in size (~110mm), have no hi vis non-slip tread fitted, do not meet AS1657 requirements and posing a slip/fall risk.</p> <p>3) Handrail does not meet AS requirements by not extending the full length of the stairs.</p>	C. Unlikely	3. Severe	Medium	<p>1) Modify the platform to provide adequate landing or modify the access method.</p> <p>2) Ensure the new stairwell has suitably sized steps or a access ladder that meet AS1657 requirements. Hi vis non-slip tread is also to be fitted to the nosing of each stair.</p> <p>3) Extend the handrail the full length of the stairs.</p>

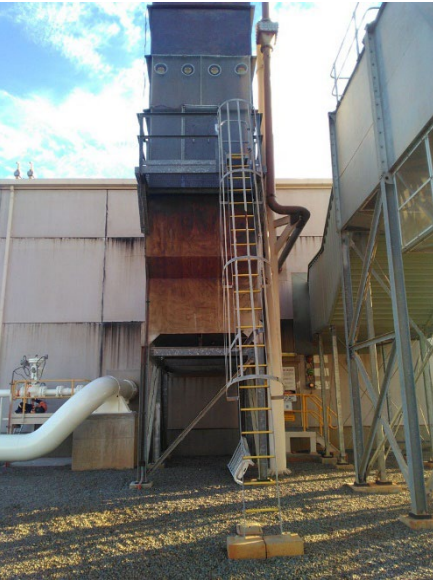
CS05-18	21/06/2023	Unit 1 Air Inlet System - Exhaust System Platform	<p>1) The landing for the ladder does not meet AS1657 requirements of 900mm.</p>	B. Remote	2. Minor	Low	<p>1) Pour a new landing.</p>

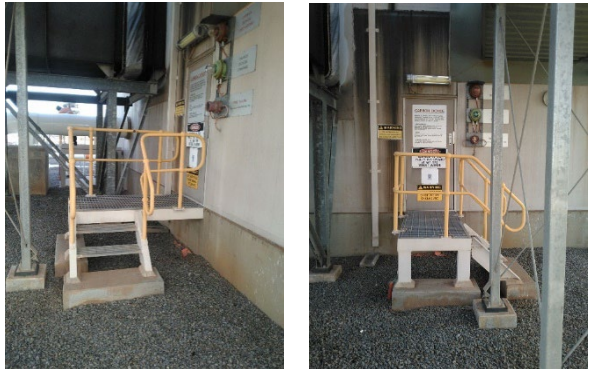
CS05-19	21/06/2023	Unit 1 - Access Doors (Multiple)	<p>1) The landing for the stairs does not meet AS1657 requirements of 900mm (actual 400mm).</p> <p>2) No hi vis (yellow) tread installed onto the nosing of each stair.</p>	C. Unlikely	2. Minor	Low	<p>1) Pour a new landing.</p> <p>2) Install hi vis (yellow) tread onto the nosing of each stair.</p>

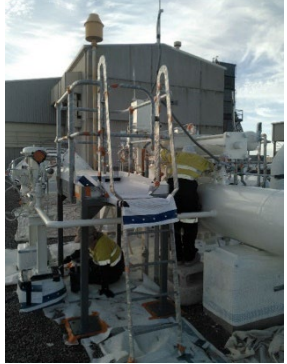
CS05-20	21/06/2023	Unit 1 - Mainline Pipework Platform	<p>1) No hi vis (yellow) tread installed onto the nosing of each stair.</p>	C. Unlikely	2. Minor	Low	<p>1) Install hi vis (yellow) tread onto the nosing of each stair.</p>

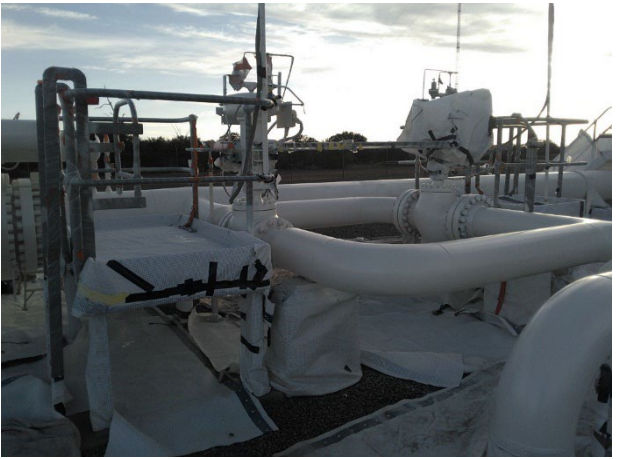
CS05-21	21/06/2023	Unit 1 - Mainline Pipework Valves / Bettic Equipment Platforms (2)	<p>1) Chain has been used in lieu of a handrail at the top of the platform, adjacent to the Bettic Equipment or Valves Chain will break in the event of a fall and therefore will not meet AS 1657 requirements for guardrails.</p> <p>2) No hi vis (yellow) tread installed onto each ladder rung.</p>	C. Unlikely	3. Severe	Medium	<p>1) Replace the chain with a handrail that meets AS 1657 requirement.</p> <p>2) Hi vis (yellow) non-slip tread to be installed on the ladder rungs.</p>

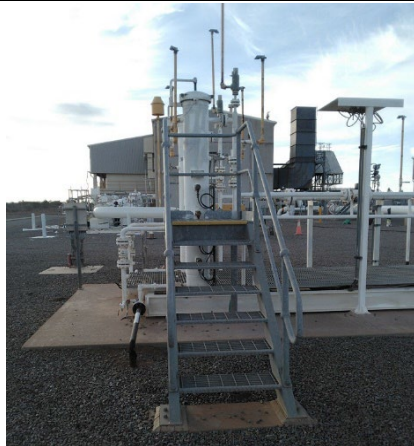
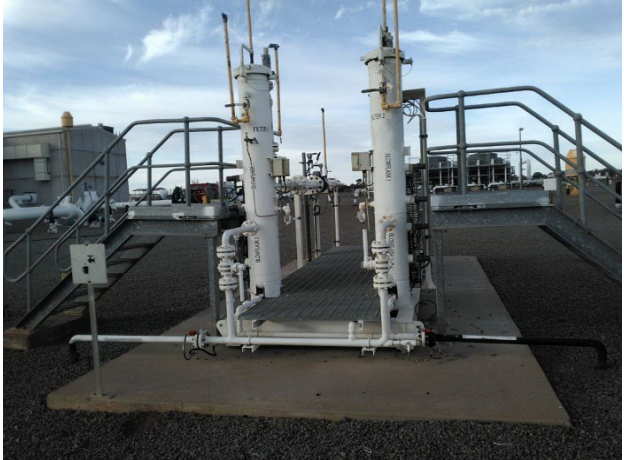
CS05-22	21/06/2023	Unit 1 - Utility Gas Skid	<p>1) The landing for the stairs does not meet AS1657 requirements of 900mm.</p> <p>2) No hi vis (yellow) tread installed onto the nosing of each stair.</p> <p>3) The Step Up for the two access points for the platform is 410mm and therefore the AS requirements state at least 1 step be provided for safe access.</p>	C. Unlikely	2. Minor	Low	<p>1) Pour a new landing.</p> <p>2) Install hi vis (yellow) tread onto the nosing of each stair.</p> <p>3) Install a stair with hi vis (yellow) tread on the nosing, at each access point to to enable safe access and compliance with the AS requirements.</p>

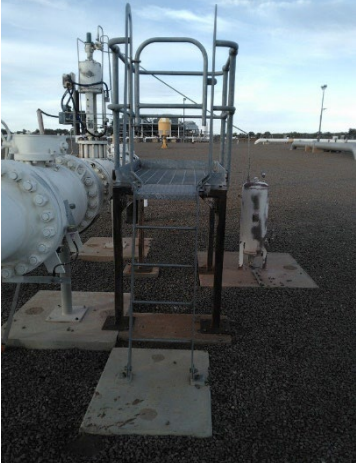
CS05-23	21/06/2023	Unit 1 - Inflow Gas Pipework - Platform	<p>1) The landing for the ladder does not meet AS1657 requirements of 900mm (actual 400mm).</p> <p>2) No hi vis (yellow) tread installed onto each ladder rung.</p>	C. Unlikely	2. Minor	Low	<p>1) Pour a new landing.</p> <p>2) Hi vis (yellow) non-slip tread to be installed on the ladder rungs.</p>

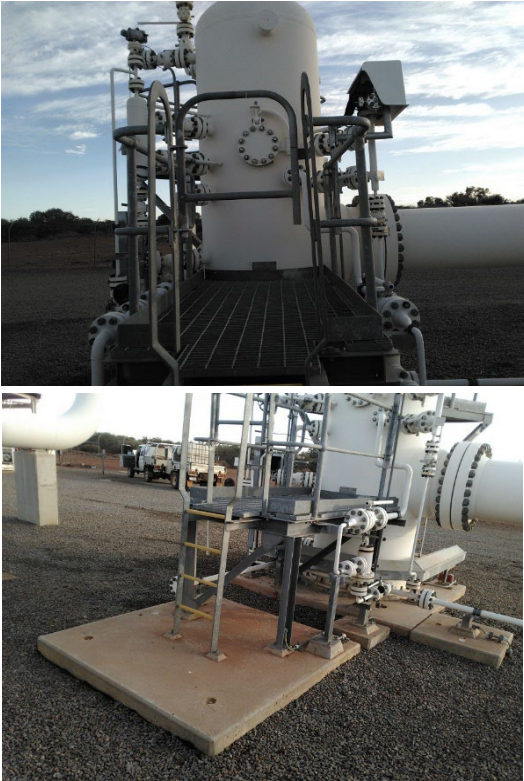
Reference	Date added	Location on Site	Issue	Likelihood	Consequence	Risk Score	Suggestions	Evidence	What is being completed	Date planned for completion	Date completed	Comments
CS05-24	21/06/2023	Unit 1 - Suction Scrubber	<p>1) The gap (450-500mm) between the handrail and structure exceeds the AS requirement (max 100mm). Note: The pipework reduces the potential to fall through the identified gaps, to ground level.</p> <p>2) The ladder rungs do not have hi vis (yellow) tread installed.</p>	C. Unlikely	2. Minor	Low	<p>1) Consider modifying the handrail to eliminate or reduce the gap to meet the AS requirement.</p> <p>2) Install hi vis (yellow) tread to all ladder rungs and the nosing of the platform / top rung.</p>

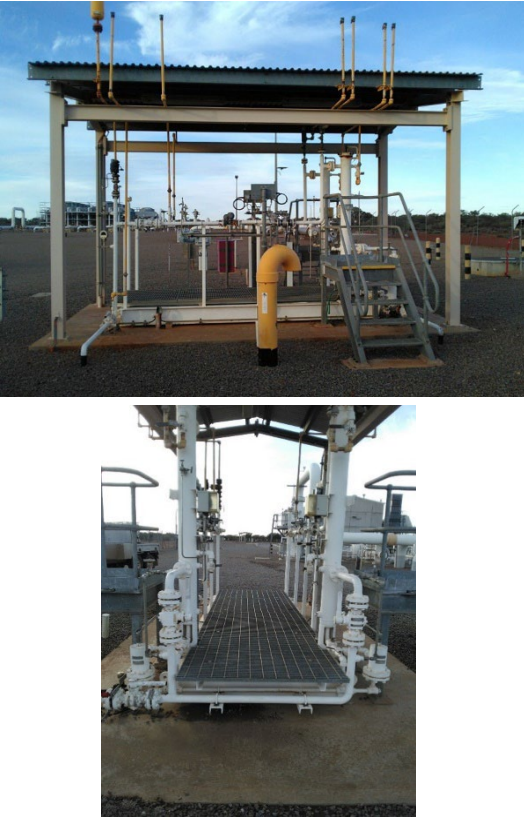
CS05-25	21/06/2023	Unit 1 - Fuel Gas Skid	<p>1) The landing for the stairs does not meet AS1657 requirements of 900mm.</p> <p>2) No hi vis (yellow) tread installed onto the nosing of each stair and the edge of each access point for the skid.</p> <p>3) The Step Up for the two access points for the platform is 410mm and therefore the AS requirements state at least 1 step be provided for safe access.</p>	C. Unlikely	2. Minor	Low	<p>1) Pour a new landing.</p> <p>2) Install hi vis (yellow) tread onto the nosing of each stair and access points for the skid.</p> <p>3) Install a stair with hi vis (yellow) tread on the nosing, at each access point to to enable safe access and compliance with the AS requirements.</p>

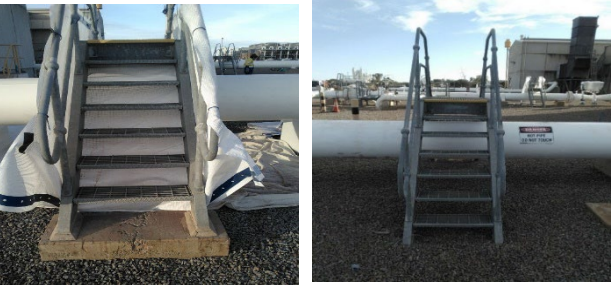
CS05-26	21/06/2023	Unit 2 - Multiple locations	Identical findings as Unit 1.				Identical recommendations as Unit 1.					
CS05-27	21/06/2023	Multiple Stairs Over Pipework	<p>1) The landing for the stairs does not meet AS1657 requirements of 900mm (actual 400mm or landing is blue metal).</p> <p>2) No hi vis (yellow) tread installed onto the nosing of each stair.</p>	C. Unlikely	2. Minor	Low	<p>1) Pour a new landing.</p> <p>2) Install hi vis (yellow) tread onto the nosing of each stair.</p>

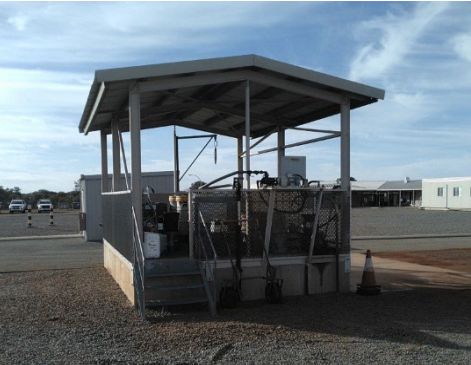
CS05-28	21/06/2023	Hazardous Substance Area	<p>1) The landing for the stairs does not meet AS1657 requirements of 900mm (landing is blue metal).</p> <p>2) No hi vis (yellow) tread installed onto the nosing of each stair.</p>	C. Unlikely	2. Minor	Low	<p>1) Pour a new landing.</p> <p>2) Install hi vis (yellow) tread onto the nosing of each stair.</p>

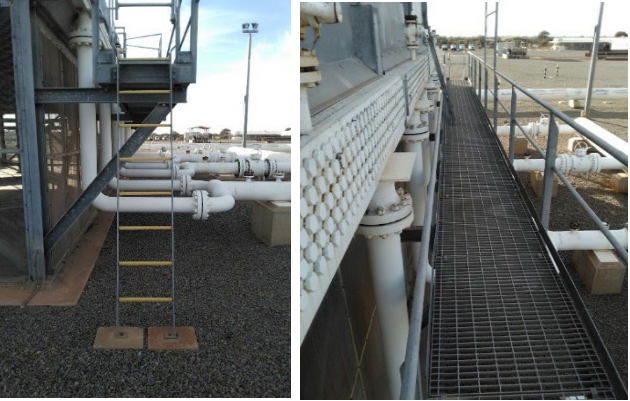
CS05-30	8/08/2023	Aftercooler Fans 1-6 - Middle Platform	<p>1) The landing for the stairs does not meet AS1657 requirements of 900mm.</p>	C. Unlikely	2. Minor	Low	<p>1) Pour a new landing.</p>

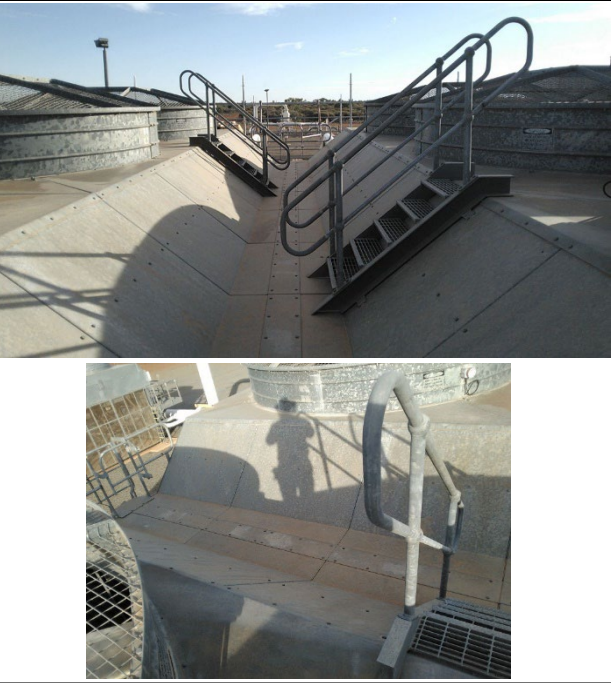
Reference	Date added	Location on Site	Issue	Likelihood	Consequence	Risk Score	Suggestions	Evidence	What is being completed	Date planned for completion	Date completed	Comments
CS05-31	8/08/2023	Aftercooler Fans 1-6 - Top Platform - Top Access Way	<p>1) Stairs do not have hi vis (yellow) tread installed onto the nosing of each stair.</p> <p>2) Open edge adjacent to each set of stairs, running along the platform. This exposes personnel to a fall into the access way.</p>	C. Unlikely	3. Severe	Medium	<p>1) Install hi vis (yellow) tread onto the nosing of each stair.</p> <p>2) Install handrail along the open edge of the access way, on the top platform.</p>

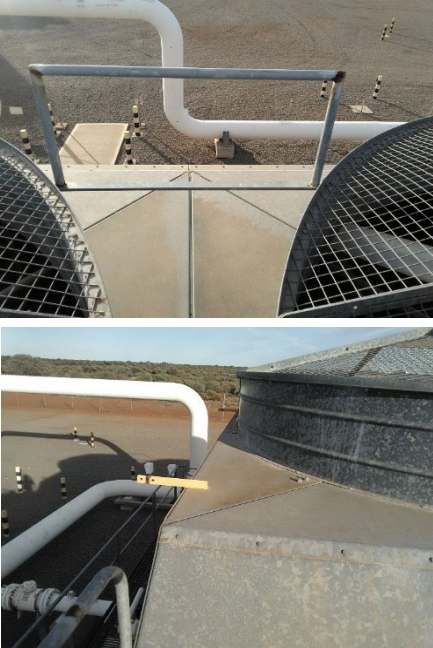
CS05-32	8/08/2023	Aftercooler Fans 1-6 - Top Platform - Top Platform	<p>1) The top platforms have several areas without handrails installed to prevent access to open edges. This creates the potential for a person to fall from height resulting in a fatality or significant injury due to the total fall distance.</p> <p>2) Handrails between the fans does not have bottom rail / mount is 600mm from the bottom of platform, this exceed AS1657 requirements of 450mm. No toeboard in place. Potential for personnel to climb under.</p>	C. Unlikely	3. Severe	High	<p>1) Install handrails to eliminate exposure to a unprotected edge.</p> <p>2) Install toeboard underneath the existing handrails.</p>

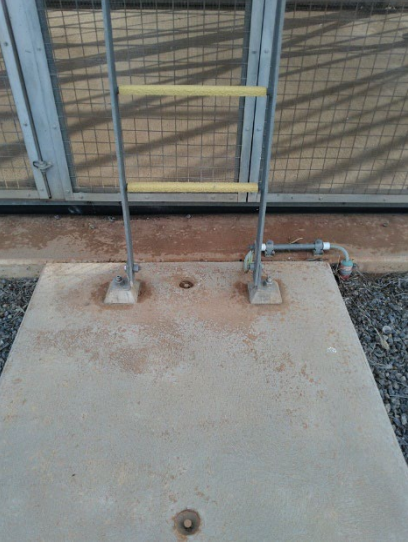
CS05-33	8/08/2023	Aftercooler Fans 7-9 - Ladder to Top Platform	<p>1) Step up from the landing to the first ladder rung is 460mm. This exceeds the AS1657 requirements (<=150mm).</p>	C. Unlikely	2. Minor	Low	<p>1) Modify the ladder to ensure it runs full length and risers meet AS requirements.</p>

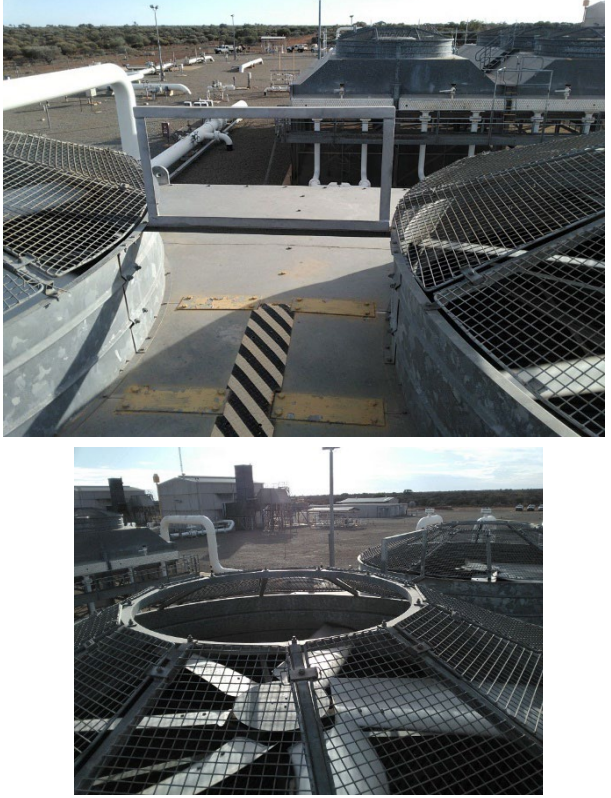
CS05-34	8/08/2023	Aftercooler Fans 7-9 - Top Platform	<p>1) Handrails between the fans does not have bottom rail / mount is 580mm from the bottom of platform, this exceed AS1657 requirements of 450mm. No toeboard in place. Potential for personnel to climb under.</p> <p>2) No guarding has been installed on the top of the fan enclosures, to prevent access during operation. Multiple fans at this location.</p>	C. Unlikely	3. Severe	High	<p>1) Install toeboard underneath the existing handrails.</p> <p>2) Install a grid mesh hatch or similar and attach it to the existing structure.</p>

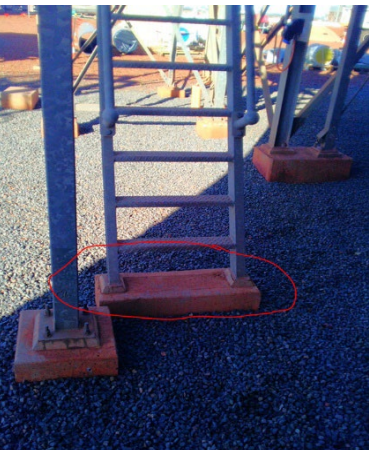
Reference	Date added	Location on Site	Issue	Likelihood	Consequence	Risk Score	Suggestions	Evidence	What is being completed	Date planned for completion	Date completed	Comments
CS06-1	2/02/2023	Example - Lube oil cooler unit 1	<p>1) Landing does not meet AS requirement of 900mm</p> <p>2) Stair treads too narrow and no non-slip</p>				<p>1.1) Remove old landing and install new precast one</p> <p>1.2) Pour new landing</p> <p>2.1) Replace ladder with new treads and non-slip</p>

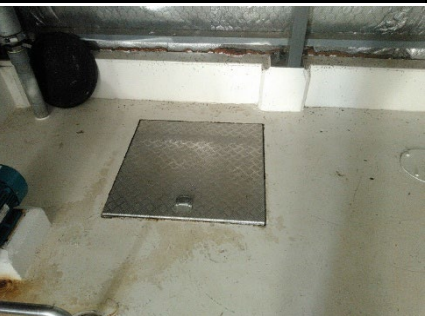
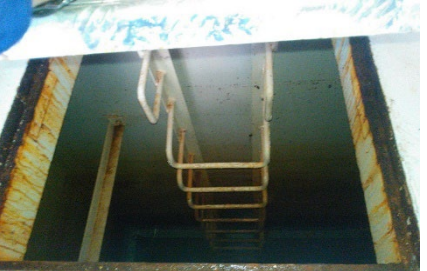
Replace ladder and landing. Pour new landing			
CS06-1	29/08/2023	Water Treatment Plant - Pit Inside Building	<p>1) Poor access / egress from ladder.</p> <p>2) The foot of the ladder does not rest on or terminate above the landing. There is also no clear handgrips to assist the person when mounting and dismounting the ladder. Therefore it does not meet AS 1657 requirements.</p> <p>3) No non-slip tread on ladder rungs.</p> <p>Note: This inspection pit is considerably smaller than some other Compressor Stations.</p>	C. Unlikely	3. Severe	Medium	<p>1) Consider the position of the ladder when being redesigned, to allow for safe access / egress.</p> <p>2) Redesign the ladder and hand grips to provide suitable access and meet AS1657 requirements.</p> <p>3) Replacement ladder to have hi vis (yellow) non-slip tread installed on the rungs.</p>

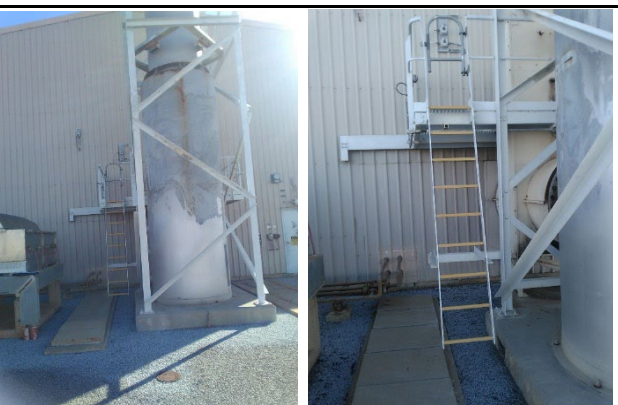
CS06-2	29/08/2023	Unit 1 - Exhaust Stack Platform	<p>1) The ladder does not meet AS requirements, including the ladder does run full length to the landing and the step up is 3400mm (AS <=150mm).</p> <p>2) Gap between the handrail and structure (130mm) and does not meet AS requirements (max 100mm).</p> <p>Note: Comment only given the small difference above the AS requirement.</p>	C. Unlikely	3. Severe	Medium	<p>1.1) Install a landing that meets AS requirements.</p> <p>1.2) Modify the ladder so its runs to the new landing and the first step up meets AS requirements.</p> <p>2) No action required.</p>

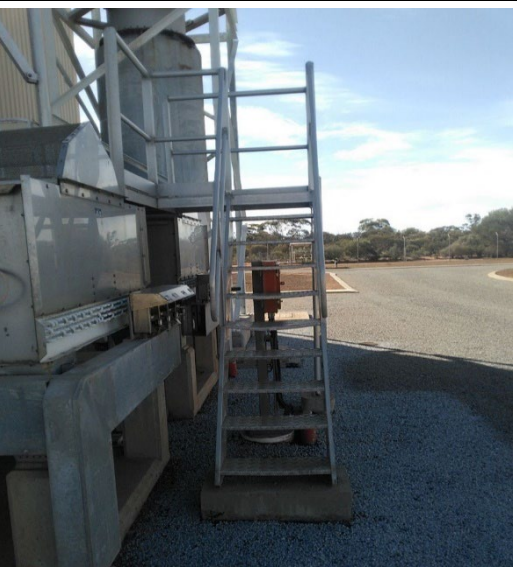
CS06-3	29/08/2023	Compressor Unit 1 Oil Cooler Fans - Access Stairs	<p>1) The landing for the stairs does not meet AS1657 requirements of 600mm minimum.</p> <p>2) The length of the handrail when compared to the full length of the stairs and landing, is not compliant with the AS requirements. The current design also increases the potential of being unable to arrest a slip / fall.</p> <p>3) No hi vis (yellow) tread installed onto each stair.</p> <p>4) 1 x step identified with a bow in it.</p>	C. Unlikely	3. Severe	Medium	<p>1) Pour a new landing.</p> <p>2) Modify the handrail to run the full length of the stairs.</p> <p>3) Install hi vis (yellow) tread onto each stair.</p> <p>4) Repair or replace the damaged step.</p>

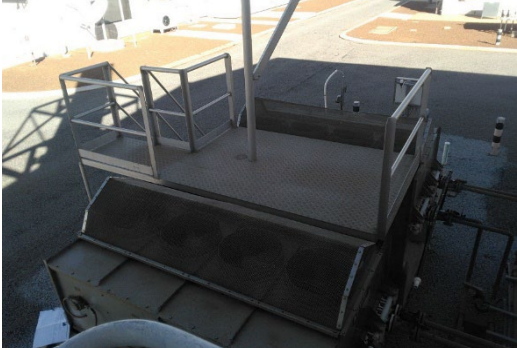
CS06-4	29/08/2023	Compressor Unit 1 Oil Cooler Fans - Platform	<p>1) The existing handrail does not extend around the outside of the fan enclosure on other side. This creates the risk of a fall of ~1.9m.</p>	C. Unlikely	3. Severe	Medium	<p>1) Install additional handrails and supporting structure around both fan enclosures.</p>

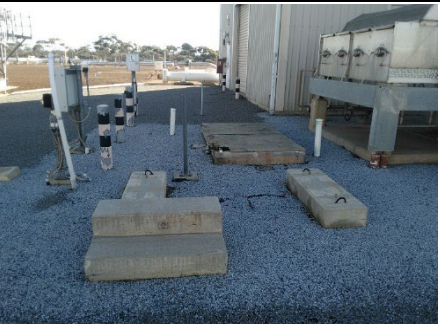
CS06-5	29/08/2023	Steps / Landings For Tank (Removed)	<p>1) Redundant Steps / Landings for a Tank that has since been removed. They pose a trip hazard to personnel walking through this area.</p>	B. Remote	2. Minor	Low	<p>1) Remove the redundant steps / landings.</p>

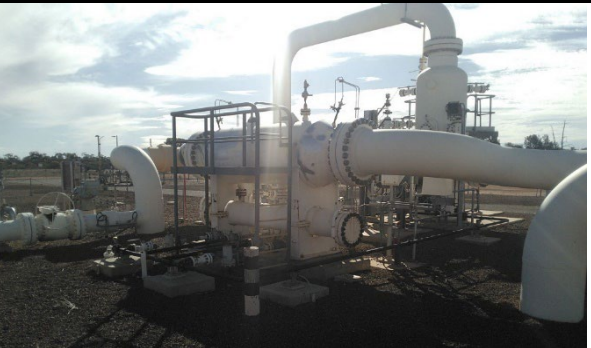
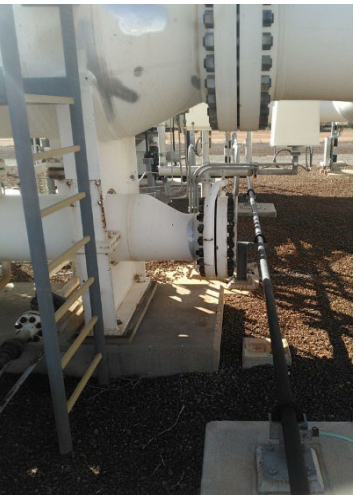
CS06-6	29/08/2023	Platform for Piping to Unit 1	<p>1.1) The landing for the ladder does not meet AS1657 requirements of 600mm minimum.</p> <p>1.2) Small bore piping and concrete landing poses a trip hazard for personnel using the ladder.</p>	C. Unlikely	3. Severe	Medium	<p>1) Option A: Reroute the piping so that it does not pose a risk to personnel accessing the ladder.</p> <p>Option B: Modify the platform so the potential for interaction with the small bore piping is eliminated.</p>

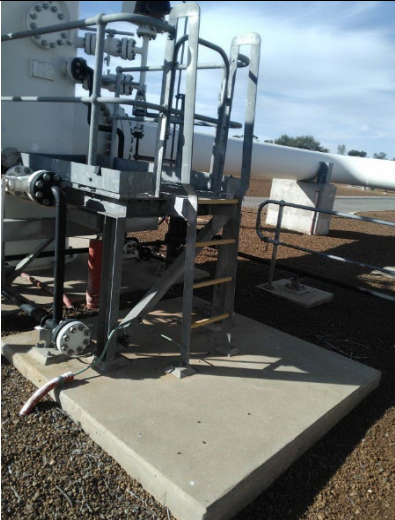
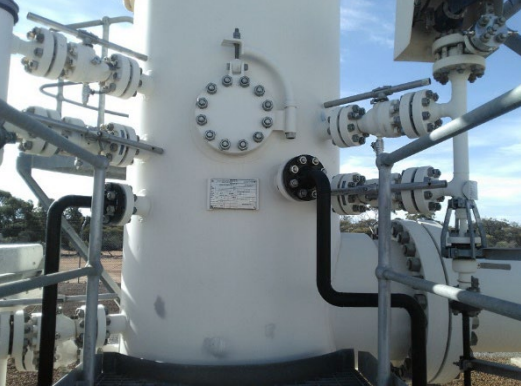
Reference	Date added	Location on Site	Issue	Likelihood	Consequence	Risk Score	Suggestions	Evidence	What is being completed	Date planned for completion	Date completed	Comments
CS06-7	29/08/2023	Unit 1 Suction Scrubber	1) The gap between the handrail and structure exceeds the AS requirement (max 100mm, actual 370mm).	B. Remote	2. Minor	Low	1) Consider modifying the handrail to eliminate or reduce the gap to meet the AS requirement.

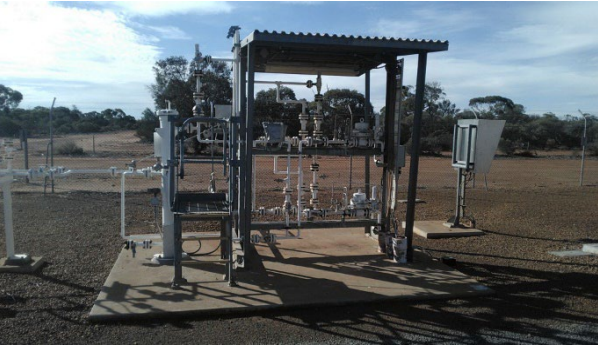
CS06-8	29/08/2023	Unit 1 Fuel Gas Skid	1) The landing for the ladder does not meet AS1657 requirements of 600mm minimum.	C. Unlikely	2. Minor	Low	1) Extend the landing.

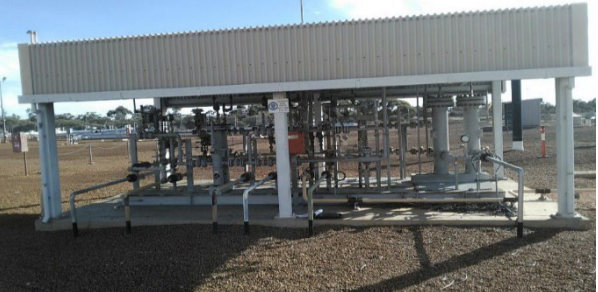
CS06-9	29/08/2023	Unit 1 Pressure Reduction Skid	1) Landing and step up / down is impacted by a existing pipework. Therefore the AS requirements are not being met and a trip hazard is present. 2) No hi vis (yellow) strip on the nosing (ends) of the grid mesh platform.	B. Remote	2. Minor	Low	1) Install a step and platform over the pipework, that meet AS requirements (e.g. hi vis nosing, step riser height). 2) Install hi vis (yellow) non-slip strip on the nosing of the skid's access point.

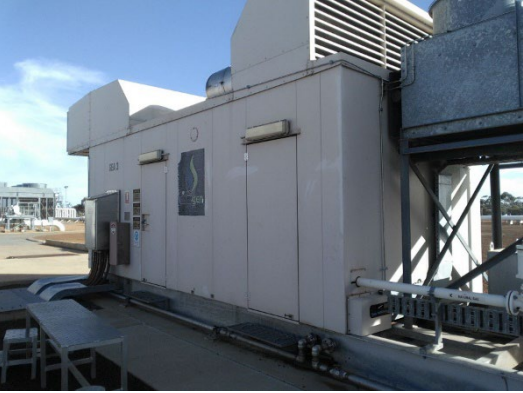
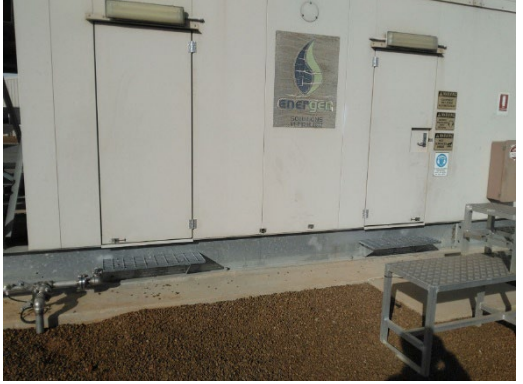
CS06-10	29/08/2023	GEA 3	1) No hi vis (yellow) tread installed onto the nosing of each stair. 2) Landing for the doors on one side of the GEA does not meet AS1657 requirements of 600mm minimum.	C. Unlikely	3. Severe	Medium	1) Install hi vis (yellow) tread onto the nosing of each stair. 2) Extend the landing.

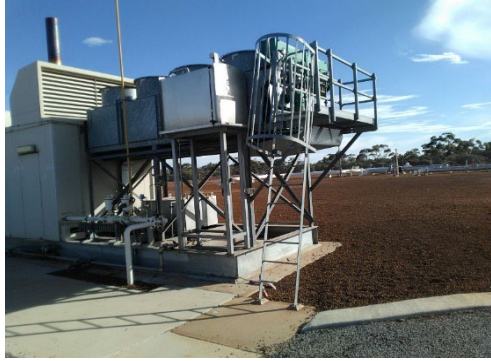
CS06-11	29/08/2023	GEA 3 After Cooler Fans	1) No hi vis (yellow) tread installed onto the ladder rungs.	C. Unlikely	2. Minor	Low	1) Install hi vis (yellow) tread onto the ladder rungs.

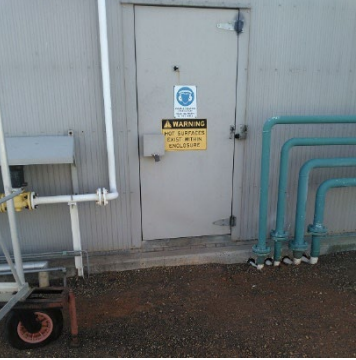
CS06-12	29/08/2023	GEA 1 (Modra 06-01)	1) Landing for the doors on one side of the GEA does not meet AS1657 requirements of 600mm minimum.	C. Unlikely	3. Severe	Medium	1) Extend the landing.

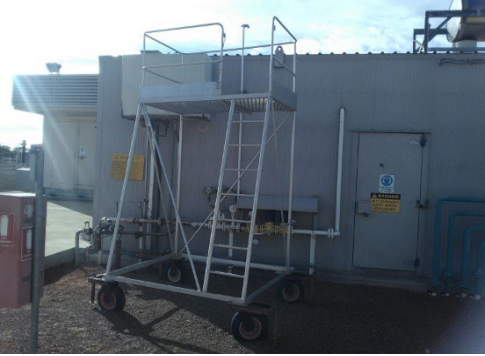
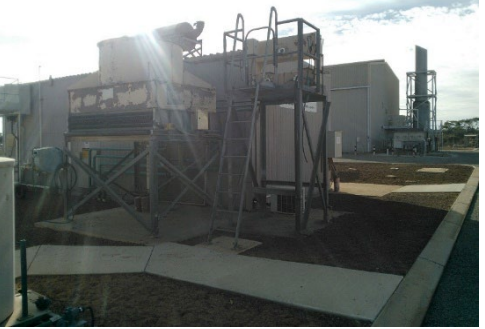
CS06-13	29/08/2023	GEA 1 (Modra 06-01) - After Cooler Fans	1) No hi vis (yellow) tread installed onto each ladder rung. This applies to both the portable platform's ladder and the fixed ladder. 2) Chain has been used in lieu of a self closing gate at the top of the ladder on the portable platform. The chain will break in the event of a fall and therefore will not meet AS 1657 requirements for guardrails.	C. Unlikely	4. Major	High	1) Install hi vis (yellow) tread onto each ladder rung. This applies to both the portable platform's ladder and the fixed ladder. 2) Modify the platform so the chain can be replaced with a self closing gate.

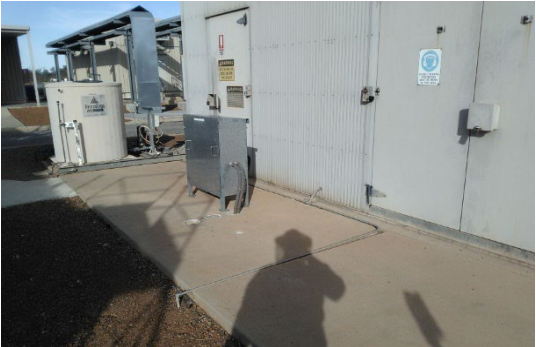
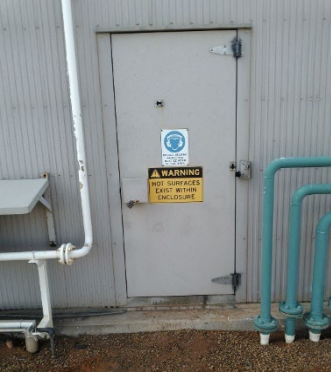
Reference	Date added	Location on Site	Issue	Likelihood	Consequence	Risk Score	Suggestions	Evidence	What is being completed	Date planned for completion	Date completed	Comments
CS06-14	29/08/2023	GEA 2 (Modra 06-02)	<p>1) Landing for the doors on one side of the GEA does not meet AS1657 requirements of 600mm minimum.</p> <p>2) The landing for the doors on one side of the GEA have a section of small bore piping that poses a trip hazard.</p>	C. Unlikely	3. Severe	Medium	<p>1) Extend the landing.</p> <p>2) Option A: Reroute the piping to outside of the walkway.</p> <p>Option B: Install a step over it to eliminate potential interaction with the piping at the access door. Spray paint (yellow) the remaining section of pipe to highlight the hazard.</p>

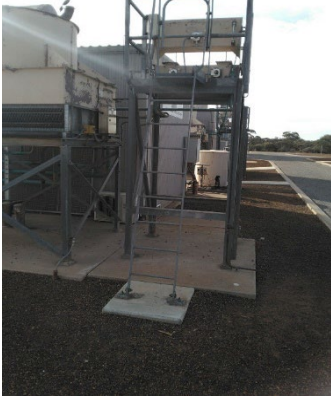
CS06-15	29/08/2023	GEA 2 (Modra 06-02) - After Cooler Fans	<p>1) No hi vis (yellow) tread installed onto the ladder rungs.</p> <p>2) The landing for the ladder does not meet AS1657 requirements of 600mm minimum.</p>	C. Unlikely	2. Minor	Low	<p>1) Install hi vis (yellow) tread onto the ladder rungs.</p> <p>2) Extend the landing.</p>

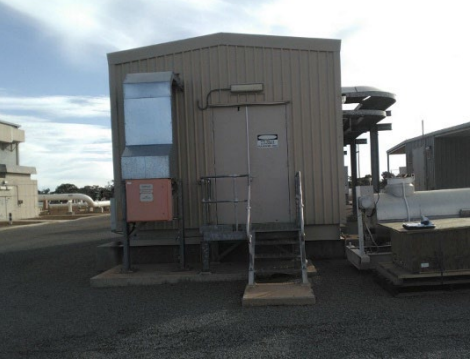
CS06-16	29/08/2023	DEA Substation	1) No hi vis (yellow) tread installed onto the nosing of each stair.	C. Unlikely	2. Minor	Low	1) Install hi vis (yellow) tread onto the nosing of each stair.

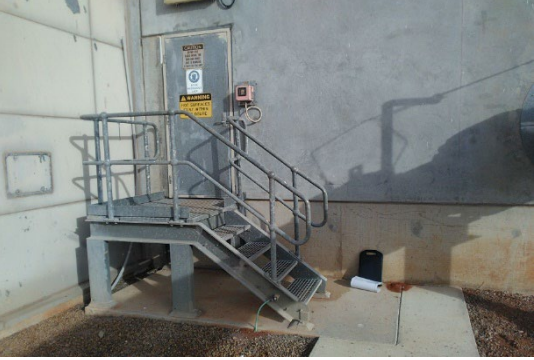
CS06-17	29/08/2023	Unit 2 Access Stairs	1) No hi vis (yellow) tread installed onto the nosing of each stair.	C. Unlikely	2. Minor	Low	1) Install hi vis (yellow) tread onto the nosing of each stair.

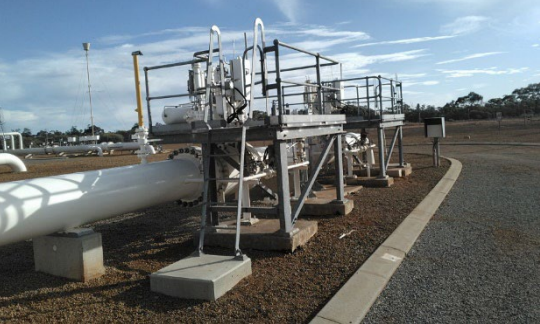
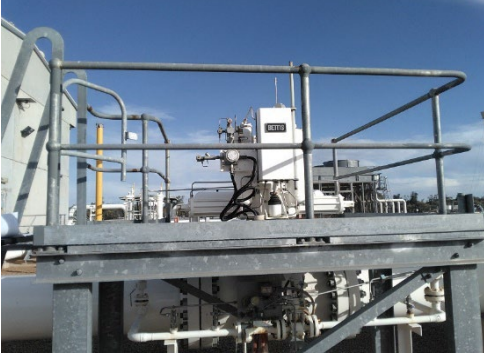
CS06-18	29/08/2023	Bettis Equipment Platform #1 - East of Unit 2 (closest to Unit 2)	<p>1) No hi vis (yellow) tread installed onto the ladder rungs.</p> <p>2) The landing for the ladder does not meet AS1657 requirements of 600mm minimum.</p> <p>3) Open edge on one side of platform and exposes a person to a fall of ~1.6m</p>	C. Unlikely	3. Severe	High	<p>1) Install hi vis (yellow) tread onto the ladder rungs.</p> <p>2) Extend the landing.</p> <p>3) Install handrails and kick plate onto the open side of the platform.</p>

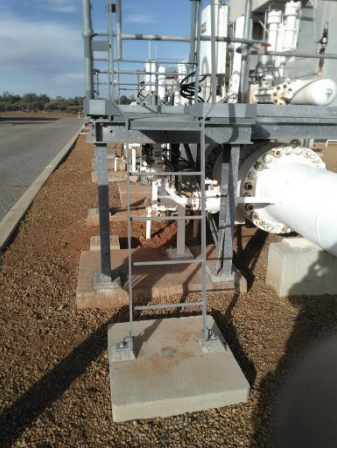
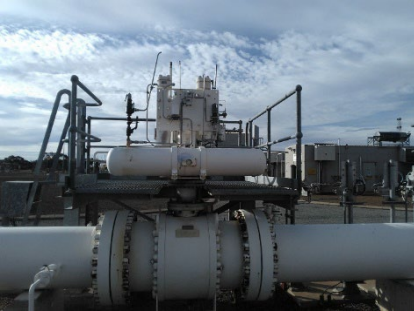
CS06-19	29/08/2023	Bettis Equipment Platform #2 - East of Unit 2	<p>1) No hi vis (yellow) tread installed onto the ladder rungs.</p> <p>2) The landing for the ladder does not meet AS1657 requirements of 600mm minimum.</p> <p>3) Open edge on one side of platform and exposes a person to a fall of ~1.6m</p>	C. Unlikely	3. Severe	High	<p>1) Install hi vis (yellow) tread onto the ladder rungs.</p> <p>2) Extend the landing.</p> <p>3) Modify the platform to allow personnel to access both sides of the equipment, whilst having edge protection in place. Ensure the new / modified platform meets AS1657 requirements.</p>

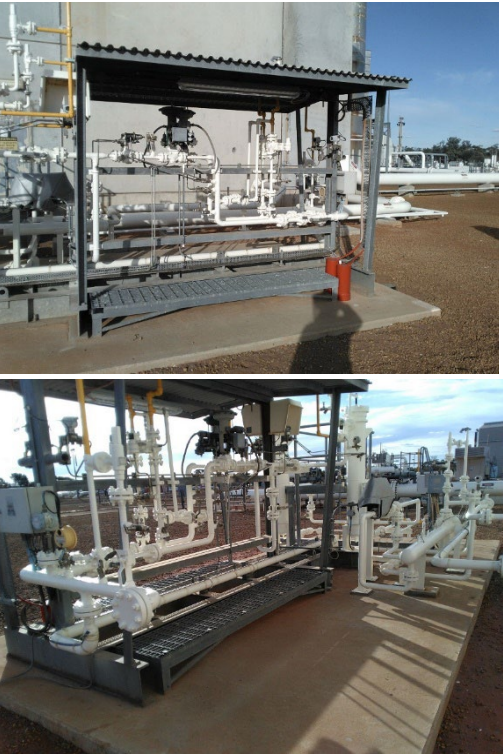
Reference	Date added	Location on Site	Issue	Likelihood	Consequence	Risk Score	Suggestions	Evidence	What is being completed	Date planned for completion	Date completed	Comments
CS06-20	30/08/2023	Unit 2 Turbine Fuel Gas Skid	<p>1) No hi vis (yellow) tread installed onto the nosing of each stair.</p> <p>2) The landing on one side of the skid does not meet AS1657 requirements of 600mm minimum.</p>	C. Unlikely	2. Minor	Low	<p>1) Install hi vis (yellow) tread onto the nosing of each stair.</p> <p>2) Extend the landing.</p>

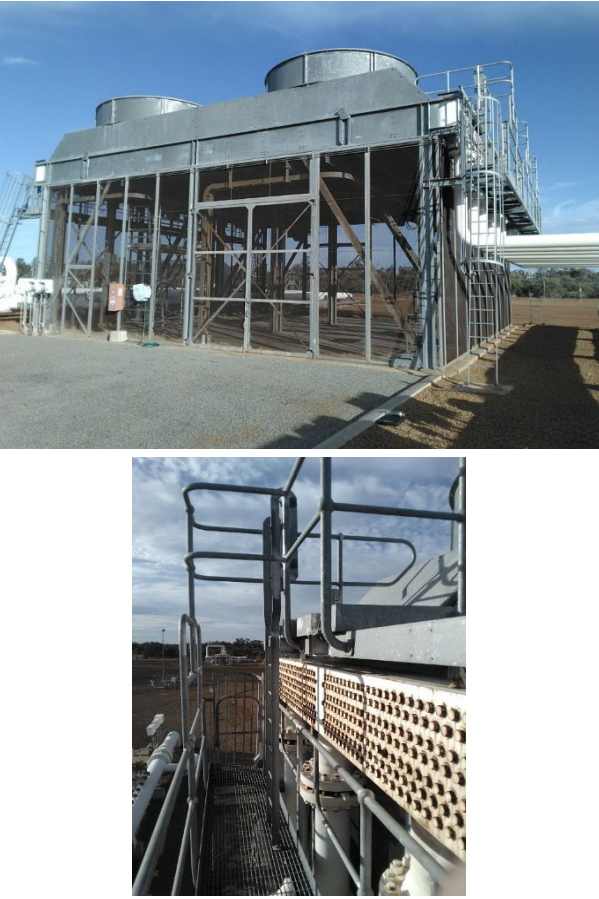
CS06-21	30/08/2023	Middle Platform (Access Way) For After Cooler Fans	<p>1) No hi vis (yellow) tread installed onto the ladder rungs.</p> <p>2) The landing for the ladders (from ground to first platform) does not meet AS1657 requirements of 600mm minimum.</p>	C. Unlikely	2. Minor	Low	<p>1) Install hi vis (yellow) tread onto the ladder rungs.</p> <p>2) Extend the landing.</p>

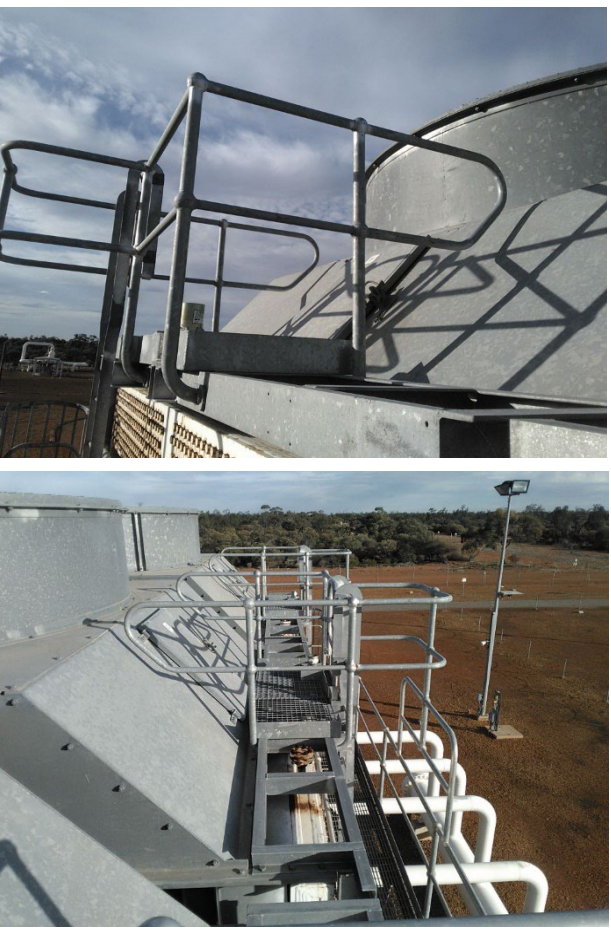
CS06-22	30/08/2023	Top Platform for each After Cooler Fan	<p>1.1) There is no method for accessing this platform from the below walkway without climbing onto structural steel and being exposed to a fall.</p> <p>1.2) Gap between the existing handrail and the structure on both sides of the platform. This poses a potential of a slip / trip.</p> <p>2) No hi vis (yellow) tread installed onto the ladder rungs.</p>	C. Unlikely	4. Major	High	<p>1.1) Install signage to highlight the fall from height risk until a suitable means of access is installed.</p> <p>1.2) Modify the platform to - allow for safe access to the top of the fans; - eliminate or reduce the gap between the existing handrail and floor / structure.</p> <p>2) Install hi vis (yellow) tread onto the ladder rungs.</p>

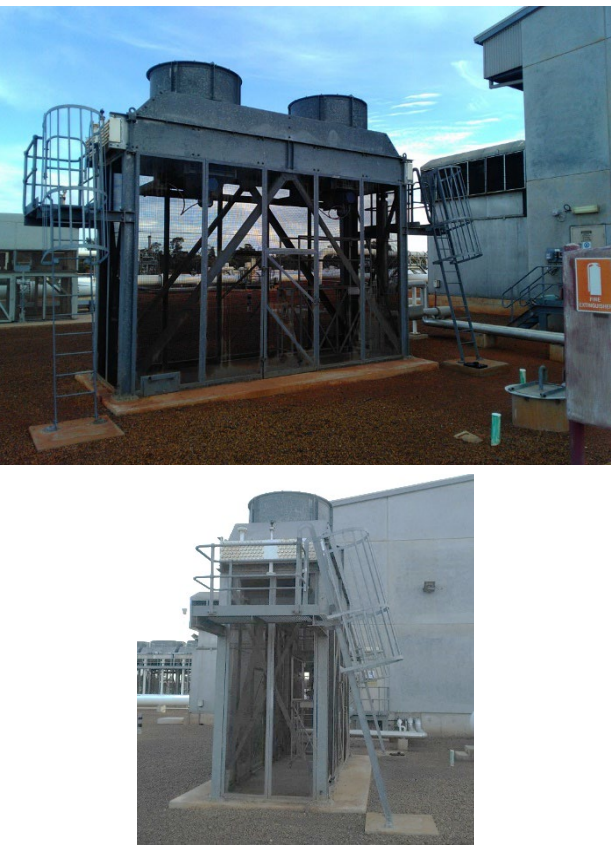
CS06-23	30/08/2023	Unit 2 After Cooler Fans	<p>1) No hi vis (yellow) tread installed onto the ladder rungs.</p> <p>2) The landing for the ladders (from ground to first platform) does not meet AS1657 requirements of 600mm minimum.</p> <p>3) The step up from the landing to the first ladder rung exceeds AS requirements.</p> <p>4) There is no method for accessing the top of the after cooler fans without climbing onto structural steel and being exposed to a fall.</p>	C. Unlikely	4. Major	High	<p>1) Install hi vis (yellow) tread onto the ladder rungs.</p> <p>2) Extend the landing.</p> <p>3) Modify the ladder or install a intermediate step to ensure the step up distances in AS1657 are met.</p> <p>4) Consider installing a platform to enable access to the top of the after cooler fans.</p>

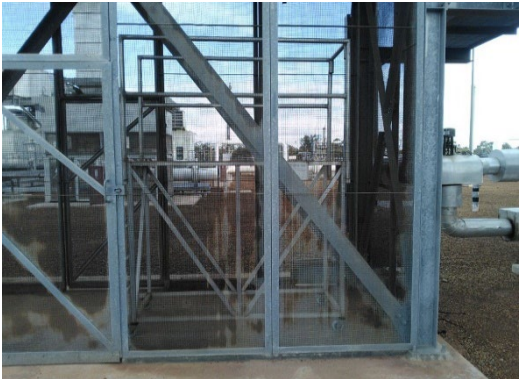
CS06-24	30/08/2023	Mobile Scaffold - Inside of Unit 2 After Cooler Fans Enclosure	<p>1) No hi vis (yellow) tread installed onto the ladder rungs.</p> <p>2) No handrail and self closing gate around the ladder opening.</p> <p>3) The mid rail on one side of the mobilise scaffold is missing.</p>	C. Unlikely	3. Severe	Medium	<p>1) Install hi vis (yellow) tread onto the ladder rungs.</p> <p>2) Install handrail and self closing gate (or equivalent) around the ladder opening.</p> <p>3) Install a mid rail on the missing side of the mobile scaffold.</p>

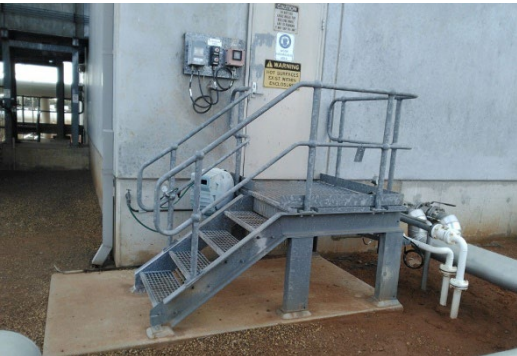
Reference	Date added	Location on Site	Issue	Likelihood	Consequence	Risk Score	Suggestions	Evidence	What is being completed	Date planned for completion	Date completed	Comments
CS06-25	30/08/2023	Unit 2 Access Stairs	1) No hi vis (yellow) tread installed onto the nosing of each stair.	C. Unlikely	2. Minor	Low	1) Install hi vis (yellow) tread onto the nosing of each stair.

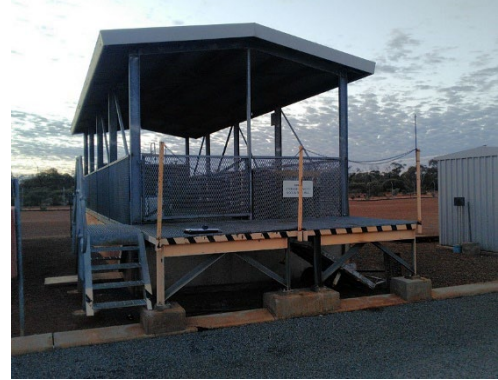
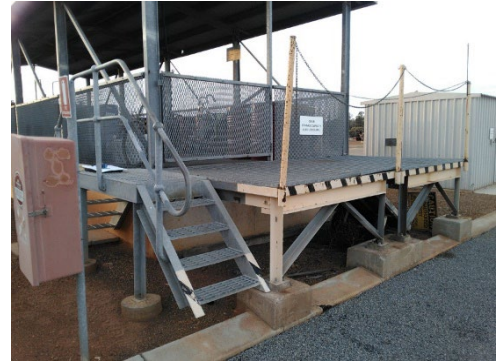
CS06-26	30/08/2023	Dangerous Good Storage Shed - Access Road Side	<p>Stairs - Closest to Access Road</p> <p>1) The landing is obstructed from the kerb which is a curved surface. This poses a trip hazard and the landing does not meet AS1657 requirements of 600mm minimum.</p> <p>2) The stairs do not run the full length to the landing as it is obstructed by concrete support and kerbing. The landing does not meet AS1657 requirements of 600mm minimum.</p> <p>3) No hi vis (yellow) tread installed onto the nosing of the stairs.</p> <p>Stairs - Furthest from Access Road</p> <p>4) The stairs do not run the full length to the landing.</p> <p>5) The landing does not meet AS1657 requirements of 600mm minimum.</p> <p>6) No hi vis (yellow) tread installed onto the nosing of the stairs.</p> <p>Platform</p> <p>7) Chain has been used in lieu of a self closing gate at the top of the ladder on</p>	C. Unlikely	3. Severe	Medium	<p>1) Redesign and orientate the stairs to run parallel with the road.</p> <p>2) Pour a new landing for the new stairs. Remove the redundant landing.</p> <p>3) Install hi vis (yellow) tread onto the nosing of the stairs.</p> <p>4) As per action #1 and #2.</p> <p>5) As per action #1 and #2.</p> <p>6) As per action #3.</p> <p>7) Modify the platform so the chain can be replaced with handrails and/or self closing gate. The gate will need to support the loading and unloading of drums / etc. onto the platform.</p>

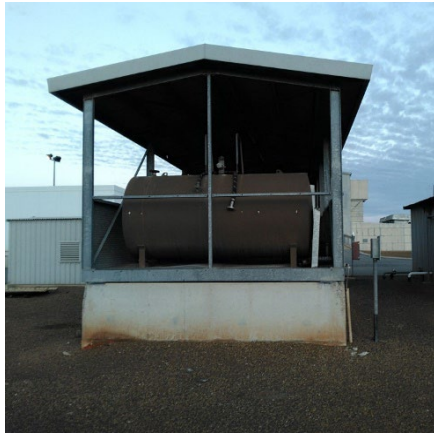
CS06-27	30/08/2023	Dangerous Good Storage Shed - Fencing Side	1) Only 1 handrail has been installed and no kick plate has been installed. This provides potential to climb through.	B. Remote	3. Severe	Low	1) Install kick plate and handrail. If access is required then install a self closing gate on one side.

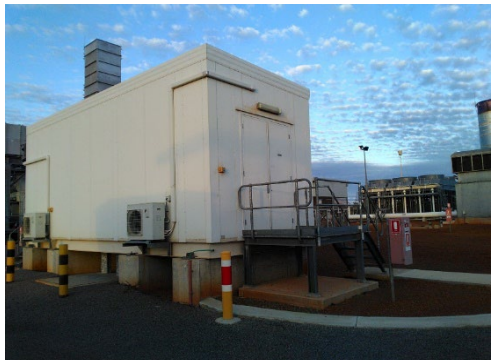
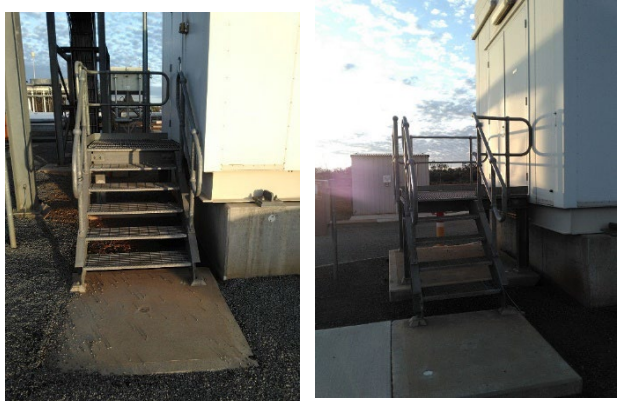
CS06-28	30/08/2023	Substation near Unit 3	1) No hi vis (yellow) tread installed onto the nosing of the stairs.	C. Unlikely	2. Minor	Low	1) Install hi vis (yellow) tread onto the nosing of the stairs.

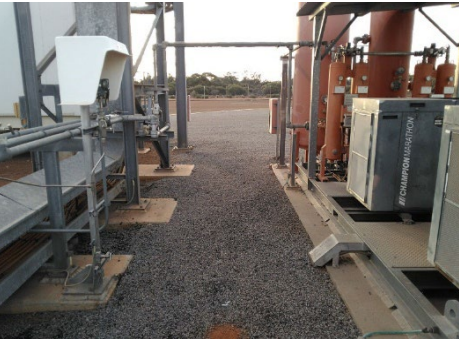
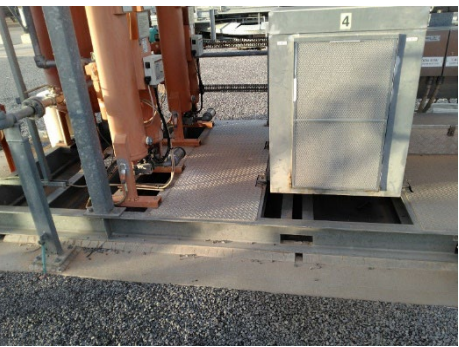
CS06-29	30/08/2023	Desiccant Dryers x 2	<p>1) The landing (260mm) does not meet AS requirement of 600mm (Depth).</p> <p>2) No hi vis (yellow) tread installed on the nosing of the platform.</p> <p>3) Cable tray adjacent to step up is a trip hazard.</p>	B. Remote	2. Minor	Low	<p>1) Remove old landing and pour a new landing.</p> <p>2) Install hi vis (yellow) tread onto the nosing of the two access points.</p> <p>3.1) Relocate the cable tray to eliminate the trip hazard if practically possible.</p> <p>3.2) If the cable tray can not be relocated then place a step over it to protect it or apply hi vis tape to highlight the hazard.</p>

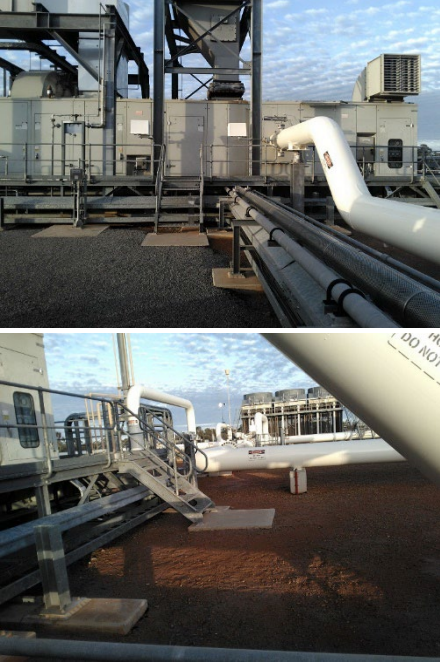
Reference	Date added	Location on Site	Issue	Likelihood	Consequence	Risk Score	Suggestions	Evidence	What is being completed	Date planned for completion	Date completed	Comments
CS06-30	30/08/2023	Unit 3 - Multiple Access Stairs	1) No hi vis (yellow) tread installed onto the nosing of the stairs.	C. Unlikely	2. Minor	Low	1) Install hi vis (yellow) tread onto the nosing of the stairs.
