Revised Final Plan
Attachment 9.12

Structures & Operational Sites - Working at Heights - Appendix B

**Dampier Bunbury
Pipeline**

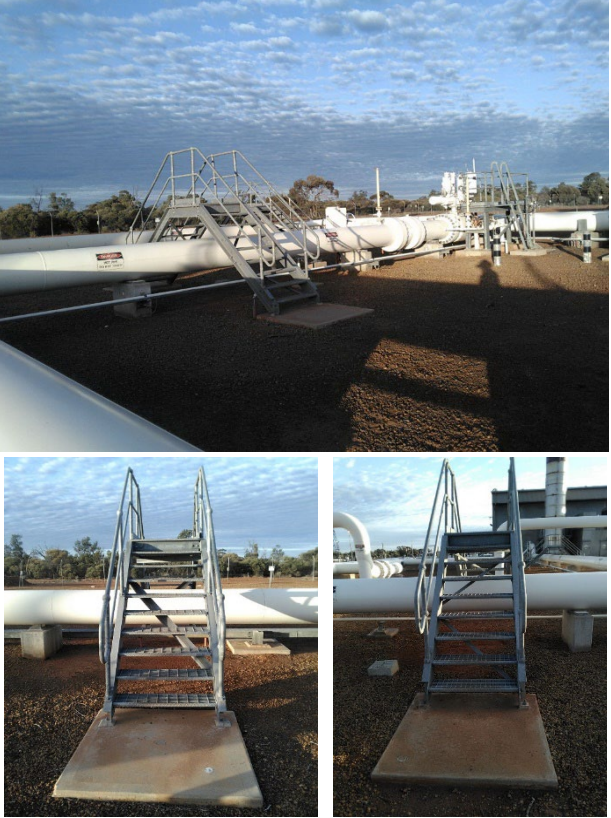
CS06-31	30/08/2023	Multiple Access Stairs For Hoping Over Piping (e.g. near Unit 3, After Cooler Fans)	1) No hi vis (yellow) tread installed onto the nosing of the stairs.	C. Unlikely	2. Minor	Low	1) Install hi vis (yellow) tread onto the nosing of the stairs.

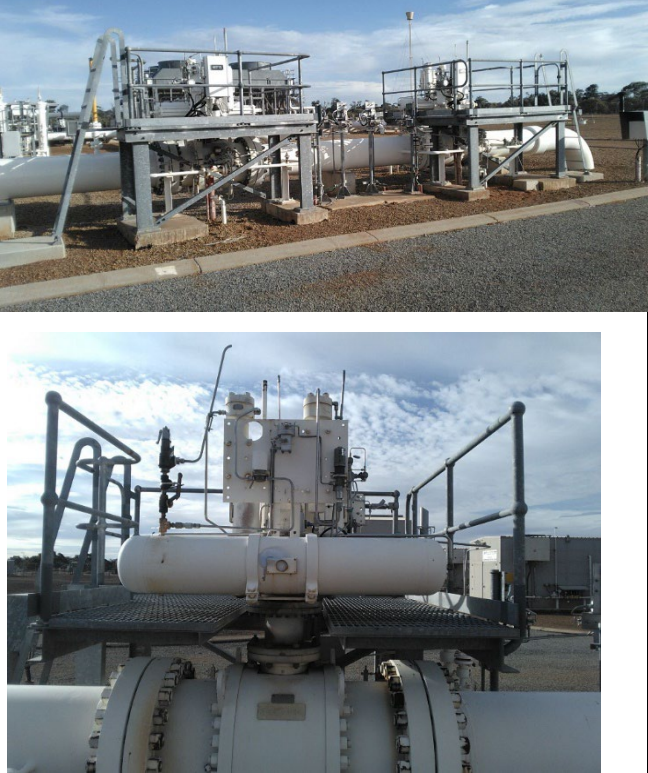
CS06-32	6/10/2023	2 x Bettis Equipment / Actuated Valves Near Unit 3	1) No hi vis (yellow) tread installed onto the ladder rungs. 2) The landings for one of the ladders does not meet AS1657 requirements of 600mm depth minimum. 3) Open edge on one side of platform and exposes a person to a fall of ~1.6m	C. Unlikely	3. Severe	High	1) Install hi vis (yellow) tread onto the ladder rungs. 2) Extend the landing. 3) Modify the platform to allow personnel to access both sides of the equipment, whilst having edge protection in place. Ensure the new / modified platform meets AS1657 requirements.

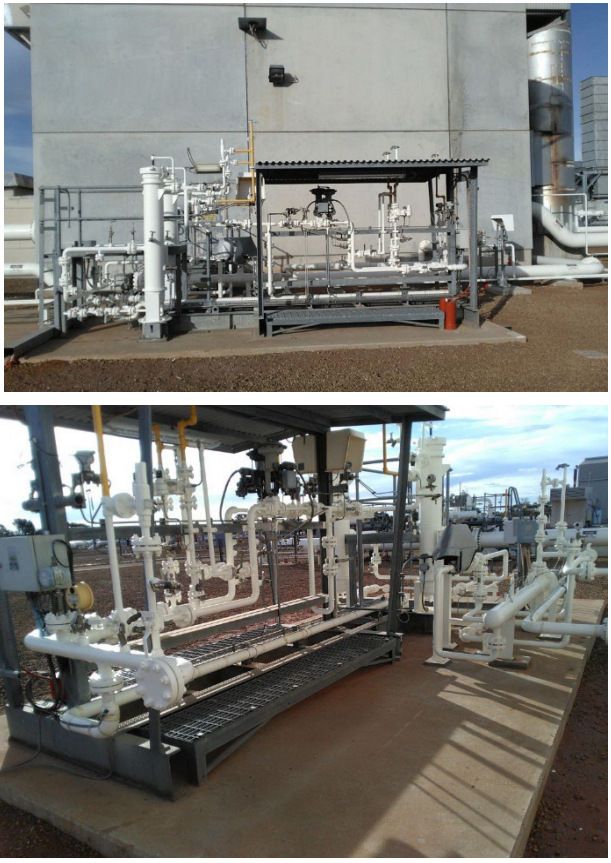
CS06-33	6/10/2023	Unit 3 Turbine Fuel Gas Skid	1) No hi vis (yellow) tread installed onto the nosing of each stair. 2) The landing on one side of the skid does not meet AS1657 requirements of 600mm minimum.	C. Unlikely	2. Minor	Low	1) Install hi vis (yellow) tread onto the nosing of each stair. 2) Extend the landing.

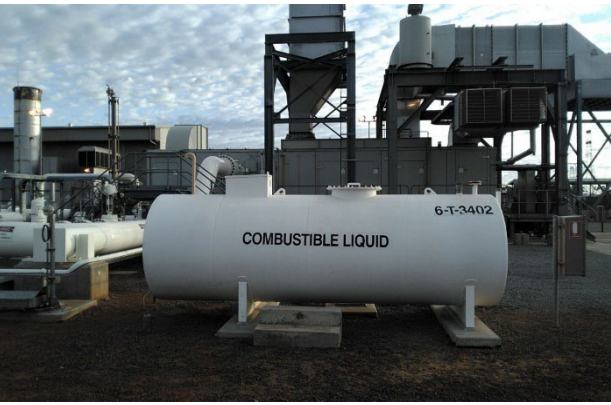
CS06-36	6/10/2023	Combustible Liquid Tank Near Unit 3	<p>1) Access stairs do not provide safe access to the 2 x hatches. Currently personnel have to over-reach.</p>	D. Occasional	2. Minor	Low	<p>1) Remove the existing access stairs and install with AS compliant stairs, platform and landing.</p>

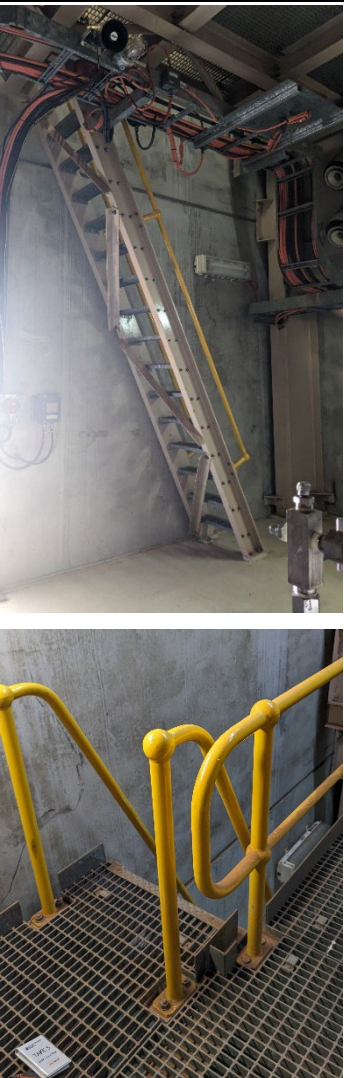
CS06-37	7/02/2023	Unit 2 - Lower Access Stairs for First Platform (Crane)	<p>1) No hi vis (yellow) tread installed onto the nosing of stairs (width 550mm).</p> <p>2) No self closing gate installed at the top of the stairs.</p> <p>3) Greater potential to fall if facing away from the stairs when descending.</p> <p>Note: Reported by Craig Hastie.</p>	D. Occasional	3. Severe	Medium	<p>1) Install hi vis (yellow) tread onto the nosing of the stairs.</p> <p>2) Install a self closing gate at the top of the stairs.</p> <p>3) Install signage on both sides of the gate to instruct personnel to only descend the stairs whilst facing towards the stair.</p>

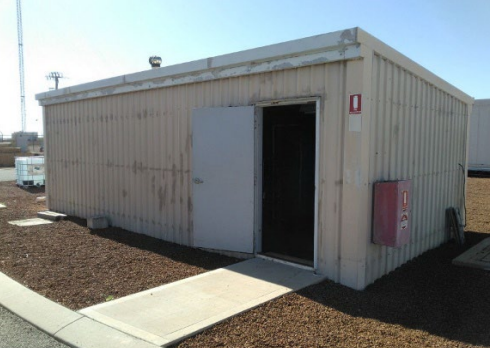
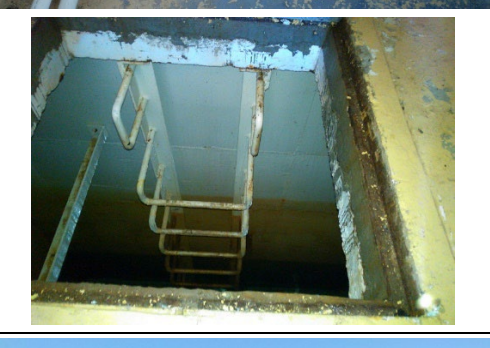
Reference	Date added	Location on Site	Issue	Likelihood	Consequence	Risk Score	Suggestions	Evidence	What is being completed	Date planned for completion	Date completed
C507-1	2/02/2023	Example - Lube oil cooler unit 1	1) Landing does not meet AS requirement of 900mm 2) Stair treads too narrow and no non-slip				1.1) Remove old landing and install new precast one 1.2) Pour new landing 2.1) Replace ladder with new treads and non-slip		Replace ladder and landing. Pour new landing		
C507-1	2/11/2023	Water Treatment Plant - Access Door and Pit inside Building	1) Poor access / egress from ladder. 2) The foot of the ladder does not rest on or terminate above the landing. There is also no clear handgrips to avoid the person when mounting and dismounting the ladder. Therefore it does not meet AS 1657 requirements. 3) No non-slip tread on ladder rungs. 4) The steps to the access door has anti-slip tape previously installed but this shows signs of excessive wear.	C. Unlikely	3. Severe	Medium	1) Consider the position of the ladder when being redesigned, to allow for safe access / egress. 2) Redesign the ladder and hand grips to provide suitable access and meet AS1657 requirements. 3) Replacement ladder to have hi vis (yellow) non-slip tread installed on the rungs. 4) Re-install the anti-slip tape if warranted.

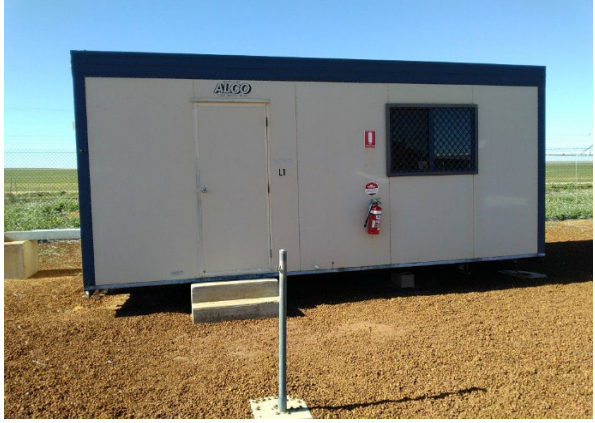
C507-2	2/11/2023	Laundry - Demountable Building	1) Landing is gravel and can be slippery under your foot. 2) Stair risers are inconsistent and do not meet AS 1657 requirements.	C. Unlikely	2. Minor	Low	1) Install a landing that meets AS requirements. 2) Replace the stairs with AS compliant stairs.

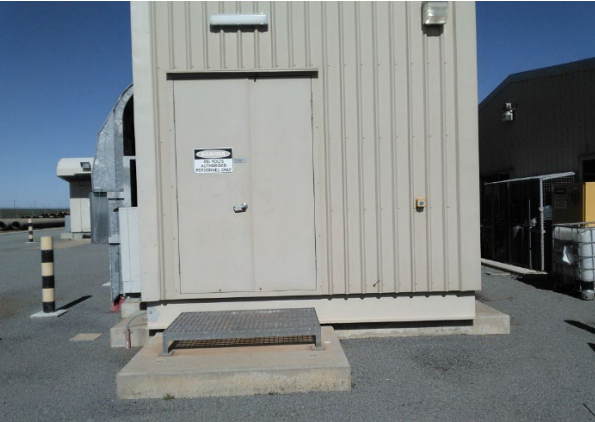
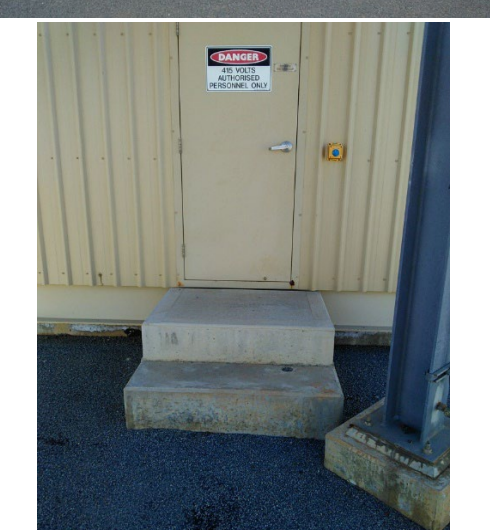
C507-3	2/11/2023	Primary Switch Room (next to Control Room)	1) North and South side's stair dimensions are not consistent and do not meet AS 1657 requirements. 2) The landing for the south side stairs is partially obstructed by structural beam and concrete landing.	C. Unlikely	2. Minor	Low	1) Replace both the north and south stairs with AS compliant stairs. 2) Consider using hi vis paint to highlight the hazard.

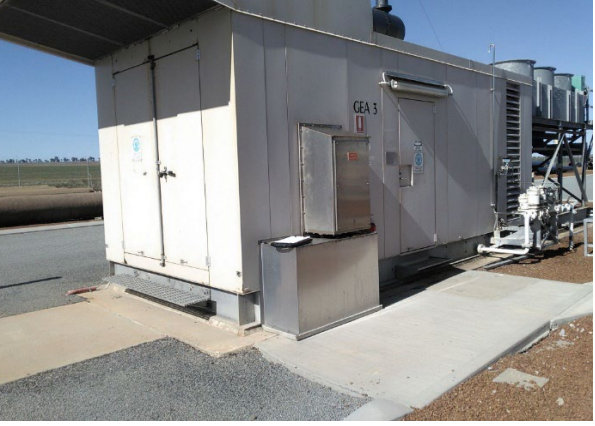
C507-4	2/11/2023	GEA 3 - All access doors	1) No hi vis (yellow) tread installed onto each stair.	C. Unlikely	2. Minor	Low	1) Install hi vis (yellow) tread onto each stair.

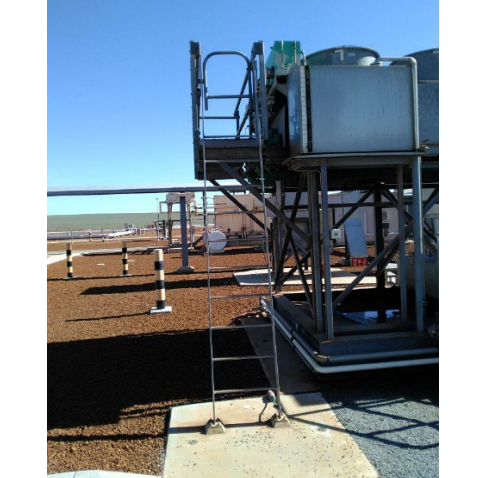
C507-5	2/11/2023	GEA 3 - Platform on South Side	1) Identified the potential for personnel to have to over-reach or use a safety when refilling the oil from the top platform. This exposes personnel to a potential fall. 2) No hi vis (yellow) tread installed onto each ladder rung. 3) The first ladder rung is 290mm above the landing. This exceeds the AS1657 requirement of <=150mm.	C. Unlikely	3. Severe	Medium	1) In consultation with FMO, redesign the platform to allow access to refill the oil. 2) Install hi vis (yellow) tread onto each ladder rung. 3) Modify or replace the ladder to ensure it meets the AS requirements (including step up from landing to the first ladder rung).

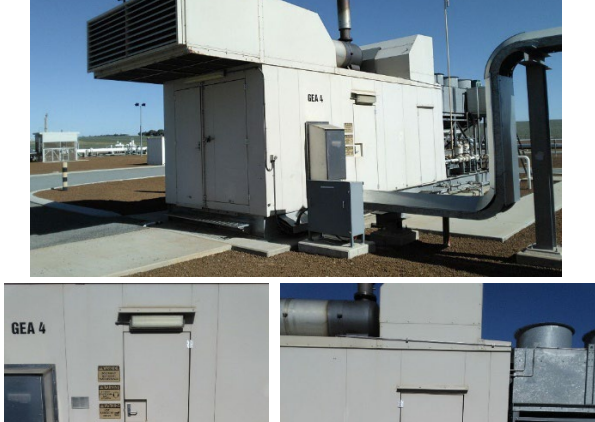
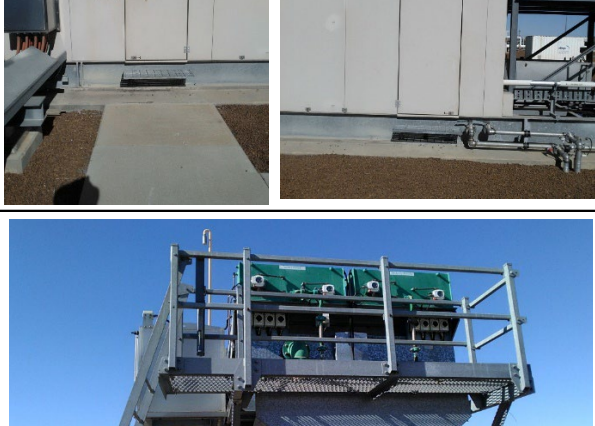
C507-6	2/11/2023	GEA 4 - All access doors	1) No hi vis (yellow) tread installed onto each stair. 2) The landing for some stairs does not meet AS 1657 requirements.	C. Unlikely	2. Minor	Low	1) Install hi vis (yellow) tread onto each stair. 2) Extend the landing for stairs where the existing landing does not meet AS 1657.

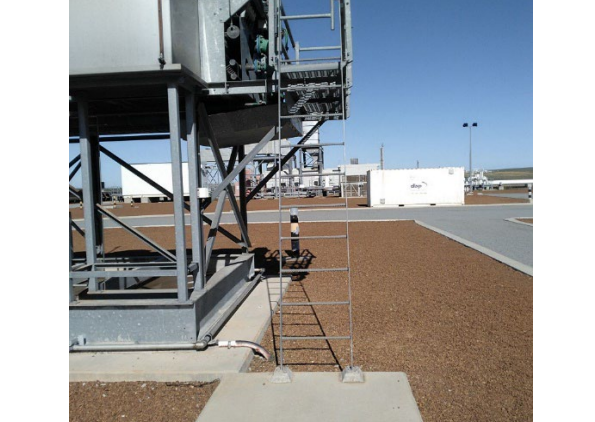
C507-7	2/11/2023	GEA 4 - Platform on West Side	1) Identified the potential for personnel to have to over-reach or use a safety when refilling the oil from the top platform. This exposes personnel to a potential fall. 2) No hi vis (yellow) tread installed onto each ladder rung. 3) The first ladder rung is 290mm above the landing. This exceeds the AS1657 requirement of <=150mm.	C. Unlikely	3. Severe	Medium	1) In consultation with FMO, redesign the platform to allow access to refill the oil. 2) Install hi vis (yellow) tread onto each ladder rung. 3) Modify or replace the ladder to ensure it meets the AS requirements (including step up from landing to the first ladder rung).

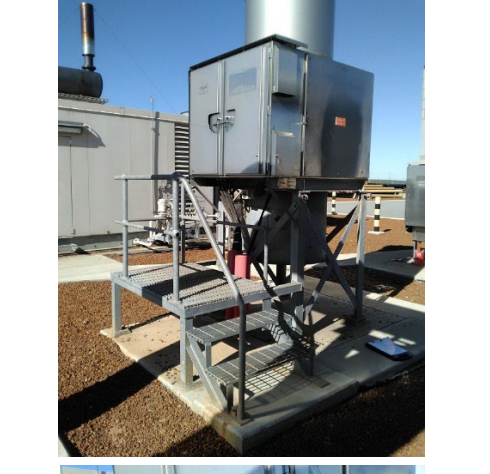
C507-8	2/11/2023	Load Bank 3	1) No hi vis (yellow) tread installed onto each stair. 2) The landing for some stairs does not meet AS 1657 requirements. 3) No handrail has been installed on the right handside of stairs. Potential of a fall of 600mm.	C. Unlikely	3. Severe	Medium	1) Install hi vis (yellow) tread onto each stair. 2) Extend the landing for stairs where the existing landing does not meet AS 1657. 3) Install the missing handrail for the access stairs.

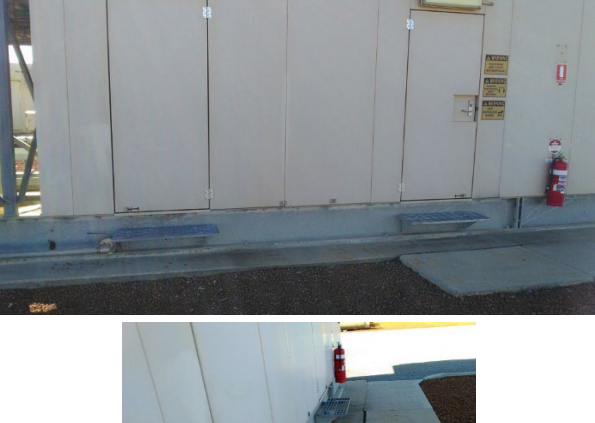
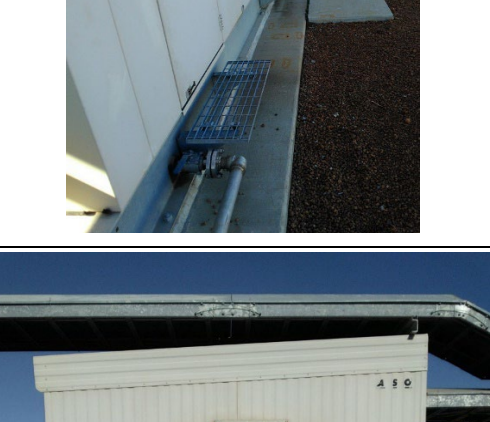
C507-9	2/11/2023	GEA 1 - All access doors	1) No hi vis (yellow) tread installed onto each stair. 2) The landing for some stairs does not meet AS 1657 requirements.	C. Unlikely	2. Minor	Low	1) Install hi vis (yellow) tread onto each stair. 2) Extend the landing for stairs where the existing landing does not meet AS 1657.

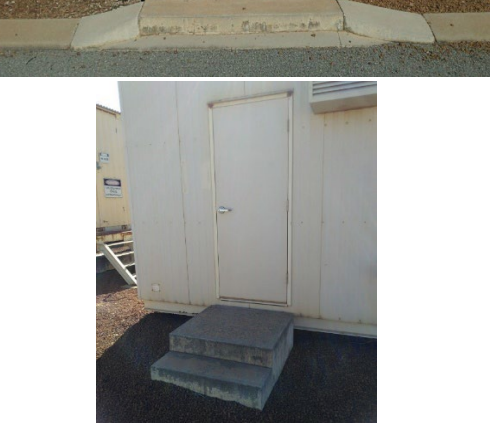
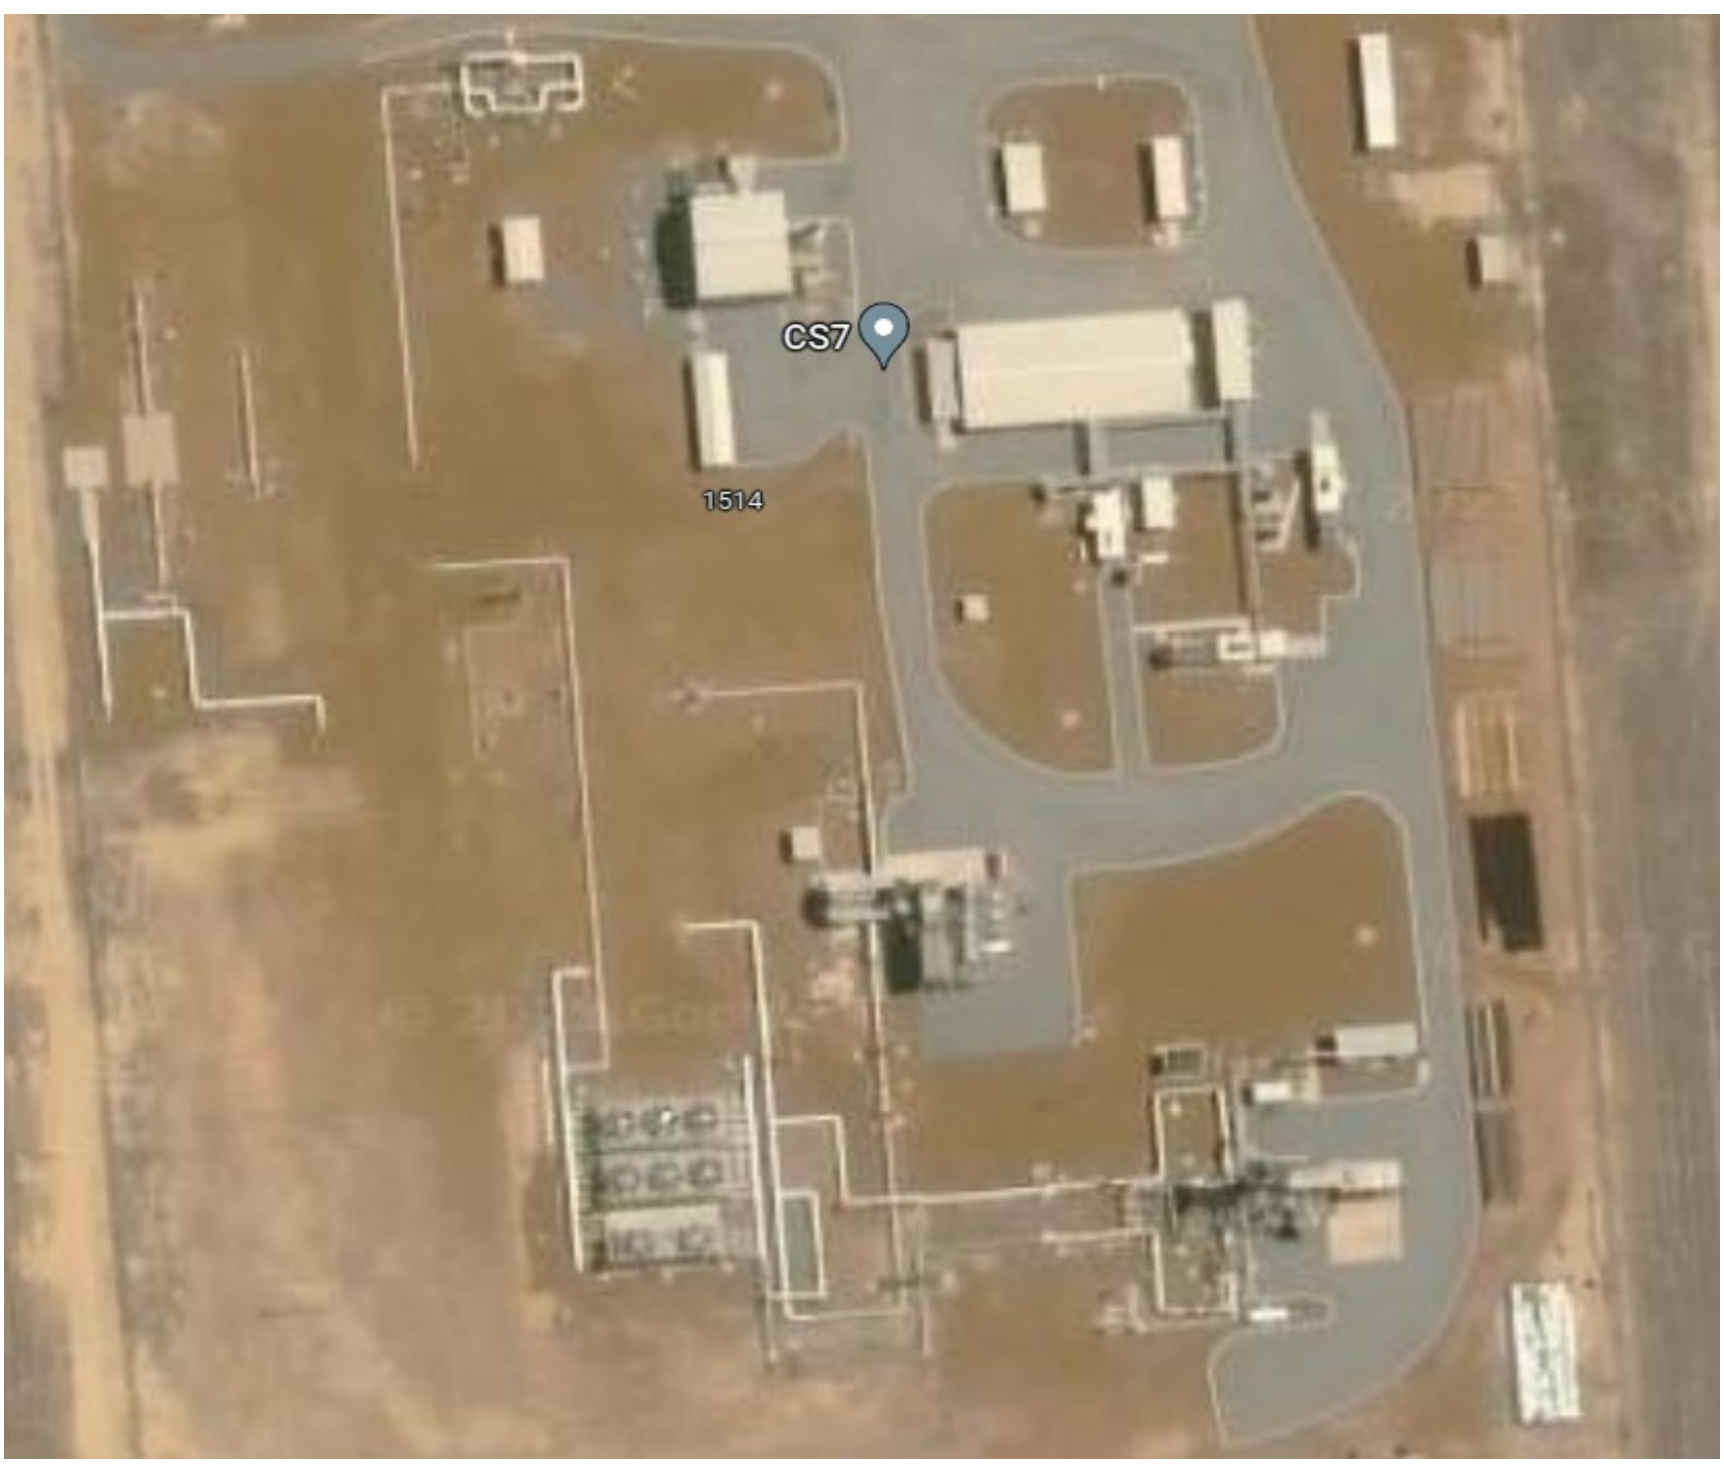
C507-10	2/11/2023	UPS Room	1) Landing is gravel and can be slippery under your foot. 2) The landing for the north access door is off centred and has sloping sides for the middle step.	C. Unlikely	3. Severe	Medium	1) Install a landing that meets AS requirements. 2) Recommend replacing the stairs and modify the landing (if required) to ensure safe access and compliance with AS 1657. Consider the need for handrails.

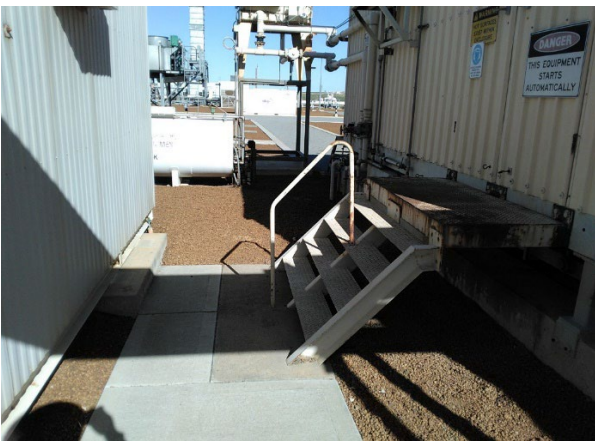
C507-11	2/11/2023	GEA 2 - West Access Doors	<p>1) The access stairs and top landing do not have handrails as required by AS 1657.</p> <p>2) Ground used as landing. This has potential to be deteriorated by weather conditions and be slippery.</p> <p>3) No hi vis (yellow) anti-slip tread installed on the nosing of the stairs.</p> <p>Note: Potential for a fall of 980mm.</p>	C. Unlikely	3. Severe	Medium	<p>1) Install handrails for the access stairs.</p> <p>2) Ensure hi vis (yellow) anti-slip tread is installed on the nosing of all stairs (width 1680mm / 2 x 960mm).</p> <p>3) Consider pouring a landing that meets AS requirements.</p>

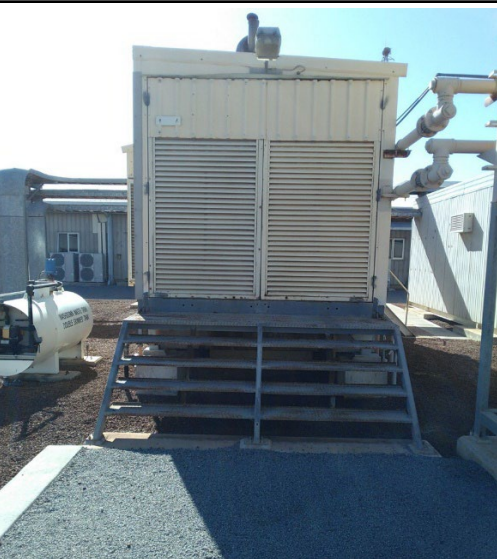
C507-12	2/11/2023	GEA 2 - South Access Doors	<p>1) The access stairs and top landing do not have handrails installed as required by AS 1657.</p> <p>2) Ground used as landing. This has potential to be deteriorated by weather conditions and be slippery.</p> <p>3) No hi vis (yellow) anti-slip tread installed on the nosing of the stairs.</p> <p>Note: Potential for a fall of 1120mm.</p>	D. Occasional	3. Severe	Medium	<p>1) Install handrails for the access stairs.</p> <p>2) Ensure hi vis (yellow) anti-slip tread is installed on the nosing of all stairs (width 2800mm / 2 x 1400mm).</p> <p>3) Consider pouring a landing that meets AS requirements.</p>

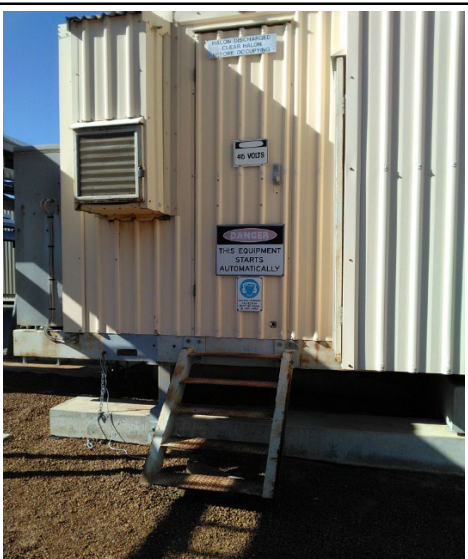
C507-13	2/11/2023	GEA 2 - East Access Door	<p>1) The access stairs do not meet AS 1657 requirements, including no handrails available and the stairs do not run to the landing.</p> <p>2) Ground used as landing. This has potential to be deteriorated by weather conditions and be slippery.</p> <p>3) No hi vis (yellow) anti-slip tread installed on the nosing of the stairs.</p> <p>Note: Potential for a fall of 920mm.</p>	D. Occasional	3. Severe	Medium	<p>1) Install handrails for the access stairs.</p> <p>2) Ensure hi vis (yellow) anti-slip tread is installed on the nosing of all stairs (width 800mm).</p> <p>3) Consider pouring a landing that meets AS requirements.</p>

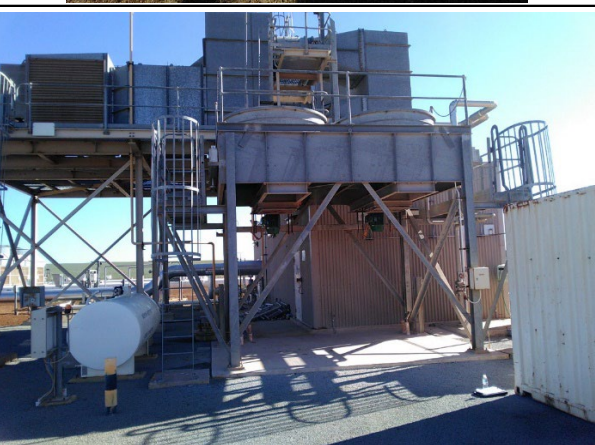
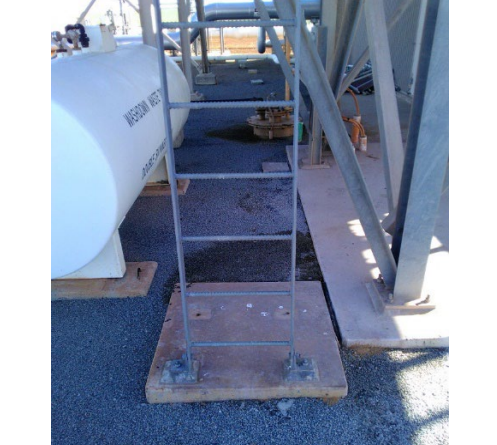
C507-14	2/11/2023	Unit 2 - Access Ladders for Lowest Platforms	<p>1) The landing for the two access ladders do not meet AS 1657 requirements.</p> <p>2) No hi vis (yellow) tread installed on the ladder rungs.</p>	C. Unlikely	2. Minor	Low	<p>1) Pour a landing for each ladder that meets AS requirements.</p> <p>2) Install hi vis (yellow) tread to all ladder rungs and the nosing of the platform / top rung.</p>

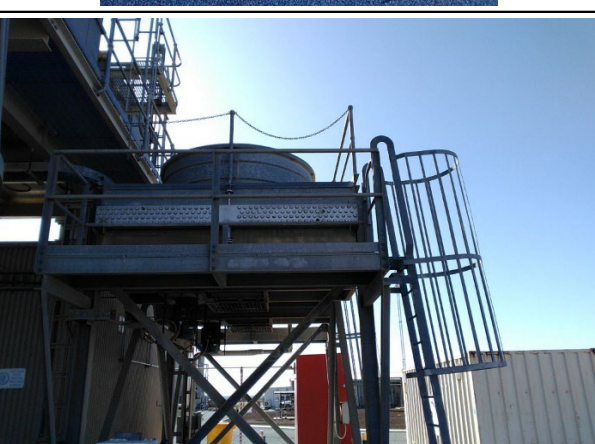
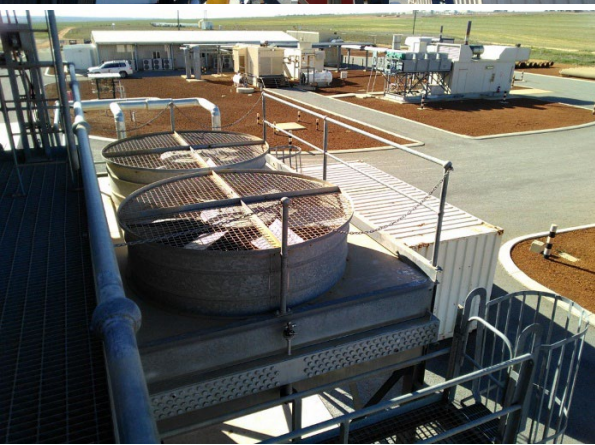
C507-15	2/11/2023	Unit 2 - Lowest Platforms	<p>1) Chain has been used in lieu of a handrail for two sides of this platform. Chain will break in the event of a fall.</p> <p>2) There is no method for accessing this platform from the below walkway without climbing onto structural steel and being exposed to a fall. Additionally no top rail has been installed on the interior sides of the platform (closest side to the fans).</p> <p>3) Gaps (1220mm) between the handrail for the walkway and adjacent platform exceeds AS requirements (100mm max).</p>	C. Unlikely	4. Major	High	<p>1) Replace the chains with a handrail with a lockable gate for access.</p> <p>2.1) Install signage to highlight the fall from height risk until a suitable means of access is installed.</p> <p>2.2) Modify the platform to allow for safe access ladder or stairs from the adjacent walkway or ground level.</p> <p>3) Modify the handrail to eliminate or reduce the gaps to below the AS requirements.</p>

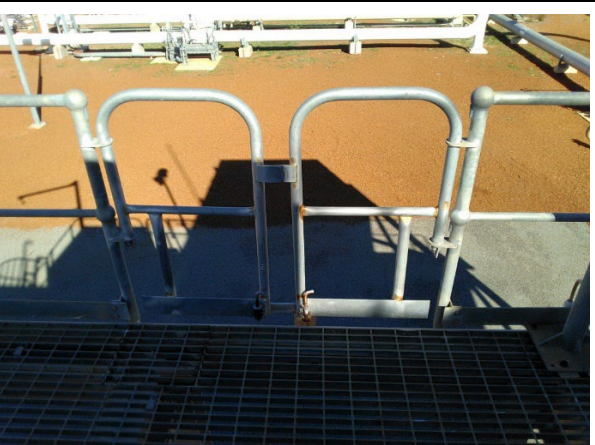
C507-16	2/11/2023	Unit 2 - Middle Platform (South Side)	<p>1) When the existing gate is opened to allow mobile plant lifting loads onto/off the platform, it creates the potential for a person fall from height. A fall from this location would likely result in a fatality or significant injury.</p>	C. Unlikely	4. Major	High	<p>1.1) Recommend replacing the existing gate with a purpose built safety gate (e.g. UMG18 Messexime Safety Gates). This type of gate eliminates the risk. It should be painted a hi vis colour (i.e. yellow) and have pinch point stickers or similar installed on the safety gate.</p> <p>1.2) Install signage to highlight the fall from height risk until an alternative safety gate is installed.</p>

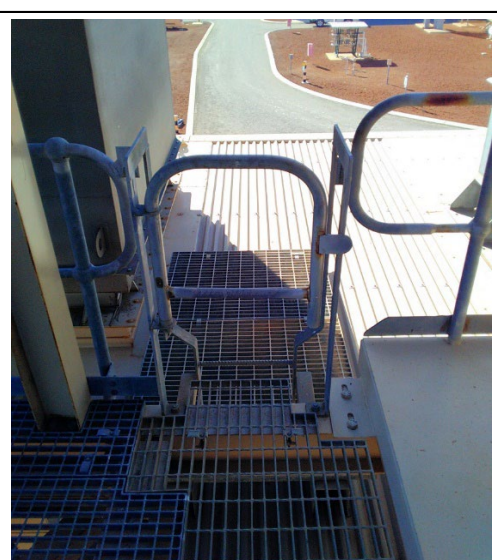
C507-17	2/11/2023	Unit 2 - Middle Platform (North Side)	<p>1) Self closing gate leads onto a section of roof with no edge protection in place. This exposes personnel on the roof to a potential for a fall from height resulting in a fatality or significant injury.</p>	C. Unlikely	4. Major	High	<p>1.1) Install edge protection along the exposed edges of the roof.</p> <p>1.2) Install signage to highlight the fall from height risk until edge protection is installed.</p>

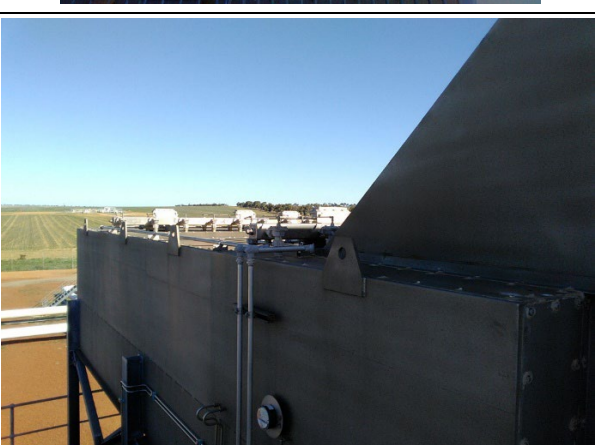
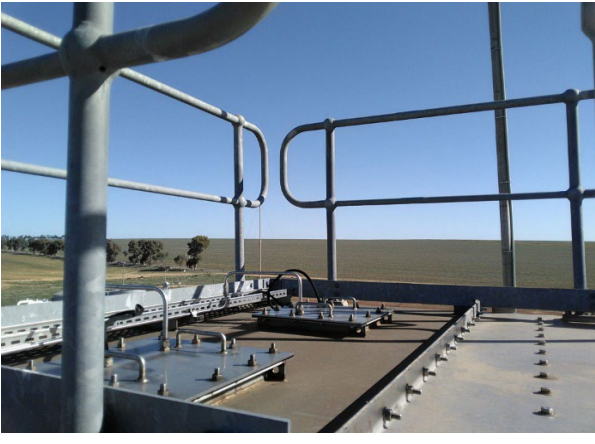
C507-18	2/11/2023	Unit 2 - Top Platform and Access to the Top of the Exhaust System	<p>1) No access to the top of the exhaust system or the riser is provided.</p>	B. Remote	3. Severe	Medium	<p>1) Provide a work platform and access stairs / ladders, to allow safe access for maintenance tasks.</p>

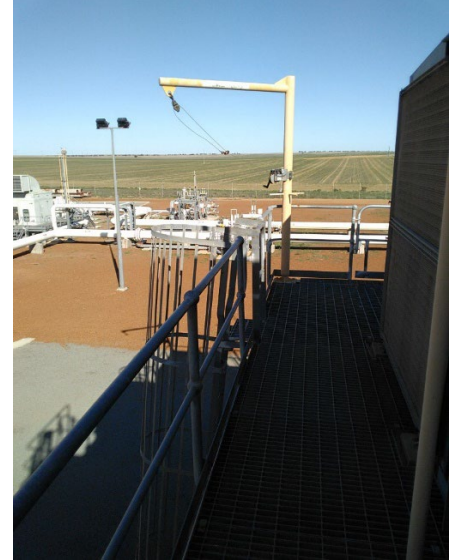
C507-19	2/11/2023	Unit 2 - Second From The Top Platform (East Side)	<p>1) No hi vis (yellow) tread installed on the ladder rungs.</p>	C. Unlikely	2. Minor	Low	<p>1) Install hi vis (yellow) tread to all ladder rungs and the nosing of the platform / top rung.</p>

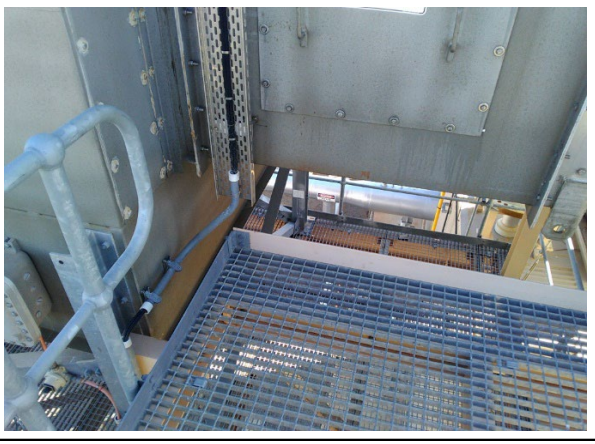
C507-20	2/11/2023	Unit 2 - Second From The Top Platform (West Side)	<p>1) Gap between the kickboard and the exhaust ducting is 450mm high and 2040mm wide. Potential for a person to fall if it was accessed.</p>	B. Remote	3. Severe	Medium	<p>1) Consider installing a handrail or similar, between the exhaust system and the kick plate.</p>

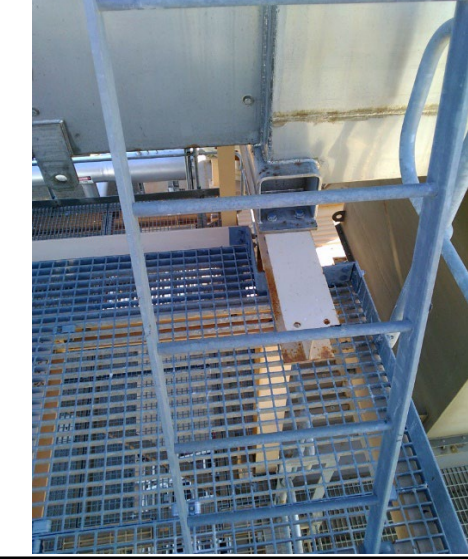
C507-21	2/11/2023	Unit 2 - Second From The Top Platform (North Side)	<p>1) No hi vis (yellow) tread installed on the ladder rungs.</p>	C. Unlikely	2. Minor	Low	<p>1) Install hi vis (yellow) tread to all ladder rungs and the nosing of the platform / top rung.</p>

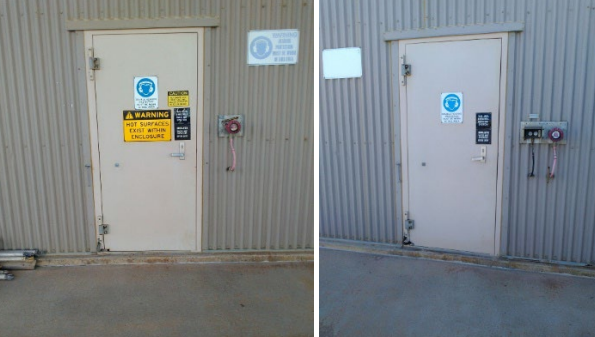
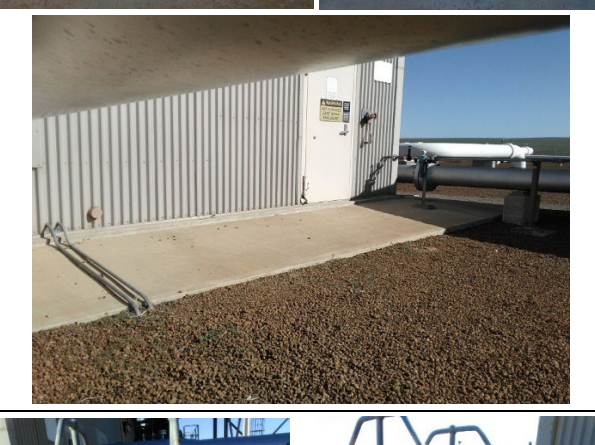
C507-22	2/11/2023	Unit 2 - Ground Level Access Doors	<p>1) Lip at each of the doors pose a trip / slip hazard and is not easily identifiable.</p> <p>2) Conduit in walkway poses a trip hazard.</p>	D. Occasional	2. Minor	Low	<p>1) Either remove the lip or extend the landing to meet AS 1657.</p> <p>2) Consider rerouting the cable if possible. Alternatively consider painting it in hi vis yellow to make it easily identifiable.</p>

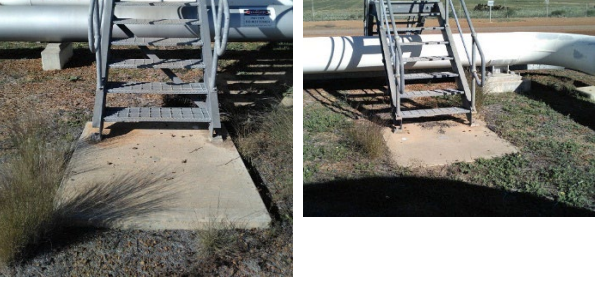
C507-23	2/11/2023	Multiple Walkways over Pipework near Unit 2	<p>1) Some access stairs landings are too small and/or pose a trip / slip hazard.</p> <p>2) Some access stairs do not have hi vis (yellow) tread installed on the nosing of each stair.</p>	D. Occasional	2. Minor	Low	<p>1) Extend the landing for the required stairs.</p> <p>2) Install hi vis (yellow) tread on the nosing on the stairs.</p>

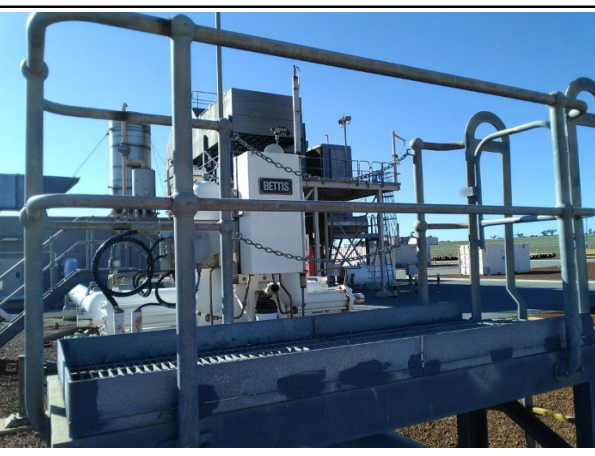
C507-24	2/11/2023	Bettis Equipment Platforms	1) Chain has been used in lieu of a handrail at the top of the platform, adjacent to the Bettis Equipment or Valves Chain will break in the event of a fall and therefore will not meet AS 1657 requirements for guardrails. 2) No Hi vis (yellow) tread installed onto each ladder rung.	C. Unlikely	3. Severe	Medium	1) Replace the chain with a handrail that meets AS 1657 requirement. 2) Hi vis (yellow) non-slip tread to be installed on the ladder rungs.

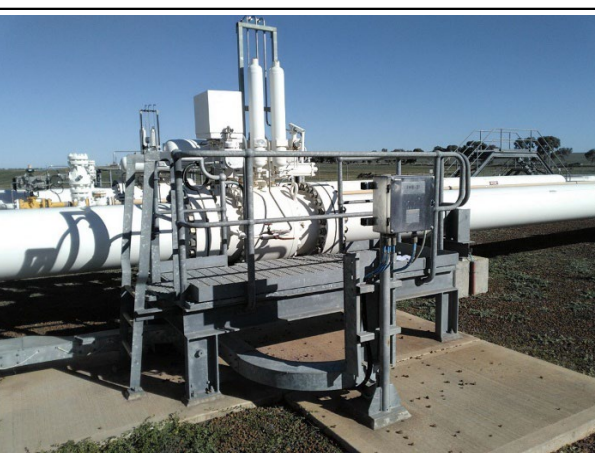
C507-25	2/11/2023	Platforms for Mainline Pipework / Valves	1) Open edge on one side of platform and exposes a person to a fall into or between pipework. Potential fall of 800mm.	C. Unlikely	3. Severe	Medium	1) Modify the platform to allow personnel to access the equipment, whilst having edge protection in place. Ensure the new / modified platform meets AS1657 requirements.

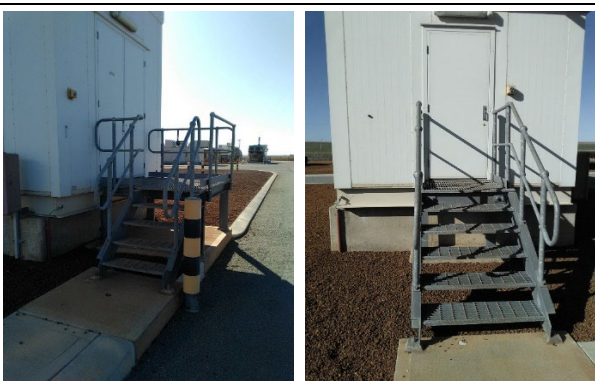
C507-26	27/11/2023	Equipment Room / Electrical Substation	1) No Hi vis (yellow) tread installed onto the nosing of each stair.	D. Occasional	2. Minor	Low	1) Hi vis (yellow) non-slip tread to be installed on the nosing of each stair.

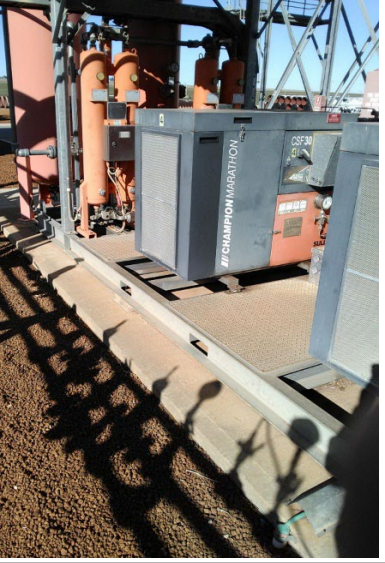
C507-27	27/11/2023	Desiccant Dryers x 2	1) The landing (320mm) does not meet AS requirement of 600mm (Depth). 2) No Hi vis (yellow) tread installed on the nosing of the platform.	B. Remote	2. Minor	Low	1) Remove old landing and pour a new landing. 2) Install Hi vis (yellow) tread onto the nosing of the two access points.

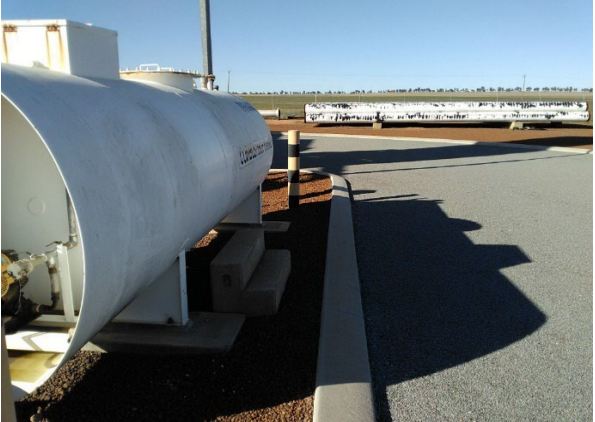
C507-30	27/11/2023	Combustible Liquids Tank Near Unit 3	1) Access stairs do not provide safe access to the 2 x hatches. Currently personnel have to over-reach.	D. Occasional	2. Minor	Low	1) Remove the existing access stairs and install with AS compliant stairs, platform and landing.

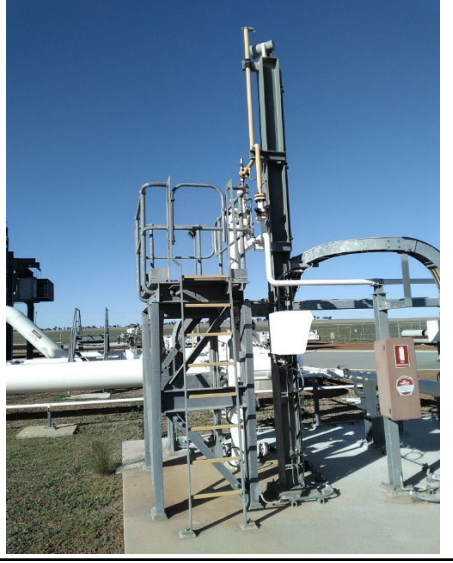
C507-32	27/11/2023	Platform for Vent / Riser near Unit 3	1) Existing design of the platform does not permit personnel to access the top vent without the use of a large platform ladder at ground level or using a safety step (or similar) on the platform. Both means of access exposes personnel of a fall ~3m.	C. Unlikely	3. Severe	Medium	1) Modify the platform and handrail to provide safe access to the vent.

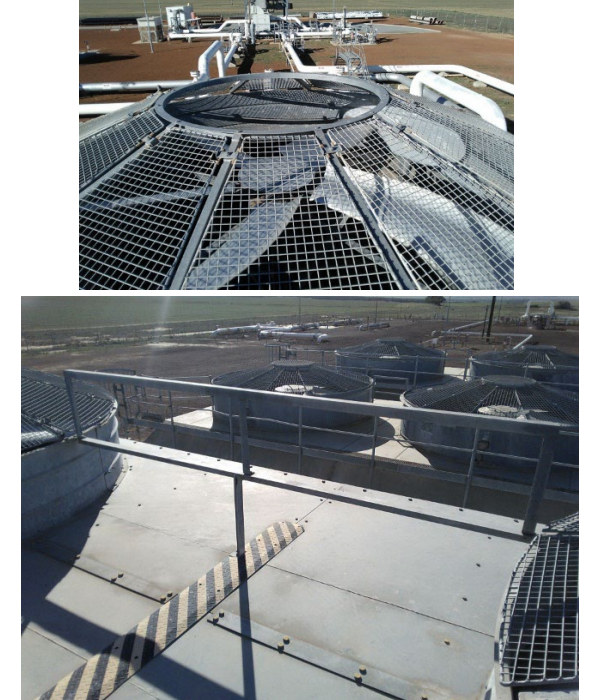
C507-33	5/12/2023	Aftercooler Fans 7-9 - Top Platform	1) Handrails between the fans does not have bottom rail / mount is 580mm from the bottom of platform, this exceed AS1657 requirements of 450mm. No toeboard in place. Potential for personnel to climb under. 2) No guarding has been installed on the top of the fan enclosures, to prevent access during operation. Multiple fans at this location.	C. Unlikely	3. Severe	High	1) Install toeboard underneath the existing handrails. 2) Install a grid mesh hatch or similar and attach it to the existing structure.

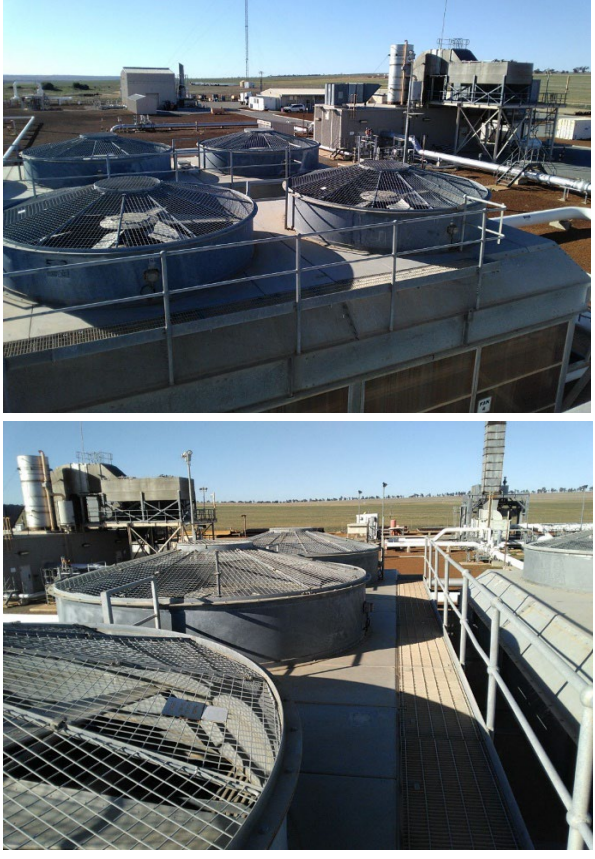
C507-34	5/12/2023	Aftercooler Fans 1-6 - Top Platform - Top Platform	1) The top platforms have several areas without handrails installed to prevent access to open edges. This creates the potential for a person to fall from height resulting in a fatality or significant injury due to the total fall distance. 2) Handrails between the fans does not have bottom rail / mount is 600mm from the bottom of platform, this exceed AS1657 requirements of 450mm. No toeboard in place. Potential for personnel to climb under.	C. Unlikely	3. Severe	High	1) Install handrails to eliminate exposure to a unprotected edge. 2) Install toeboard underneath the existing handrails.

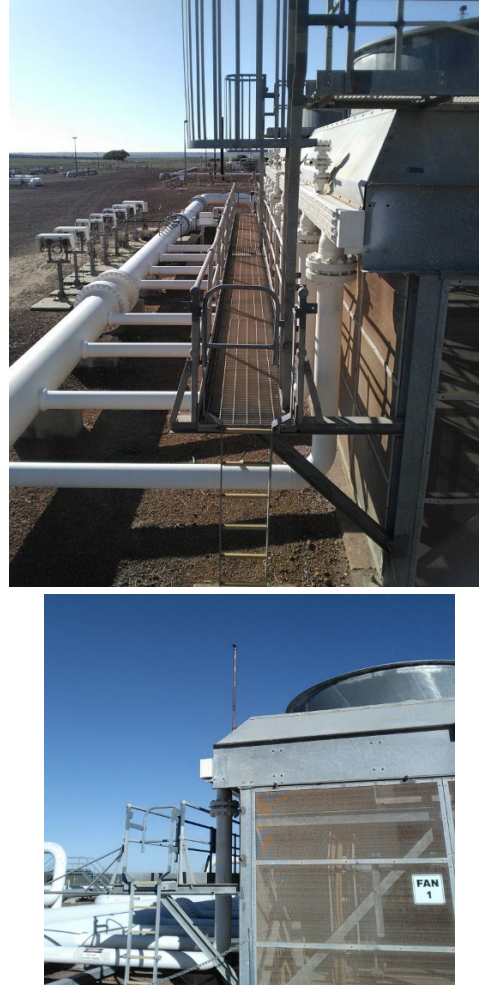
C507-35	5/12/2023	Aftercooler Fans 1-6 - Top Platform - Middle Platform	1) No access to Riser on the East side of the Aftercool Fans 1-6. 2) No 'back scratcher' installed for personnel using the ladders to the top platform, on the West side.	C. Unlikely	3. Severe	High	1) Install platform or equivalent, to provide access to the Riser. 2) Install 'back scratchers' for all ladders on the West side.

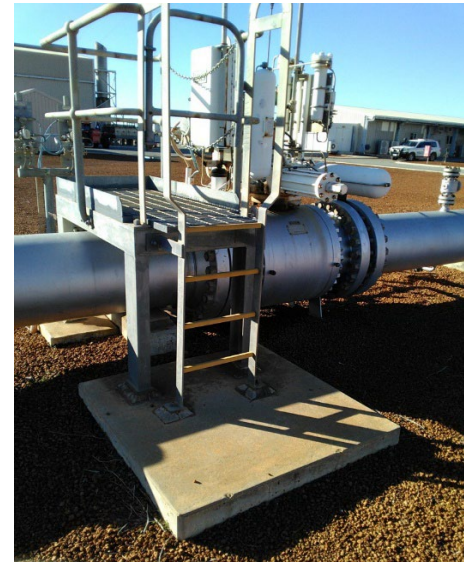
C507-36	28/11/2023	Bettis Equipment	1) Chain has been used in lieu of a handrail at the top of the platform, adjacent to the Bettis Equipment or Valves Chain will break in the event of a fall and therefore will not meet AS 1657 requirements for guardrails.	C. Unlikely	3. Severe	Medium	1) Replace the chain with a handrail that meets AS 1657 requirement.

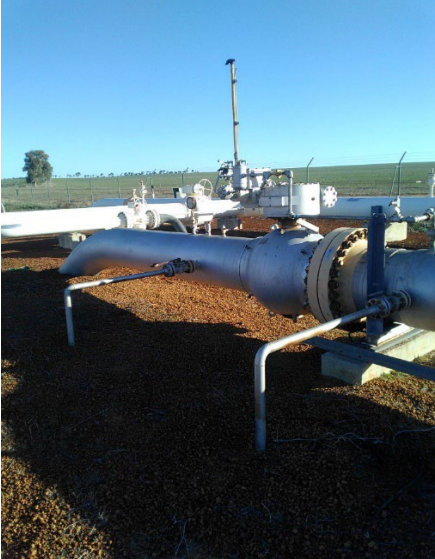
C507-37	28/11/2023	Vent on Pipework for Piggng	1) Access to Vents for maintenance tasks currently completed using a platform ladder on blue metal. This creates the potential for the ladder to be unstable and cause a fall from height. Alternative personnel may choose to sit on the pipe itself. Note: Potential for a fall of ~3m.	C. Unlikely	3. Severe	Medium	1) Option A: Install concrete landing for platform ladder to be set up on. Option B: Install a purpose built platform and access stairs or ladder that is AS compliant.

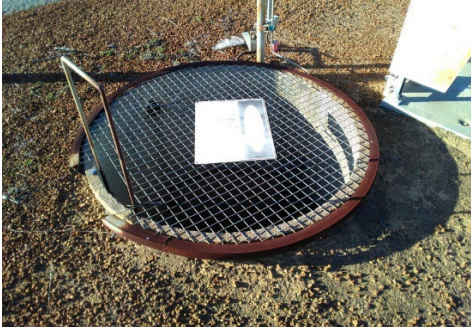
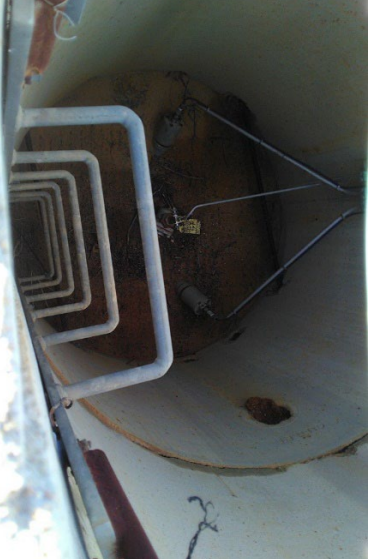
C507-38	5/12/2023	Confined Space - Access Ladder	1) Design of the ladder and hold points does not allow for easy access to / from and creates the potential for a fall. 2) No non-slip tread on ladder rungs.	B. Remote	3. Severe	Medium	1) Modify or replace the ladder, ensuring it extends 1m past the top landing, with sufficient locations to hold onto when mounting / dismounting the ladder and provides easy access to personnel. 2) Modified or replacement ladder to have hi vis (yellow) non-slip tread installed on the rungs.

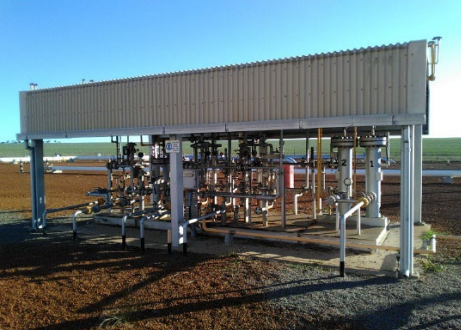
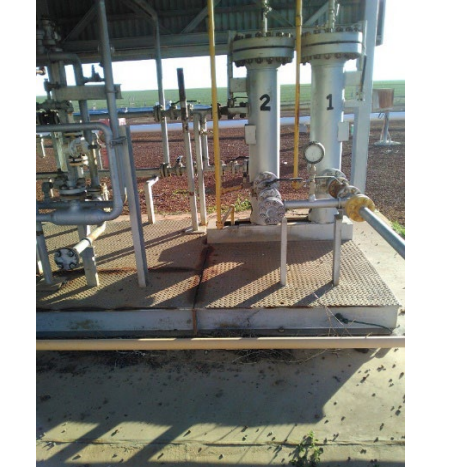
C507-39	5/12/2023	Unit 1 Pressure Reduction Skid	1) Landing and step up / down is impacted by existing pipework. Therefore the AS requirements are not being met and a trip hazard is present. 2) No Hi vis (yellow) strip on the nosing (ends) of the grid mesh platform.	B. Remote	2. Minor	Low	1) Install a step and platform over the pipework, that meet AS requirements (e.g. hi vis nosing, step riser height). 2) Install Hi vis (yellow) non-slip strip on the nosing of the skid's access point.

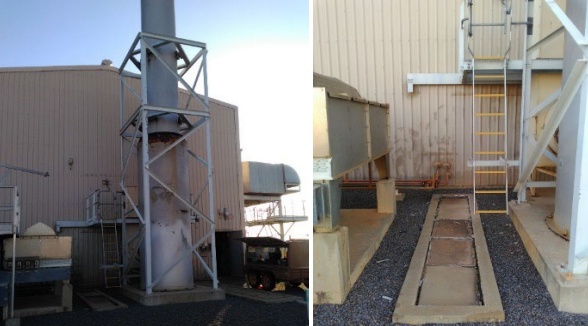
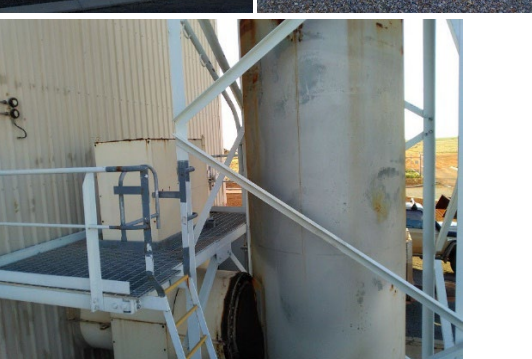
C507-40	5/12/2023	Unit 1 - Exhaust Stack Platform	1) The ladder does not meet AS requirements, including the ladder does run full length to the landing and the step up is 340mm (AS <150mm). 2) Gap between the handrail and structure (130mm) and does not meet AS requirements (max 100mm). Note: Comment only given the small difference above the AS requirement.	C. Unlikely	3. Severe	Medium	1.1) Install a landing that meets AS requirements. 1.2) Modify the ladder so its runs to the new landing and the first step up meets AS requirements. 2) No action required.
