Revised Final Plan
Attachment 9.12

Structures & Operational Sites - Working at Heights - Appendix B

**Dampier Bunbury
Pipeline**

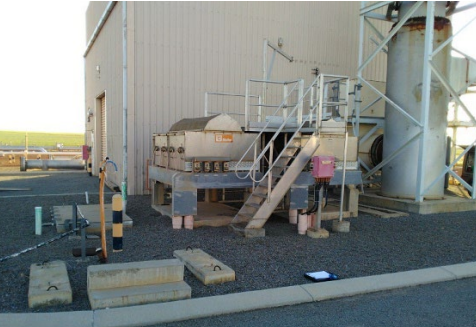
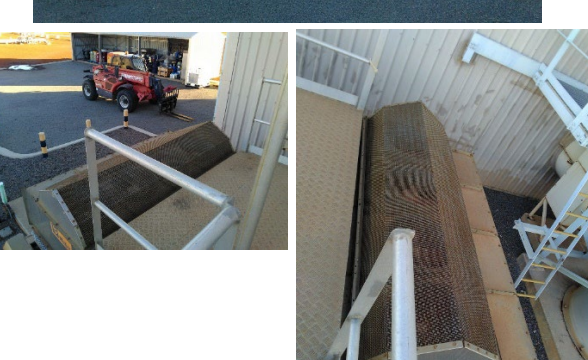
C507-41	5/12/2023	Unit 1 Oil Cooler Fans - Access Stairs	1) The landing for the stairs does not meet AS1657 requirements of 600mm minimum. 2) The length of the handrail when compared to the full length of the stairs and landing, is not compliant with the AS requirements. The current design also increases the potential of being unable to arrest a slip / fall. 3) No Hi vis (yellow) tread installed onto each stair. 4) 1 x step identified with a bow in it.	C. Unlikely	3. Severe	Medium	1) Pour a new landing. 2) Modify the handrail to run the full length of the stairs. 3) Install Hi vis (yellow) tread onto each stair. 4) Repair or replace the damaged step.

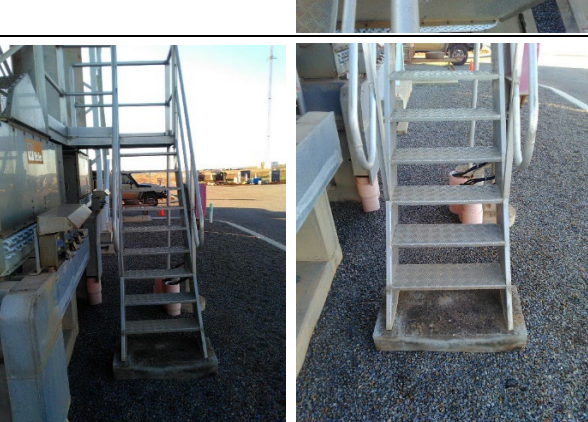
C507-42	5/12/2023	Unit 1 Oil Cooler Fans - Platform	1) The existing handrail does not extend around the outside of the fan enclosure on other side. This creates the risk of a fall of ~1.9m.	C. Unlikely	3. Severe	Medium	1) Install additional handrails and supporting structure around both fan enclosures.

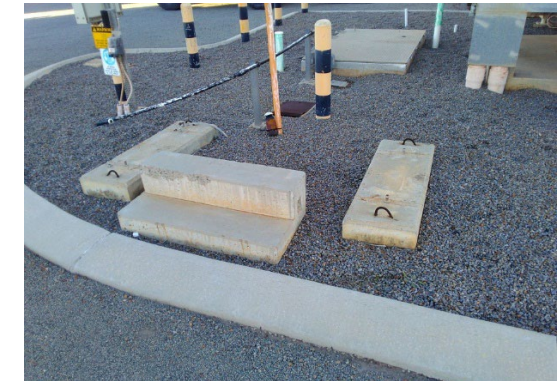
C507-43	5/12/2023	Steps / Landings For Tank (Removed)	1) Redundant Steps / Landings for a Tank that has since been removed. They pose a trip hazard to personnel walking through this area.	B. Remote	2. Minor	Low	1) Remove the redundant steps / landings.

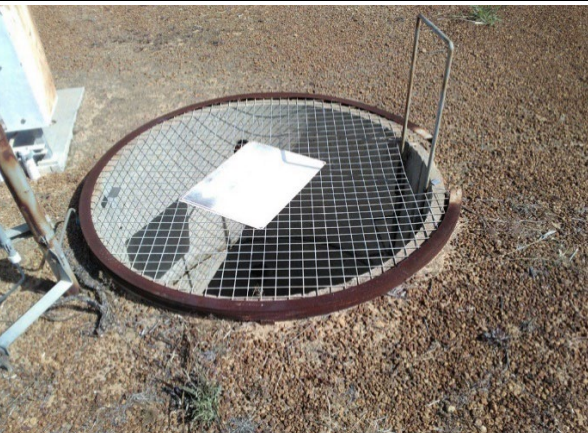
C507-44	5/12/2023	Confined Space Pit for HV110	1) Design of the ladder and hold points does not allow for easy access to / from and creates the potential for a fall. 2) No non-slip tread on ladder rungs.	B. Remote	3. Severe	Medium	1) Modify or replace the ladder, ensuring it extends 1m past the top landing, with sufficient locations to hold onto when mounting / dismounting the ladder and provides easy access to personnel. 2) Modified or replacement ladder to have hi vis (yellow) non-slip tread installed on the rungs.

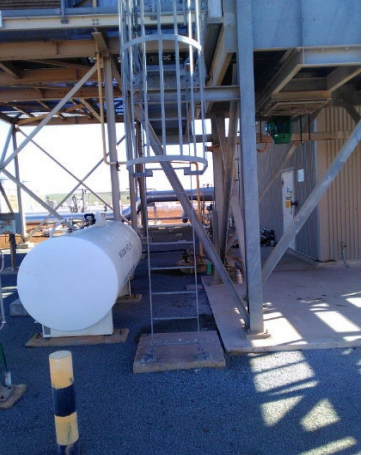
C507-45	5/12/2023	Unit 2 - Ladders at Ground Level	1) Landings for multiple ladders at ground level do not meet AS requirement of 900mm. 2) No non-slip tread on ladder rungs.	B. Remote	2. Minor	Low	1.1) Remove old landing and install new precast one 1.2) Pour new landing 2) Modified or replacement ladder to have hi vis (yellow) non-slip tread installed on the rungs.

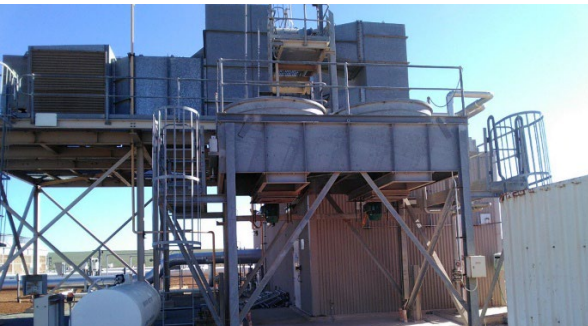
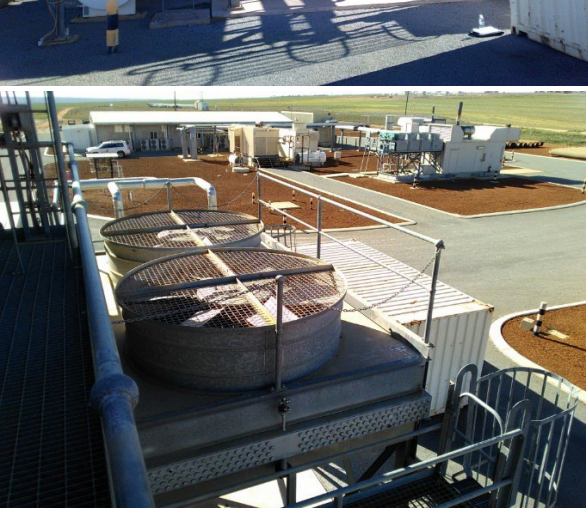
C507-46	5/12/2023	Unit 2 - Lowest Platforms	1) Chain has been used in lieu of a handrail for two sides of this platform. Chain will break in the event of a fall. 2) There is no method for accessing this platform from the below walkway without climbing onto structural steel and being exposed to a fall. Additionally no top rail has been installed on the interior sides of the platform (closest side to the fans). 3) Gaps (~270mm) between the handrail for the walkway and adjacent platform exceeds AS requirements (100mm max).	C. Unlikely	4. Major	High	1) Replace the chains with a handrail with a lockable gate for access. 2.1) Install signage to highlight the fall from height risk until a lockable means of access is installed. 2.2) Modify the platform to allow for safe access ladder or stairs from the adjacent walkway or ground level. 3) Modify the handrail to eliminate or reduce the gaps to below the AS requirements.

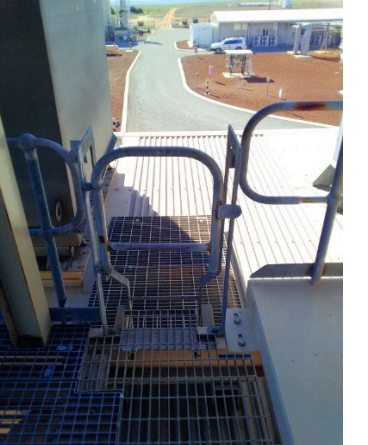
C507-47	5/12/2023	Unit 2 - Middle Platform (North Side)	1) Self-closing gate leads onto a section of roof with no edge protection in place. This exposes personnel on the roof, to a potential for a fall from height resulting in a fatality or significant injury.	C. Unlikely	4. Major	High	1.1) Install edge protection along the exposed edges of the roof. 1.2) Install signage to highlight the fall from height risk until edge protection is installed.

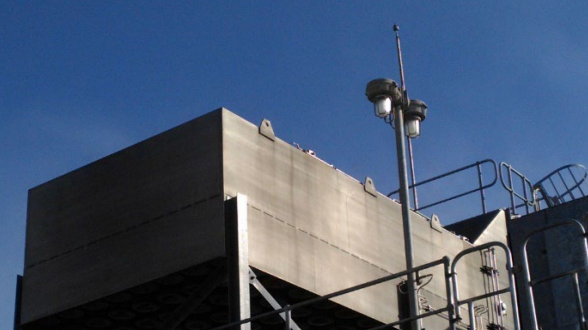
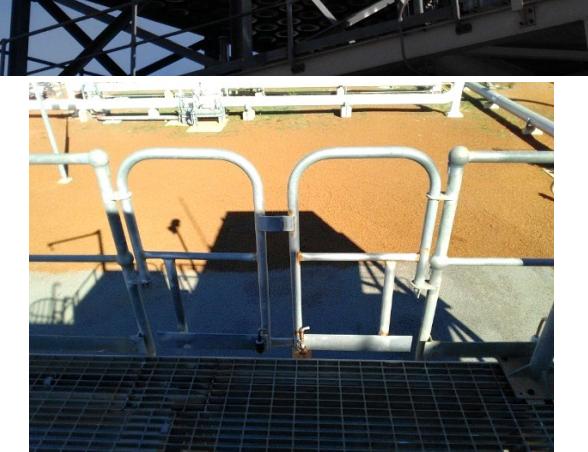
C507-48	5/12/2023	Unit 2 - Middle Platform (South Side)	1) When the existing gate is opened to allow mobile plant lifting loads onto/off the platform, it creates the potential for a person fall from height. A fall from this location would likely result in a fatality or significant injury.	C. Unlikely	4. Major	High	1.1) Recommend replacing the existing gate with a purpose built safety gate (i.e. UME28 Mezzanine Safety Gate). This type of gate eliminates the risk. It should be painted a hi vis colour (i.e. yellow) and have pinch point stickers or similar installed on the safety gate. 1.2) Install signage to highlight the fall from height risk until an alternative safety gate is installed.

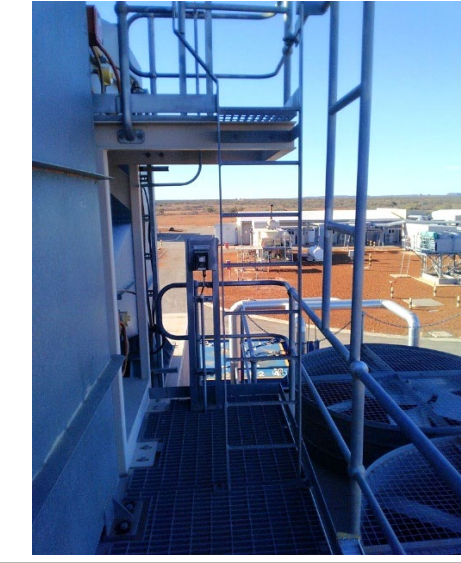
C507-49	5/12/2023	Unit 2 - Second From The Top Platform (East Side)	1) No Hi vis (yellow) tread installed on the ladder rungs.	C. Unlikely	2. Minor	Low	1) Install Hi vis (yellow) tread to all ladder rungs and the nosing of the platform / top rung.

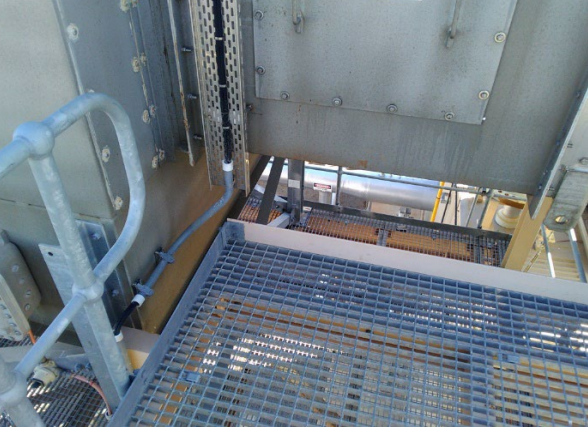
C507-50	5/12/2023	Unit 2 - Second From The Top Platform (West Side)	1) Gap between the kickboard and the exhaust ducting is 410mm high and 2040mm wide. Potential for a person to fall if it was accessed.	B. Remote	3. Severe	Medium	1) Consider installing a handrail or similar, between the exhaust system and the kick plate.

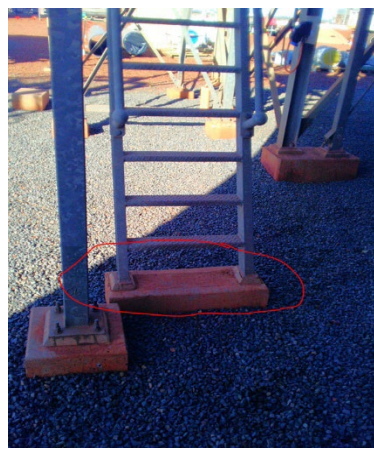
Reference	Date added	Location on Site	Issue	Likelihood	Consequence	Risk Score	Suggestions	Evidence	What is being completed	Date planned for completion	Date completed
	2/02/2023	Example - Lube oil cooler unit 1	1) Landing does not meet AS requirement of 900mm 2) Stair treads too narrow and no non-slip				1.1) Remove old landing and install new precast one 1.2) Pour new landing 2.1) Replace ladder with new treads and non-slip

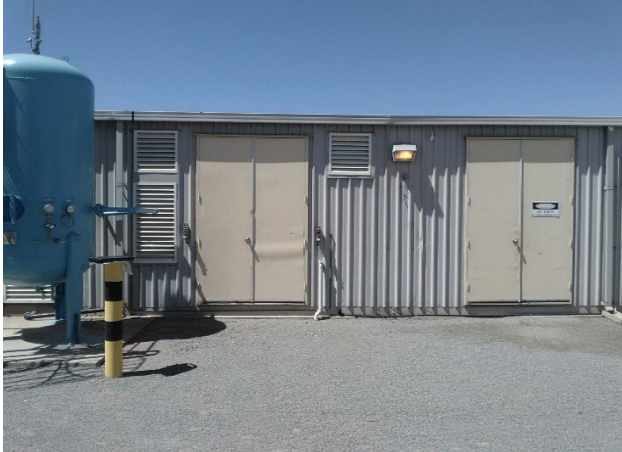
CS08-2	13/02/2024	Control Room - North Access Doors	1) Landing is too small. Concrete lip poses a slip / trip / fall hazard.	C. Unlikely	2. Minor	Low	1) Extend the concrete landing.

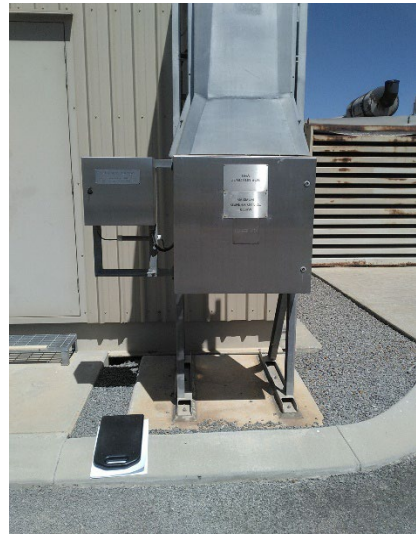
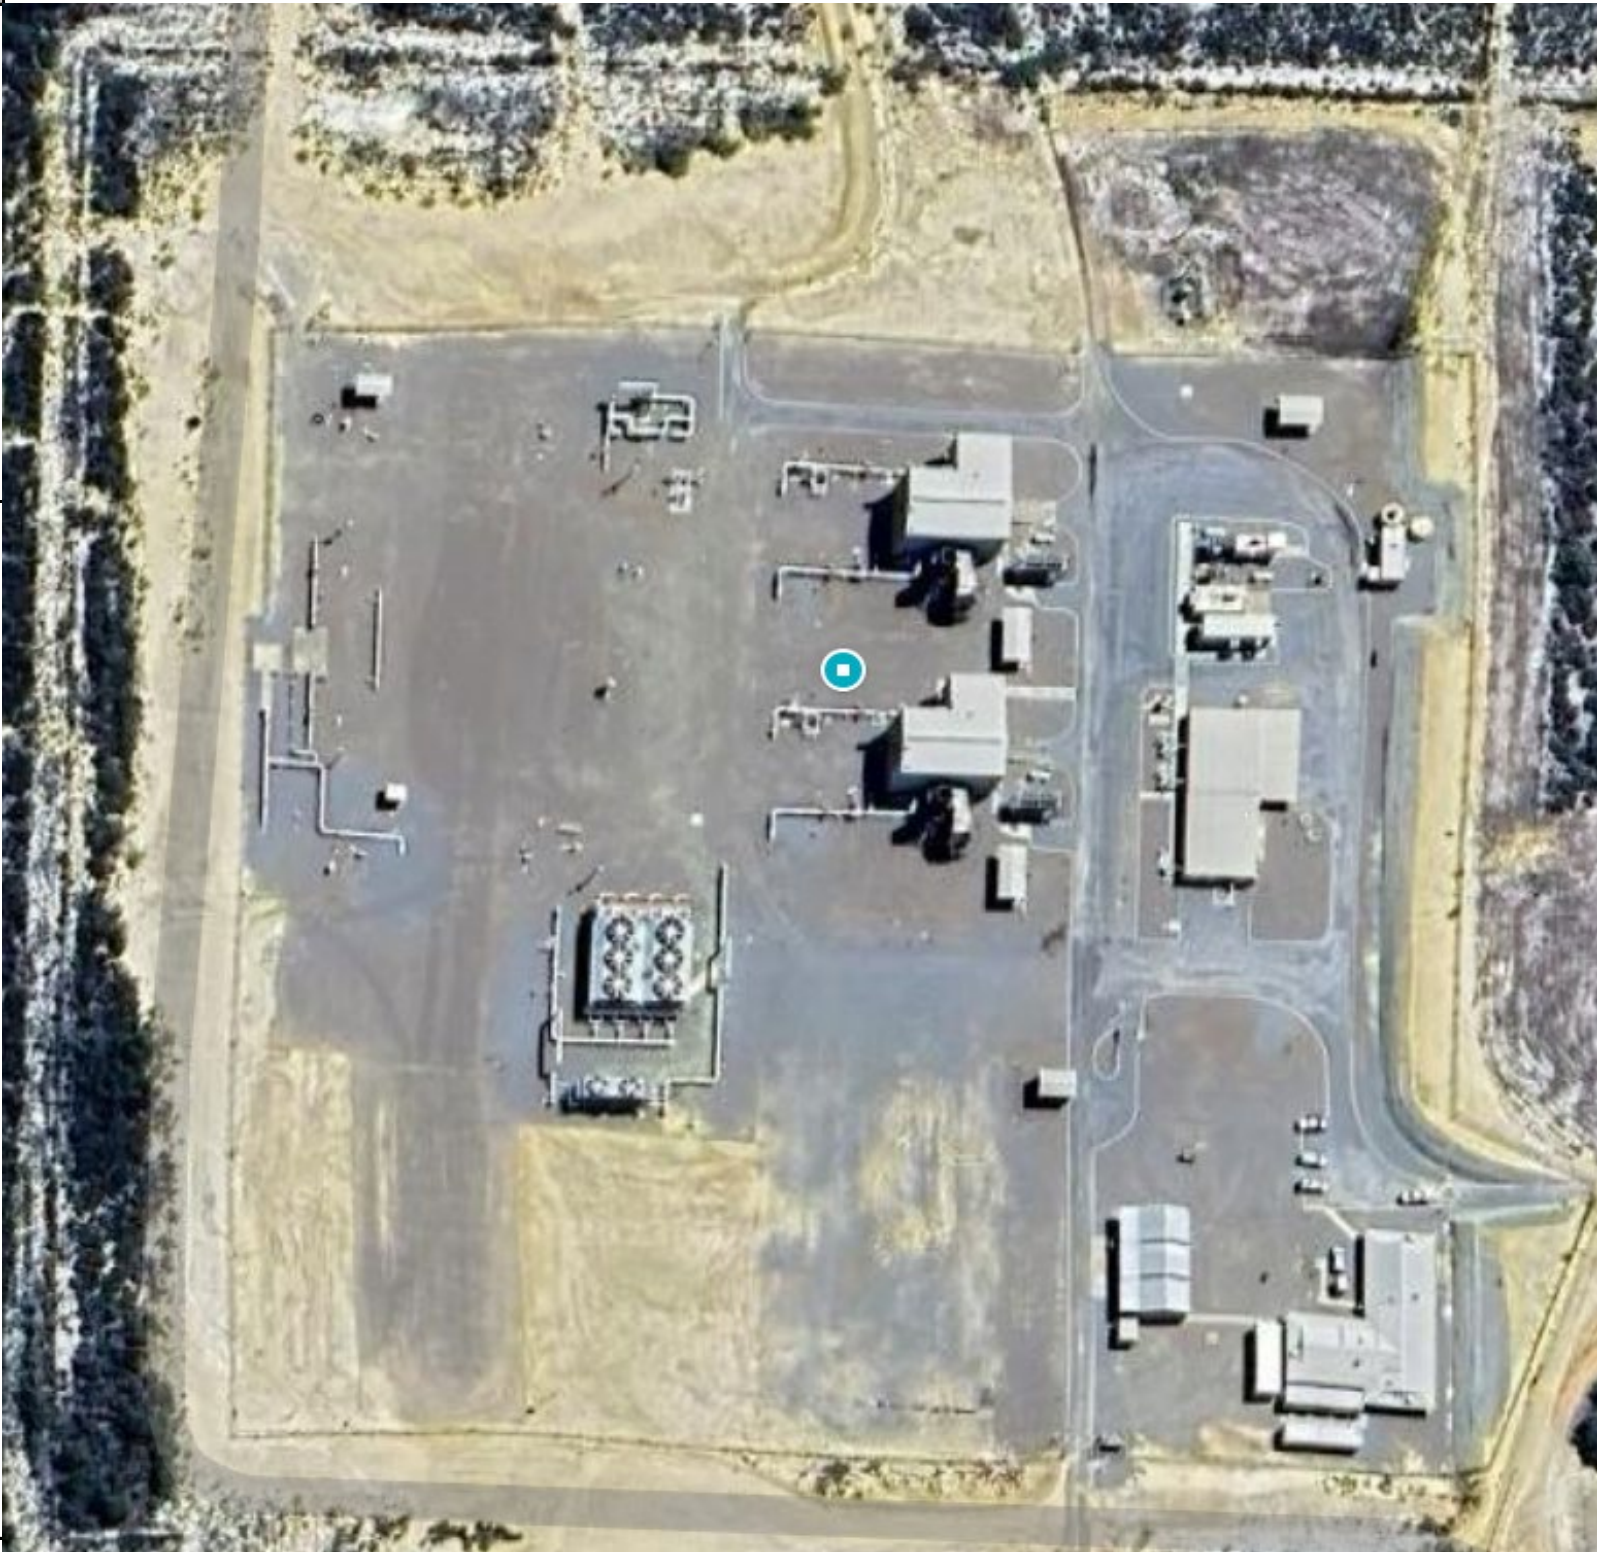
CS08-4	13/02/2024	DEA Junction Box (CS000-5249-3001-03)	1) The landing when accessing the DEA Junction Box is concrete kerbing. This uneven surface poses a slip / fall (same level) risk.	C. Unlikely	2. Minor	Low	1) Extend the concrete landing and modify the kerbing to suit.

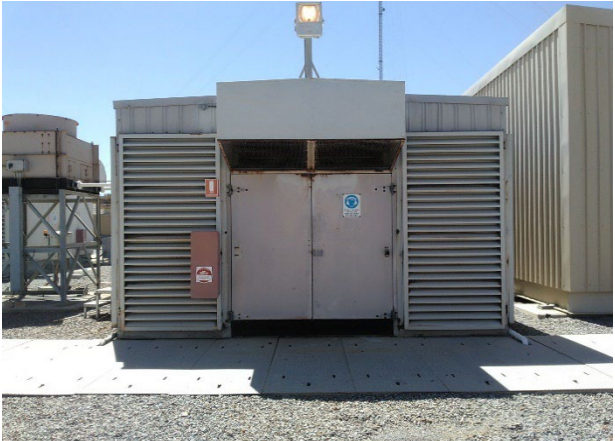
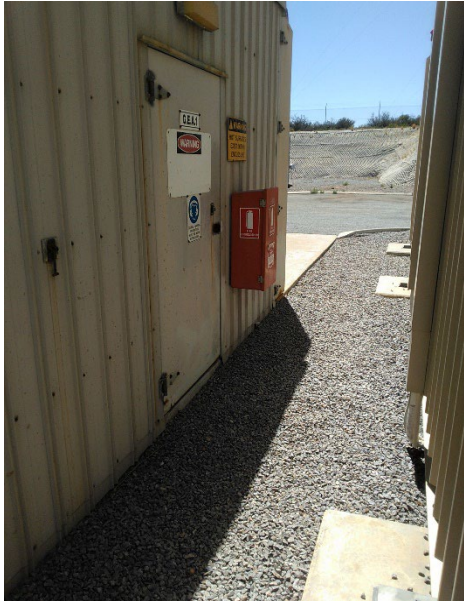
Reference	Date added	Location on Site	Issue	Likelihood	Consequence	Risk Score	Suggestions	Evidence	What is being completed	Date planned for completion	Date completed
CS08-5	13/02/2024	GEA 1 - Access Doors	1) The side door has blue metal as the landing surface.	C. Unlikely	2. Minor	Low	1) Pour a landing to meet AS requirements.

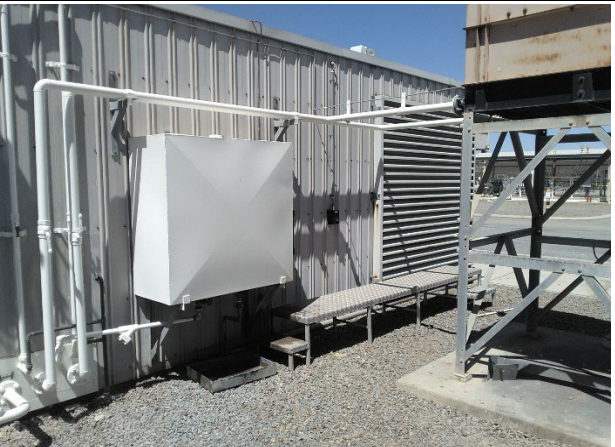
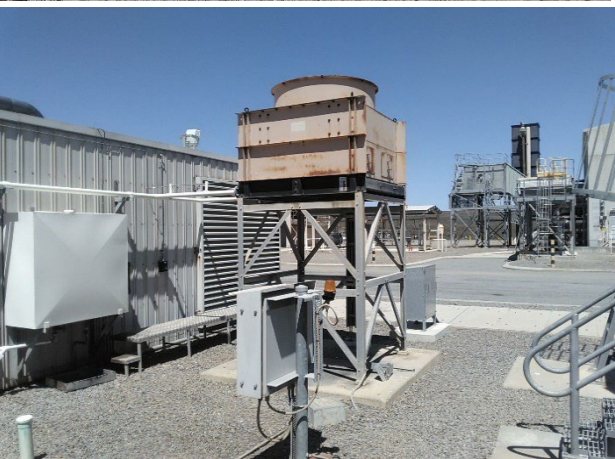
CS08-6	13/02/2024	GEA 1 - Platform For Oil / Hydraulic Fluid Tank and Exhaust Fan	1) Temporary access stairs are also used as a work platform for the Oil / Hydraulic Fluid Tank. Requirements for work platform not met. 2) No hi vis (yellow) tread installed onto each stair. 3) No access provided to exhaust fan. Personnel required to set up a platform ladder on blue metal. This creates the potential for the ladder to be unstable and cause a fall from height.	C. Unlikely	3. Severe	Medium	1) Install a platform with stair access to replace the temporary stairs. Note: If 3 stairs will be required so handrails will also be required. 2) Install hi vis (yellow) tread onto each stair. 3) Option A: Install concrete landing for platform ladder to be set up on. Option B: Install a purpose built platform and access stairs or ladder that is AS compliant.

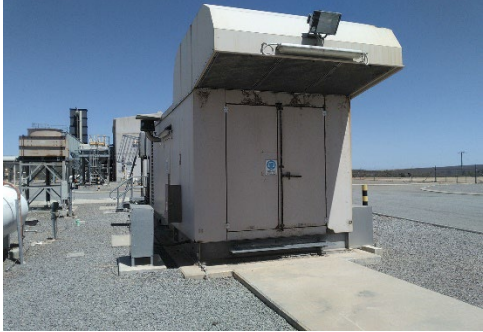
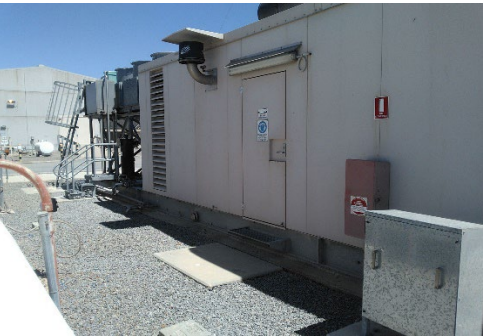
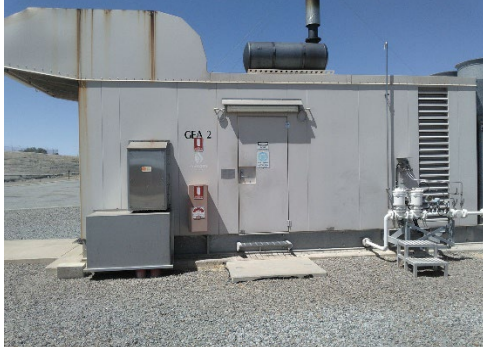
CS08-7	13/02/2024	GEA 2 - Access Doors	1) No hi vis (yellow) tread installed onto each stair. 2) The landing for some stairs does not meet AS 1657 requirements.	C. Unlikely	2. Minor	Low	1) Install hi vis (yellow) tread onto each stair. 2) Extend the landing for stairs where the existing landing does not meet AS 1657.

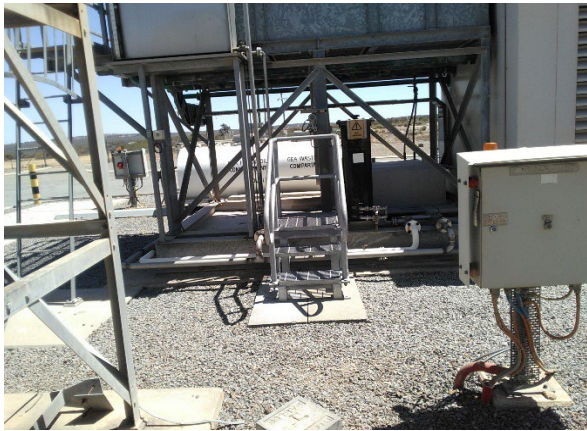
CS08-8	13/02/2024	GEA 2 - Ground Level Platform	1) No hi vis (yellow) tread installed onto the nosing of stairs and platform. 2) The landing does not meet AS 1657 requirements.	C. Unlikely	2. Minor	Low	1) Install hi vis (yellow) tread onto each stair. 2) Pour a landing to meet AS requirements.

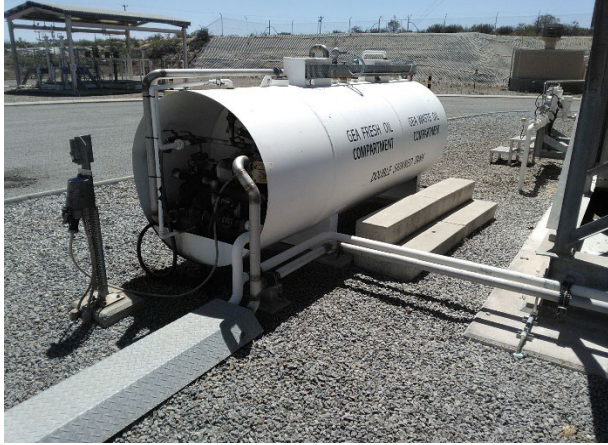
CS08-10	13/02/2024	GEA Fresh Oil and Waste Oil Tank	<p>1) Temporary access stairs are also used as a work platform. Requirements for work platform not met.</p> <p>2) No hi vis (yellow) tread installed onto each stair.</p> <p>3) Two pipes adjacent to the stairs pose a trip hazard.</p>	C. Unlikely	2. Minor	Low	<p>1) Install a platform with stair access to replace the temporary stairs. Note: If 3 stairs or stairs are <=1m wide, then handrails will also be required.</p> <p>2) Install hi vis (yellow) tread onto each stair.</p> <p>3) Consider installing a handrail to prevent access or a hopover to provide safe access.</p>

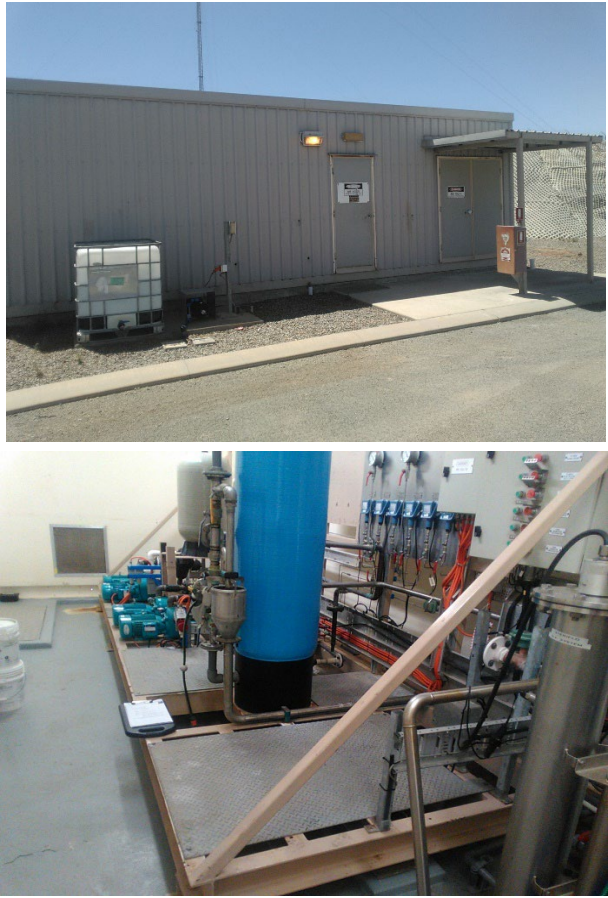
CS08-11	13/02/2024	Water Treatment Plant - Access Doors	<p>1) No hi vis (yellow) tread installed onto each stair.</p> <p>2) Step up for the accessing the door from the inside exceed AS requirements (actual 400mm).</p>	C. Unlikely	2. Minor	Low	<p>1) Install hi vis (yellow) tread onto each stair.</p> <p>2) Consider installing an interim stair on the inside of the building.</p>

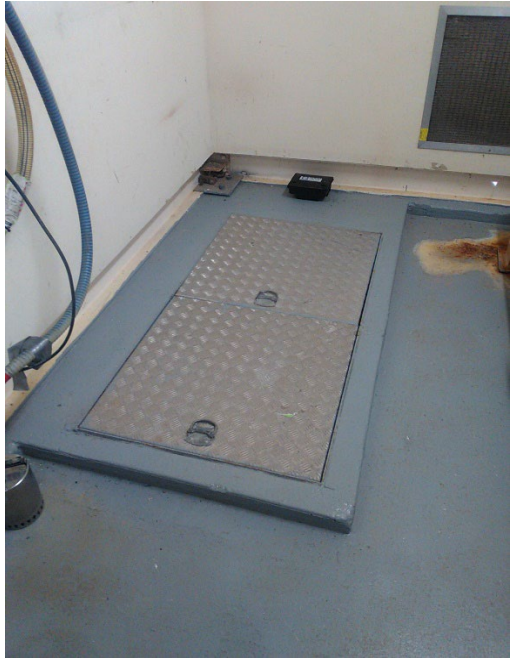
CS08-12	13/02/2024	Water Treatment Plant - Pit Inside Building	<p>1) Poor access / egress from ladder.</p> <p>2) The foot of the ladder does not rest on or terminate above the landing. There is also no clear handgrips to assist the person when mounting and dismounting the ladder. Therefore it does not meet AS 1657 requirements.</p> <p>3) No non-slip tread on ladder rungs.</p>	C. Unlikely	3. Severe	Medium	<p>1) Consider the position of the ladder when being redesigned, to allow for safe access / egress.</p> <p>2) Redesign the ladder and hand grips to provide suitable access and meet AS1657 requirements.</p> <p>3) Replacement ladder to have hi vis (yellow) non-slip tread installed on the rungs.</p>

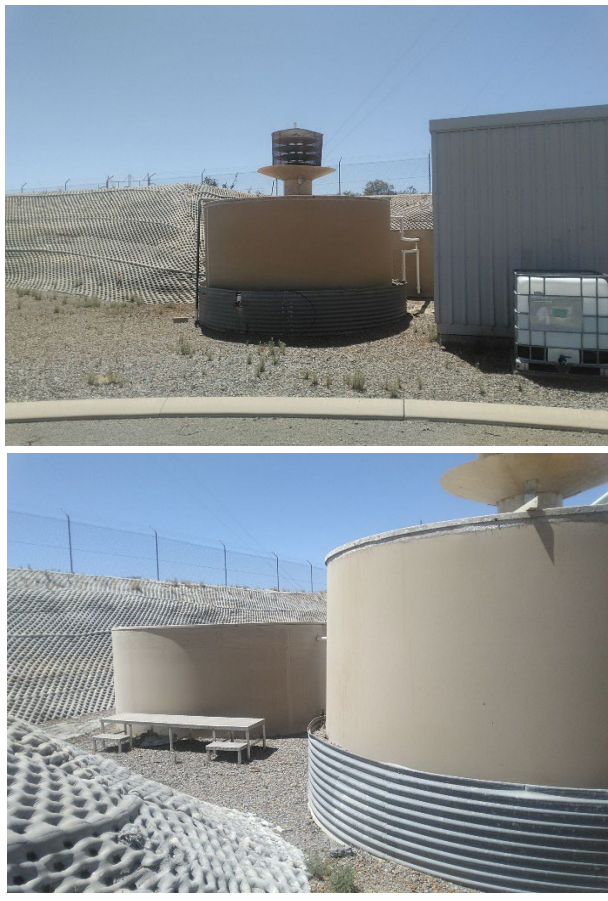
CS08-13	13/02/2024	Water Treatment Plant - 2 x Tanks	<p>1) 1 Tank has no means of access provided.</p> <p>2) 1 x Tank has temporary steps used for access and as a work platform. These do not meet AS requirements</p>	C. Unlikely	3. Severe	Medium	<p>1) Install a landing, access stairs and platform. Note: If 3 stairs or stairs are <=1m wide, then handrails will also be required.</p> <p>2) Option A: Install hi vis (yellow) tread onto each stair. Also consider install handrail for the work platform. Option B: Install a access ladder and platform that meets AS requirements (preferred option). Option C: Implement a 1500 x 1500 precast concrete for ladder to sit on to access the tank.</p>

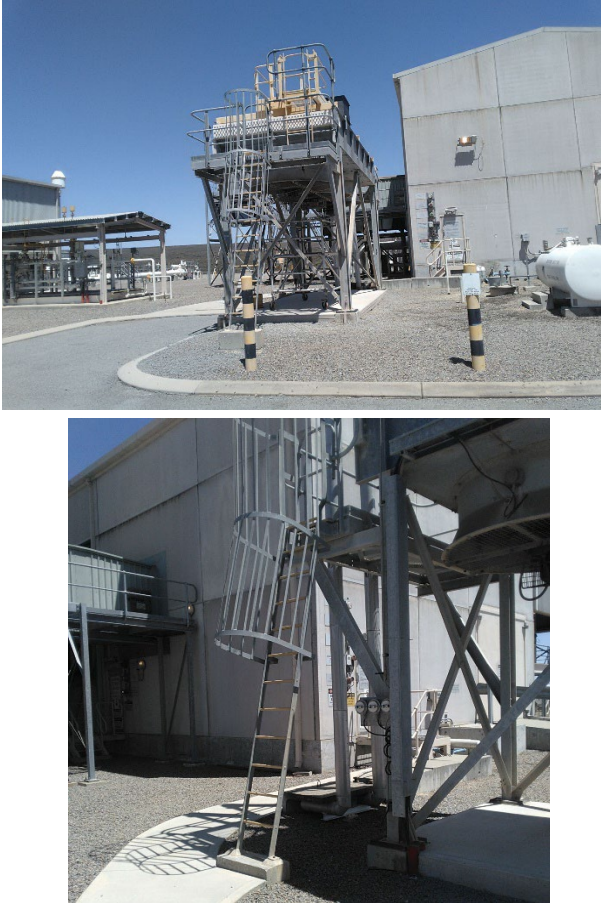
CS08-16	13/02/2024	Compressor Unit 1 - After Cooler Fans - Ground Level Ladders x 2	1) The concrete landing (depth 230-250mm) does not meet the AS requirements (depth min 900mm from bottom rung). 2) The concrete landing that is being used as an additional stair to allow access to the ladder (350mm - south side / 300mm west side) does not meet the AS requirements.	D. Occasional	2. Minor	Low	1) Pour a new landing. 2) Modify the ladder to run the full length to the landing and ensure the step up requirements for the ladder meets AS requirements (e.g. 300-450mm requires at least 1 stair).

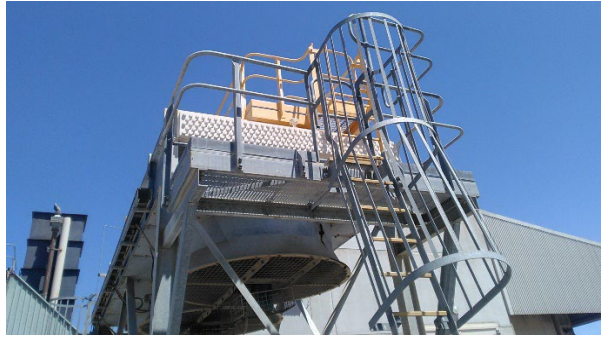
CS08-17	13/02/2024	Stage 1 Compressor Unit 1 - After Cooler Fans - Middle Platform (East Side)	1) No handrails on the side of the platform that faces the structure. Gap between the kick plate and structure is 630mm and the AS requirement is max 100mm. Potential fall of ~5m.	B. Remote	3. Severe	Low	1) Install handrails between the existing platform and structure to eliminate or reduce the gaps to meet AS requirements.

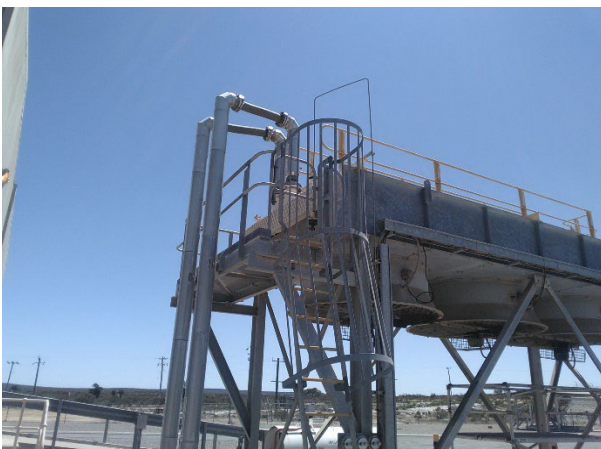
CS08-18	13/02/2024	Compressor Unit 1 - After Cooler Fans - Middle Platform (West Side)	1) No handrails on the side of the platform that faces the structure. Gap between the kick plate and structure is 670mm and the AS requirement is max 100mm. Potential fall of ~5m.	B. Remote	3. Severe	Low	1) Install handrails between the existing platform and structure to eliminate or reduce the gaps to meet AS requirements.

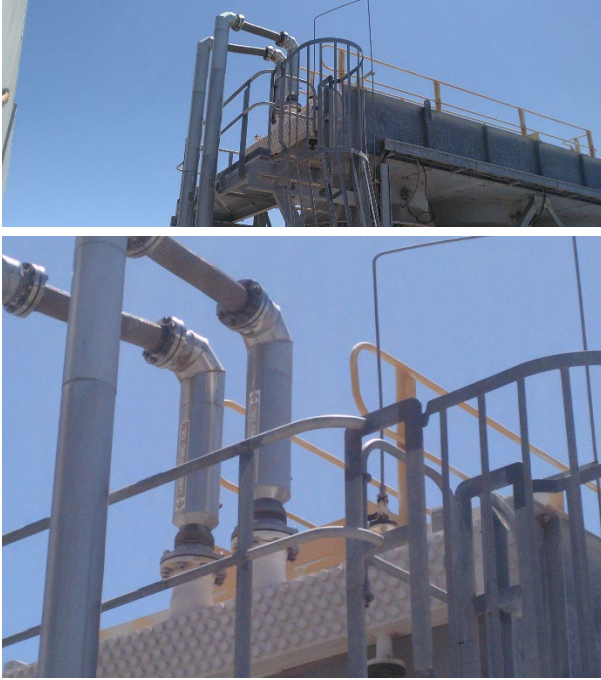
CS08-19	13/02/2024	Compressor Unit 1 - After Cooler Fans - Top Platform	1) No handrail on the western end of the top platform. Personnel at risk of a fall ~5m when performing maintenance activities on the piping.	C. Unlikely	3. Severe	High	1) Modify the platform and handrails to provide access for maintenance tasks without being exposed to the risk of a fall.

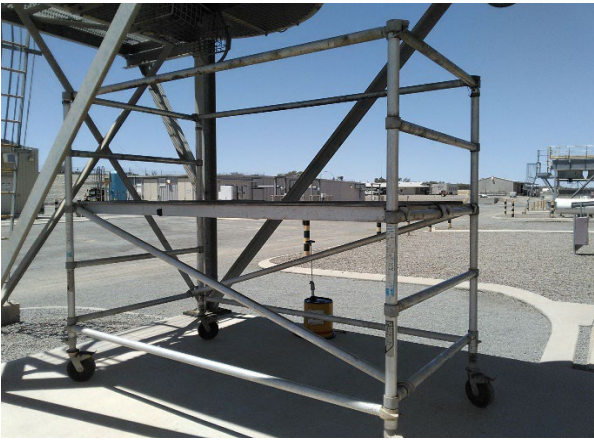
Reference	Date added	Location on Site	Issue	Likelihood	Consequence	Risk Score	Suggestions	Evidence	What is being completed	Date planned for completion	Date completed
CS08-20	13/02/2024	Mobile Scaffold - Beneath Unit 1 After Cooler Fans	1) No hi vis (yellow) tread installed onto the ladder rungs. 2) No handrail and self closing gate around the ladder opening. 3) The mid rail on one side of the mobilise scaffold is missing.	C. Unlikely	3. Severe	Medium	1) Install hi vis (yellow) tread onto the ladder rungs. 2) Install handrail and self closing gate (or equivalent) at access point. 3) Install a mid rail on the missing side of the mobile scaffold.

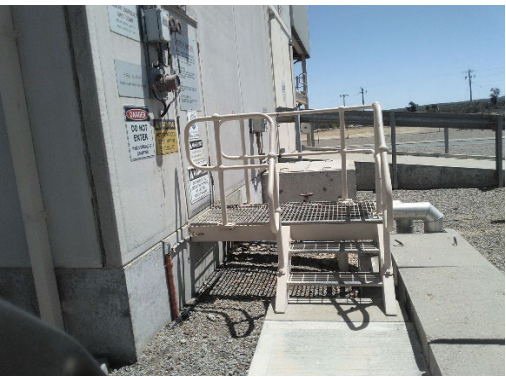
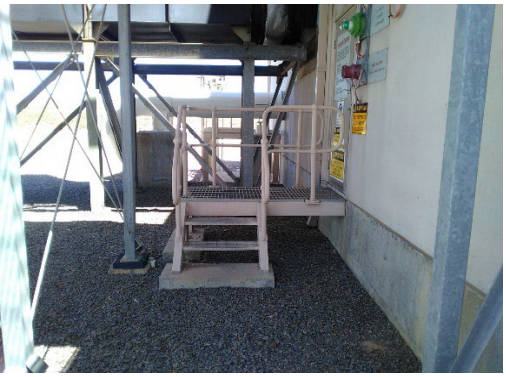
CS08-21	13/02/2024	Unit 1 Access Stairs - Multiple Locations	1) The landing for some stairs do not meet AS1657 requirements of 900mm (actual 400mm). 2) No hi vis (yellow) tread installed onto the nosing of each stair.	C. Unlikely	2. Minor	Low	1) Pour a new landing. 2) Install hi vis (yellow) tread onto the nosing of each stair (600mm to 750mm width).

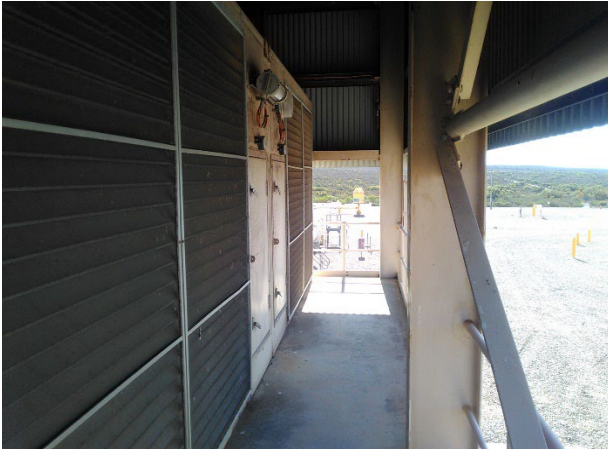
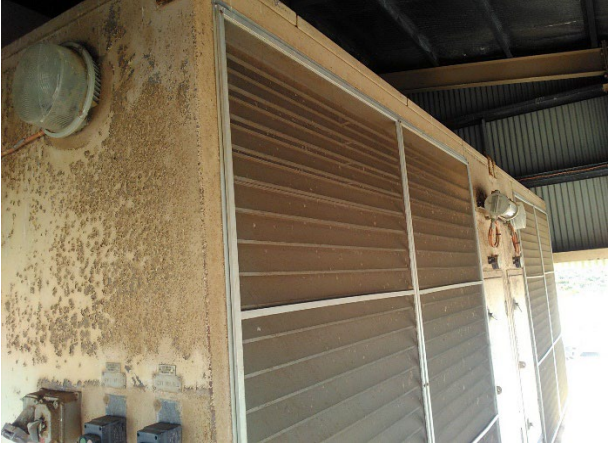
CS08-23	13/02/2024	Unit 1 North Access Stairs / Platform	1) FMOs required to climb onto the the Vent Fans structure to access the shaft ontop of it. FMOs access this shaft as part of scheduled inspections of the fire suppression system. Note: Reported by Jeramie Di Mascia (FMO LH).	C. Unlikely	3. Severe	High	1.1) Modification to be made to enable the installation of access stairs / ladder onto the structure and additional handrails to prevent a fall over the handrails. 1.2) Hi vis (yellow) tread to be installed on the access stairs / ladder. 1.3) Kick plates and handrails to be installed on the top of the structure to prevent a fall. 1.4) Review the means of accessing the hatch ontop of the structure, to ensure no additional risks are created when entering / exiting the hatch.

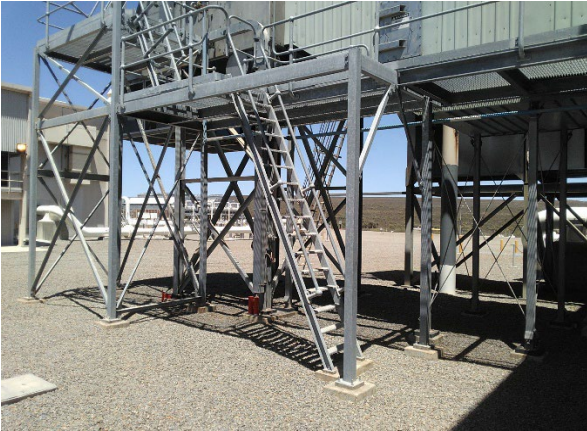
CS08-24	13/02/2024	Unit 1 Air Inlet System - Bottom Platform	1) The landing for the ladder does not meet AS1657 requirements of 900mm. 2) The angle of the slope (58.40 degrees) exceeds AS1657 requirements of Min 20 degrees and Max 45 degrees. Calculation Notes: 3.8m Rise (height), 2.2m Run (length), 16 Runs (steps). 3) The steps nosing do not have no hi vis non-slip tread fitted and posings a slip/fall risk. 4) Handrail does not meet AS requirements by beginning within a max of 900mm of the landing. 5) Greater potential to fall if facing away from the stairs when descending.	C. Unlikely	3. Severe	Medium	1) Pour a new landing. 2) Install a new stairwell that complies with AS1657. The new stairwell will need to be installed with a different orientation to avoid head height hazards (e.g. cross beams). 3) Hi vis non-slip tread is also to be fitted to the nosing of each stair. 4) Modify the handrail to meet the AS requirements. 5) Install signage on both sides of the gate to instruct personnel to only descend the stairs whilst facing towards the stair. Check AS requirement for when the handrail can stop. Check AS requirement for the tread depth for this type of staircase. May differ.

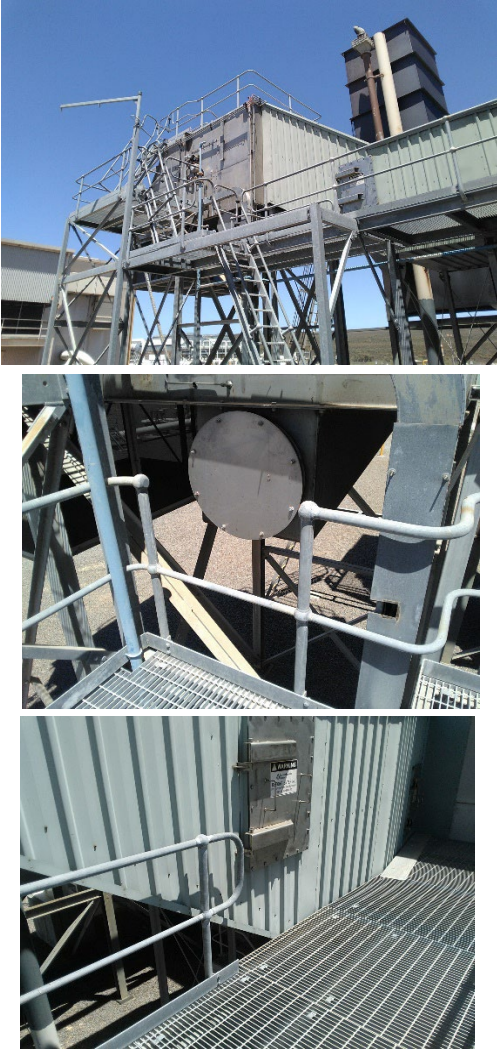
Reference	Date added	Location on Site	Issue	Likelihood	Consequence	Risk Score	Suggestions	Evidence	What is being completed	Date planned for completion	Date completed
CS08-25	13/02/2024	Unit 1 Air Inlet System - Middle Platform	<p>1) The steps nosing do not have no hi vis non-slip tread fitted and posings a slip/fall risk.</p> <p>2) Handrail does not meet AS requirements by not extending the full length of the stairs.</p> <p>3) ~230mm Gap between the structure and the handrail is not compliant with AS requirements (max 100mm).</p> <p>4) No kick plate installed on the end of the grid mesh facing the ducting. This creates a slip/fall and dropped object risk.</p>	B. Remote	2. Minor	Low	<p>1) Hi vis non-slip tread is also to be fitted to the nosing of each stair.</p> <p>2) Extend the handrail the full length of the stairs.</p> <p>3) Modify the handrail to extend within 100mm of the structure.</p> <p>4) Install a kick plate along the open edge of the grid mesh.</p>

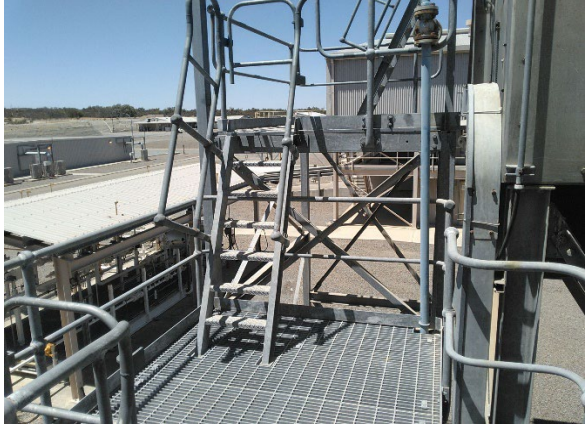
CS08-26	13/02/2024	Unit 1 Air Inlet System - Third Level Platform	<p>1) The landing for the ladder does not meet AS1657 requirements of 900mm.</p> <p>2) The steps are small in size (~110mm), have no hi vis non-slip tread fitted, do not meet AS1657 requirements and posings a slip/fall risk.</p> <p>3) Handrail does not meet AS requirements by not extending the full length of the stairs.</p>	C. Unlikely	3. Severe	Medium	<p>1) Modify the platform to provide adequate landing or modify the access method.</p> <p>2) Ensure the new stairwell has suitably sized steps or a access ladder that meet AS1657 requirements. Hi vis non-slip tread is also to be fitted to the nosing of each stair.</p> <p>3) Extend the handrail the full length of the stairs.</p>

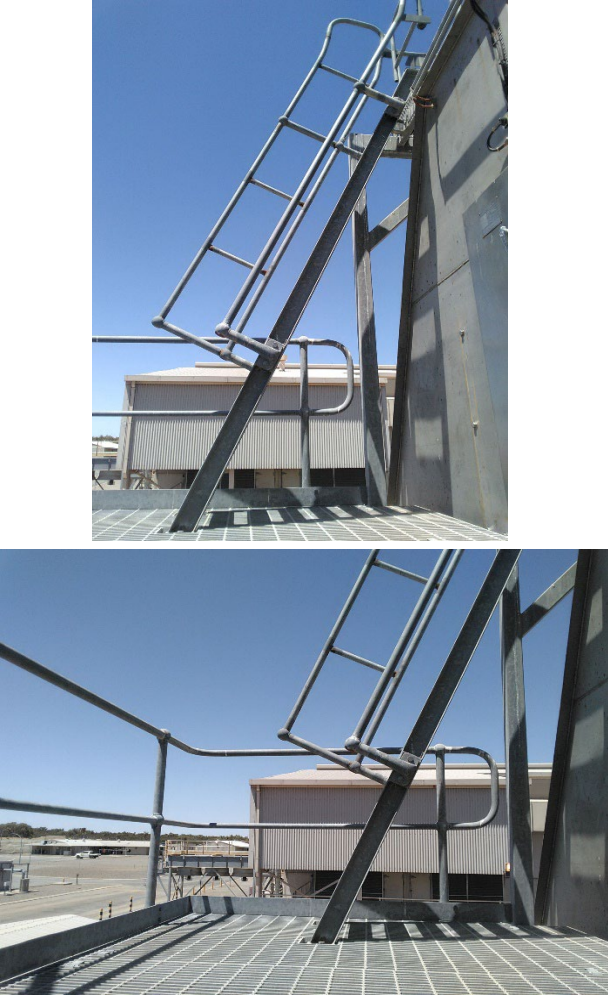
CS08-27	13/02/2024	Unit 1 Air Inlet System - Top Platform	<p>1) The landing for the ladder does not meet AS1657 requirements of 900mm.</p> <p>2) The steps are small in size (~110mm), have no hi vis non-slip tread fitted, do not meet AS1657 requirements and posings a slip/fall risk.</p> <p>3) Handrail does not meet AS requirements by not extending the full length of the stairs.</p>	C. Unlikely	3. Severe	Medium	<p>1) Modify the platform to provide adequate landing or modify the access method.</p> <p>2) Ensure the new stairwell has suitably sized steps or a access ladder that meet AS1657 requirements. Hi vis non-slip tread is also to be fitted to the nosing of each stair.</p> <p>3) Extend the handrail the full length of the stairs.</p>

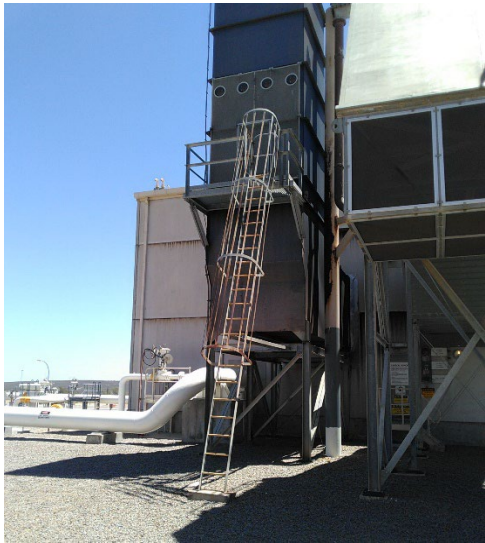
CS08-28	13/02/2024	Unit 1 Air Inlet System - Exhaust System Platform	<p>1) The landing for the ladder does not meet AS1657 requirements of 900mm.</p>	B. Remote	2. Minor	Low	<p>1) Pour a new landing.</p>

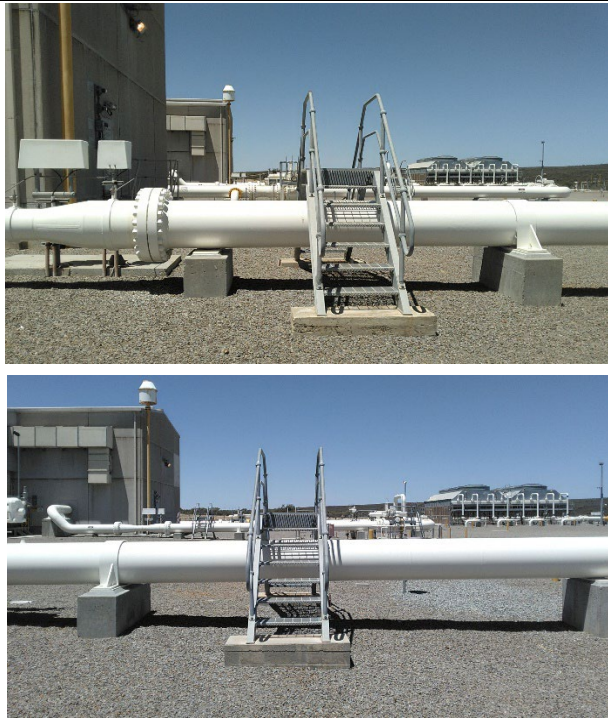
CS08-29	13/02/2024	Unit 1 - Multiple Stairs Over Pipework	<p>1) The landing for the stairs does not meet AS1657 requirements of 900mm (actual 400mm or landing is blue metal).</p> <p>2) No hi vis (yellow) tread installed onto the nosing of each stair.</p>	C. Unlikely	2. Minor	Low	<p>1) Pour a new landing.</p> <p>2) Install hi vis (yellow) tread onto the nosing of each stair (750mm width).</p>

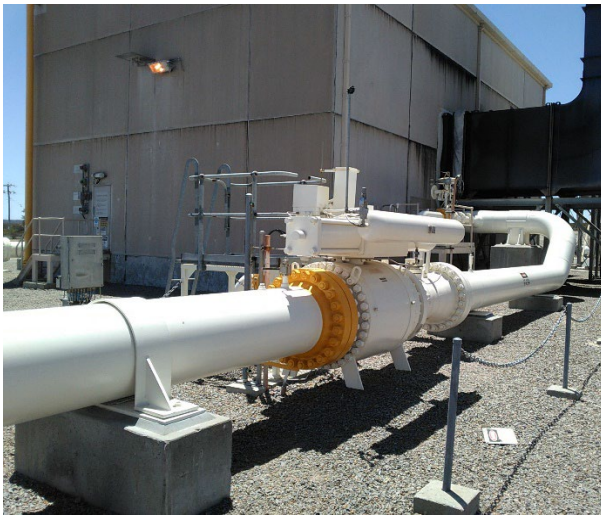
CS08-33	13/02/2024	Unit 1 - PSV1316A	<p>1) Access to PSV for maintenance tasks currently completed using a platform ladder on blue metal. This creates the potential for the ladder to be unstable and cause a fall from height (~2m).</p>	C. Unlikely	3. Severe	Medium	<p>1) Option A: Install concrete landing for platform ladder to be set up on.</p> <p>Option B: Install a purpose built platform and access stairs or ladder that is AS compliant.</p>

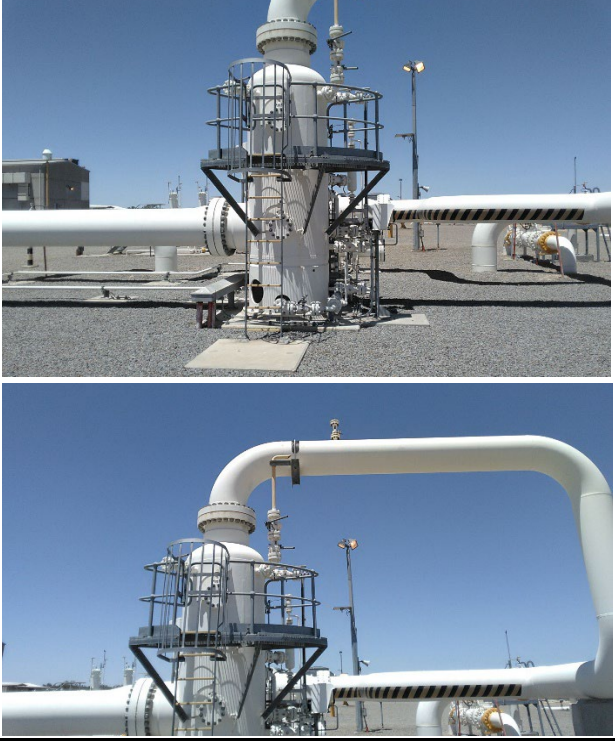
CS08-37	13/02/2024	Platform for Scrubber and adjacent Pipework	1) No access to Riser / Vent from platform without having to use a ladder on the platform. This will expose personnel to a fall over the existing handrail. 2) No access to the valves onto the top of the pipework.	C. Unlikely	2. Minor	Low	1) Modify platform and handrails to provide access to vent. 2) Install a access platform that complies with AS1567 requirements. Note: Discuss with FMOs on frequency to access both locations and methodology. This will help determine priority and suitability.

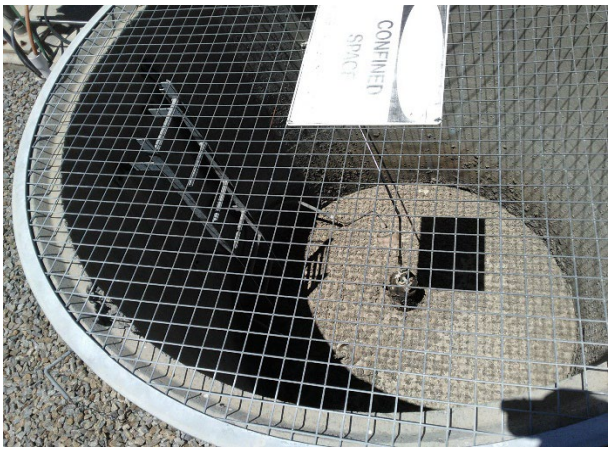
CS08-41	13/02/2024	Confined Space - Access Ladder (West Side of Plant)	<p>1) Ladder does not extend 1m past the landing at the top of the ladder and does not have sufficient locations to hold onto when mounting / dismounting.</p> <p>2) No non-slip tread on ladder rungs.</p> <p>3) Confined Space signage has faded significantly.</p>	B. Remote	3. Severe	Medium	<p>1) Modify or replace the ladder, ensuring it extends 1m past the top landing, with sufficient locations to hold onto when mounting / dismounting the ladder.</p> <p>2) Modified or replacement ladder to have hi vis (yellow) non-slip tread installed on the rungs.</p> <p>3) Replace the confined space signage as part of the improvement works.</p>

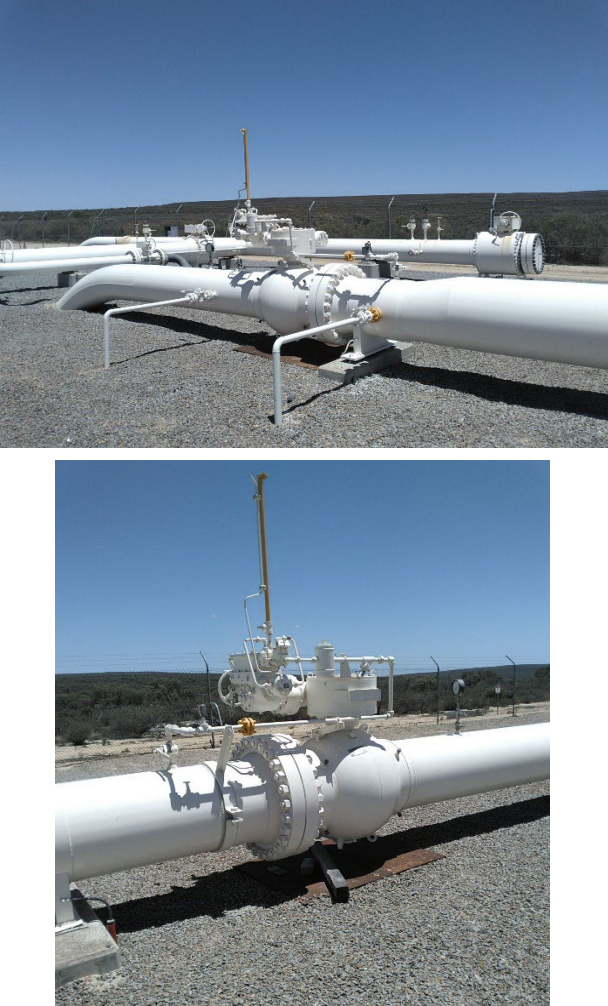
Reference	Date added	Location on Site	Issue	Likelihood	Consequence	Risk Score	Suggestions	Evidence	What is being completed	Date planned for completion	Date completed
CS08-42	13/02/2024	Pigging Area / Pipework	1) Access to Risers / Vents up to ~2000mm for maintenance tasks currently completed using a platform ladder on blue metal. This creates the potential for the ladder to be unstable and cause a fall from height.	C. Unlikely	3. Severe	Medium	1) Option A: Install concrete landing for platform ladder to be set up on. Option B: Install a purpose built platform and access stairs or ladder that is AS compliant.

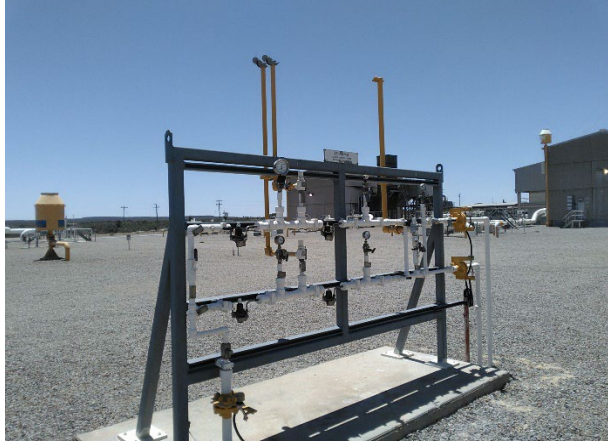
CS08-43	13/02/2024	LP-124 / LP-146 Station Control Valves - Instrument Gas Supply	1) The landing is too small on the south side of the skid.	C. Unlikely	2. Minor	Low	1) No action required. Platform ladders are set up on the opposite side of skid to accent the risers / vents.
