Revised Final Plan
Attachment 9.12

Structures & Operational Sites - Working at Heights - Appendix B

**Dampier Bunbury
Pipeline**

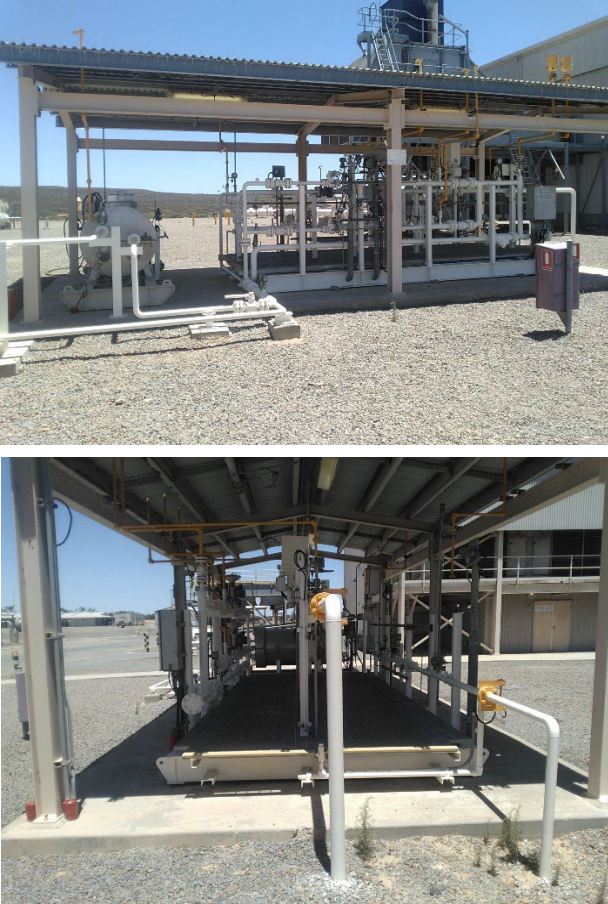
CS08-44	13/02/2024	Unit 1 - Fuel Gas Skid	1) Step up is 380mm which exceeds AS requirements (300mm-450mm requires minimum of 1 stair). 2) Pipework routed at ground level, pose a trip / fall (same level) hazard.	C. Unlikely	2. Minor	Low	1.1) Install a interim stair to assist with access and meet AS1657 requirements. Note: If 3 stairs or stairs are <=1m wide, then handrails will also be required. 1.2) Install hi vis (yellow) tread onto each stair. 2) Install a hopover to provide safe access.

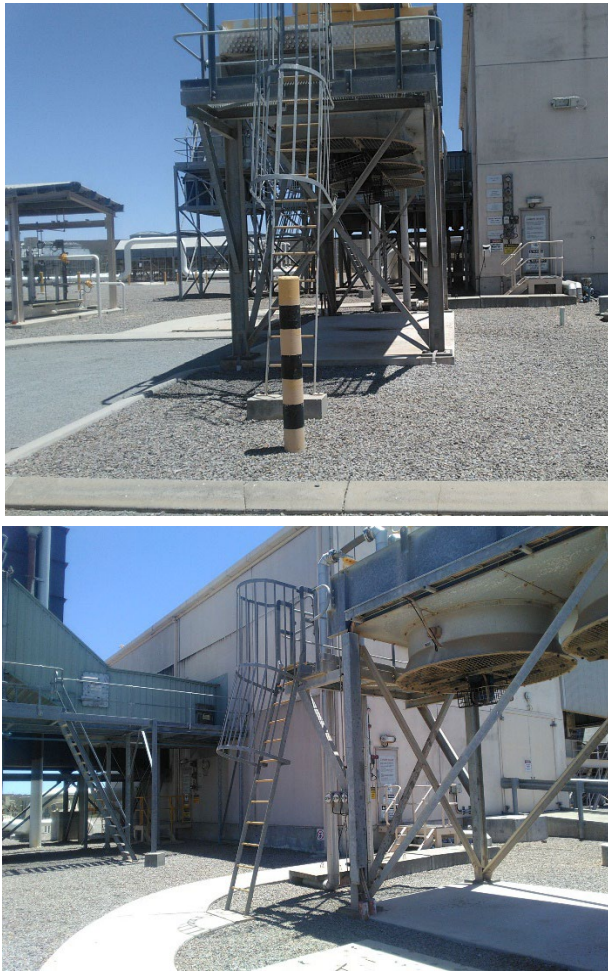
CS08-45	13/02/2024	Compressor Unit 2 - After Cooler Fans - Ground Level Ladders x 2	1) The concrete landing (depth 230-250mm) does not meet the AS requirements (depth min 900mm from bottom rung). 2) The concrete landing that is being used as an additional stair to allow access to the ladder (350mm - south side / 300mm west side) does not meet the AS requirements.	D. Occasional	2. Minor	Low	1) Pour a new landing. 2) Modify the ladder to run the full length to the landing and ensure the step up requirements for the ladder meets AS requirements (e.g. 300-450mm requires at least 1 stair).

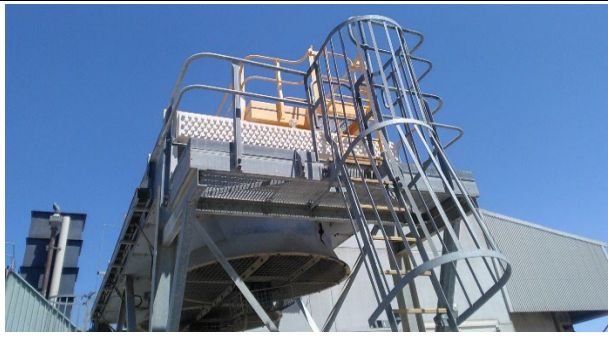
CS08-46	13/02/2024	Compressor Unit 2 - After Cooler Fans - Middle Platform (East Side)	1) No handrails on the side of the platform that faces the structure. Gap between the kick plate and structure is 630mm and the AS requirement is max 100mm. Potential fall of ~5m.	B. Remote	3. Severe	Low	1) Install handrails between the existing platform and structure to eliminate or reduce the gaps to meet AS requirements.

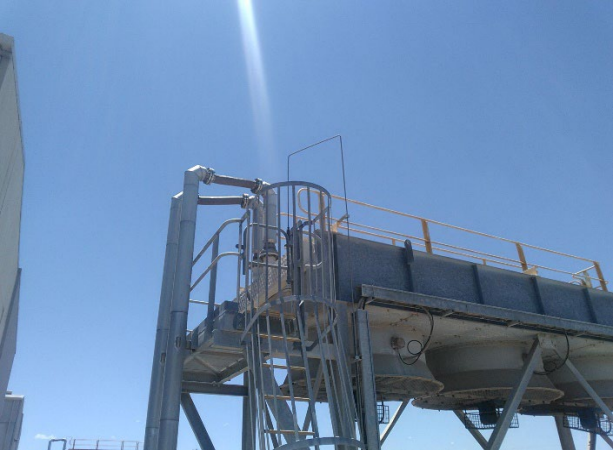
Reference	Date added	Location on Site	Issue	Likelihood	Consequence	Risk Score	Suggestions	Evidence	What is being completed	Date planned for completion	Date completed
CS08-47	13/02/2024	Compressor Unit 2 - After Cooler Fans - Middle Platform (West Side)	1) No handrails on the side of the platform that faces the structure. Gap between the kick plate and structure is 670mm and the AS requirement is max 100mm. Potential fall of ~5m.	B. Remote	3. Severe	Low	1) Install handrails between the existing platform and structure to eliminate or reduce the gaps to meet AS requirements.

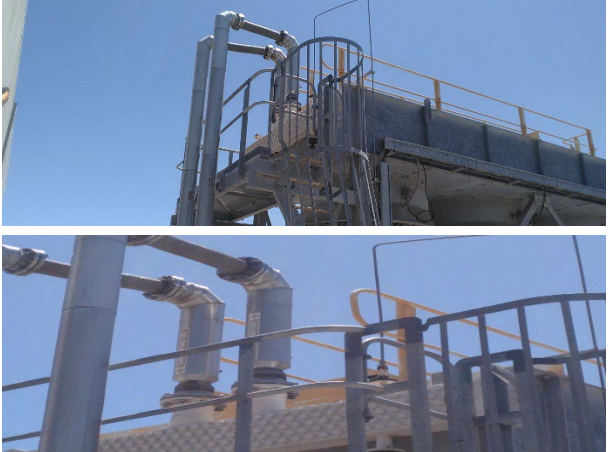
CS08-48	13/02/2024	Compressor Unit 2 - After Cooler Fans - Top Platform	1) No handrail on the western end of the top platform. Personnel at risk of a fall ~5m when performing maintenance activities on the piping.	C. Unlikely	3. Severe	High	1) Modify the platform and handrails to provide access for maintenance tasks without being exposed to the risk of a fall.

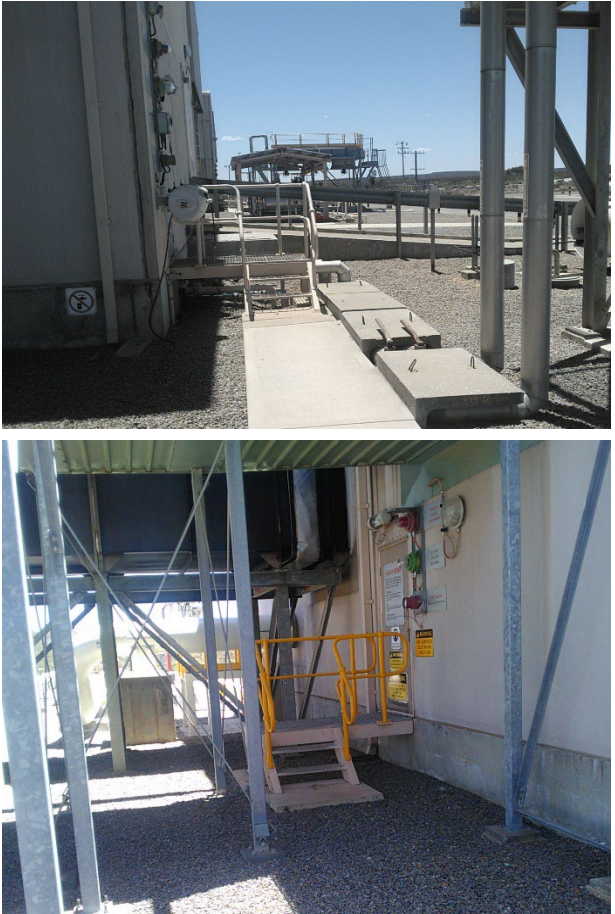
CS08-49	13/02/2024	Unit 2 Access Stairs - Multiple Locations	1) The landing for some stairs do not meet AS1657 requirements of 900mm (actual 400mm). 2) No hi vis (yellow) tread installed onto the nosing of each stair.	C. Unlikely	2. Minor	Low	1) Pour a new landing. 2) Install hi vis (yellow) tread onto the nosing of each stair (600mm to 750mm width).

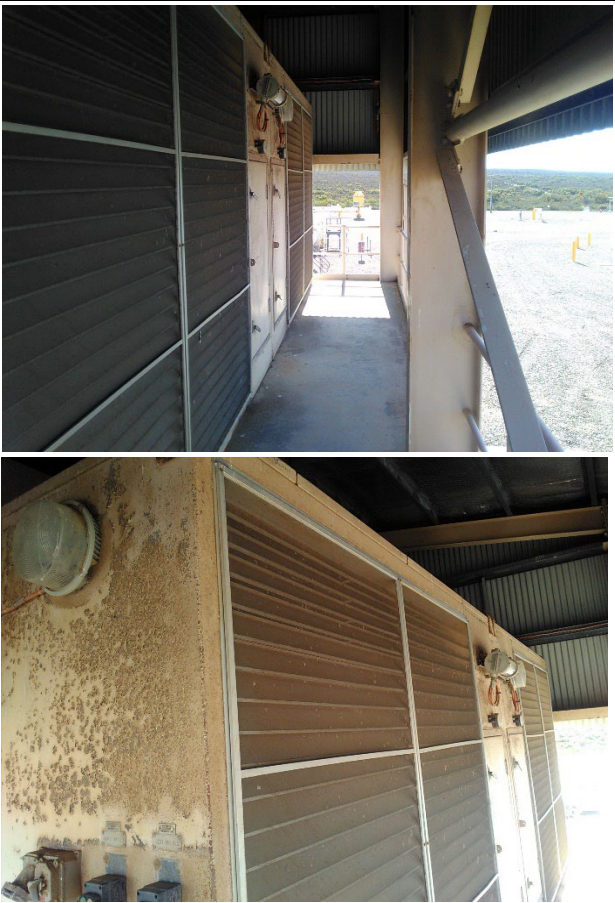
CS08-50	13/02/2024	Unit 2 North Access Stairs / Platform	1) FMOs required to climb onto the structure to access the shaft ontop of it. FMOs access this shaft as part of scheduled inspections of the fire suppression system. Note: Reported by Jeramie Di Mascia (FMO LH).	C. Unlikely	3. Severe	High	1.1) Modification to be made to enable the installation of access stairs / ladder onto the structure and additional handrails to prevent a fall over the handrails. 1.2) Hi vis (yellow) tread to be installed on the top of the access stairs / ladder. 1.3) Kick plates and handrails to be installed on the top of the structure to prevent a fall. 1.4) Review the means of accessing the hatch ontop of the structure, to ensure no additional risks are created when entering / exiting the hatch.

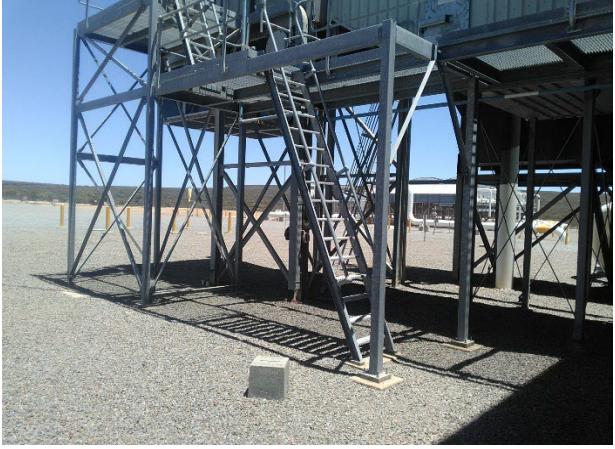
CS08-51	13/02/2024	Unit 2 Air Inlet System - Bottom Platform	1) The landing for the ladder does not meet AS1657 requirements of 900mm. 2) The angle of the slope (58.40 degrees) exceeds AS1657 requirements of Min 20 degrees and Max 45 degrees. Calculation Notes: 3.8m Rise (height), 2.2m Run (length), 16 Runs (steps). 3) The steps nosing do not have no hi vis non-slip tread fitted and posings a slip/fall risk. 4) Handrail does not meet AS requirements by beginning within a max of 900mm of the landing. 5) Greater potential to fall if facing away from the stairs when descending.	C. Unlikely	3. Severe	Medium	1) Pour a new landing. 2) Install a new stairwell that complies with AS1657. The new stairwell will need to be installed with a different orientation to avoid head height hazards (e.g. cross beams). 3) Hi vis non-slip tread is also to be fitted to the nosing of each stair. 4) Modify the handrail to meet the AS requirements. 5) Install signage on both sides of the gate to instruct personnel to only descend the stairs whilst facing towards the stair. Check AS requirement for when the handrail can stop. Check AS requirement for the tread depth for this type of staircase. May differ.

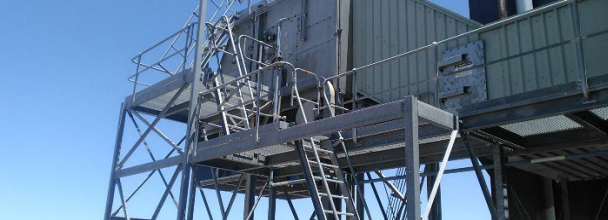
Reference	Date added	Location on Site	Issue	Likelihood	Consequence	Risk Score	Suggestions	Evidence	What is being completed	Date planned for completion	Date completed
CS08-52	13/02/2024	Unit 2 Air Inlet System - Middle Platform	<p>1) The steps nosing do not have no hi vis non-slip tread fitted and posings a slip/fall risk.</p> <p>2) Handrail does not meet AS requirements by not extending the full length of the stairs.</p> <p>3) ~230mm Gap between the structure and the handrail is not compliant with AS requirements (max 100mm).</p> <p>4) No kick plate installed on the end of the grid mesh facing the ducting. This creates a slip/fall and dropped object risk.</p>	B. Remote	2. Minor	Low	<p>1) Hi vis non-slip tread is also to be fitted to the nosing of each stair.</p> <p>2) Extend the handrail the full length of the stairs.</p> <p>3) Modify the handrail to extend within 100mm of the structure.</p> <p>4) Install a kick plate along the open edge of the grid mesh.</p>

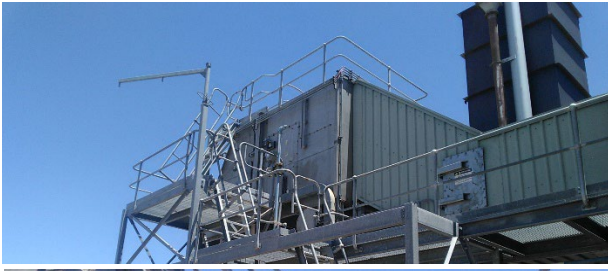
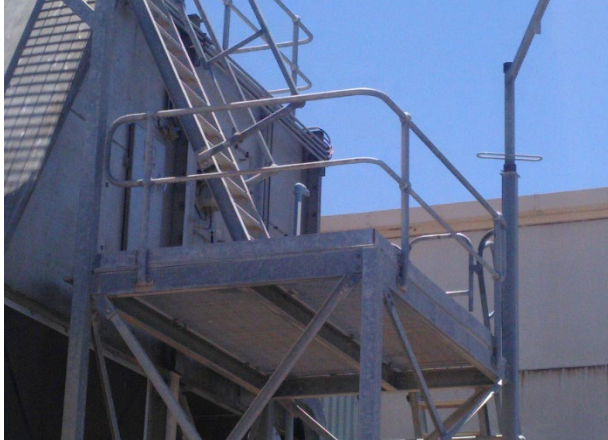
CS08-53	13/02/2024	Unit 2 Air Inlet System - Third Level Platform	<p>1) The landing for the ladder does not meet AS1657 requirements of 900mm.</p> <p>2) The steps are small in size (~110mm), have no hi vis non-slip tread fitted, do not meet AS1657 requirements and posings a slip/fall risk.</p> <p>3) Handrail does not meet AS requirements by not extending the full length of the stairs.</p>	C. Unlikely	3. Severe	Medium	<p>1) Modify the platform to provide adequate landing or modify the access method.</p> <p>2) Ensure the new stairwell has suitably sized steps or a access ladder that meet AS1657 requirements. Hi vis non-slip tread is also to be fitted to the nosing of each stair.</p> <p>3) Extend the handrail the full length of the stairs.</p>

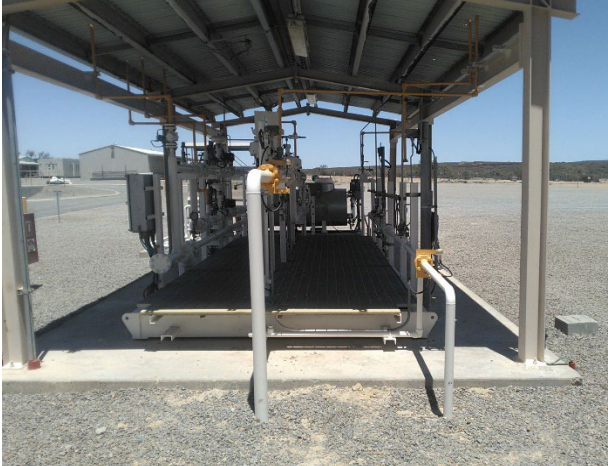
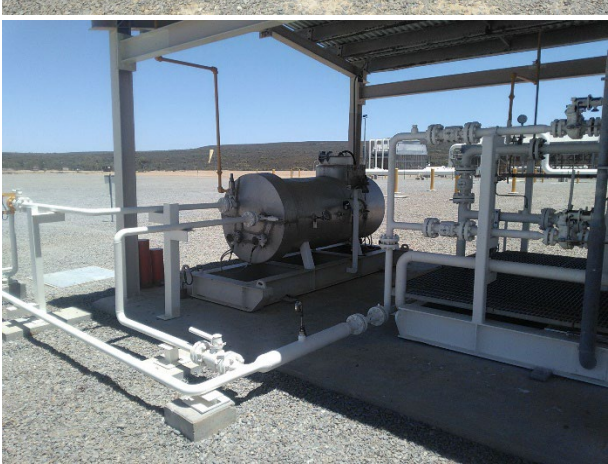
CS08-54	13/02/2024	Unit 2 - Fuel Gas Skid	<p>1) Step up is 380mm which exceeds AS requirements (300mm-450mm requires minimum of 1 stair).</p> <p>2) Pipework routed at ground level, pose a trip / fall (same level) hazard.</p>	C. Unlikely	2. Minor	Low	<p>1.1) Install a interim stair to assist with access and meet AS1657 requirements. Note: If 3 stairs or stairs are <=1m wide, then handrails will also be required.</p> <p>1.2) Install hi vis (yellow) tread onto each stair.</p> <p>2) Install a hopover to provide safe access.</p>

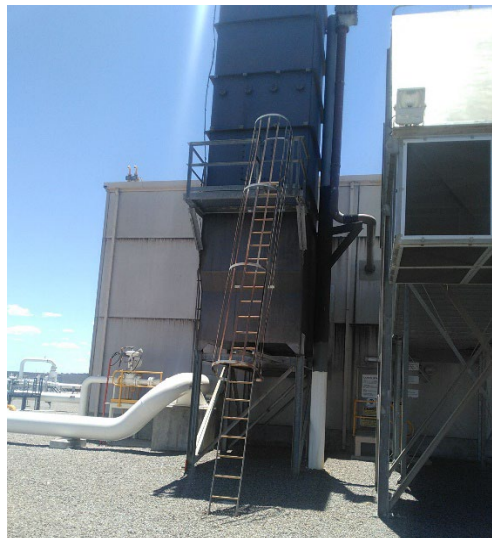
CS08-55	13/02/2024	Unit 2 Air Inlet System - Exhaust System Platform	<p>1) The landing for the ladder does not meet AS1657 requirements of 900mm.</p>	B. Remote	2. Minor	Low	<p>1) Pour a new landing.</p>

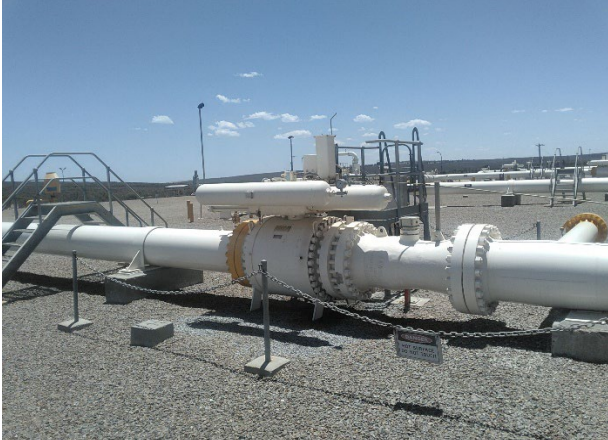
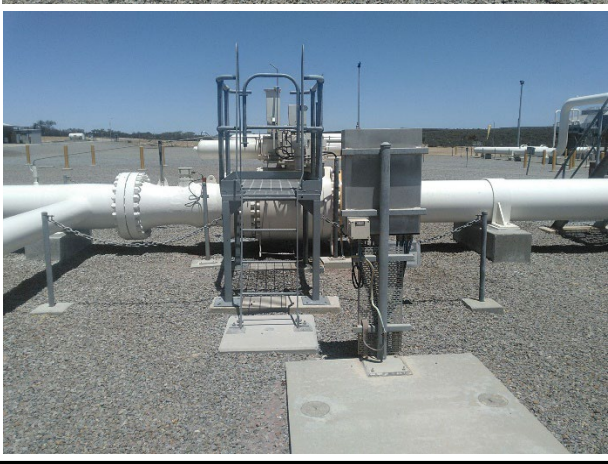
CS08-56	13/02/2024	Unit 2 - North Platform for Actuated Valve	<p>1) No hi vis (yellow) tread installed onto the nosing of each stair.</p> <p>2) The landing for the ladder does not meet AS1657 requirements of 900mm (actual 340mm)</p> <p>3) Instrument Box in close proximity of the landing. FMOs reported making contact with this box, usually when stepping back off the ladder.</p>	C. Unlikely	2. Minor	Low	<p>1) Install hi vis (yellow) tread onto the nosing of each stair.</p> <p>2) Pour a new landing.</p> <p>3) Review if Instrument Box can be relocated or if engineering options are available (e.g. padded handrail).</p>

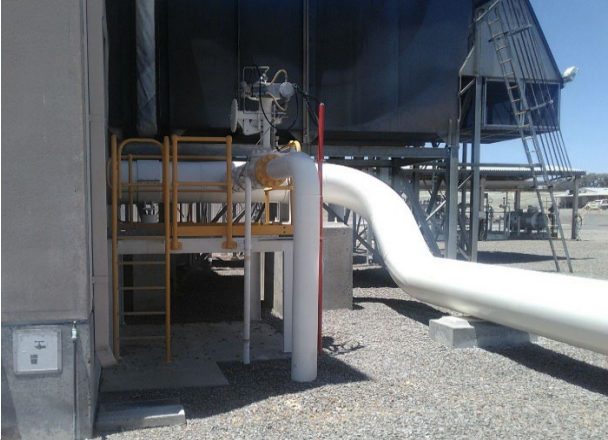
CS08-57	13/02/2024	Unit 2 - South Side Platform	<p>1) Landing is too small. Concrete drainage poses a slip / trip hazard.</p> <p>2) Gap in handrail exceeds AS requirements (max 100mm).</p>	C. Unlikely	2. Minor	Low	<p>1.1) Pour a new landing.</p> <p>1.2) Consider the drainage design into the landing modification and engineer it out if possible. If no, highlight the drainage in yellow so it stands out.</p> <p>2) Consider modifying the handrail design for the platform to eliminate the gap.</p>

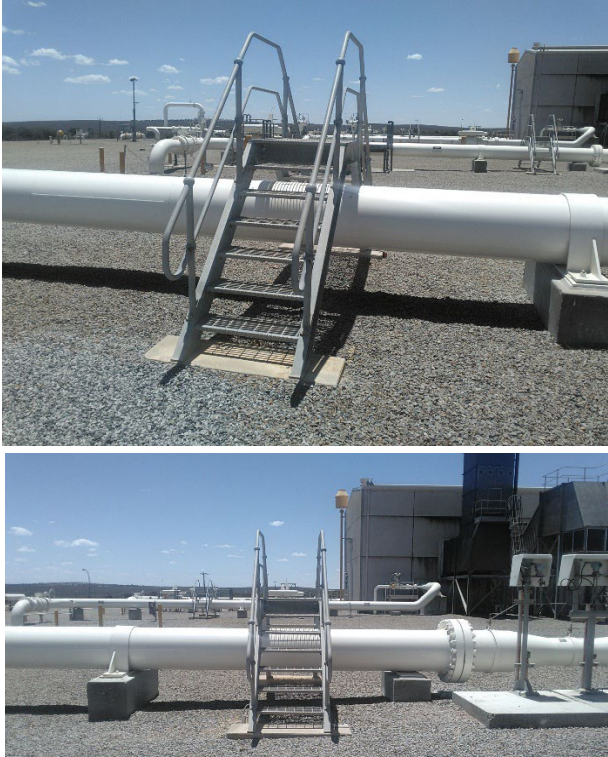
Reference	Date added	Location on Site	Issue	Likelihood	Consequence	Risk Score	Suggestions	Evidence	What is being completed	Date planned for completion	Date completed
CS08-58	13/02/2024	Unit 2 Access Stairs - Multiple Locations	1) The landing for some stairs do not meet AS1657 requirements of 900mm (actual 400mm). 2) No hi vis (yellow) tread installed onto the nosing of each stair.	C. Unlikely	2. Minor	Low	1) Pour a new landing. 2) Install hi vis (yellow) tread onto the nosing of each stair (600mm to 750mm width).

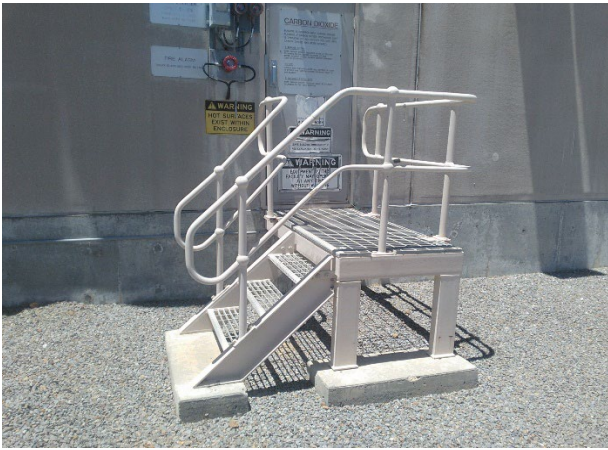
CS08-59	13/02/2024	Unit 2 Access Stairs - East Side	1) Concrete block used as a stair does not meet the AS requirement for consistent risers in stairways. 2) No hi vis (yellow) tread installed onto the nosing of each stair.	C. Unlikely	2. Minor	Low	1) Modify or replace the stairs to be AS compliant. 2) Install hi vis (yellow) tread onto the nosing of each stair.

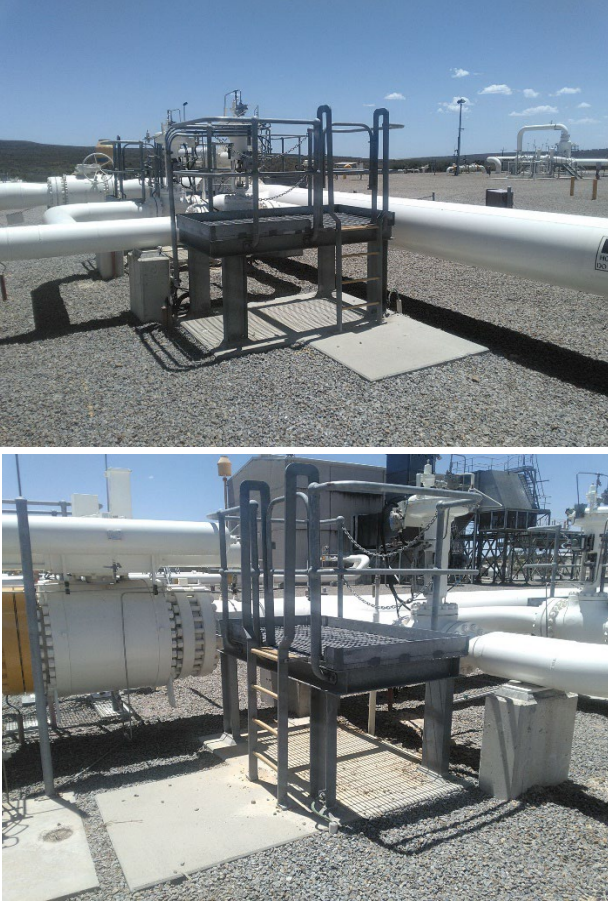
CS08-60	13/02/2024	Anti-Surge Valves - 2 x Platforms	1) Chain has been used in lieu of a handrail. The chain will likely break in the event of a fall (~1.5m).	C. Unlikely	3. Severe	Medium	1) Replace the chains with handrails.

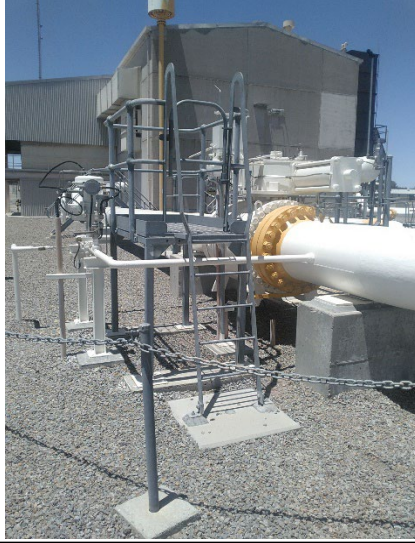
CS08-61	13/02/2024	Unit 2 - North Platform for Actuated Valve	1) No hi vis (yellow) tread installed onto the nosing of each stair. 2) The landing for the ladder does not meet AS1657 requirements of 900mm (actual 340mm)	C. Unlikely	2. Minor	Low	1) Install hi vis (yellow) tread onto the nosing of each stair. 2) Pour a new landing.

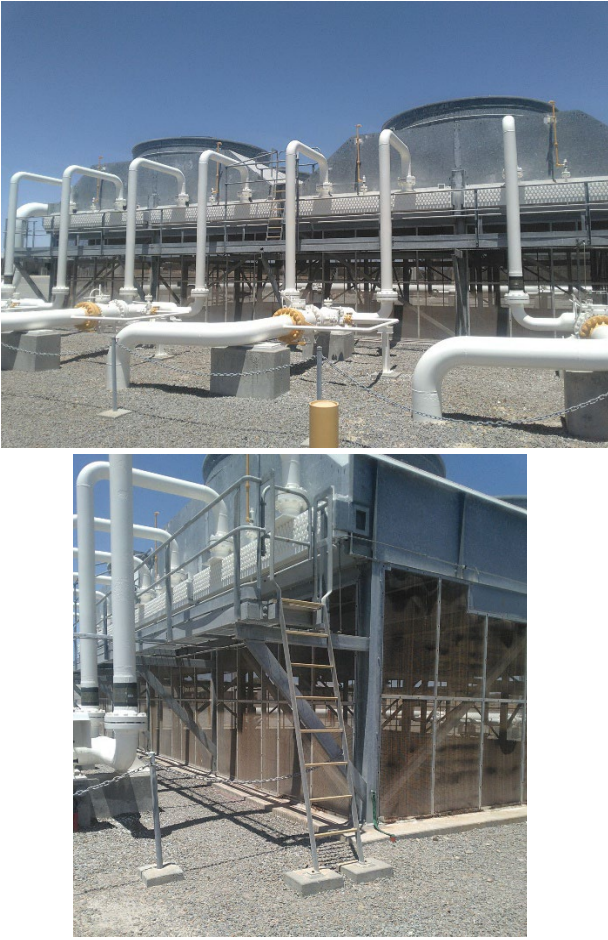
CS08-62	13/02/2024	After Cooler Fans 1-6 - Lower Platform (North Side)	1) The landing for the ladder does not meet AS1657 requirements of 900mm. It also poses a trip / slip hazard.	C. Unlikely	2. Minor	Low	1) Pour a new landing.

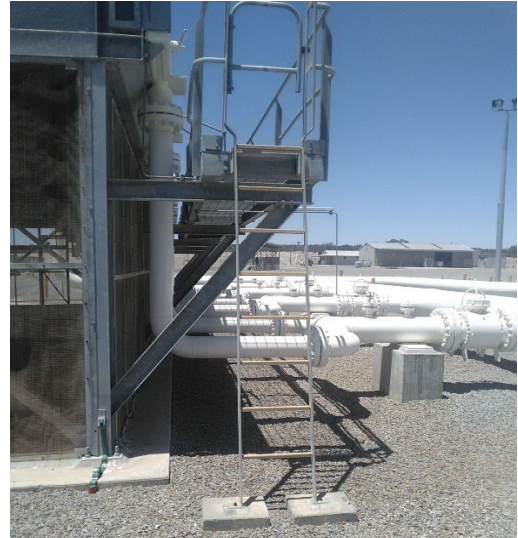
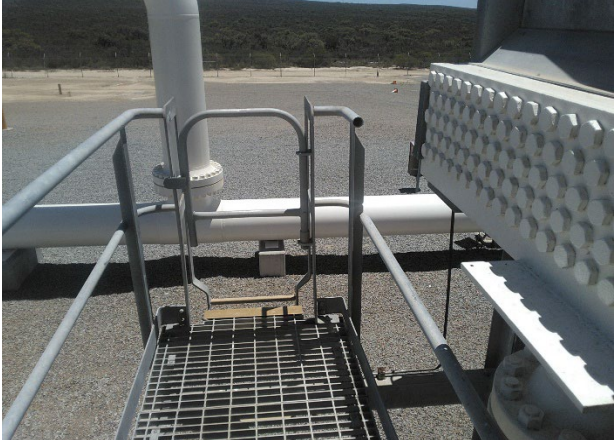
Reference	Date added	Location on Site	Issue	Likelihood	Consequence	Risk Score	Suggestions	Evidence	What is being completed	Date planned for completion	Date completed
CS08-63	13/02/2024	After Cooler Fans 1-6 - Lower Platform (South Side)	<p>1) The landing for the ladder does not meet AS1657 requirements of 900mm. It also poses a trip / slip hazard.</p> <p>2) Top handrail does not run the length of the platform, creating a gap above the AS1657 requirements (max 100mm).</p>	C. Unlikely	3. Severe	Medium	<p>1) Pour a new landing.</p> <p>2) Install handrails between the existing platform and structure to eliminate or reduce the gaps to meet AS requirements.</p>

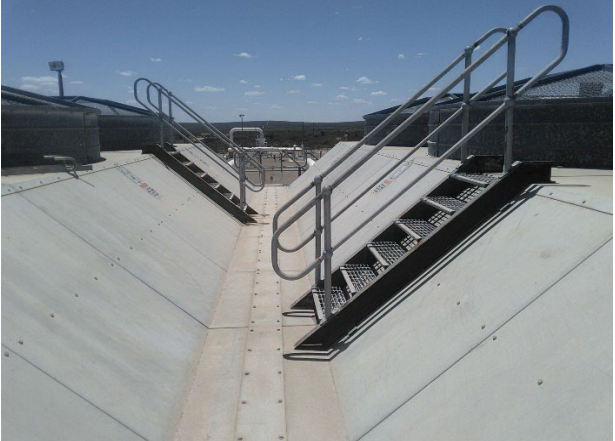
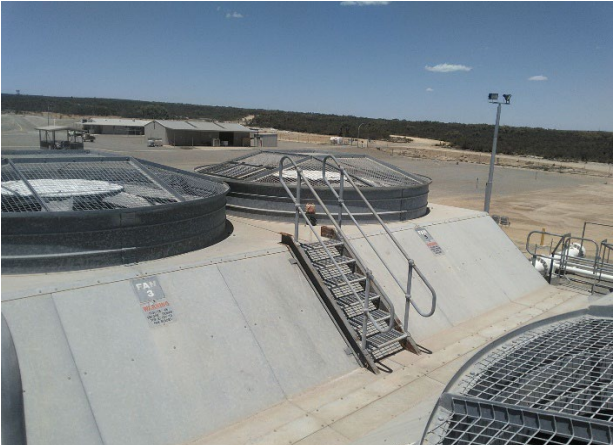
CS08-64	13/02/2024	After Cooler Fans 1-6 - Middle and Top Platform	<p>1) Stairs do not have hi vis (yellow) tread installed onto the nosing of each stair.</p> <p>2) Open edge adjacent to each set of stairs, running along the platform. This exposes personnel to a fall into the access way.</p> <p>3) The top platforms have several areas without handrails installed to prevent access to open edges. This creates the potential for a person to fall from height resulting in a fatality or significant injury due to the total fall distance.</p>	C. Unlikely	3. Severe	High	<p>1) Install hi vis (yellow) tread onto the nosing of each stair.</p> <p>2) Install handrail along the open edge of the access way, on the top platform.</p> <p>3) Install handrails to eliminate exposure to a unprotected edge.</p>

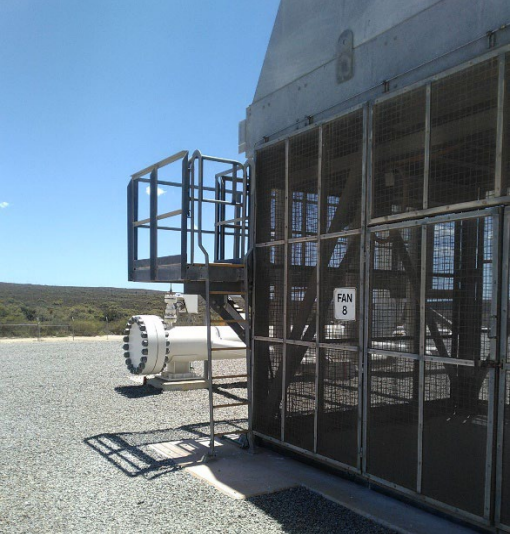
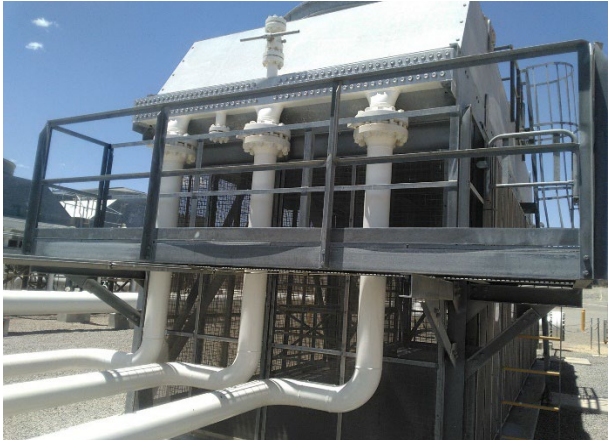
CS08-65	13/02/2024	After Cooler Fans 7-8 - Lower Platform	<p>1) Top handrail does not run the length of the platform, creating a gap above the AS1657 requirements (max 100mm).</p>	C. Unlikely	3. Severe	Medium	<p>1) Install handrails between the existing platform and structure to eliminate or reduce the gaps to meet AS requirements.</p>

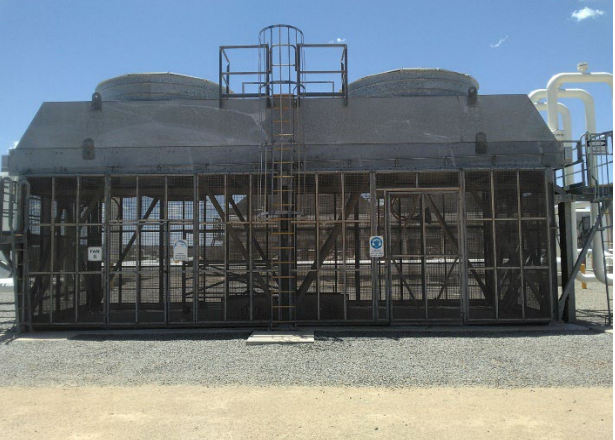
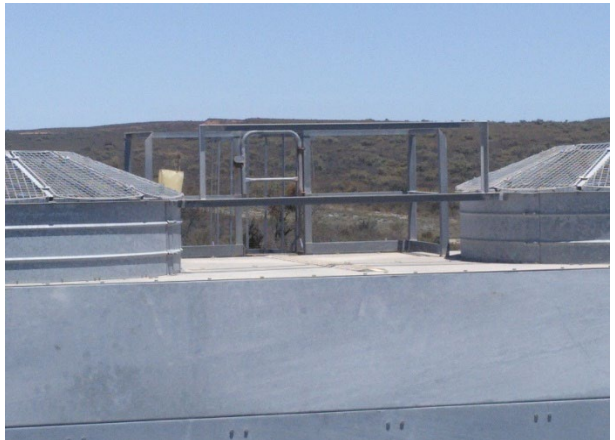
CS08-66	13/02/2024	After Cooler Fans 7-8 - Top Platform	<p>1) The ladder does not run the full length to the landing at ground level (ground to first rung is 440mm) and is therefore does not meet AS requirements.</p> <p>2) Handrails between the fans does not have bottom rail / mount is 580mm from the bottom of platform, this exceed AS1657 requirements of 450mm. No toeboard in place. Potential for personnel to climb under.</p> <p>3) No guarding has been installed on the top of the fan enclosures, to prevent access during operation. Multiple fans at this location.</p>	C. Unlikely	3. Severe	High	<p>1) Modify the ladder to ensure it runs full length and risers meet AS requirements.</p> <p>2) Install toeboard underneath the existing handrails.</p> <p>3) Install a grid mesh hatch or similar and attach it to the existing structure.</p>

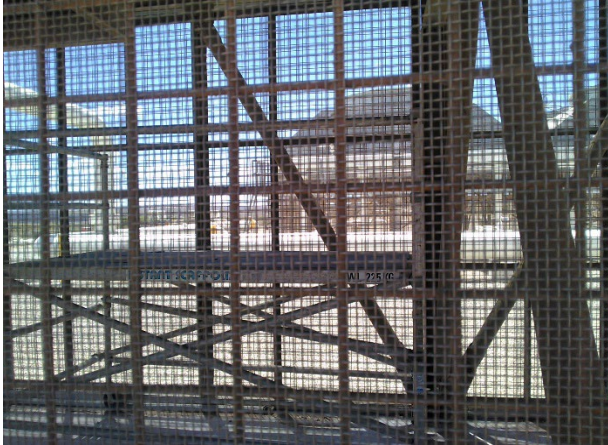
Reference	Date added	Location on Site	Issue	Likelihood	Consequence	Risk Score	Suggestions	Evidence	What is being completed	Date planned for completion	Date completed
CS08-67	13/02/2024	After Cooler Fans 7-8 - Mobile Scaffold	1) No hi vis (yellow) tread installed onto the ladder rungs. 2) No handrail and self closing gate around the ladder opening. 3) The mid rail on one side of the mobilise scaffold is missing.	C. Unlikely	3. Severe	Medium	1) Install hi vis (yellow) tread onto the ladder rungs. 2) Install handrail and self closing gate (or equivalent) at access point. 3) Install a mid rail on the missing side of the mobile scaffold.

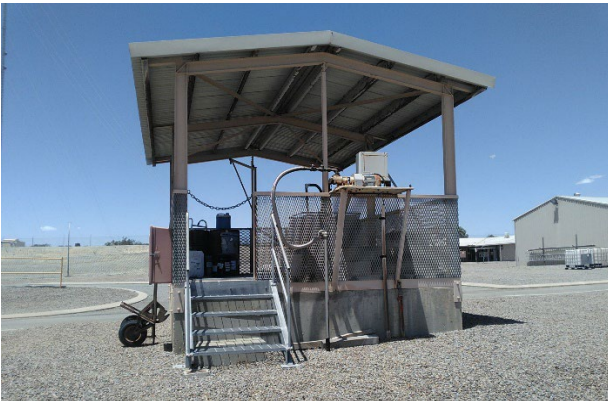
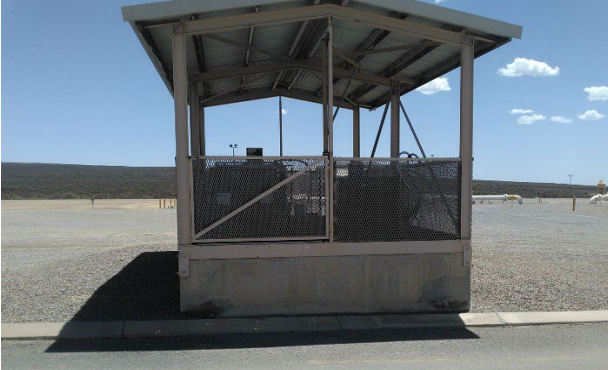
CS08-68	13/02/2024	Hazardous Substance Area	1) The landing for the stairs does not meet AS1657 requirements of 900mm (landing is blue metal). 2) No hi vis (yellow) tread installed onto the nosing of each stair.	C. Unlikely	2. Minor	Low	1) Pour a new landing. 2) Install hi vis (yellow) tread onto the nosing of each stair.

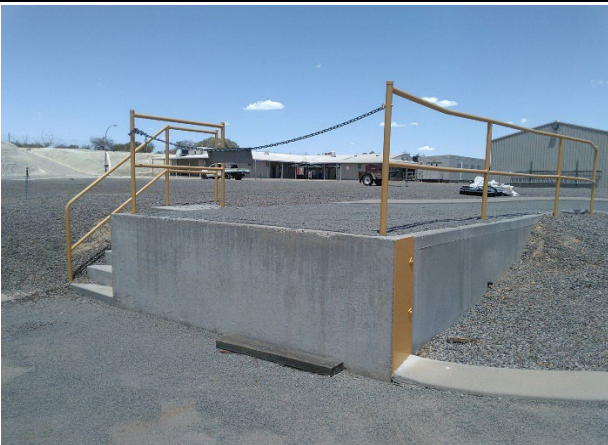
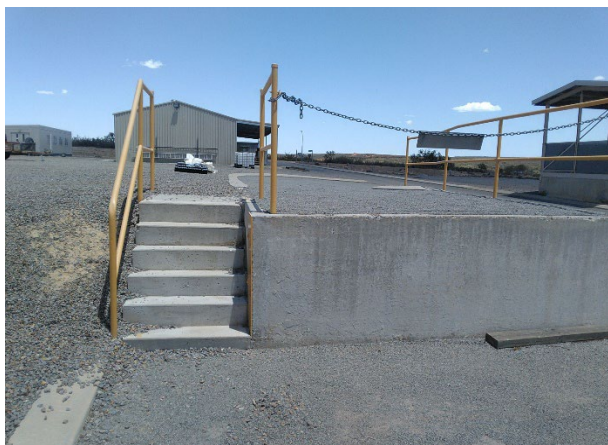
CS08-69	13/02/2024	Truck Loading / Unloading Area	1) Chain has been used in lieu of a handrail. The chain will likely break in the event of a fall (~1.5m). 2) The landing for the stairs does not meet AS1657 requirements of 900mm (landing is blue metal). 3) No hi vis (yellow) tread installed onto the nosing of each stair.	C. Unlikely	3. Severe	Medium	1) Consider replacing the chain with an alternative barrier (e.g. boom gate or spring loaded gate). 2) Pour a new landing. 3) Install hi vis (yellow) tread onto the nosing of each stair.

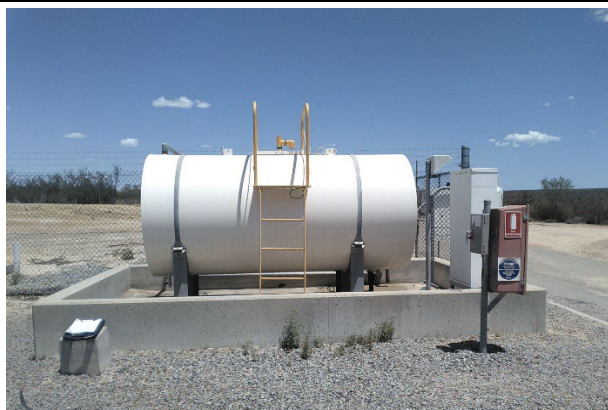
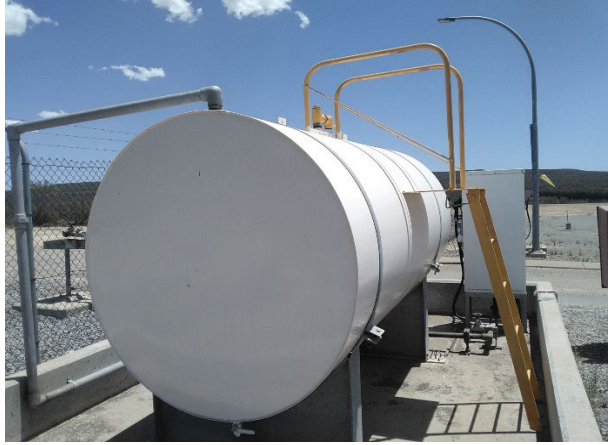
CS08-70	13/02/2024	Diesel Fuel Tank	1.1) Handrail does not meet AS requirement of 900mm. 2) No gate at the top of the work platform. 3) Landing does not meet AS requirements. Obstructed by bunding.	D. Occasional	3. Severe	Medium	1) Replace the access ladder and platform with access stairs and platform, with handrails and hi vis tread. 2) Self closing gate to be installed at the top of the platform. 3) Ensure the landing on the redesigned access stairs and platform meet the AS requirements. Modifying the bund if required.

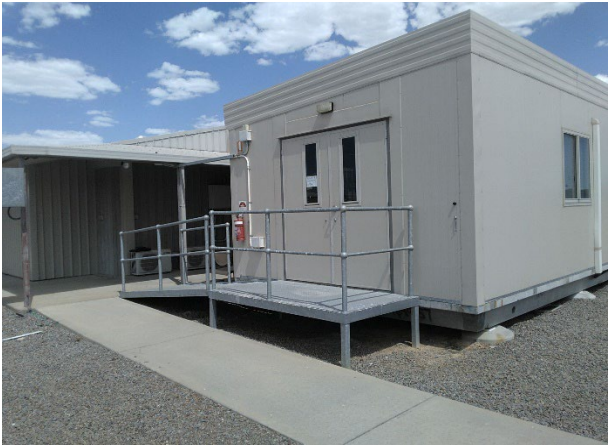
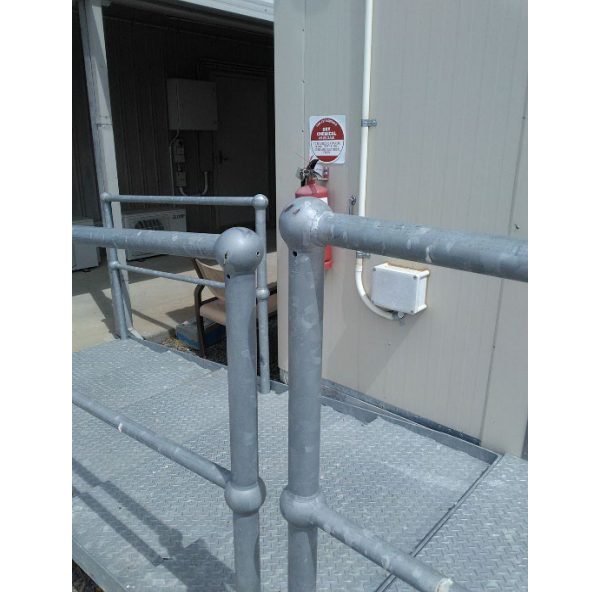
CS08-71	13/02/2024	Gym	1) No hi vis (yellow) tread installed onto the nosing of each stair. 2) 180mm gap between the building and handrail. Minimal risk of a injury in this situation.	C. Unlikely	2. Minor	Low	1) Hi vis (yellow) non-slip tread to be installed on the nosing of each stair. 2) No action required.

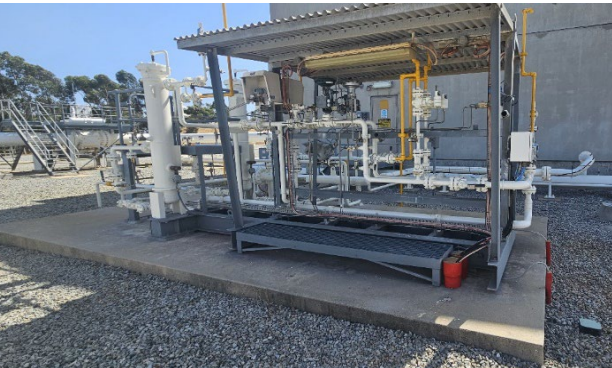
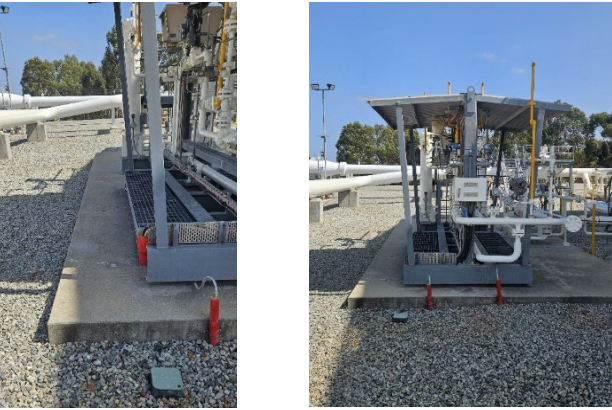
Replace ladder and landing. Pour new landing		
CS09-01	16/11/2023	Unit 1 - Fuel Gas Skid	1) No hi vis (yellow) tread installed onto the nosing of each stair. 2.1) The landing on one side of the skid does not meet AS1657 requirements of 600mm minimum. 2.2) On narrow concrete landing side, the height difference between the landing and blue metal allows potential for trip / slip. Note: INX-19141 Near Miss: Rolled Ankle when the FMO's foot landed on the narrow concrete landing on the narrow side.	C. Unlikely	2. Minor	Low	1) Install hi vis (yellow) tread onto the nosing of each stair. 2.1) Extend the landing. 2.2) Consider placing additional blue metal adjacent to landing.

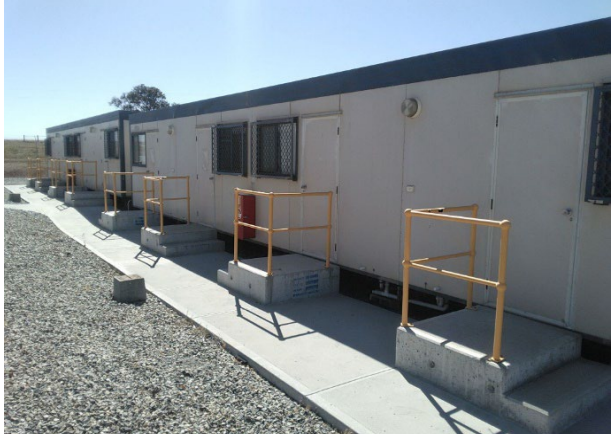
CS09-02	13/12/2023	External Accommodation Rooms	1) No hi vis (yellow) tread installed onto the nosing of each stair. 2) Minor different in stair risers identified but considered a minor risk in this situation.	C. Unlikely	2. Minor	Low	1) Hi vis (yellow) non-slip tread to be installed on the nosing of each stair. 2) No action required.

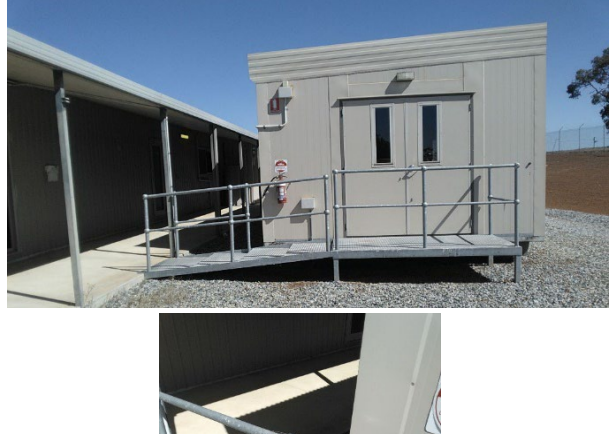
CS09-03	13/12/2023	Gym	1) No hi vis (yellow) tread installed onto the nosing of each stair. 2) 180mm gap between the building and handrail. Minimal risk of a injury in this situation.	C. Unlikely	2. Minor	Low	1) Hi vis (yellow) non-slip tread to be installed on the nosing of each stair. 2) No action required.

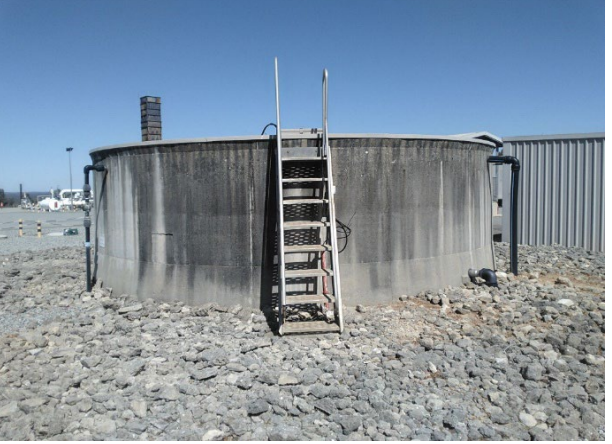
CS09-04	13/12/2023	Non-Potable Water Storage Tank	1) No purpose built landing is available. Personnel land on uneven rocks / surface. 2) No hi vis (yellow) tread installed onto the nosing of each stair. 3.1) Top of the stairs is used as a work platform. 3.2) No self closing gate has been installed for the work platform. 3.3) No top handrail has been installed on the right handside of the stairs.	C. Unlikely	3. Severe	Medium	1) Clear the ground and pour a concrete landing. 2) Install hi vis (yellow) tread onto the nosing of each stair. 3) Redesign the stairs or replace the stairs, so that AS requirements are met (e.g. self closing gate, adequate size landing, edge protection).

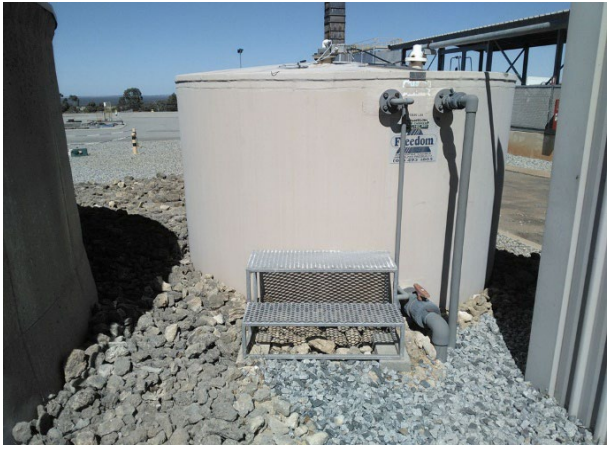
CS09-05	13/12/2023	Potable Water Storage Tank	1) Portable stairs are being used for both access and as a work platform, for the inspection hatch and fitting on the top of the tank. 2) No hi vis (yellow) tread installed onto the nosing of each stair. 3) No purpose built landing is available. Personnel land on uneven rocks / surface.	C. Unlikely	2. Minor	Low	1) Option A: Install concrete landing for platform ladder to be set up on. Option B: Install a purpose built platform and access stairs or ladder that is AS compliant. 2) Install hi vis (yellow) tread onto the nosing of each stair. 3) Clear the ground and pour a concrete landing.

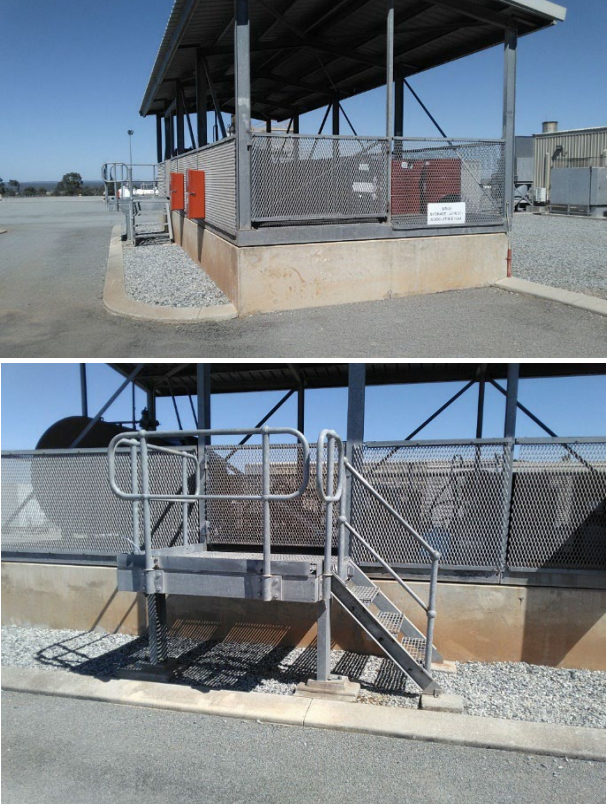
CS09-06	13/12/2023	Dangerous Good Storage Shed - Access Road Side	1) No landing for personnel is available, but concrete pads were installed for landing the stairs on. This poses a trip hazard and the uneven ground does not meet best practice or AS1657 requirements of 600mm minimum. 2) No hi vis (yellow) tread installed onto the nosing of the stairs.	C. Unlikely	2. Minor	Low	1) Pour a landing that meets AS requirements and eliminates the trip hazard. 2) Install hi vis (yellow) tread onto the nosing of the stairs.

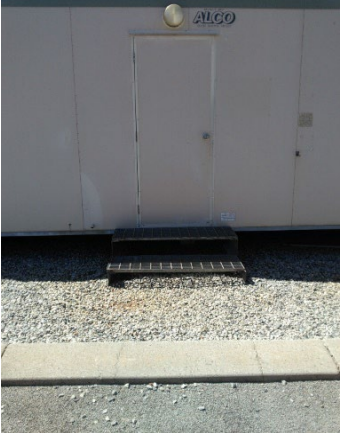
Reference	Date added	Location on Site	Issue	Likelihood	Consequence	Risk Score	Suggestions	Evidence	What is being completed	Date planned for completion	Date completed
CS09-16	13/12/2023	Storeroom	1) No hi vis (yellow) tread installed onto the nosing of each stair. 2) No designated landing available. Personnel step onto loose blue metal.	B. Remote	2. Minor	Low	1) Install hi vis (yellow) tread onto the nosing of the stairs. 2) Pour a landing that meets AS requirements.

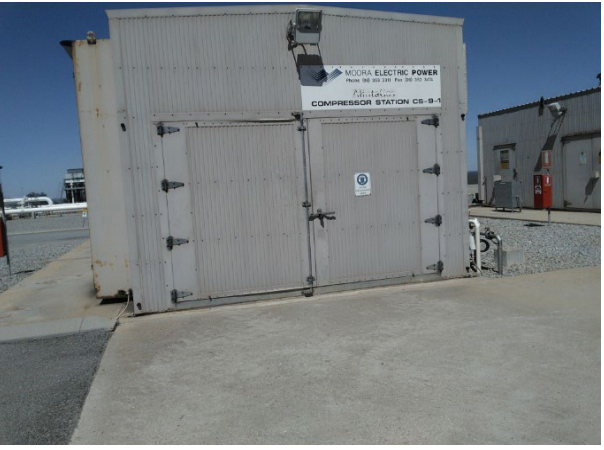
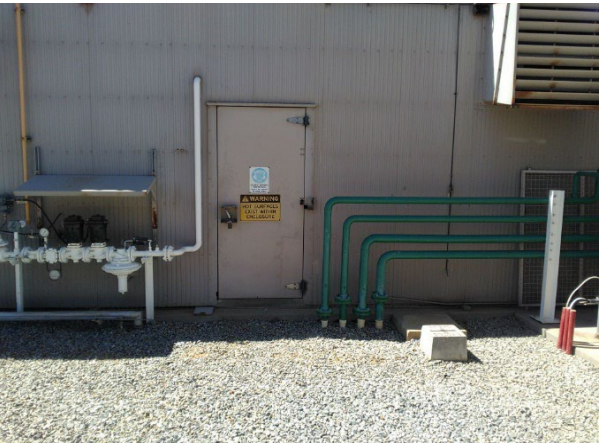
CS09-17	13/12/2023	GEA 1 (Modra 09-01)	1) Landing for the doors on one side of the GEA does not meet AS1657 requirements of 600mm minimum. 2) The landing for the doors on one side of the GEA have a section of small bore piping that poses a trip hazard.	C. Unlikely	3. Severe	Medium	1) Extend the landing. 2) Option A: Reroute the piping to outside of the walkway. Option B: Install a step over it to eliminate potential interaction with the piping at the access door. Spray paint (yellow) the remaining section of pipe to highlight the hazard.

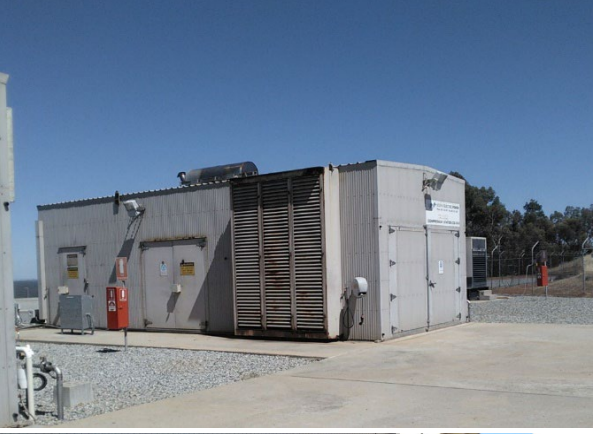
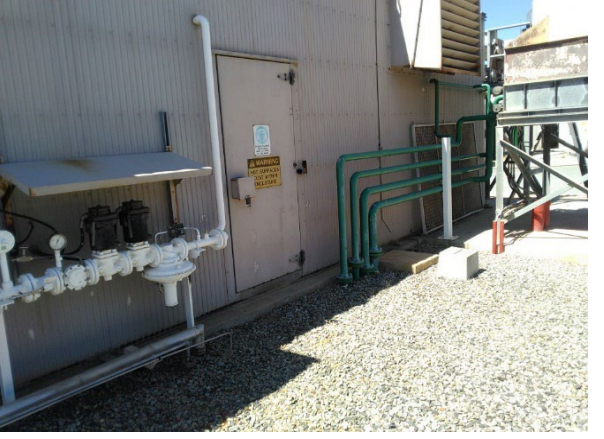
CS09-18	13/12/2023	GEA 2 (Modra 09-02)	1) Landing for the doors on one side of the GEA does not meet AS1657 requirements of 600mm minimum. 2) The landing for the doors on one side of the GEA have a section of small bore piping that poses a trip hazard.	C. Unlikely	3. Severe	Medium	1) Extend the landing. 2) Option A: Reroute the piping to outside of the walkway. Option B: Install a step over it to eliminate potential interaction with the piping at the access door. Spray paint (yellow) the remaining section of pipe to highlight the hazard.

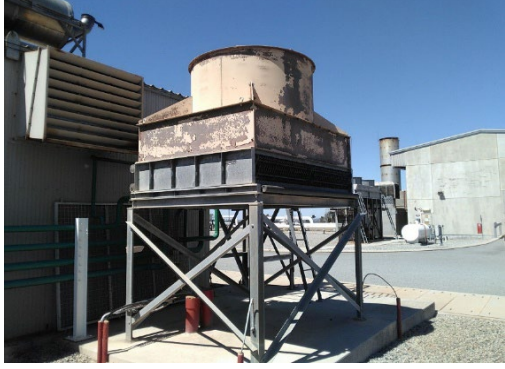
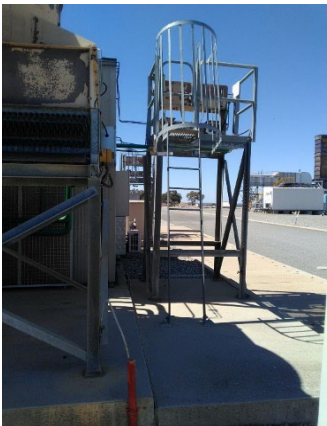
CS09-19	13/12/2023	GEA 1 / GEA 2 - After Cooler Fans	1) No hi vis (yellow) tread installed onto the ladder rungs. 2) The landing for the ladder does not meet AS1657 requirements of 600mm minimum.	C. Unlikely	2. Minor	Low	1) Install hi vis (yellow) tread onto the ladder rungs. 2) Extend the landing.

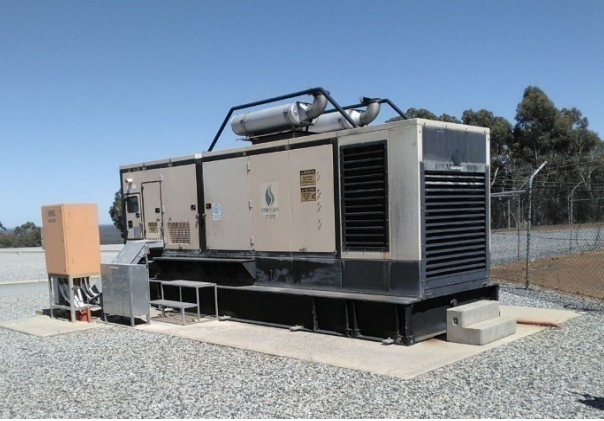
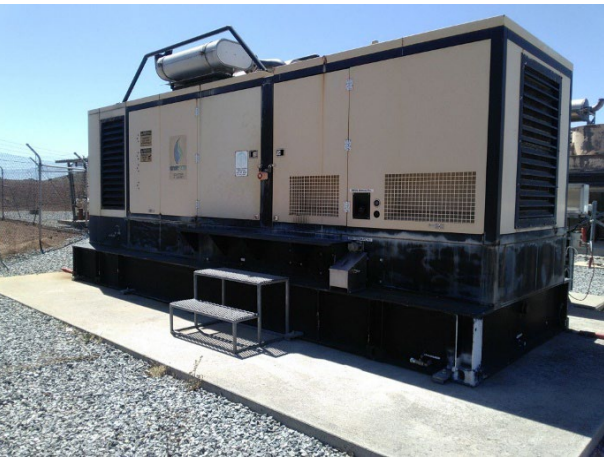
CS09-20	13/12/2023	Energen DEA - 2 x Sides	1) Temporary steps (width 1000mm, depth 300mm) have been provided on both sides to enable access to the work platform. The temporary steps complies with the AS requirement with the exemption of: - Step up from the ground to first step (300mm) and from the last stair onto the work platform (380mm) (AS requirement is 300-450mm requires a minimum of 1 step be provided); - Riser is 300mm (AS requirement is 130-225mm). 2) No handrails have been installed for the access stairs. 3) The work platform has no edge protection installed (width 2500mm, depth 290mm). This creates a fall risk of 1000mm. Note: Conversations with FMOs confirmed that the black work platform is used during inspection and maintenance tasks and when refuelling. 4) No hi vis (yellow) tread installed on the nosing of the stairs and work platform.	D. Occasional	3. Severe	High	1) Remove the temporary stairs with a purpose built access stairs that complies with the AS requirements. 2) The replacement access stairs are designed and installed with both handrails in place. Note: Relocating the existing equipment on south side may be required. 3) Redesign or replace the work platform with a purpose build platform that complies with the AS requirements including adequate edge protection. 4) Install hi vis (yellow) non-slip tread installed on the nosing of the stairs and work platform.
