Revised Final Plan
Attachment 9.12

Structures & Operational Sites - Working at Heights - Appendix B

**Dampier Bunbury
Pipeline**

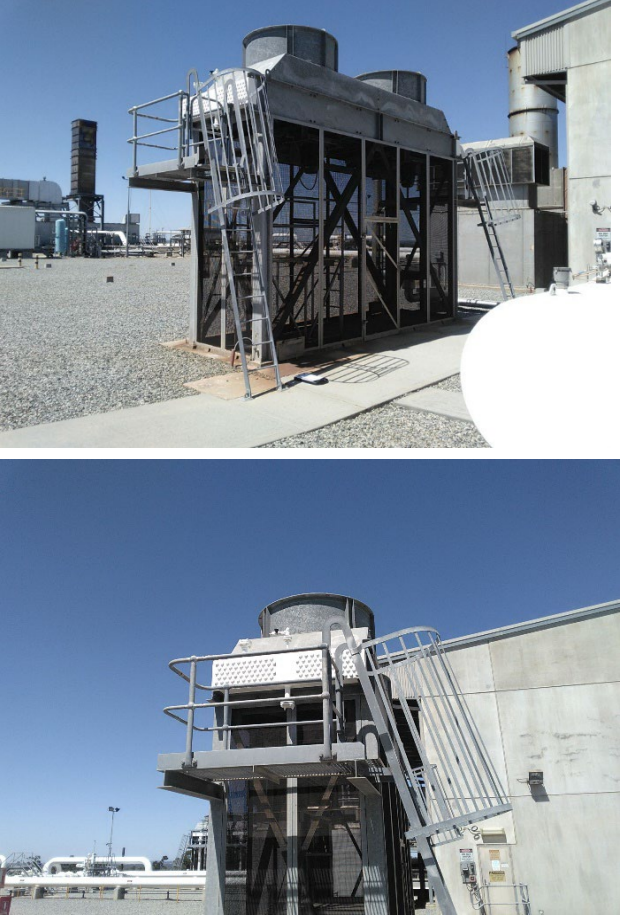
Reference	Date added	Location on Site	Issue	Likelihood	Consequence	Risk Score	Suggestions	Evidence	What is being completed	Date planned for completion	Date completed
CS09-21	13/12/2023	Unit 1 - After Cooler Fans	1) No hi vis (yellow) tread installed onto the ladder rungs. 2) The landing for the ladders (from ground to first platform) does not meet AS1657 requirements of 600mm minimum. 3) The step up from the landing to the first ladder rung exceeds AS requirements. 4) There is no method for accessing the top of the after cooler fans without climbing onto structural steel and being exposed to a fall.	C. Unlikely	4. Major	High	1) Install hi vis (yellow) tread onto the ladder rungs. 2) Extend the landing. 3) Modify the ladder or install a intermediate step to ensure the step up distances in AS1657 are met. 4) Consider installing a platform to enable access to the top of the after cooler fans.

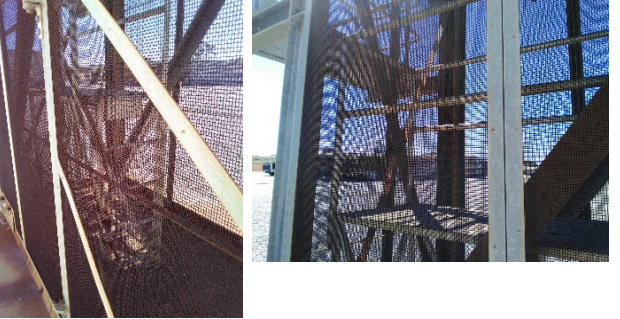
CS09-22	13/12/2023	Mobile Scaffold - Inside of Unit 1 After Cooler Fans Enclosure	1) No hi vis (yellow) tread installed onto the ladder rungs. 2) No handrail and self closing gate around the ladder opening. 3) The mid rail on one side of the mobilise scaffold is missing.	C. Unlikely	3. Severe	Medium	1) Install hi vis (yellow) tread onto the ladder rungs. 2) Install handrail and self closing gate (or equivalent) around the ladder opening. 3) Install a mid rail on the missing side of the mobile scaffold.

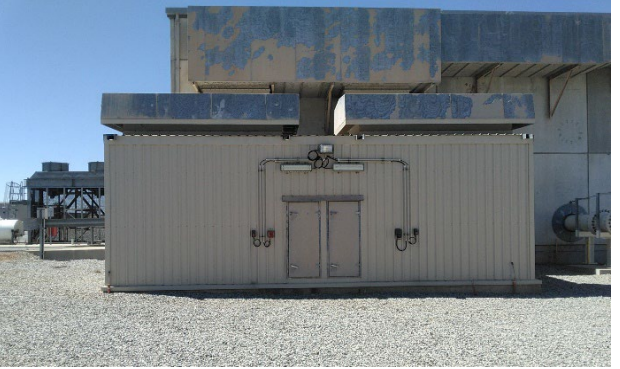
CS09-23	13/12/2023	Unit 1 - Access doors	1) No designated landing available. Personnel step onto loose blue metal.	B. Remote	2. Minor	Low	1) Pour a landing that meets AS requirements.

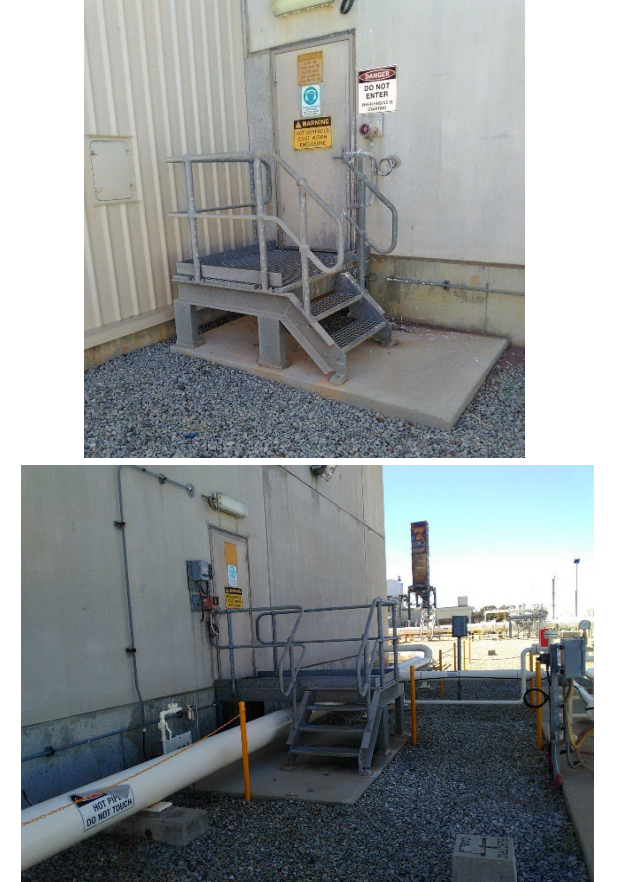
CS09-24	13/12/2023	Unit 1 - Access Stairs	1) No hi vis (yellow) tread installed onto the nosing of each stair.	C. Unlikely	2. Minor	Low	1) Install hi vis (yellow) tread onto the nosing of each stair.

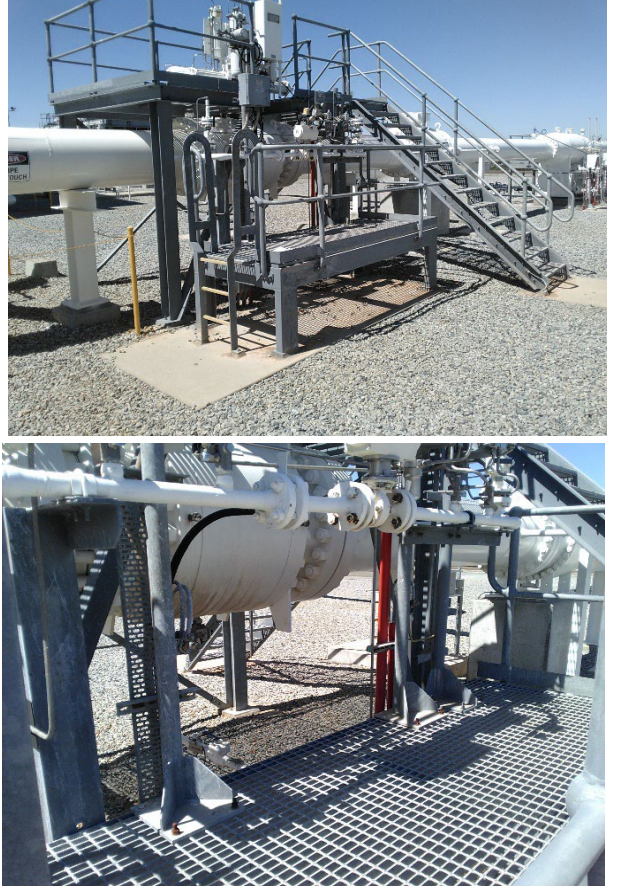
CS09-25	13/12/2023	Unit 1 - Suction Valve (Middle Platform)	1) No self closing gate has been installed. This leaves an open edge when working on the platform. 2) No handrail or kick plate on the south side of platform (where pipe is positioned)	C. Unlikely	2. Minor	Low	1) Install a self closing gate at the top of the ladder. 2) Consider installing handrail and kick plate so edge protection is provided on all side of the platform.

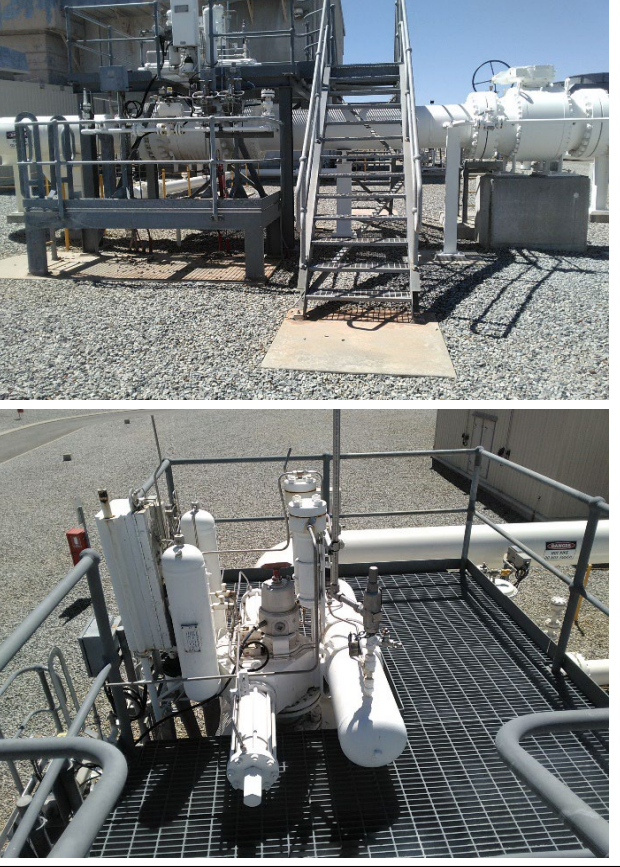
CS09-26	13/12/2023	Unit 1 - Bettis Equipment	1) No hi vis (yellow) tread installed onto the nosing of each stair.	C. Unlikely	2. Minor	Low	1) Install hi vis (yellow) tread onto the nosing of each stair.

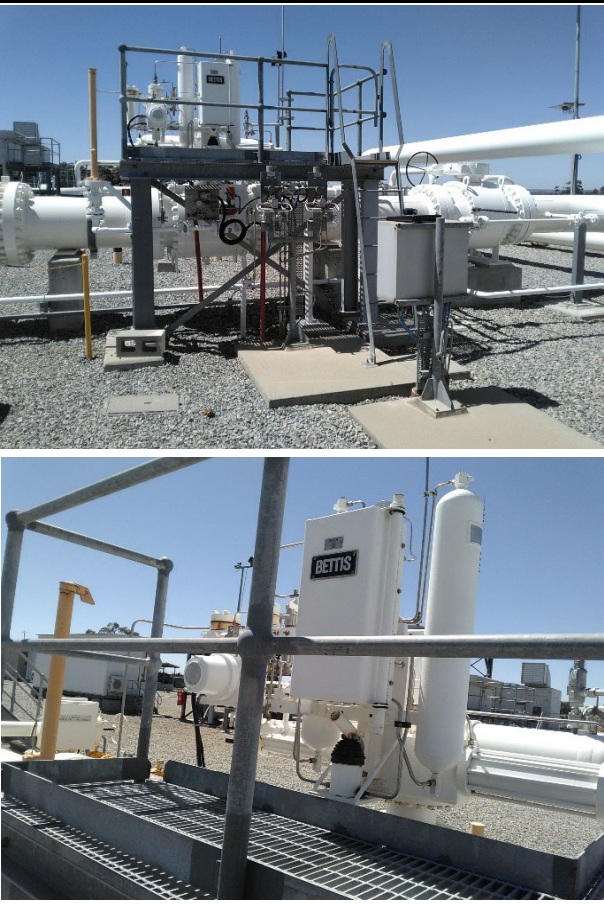
Reference	Date added	Location on Site	Issue	Likelihood	Consequence	Risk Score	Suggestions	Evidence	What is being completed	Date planned for completion	Date completed
CS09-27	13/12/2023	Bettis Equipment Near After Coolers (UV1316)	<p>1) Accessing the ladder and the landing is obstructed by FMB 6 Cabinet. ~350mm usable of landing.</p> <p>2) No hi vis (yellow) tread installed onto the nosing of each stair.</p> <p>3) No handrail install on side where Bettis Equipment is installed. Potential to lose balance and fall.</p>	C. Unlikely	3. Severe	Medium	<p>1) Move FMB6 Cabinet if feasible. If not feasible, consider using hi vis paint and/or padding to reduce risk of injury.</p> <p>2) Install hi vis (yellow) tread onto the nosing of each stair.</p> <p>3) Consider installing handrails that provide edge protection without impacting access for operation / maintenance tasks.</p>

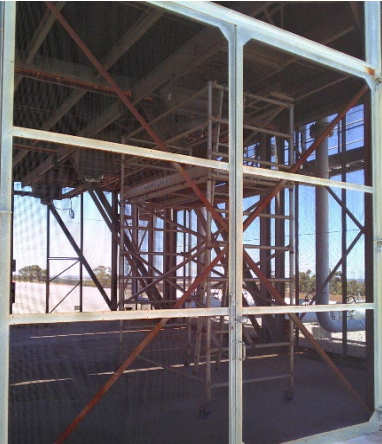
CS09-28	13/12/2023	After Cooler Fans - Mobile Scaffold on Ground Level	<p>1) No hi vis (yellow) tread installed onto the ladder rungs.</p> <p>2) No handrail and self closing gate around the ladder opening.</p> <p>3) The mid rail on one side of the mobilise scaffold is missing.</p>	C. Unlikely	3. Severe	Medium	<p>1) Install hi vis (yellow) tread onto the ladder rungs.</p> <p>2) Install handrail and self closing gate (or equivalent) around the ladder opening.</p> <p>3) Install a mid rail on the missing side of the mobile scaffold.</p>

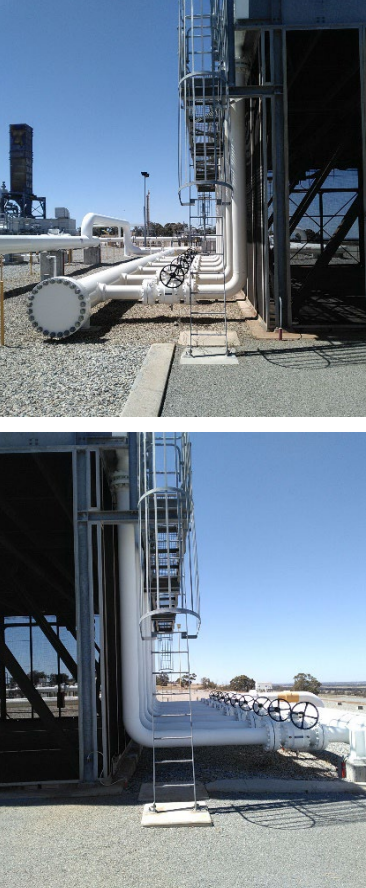
CS09-29	13/12/2023	Middle Platform (Access Way) For After Cooler Fans	<p>1) No hi vis (yellow) tread installed onto the ladder rungs.</p> <p>2) The landing for the ladders (from ground to first platform) does not meet AS1657 requirements of 600mm minimum.</p>	C. Unlikely	2. Minor	Low	<p>1) Install hi vis (yellow) tread onto the ladder rungs.</p> <p>2) Extend the landing.</p>

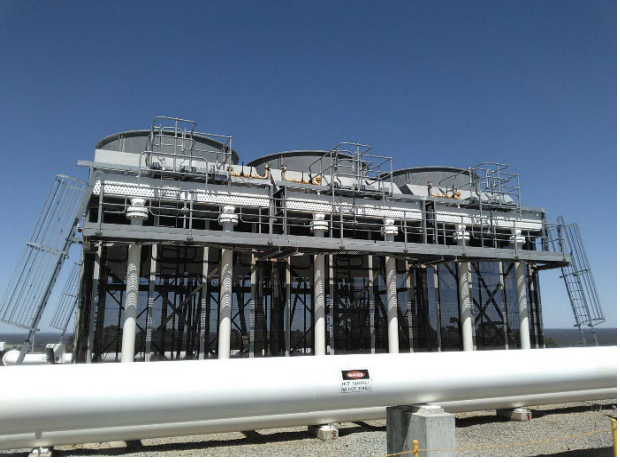
CS09-30	13/12/2023	Top Platform for each After Cooler Fan	<p>1.1) There is no method for accessing this platform from the below walkway without climbing onto structural steel and being exposed to a fall.</p> <p>1.2) Gap between the existing handrail and the structure on both sides of the platform. This poses a potential of a slip / trip.</p> <p>2) No hi vis (yellow) tread installed onto the ladder rungs.</p>	C. Unlikely	4. Major	High	<p>1.1) Install signage to highlight the fall from height risk until a suitable means of access is installed.</p> <p>1.2) Modify the platform to - allow for safe access to the top of the fans; - eliminate or reduce the gap between the existing handrail and floor / structure.</p> <p>2) Install hi vis (yellow) tread onto the ladder rungs.</p>

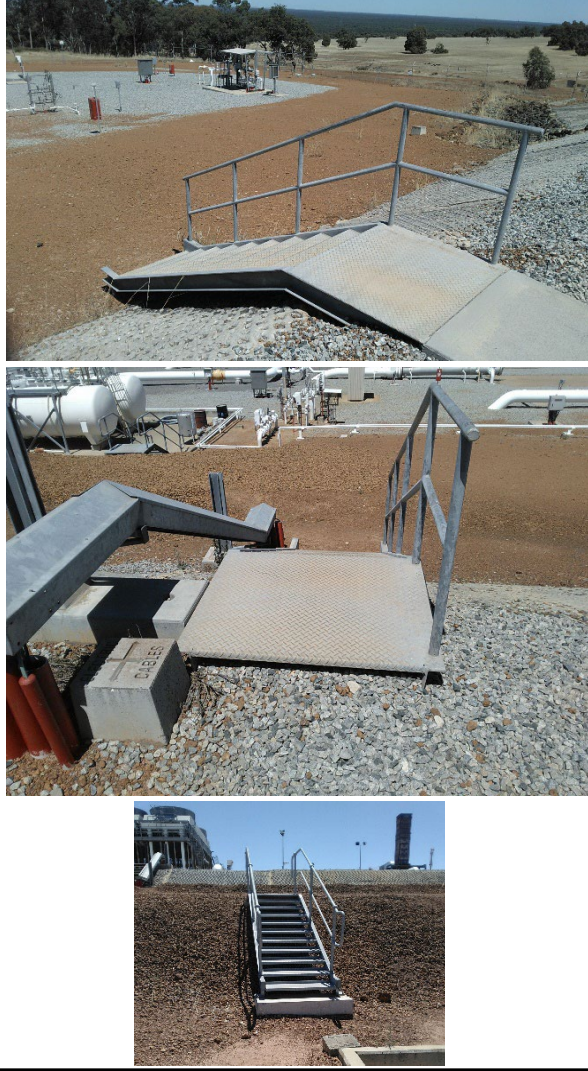
CS09-31	13/12/2023	Access Stairs Between Compressor Station Plant and Ordorant Storage Facilities	<p>1) Some stairs only one handrail installed.</p> <p>2) Some stairs do not have a designated landing at the top and/or bottom. In some cases it is dirt or blue metal.</p> <p>3) One landing does not meet AS requirements.</p> <p>4) No hi vis (yellow) tread installed onto the nosing of each stair.</p>	C. Unlikely	2. Minor	Low	<p>1) Install a handrails for the stairs without a handrail on both sides.</p> <p>2) Pour a landing that meets AS requirements, where one does not already exist.</p> <p>3) Extend the landing to meet AS requirements.</p> <p>4) Install hi vis (yellow) tread onto the nosing of each stair.</p>

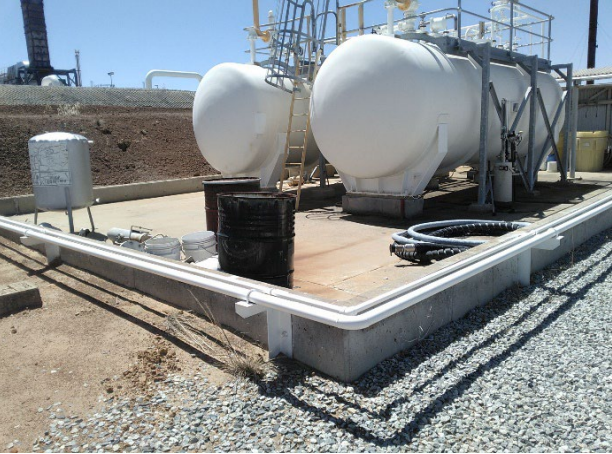
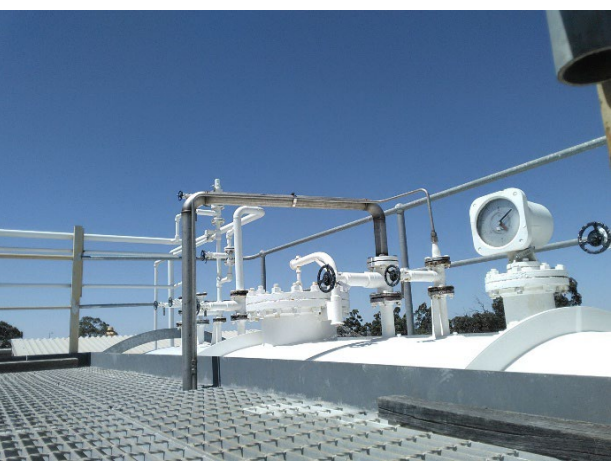
Reference	Date added	Location on Site	Issue	Likelihood	Consequence	Risk Score	Suggestions	Evidence	What is being completed	Date planned for completion	Date completed
CS09-32	13/12/2023	2 x Mercaptain Vessels	1) No non-slip tread on the access ladder rungs.	B. Remote	2. Minor	Low	1) Install hi vis (yellow) non-slip tread on the ladder rungs.

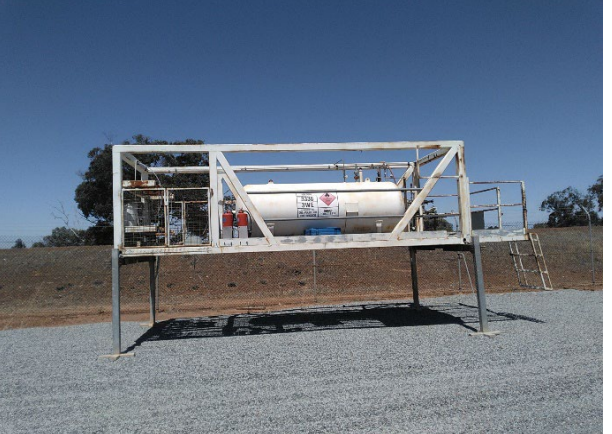
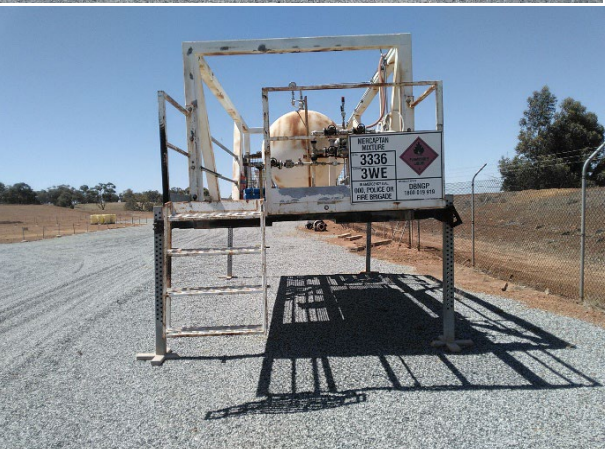
CS09-33	13/12/2023	Mercaptain Storage Vessel and Frame	1) Ladder does not meet AS requirements (e.g. full length, no handrails, no gate). <i>Note: Unclear if this structure is mothballed. FMOs / Superintendent to advised.</i>	C. Unlikely	3. Severe	Medium	1) Modify or replace the access stairs that meet AS requirements.

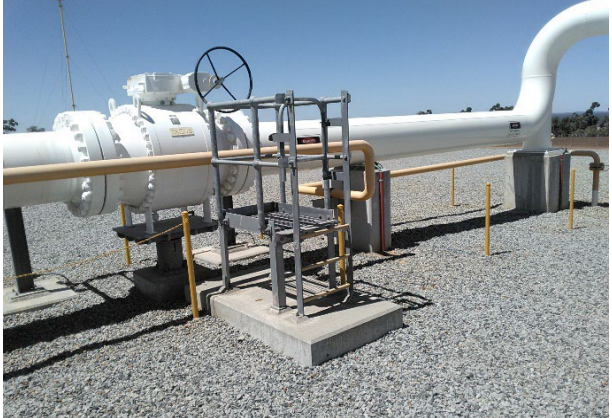
CS09-34	13/12/2023	Platform for HV2318	1) Landing does not meet AS requirement of 900mm	C. Unlikely	2. Minor	Low	1) Extend the landing.

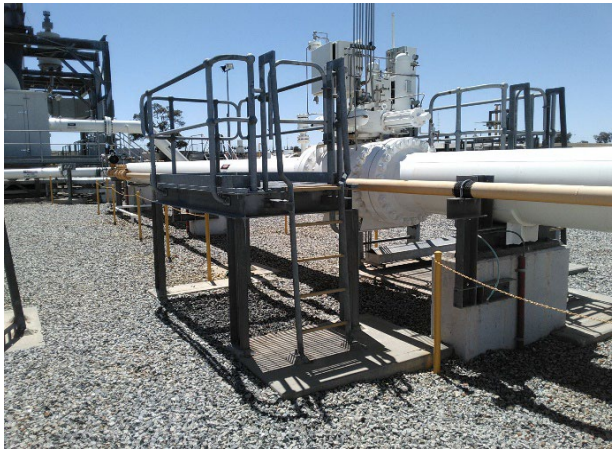
CS09-35	13/12/2023	Platform for PS2316	1) Landing does not meet AS requirement of 900mm	C. Unlikely	2. Minor	Low	1) Extend the landing.

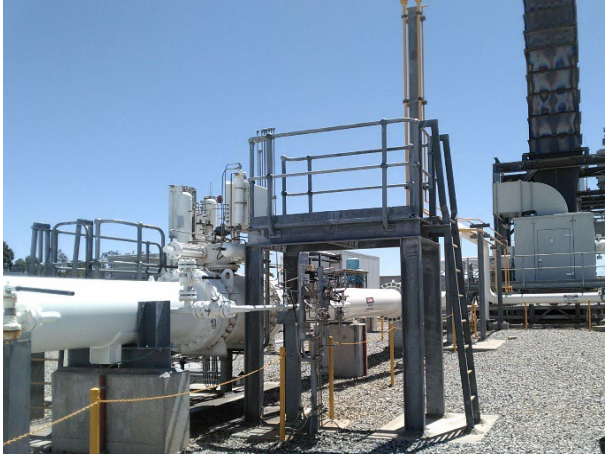
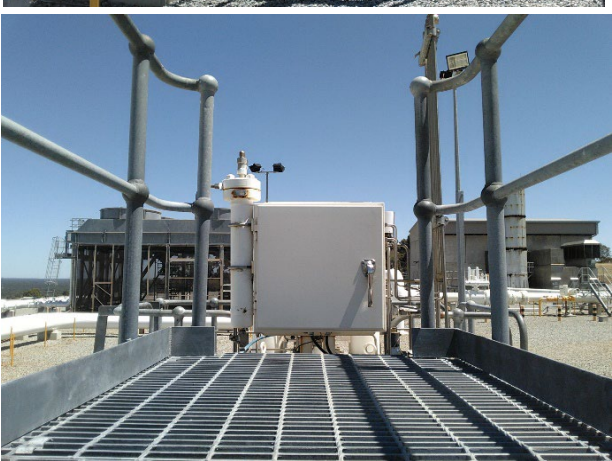
CS09-36	13/12/2023	Platform above UV2306	1) Landing does not meet AS requirement of 900mm	C. Unlikely	2. Minor	Low	1) Extend the landing.

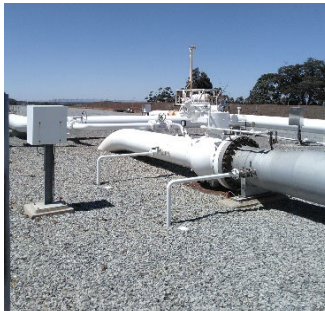
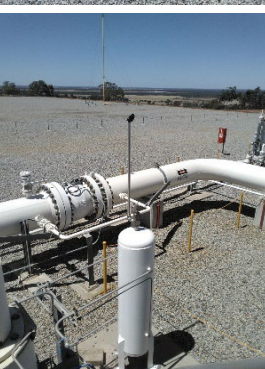
CS09-37	13/12/2023	Multiple Risers and Vents around Site	1) Access to Risers and Vents up to maintenance tasks are currently completed using a platform ladder on blue metal. This creates the potential for the ladder to be unstable and cause a fall from height.	C. Unlikely	3. Severe	Medium	Option A: Install concrete landing for platform ladder to be set up on. Option B: Install a purpose built platform and access stairs or ladder that is AS compliant.

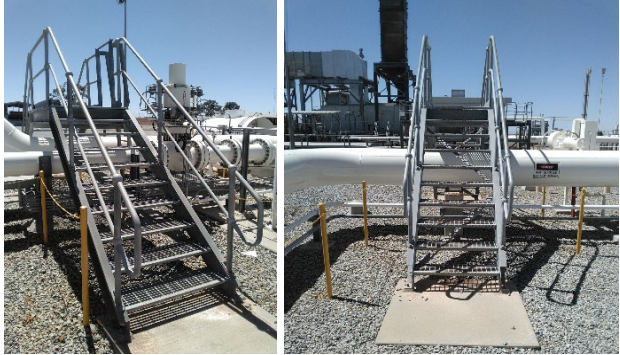
Reference	Date added	Location on Site	Issue	Likelihood	Consequence	Risk Score	Suggestions	Evidence	What is being completed	Date planned for completion	Date completed
CS09-38	13/12/2023	Multiple Walkways over Pipework	1) Some access stairs do not have hi vis (yellow) tread installed on the nosing of each stair.	D. Occasional	2. Minor	Low	1) Install hi vis (yellow) tread on the nosing on the stairs.

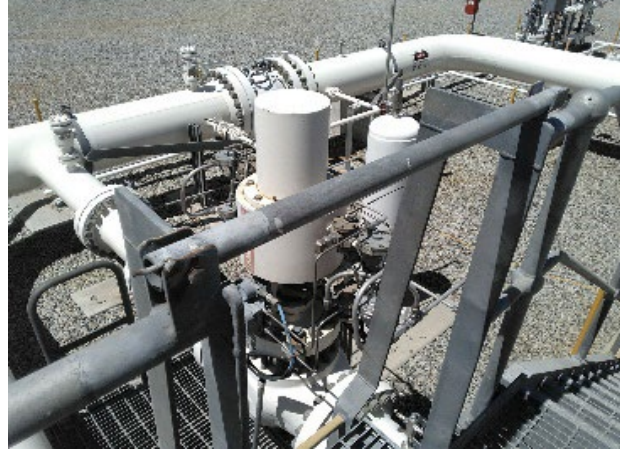
CS09-39	13/12/2023	Unit 3 Pipework (South Side) - Access Ladder For Valtek Flowserve Platform	1) Gate is not self closing (manual drop bar) and therefore is not AS compliant. It is also reliant on human behaviour to close the gate after each use. 2) No hi vis (yellow) tread is installed on the nosing of top platform / top ladder rung.	C. Unlikely	2. Minor	Low	1) Replace the existing gate with a self closing gate. 2) Install hi vis (yellow) tread on the nosing top platform / top ladder rung.

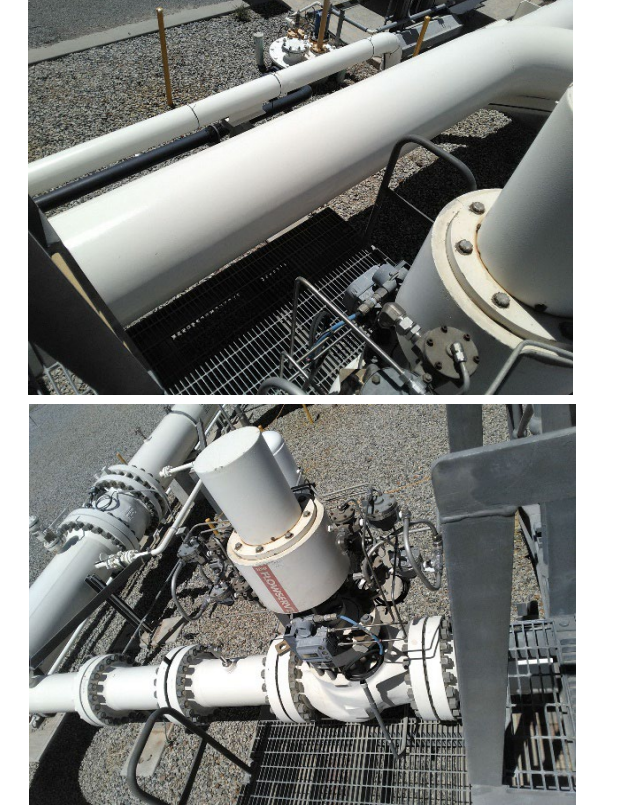
CS09-40	13/12/2023	Unit 3 Pipework (South Side) - Platform For Valtek Flowserve	1) Gap (200mm) between the grid mesh and adjacent pipework does not meet AS requirements. 2) Gap (260mm) between the handrails and adjacent pipework does not meet AS requirements.	C. Unlikely	1. Trivial	Low	1) Modify the platform and install kick plates to reduce the risk of a trip / fall through the open edges. 2) Modify the handrail to eliminate or reduce the gap between the handrail and adjacent pipework.

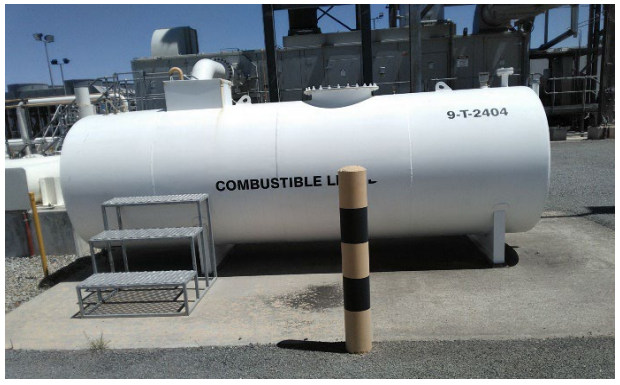
CS09-41	13/12/2023	Combustible Liquid Tank - South of Unit 3	1) Portable stairs are being used for both access and as a work platform. The riser also exceeds AS requirements. 2) No hi vis (yellow) tread installed onto the nosing of each stair.	C. Unlikely	3. Severe	Medium	1) Replace the temporary stairs with purpose built access stairs and platform that meets AS requirements.

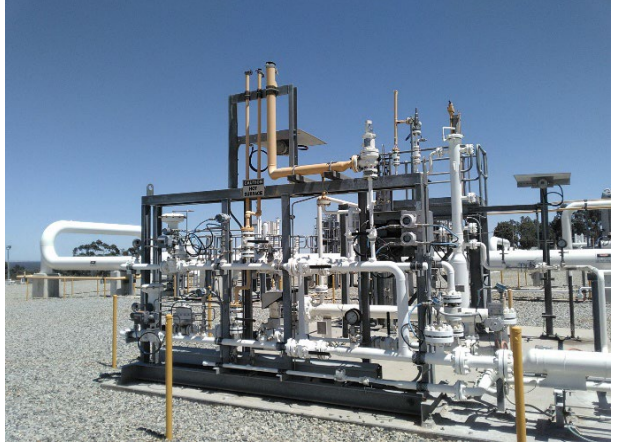
CS09-42	13/12/2023	Unit 3 Fuel Gas Skid	1) Access to Risers and Vents up to maintenance tasks are currently completed using a platform ladder on blue metal. This creates the potential for the ladder to be unstable and cause a fall from height.	C. Unlikely	3. Severe	Medium	Option A: Extend the concrete landing to provide room for a platform ladder to be set up on it. Option B: Install a purpose built platform and access stairs or ladder that is AS compliant.

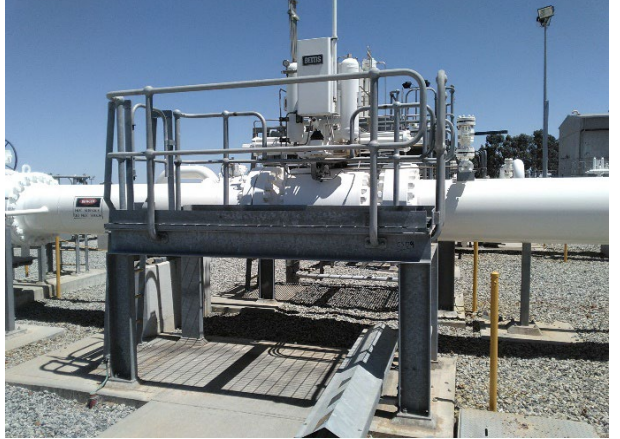
CS09-43	13/12/2023	Bettis Equipment Platform	1) No hi vis (yellow) tread installed onto each ladder rung. 2) No handrail install on side where Bettis Equipment is installed. Potential to lose balance and fall.	C. Unlikely	3. Severe	Medium	1) Install hi vis (yellow) tread onto the ladder rungs. 2) Consider installing handrails that provide edge protection without impacting access for operation / maintenance tasks.

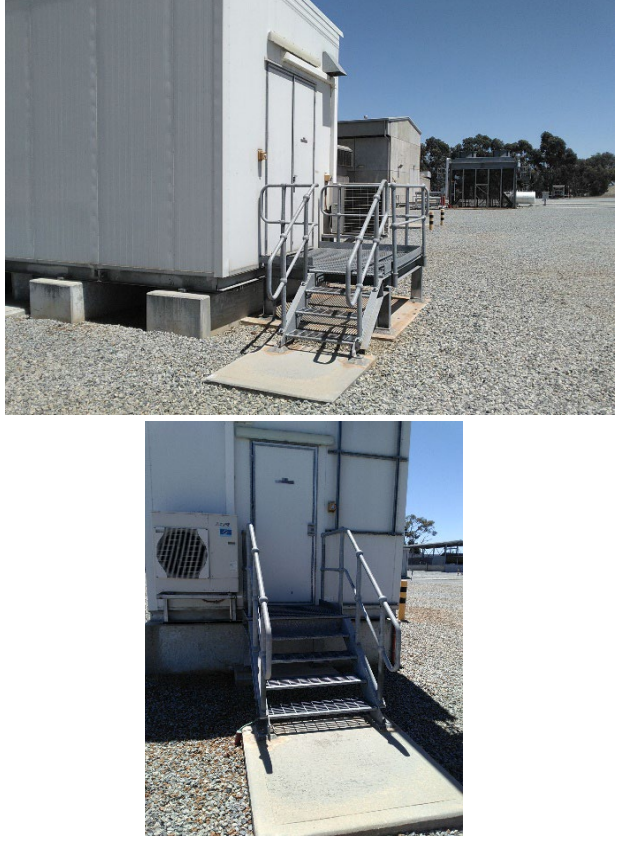
CS09-44	13/12/2023	Equipment Room Near Unit 2	1) Two sets of access stairs do not have hi vis (yellow) tread installed on the nosing of each stair.	D. Occasional	2. Minor	Low	1) Install hi vis (yellow) tread on the nosing on the stairs.

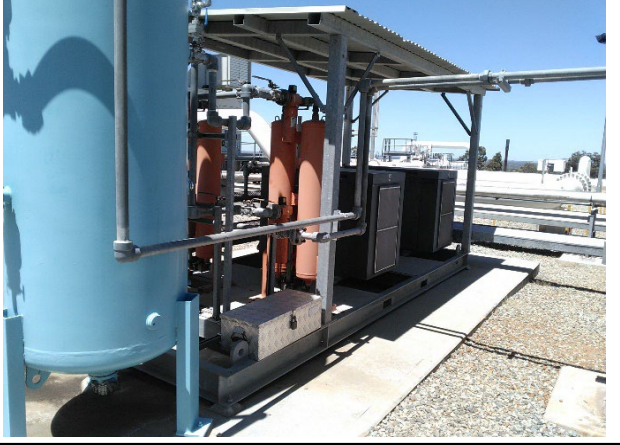
CS09-45	13/12/2023	Desiccant Dryers x 2	1) No hi vis (yellow) tread installed on the nosing of the platform.	B. Remote	2. Minor	Low	1) Install hi vis (yellow) tread onto the nosing of the two access points.

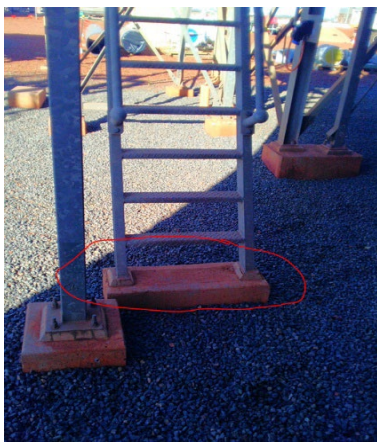
Reference	Date added	Location on Site	Issue	Likelihood	Consequence	Risk Score	Suggestions	Evidence	What is being completed	Date planned for completion	Date completed
	2/02/2023	Example - Lube oil cooler unit 1	1) Landing does not meet AS requirement of 900mm 2) Stair treads too narrow and no non-slip				1.1) Remove old landing and install new precast one 1.2) Pour new landing 2.1) Replace ladder with new treads and non-slip

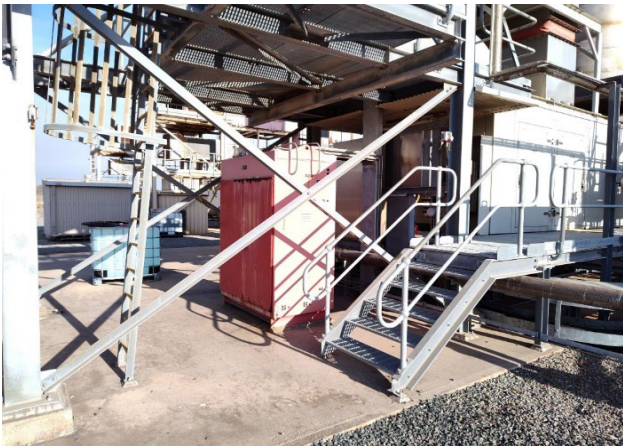
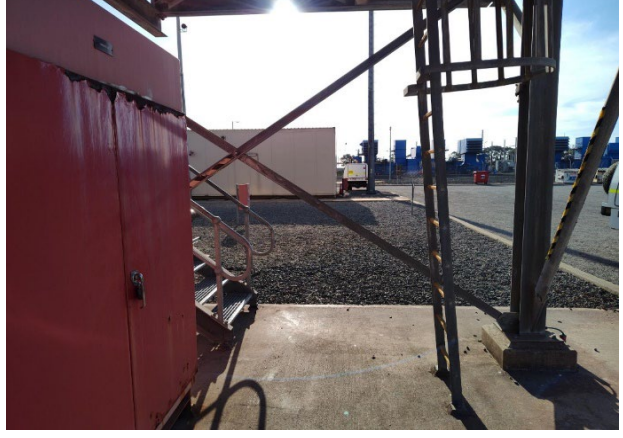
Replace ladder and landing. Pour new landing		
CS10-01	16/11/2023	Unit 3 Fire Suppression System Cabinet	1) Insufficient head room for personnel to walk under the cross bracing without having to duck down. This is a access route between the Unit 3 stairs and the Fire Suppression System Cabinet. Note: INX-19106 FMO struck head on the steel bracing, FAI Injury.	D. Occasional	2. Minor	Low	1) Option A: Install a handrail to prevent personnel using this as a access route (shortcut). Option B: Install hi vis tape and/or scaff pad (or similar) to highlight the hazard and protect personnel if contact is made.

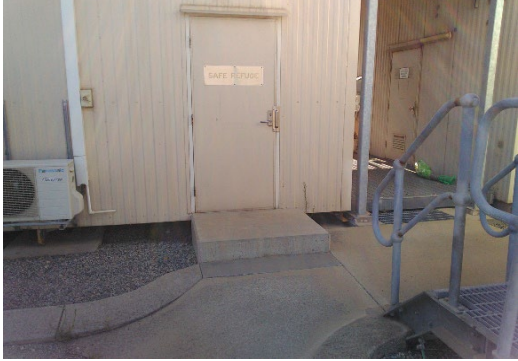
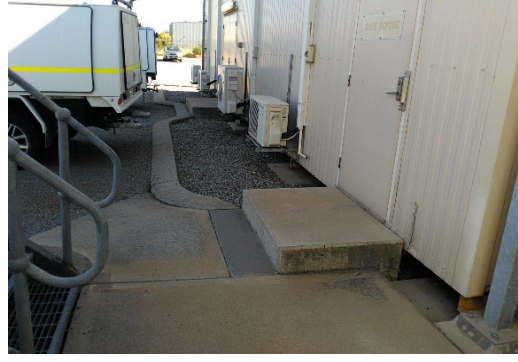
CS10-02	15/12/2023	Office / Crib Room - Access Doors	1) Concrete steps do not have hi vis installed on nosing.	C. Unlikely	2. Minor	Low	1) Install hi vis tape or similar onto the nosing of the concrete steps.

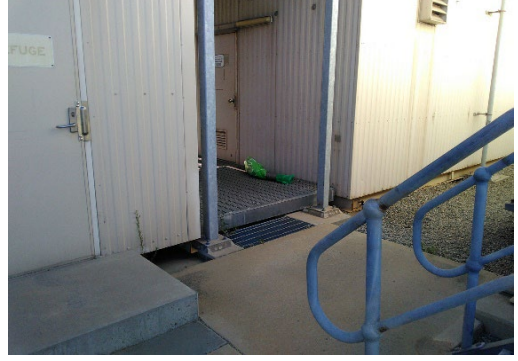
CS10-03	15/12/2023	Breezeway between Office / Crib Room and Control Room	1) No hi vis (yellow) tread installed on the nosing of the stairs / platform.	C. Unlikely	2. Minor	Low	1) Install hi vis (yellow) non-slip tread installed on the nosing of the stairs / platform.

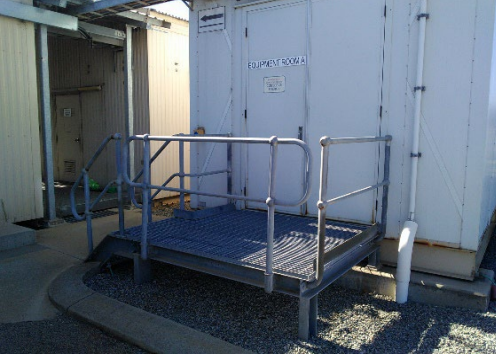
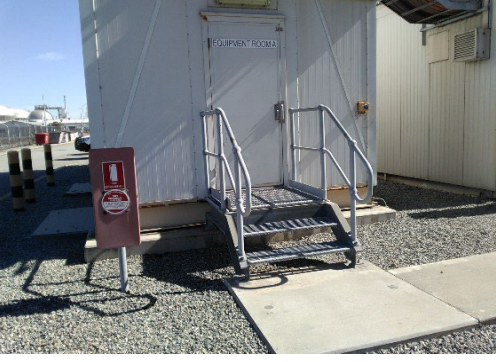
CS10-04	15/12/2023	Equipment Room A	1) No hi vis (yellow) tread installed on the nosing of the stairs.	C. Unlikely	2. Minor	Low	1) Install hi vis (yellow) non-slip tread installed on the nosing of the stairs.

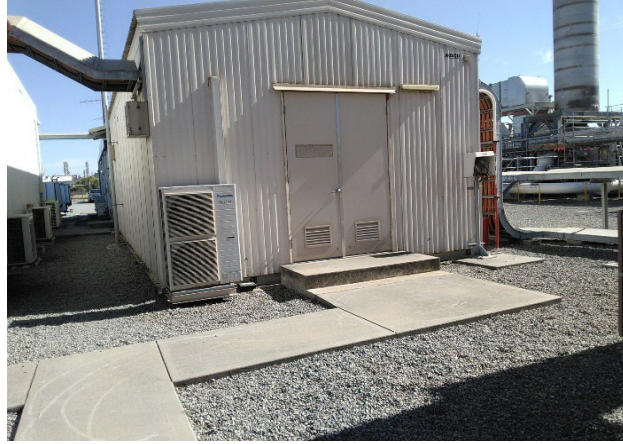
CS10-05	15/12/2023	Control Room / Substation - Rear Doors	1) Concrete steps do not have hi vis installed on nosing.	C. Unlikely	2. Minor	Low	1) Install hi vis tape or similar onto the nosing of the concrete steps.

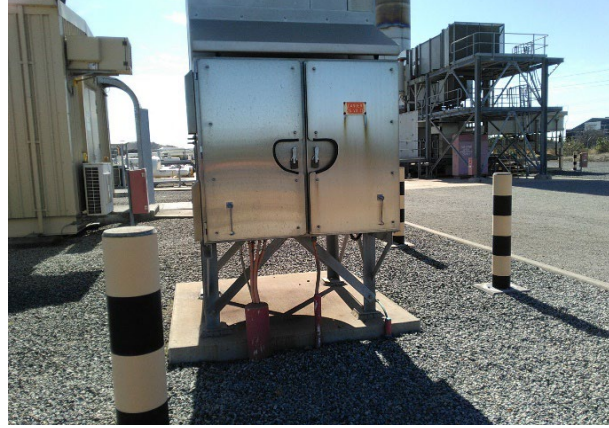
CS10-07	15/12/2023	Load Bank	1) No landing installed for personnel to stand on.	C. Unlikely	2. Minor	Low	1) Pour a new landing.

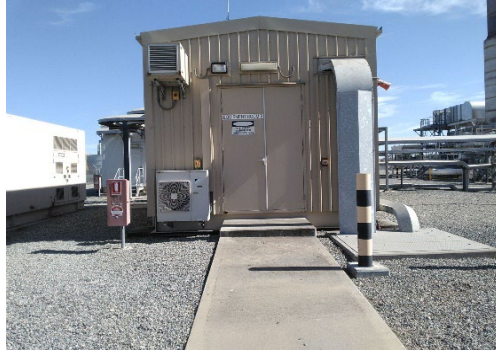
CS10-08	15/12/2023	Equipment Room B	1) No hi vis (yellow) tread installed on the nosing of the stairs.	C. Unlikely	2. Minor	Low	1) Install hi vis (yellow) non-slip tread installed on the nosing of the stairs.

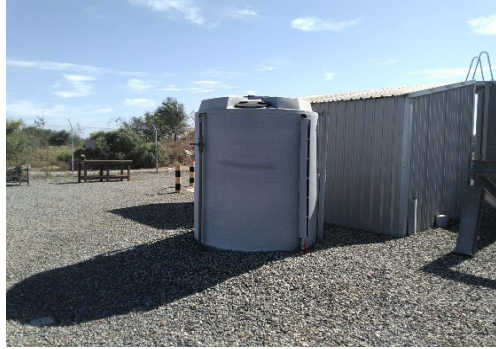
CS10-09	15/12/2023	5000L Green Tank	1) Access to the inspection hatch on the top of the tank is current by only possible by setting up a platform ladder on blue metal. This creates the potential for the ladder to be unstable and cause a fall from height. <i>Note: Potential for a fall of ~2m.</i>	C. Unlikely	3. Severe	Medium	1) Option A: Install concrete landing for platform ladder to be set up on. Option B: Install a purpose built platform and access stairs or ladder that is AS compliant.

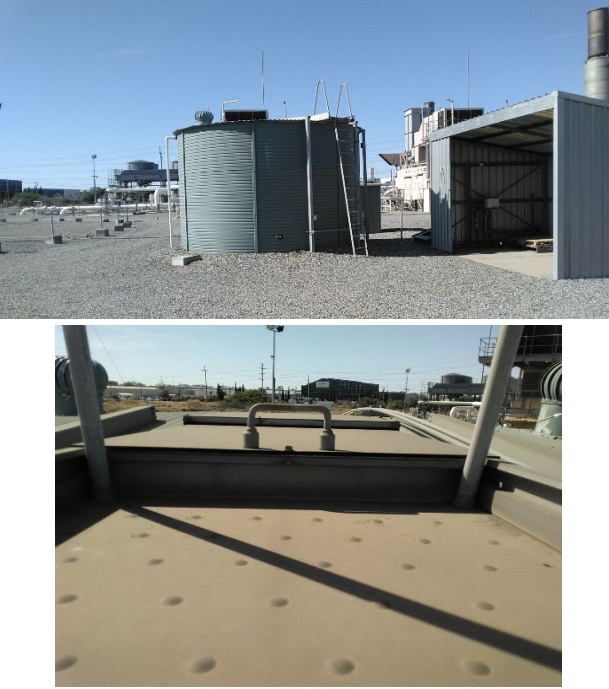
CS10-10	15/12/2023	Potable Water Tank (Larger Green Tank)	1) No purpose built landing is available. Personnel land on uneven blue metal / surface. 2) No hi vis (yellow) tread installed onto the nosing of each ladder rung. 3.1) Top of the ladder is used as a work platform. 3.2) No self closing gate has been installed for the work platform. 3.3) Handrails do not meet AS requirements	C. Unlikely	3. Severe	Medium	1) Clear the ground and pour a concrete landing. 2) Redesign the ladder and work platform or replace the stairs and work platform, so that AS requirements are met (e.g. self closing gate, adequate size landing, edge protection, hi vis tread on ladder rungs).

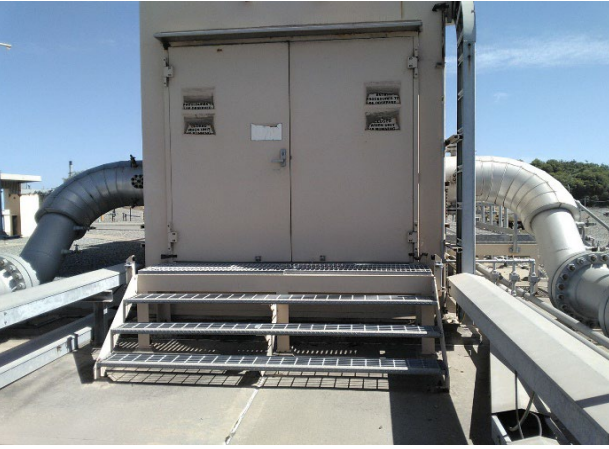
CS10-12	15/12/2023	Unit 1 Access Stairs - South Side	1) No hi vis (yellow) tread installed on the nosing of the stairs. 2) No handrails have been installed on the stairs on the South side of Unit 1.	C. Unlikely	3. Severe	Medium	1) Install hi vis (yellow) non-slip tread installed on the nosing of the stairs. 2) Pour a new landing. 3) Install handrails on the outer edges and centre of the stair cases on the South side of Unit 1.

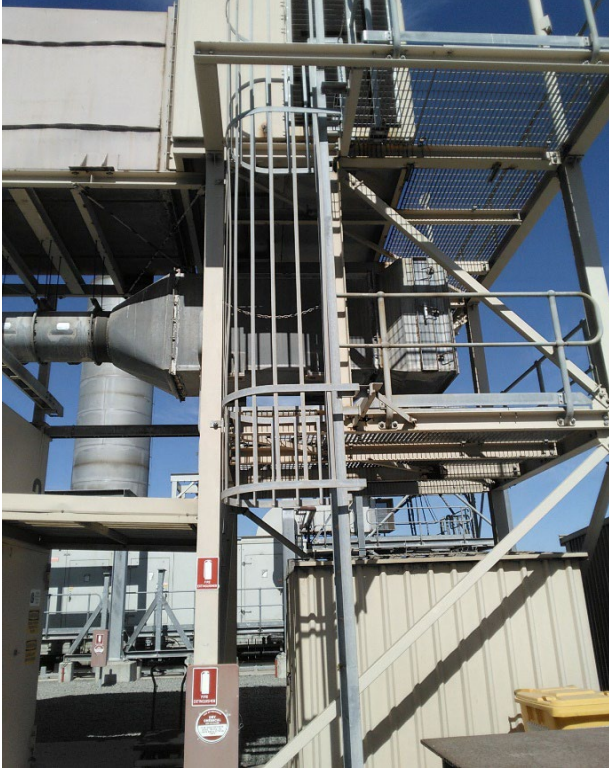
Reference	Date added	Location on Site	Issue	Likelihood	Consequence	Risk Score	Suggestions	Evidence	What is being completed	Date planned for completion	Date completed
CS10-19	15/12/2023	Unit 2 Middle Platform	1) Chain used as a gate for the platform. Chain would likely break in the event of a fall. 2) No hi vis (yellow) tread installed each ladder rung.	C. Unlikely	4. Major	High	1) Replace the chain with a self closing gate that meets AS1657 requirements. 2) Install hi vis (yellow) tread to each ladder rung.

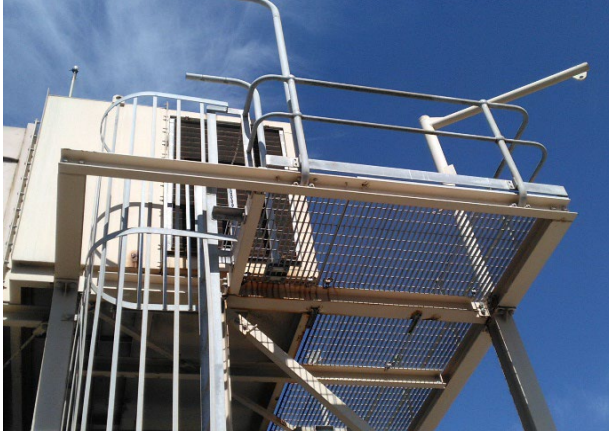
CS10-20	15/12/2023	Unit 2 Top Platform	1) Chain used as a gate for the platform. Chain would likely break in the event of a fall. 2) No hi vis (yellow) tread installed each ladder rung.	C. Unlikely	4. Major	High	1) Replace the chain with a self closing gate that meets AS1657 requirements. 2) Install hi vis (yellow) tread to each ladder rung.

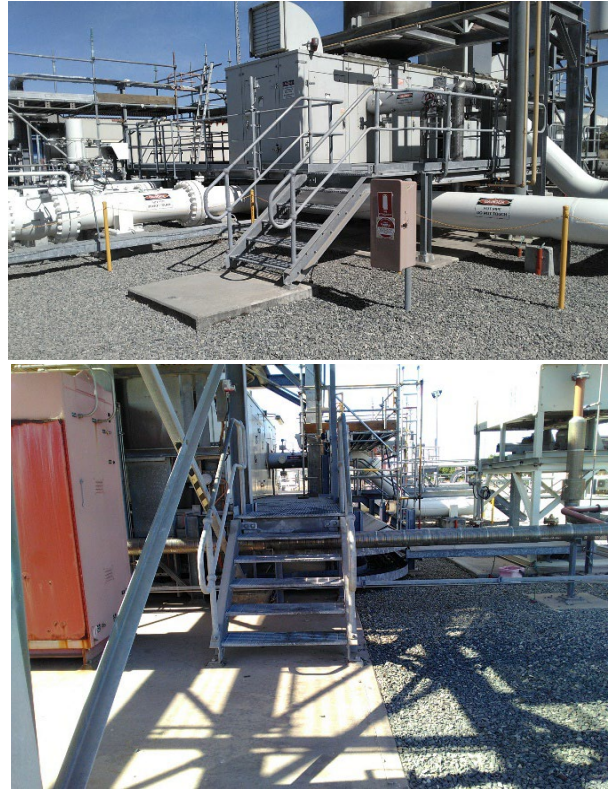
CS10-21	15/12/2023	Unit 3 Access Stairs	1) No hi vis (yellow) tread installed on the nosing of the stairs. 2) Pipe crosses walkway creating a head high hazard as personnel reported walking under it.	C. Unlikely	2. Minor	Low	1) Install hi vis (yellow) non-slip tread installed on the nosing of the stairs. 2) Consider installing barricading to prevent access below the pipe. Or alternatively install hi vis tap and Scaff Pad (or similar padding) to highlight and protect personnel from the hazard.

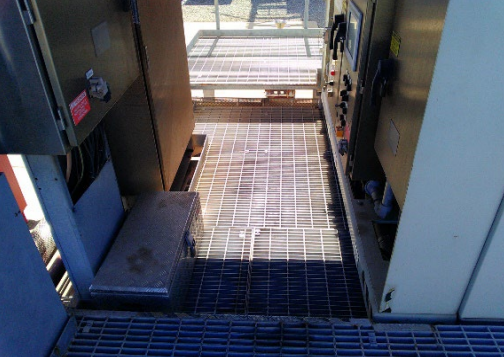
CS10-22	15/12/2023	Unit 3 Access Pathway and Access to Cabinets / Controls	1) No hi vis (yellow) tread installed on the nosing of the stairs. 2) Platform poses a head high hazard for tall personnel	C. Unlikely	2. Minor	Low	1) Install hi vis (yellow) non-slip tread installed on the nosing of the stairs. 2) Consider installing hi vis tap and Scaff Pad (or similar padding) to highlight and protect personnel should contact be made.

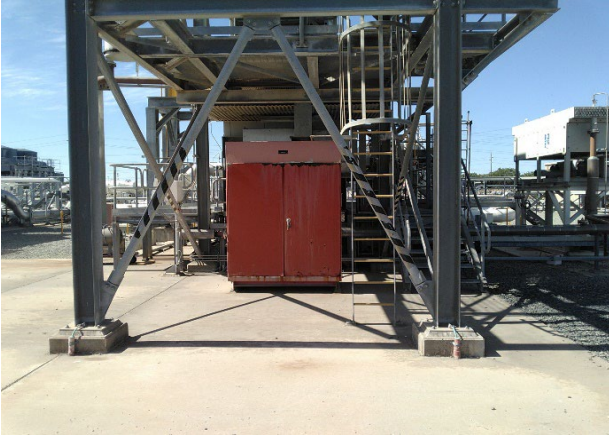
CS10-23	15/12/2023	Unit 3 Access Pathway and Fire Suppression Cabinet	Refer to CS10-02.

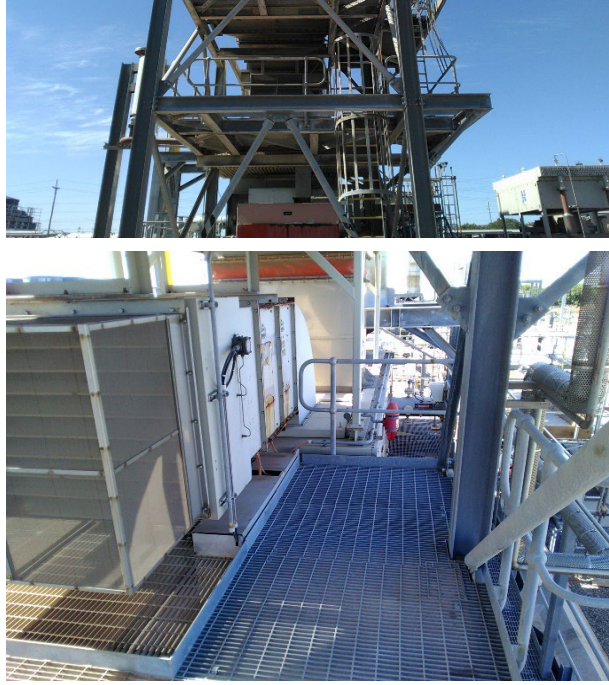
CS10-24	15/12/2023	Unit 3 Middle Platform	1) Gaps in handrails and structure were identified. The gaps varied between 150mm and 250mm (AS states maximum of 100mm). Note: Cross beam prevents a fall from occurring.				No Action Required.

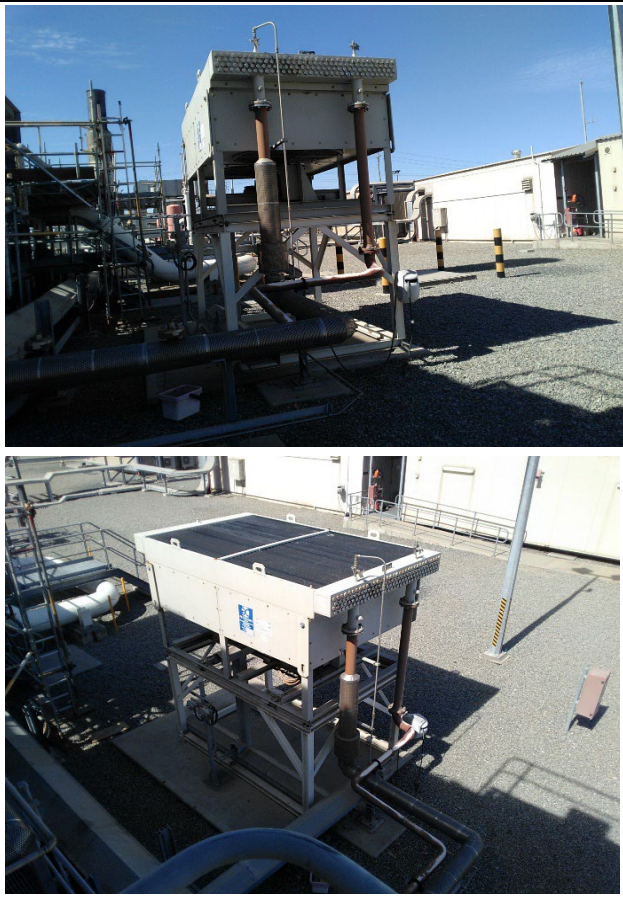
Reference	Date added	Location on Site	Issue	Likelihood	Consequence	Risk Score	Suggestions	Evidence	What is being completed	Date planned for completion	Date completed
CS10-26	15/12/2023	Unit 3 Air X-Changers	<p>1) Access to the top of the equipment, fans and small bore piping in some locations, by setting up a platform ladder on blue metal. This creates the potential for the ladder to be unstable and cause a fall from height.</p> <p><i>Note: Potential for a fall of up to ~3m.</i></p>	C. Unlikely	3. Severe	Medium	<p>1) Option A: Install concrete landing for platform ladder to be set up on.</p> <p>Option B: Install a purpose built platform and access stairs or ladder that is AS compliant.</p>

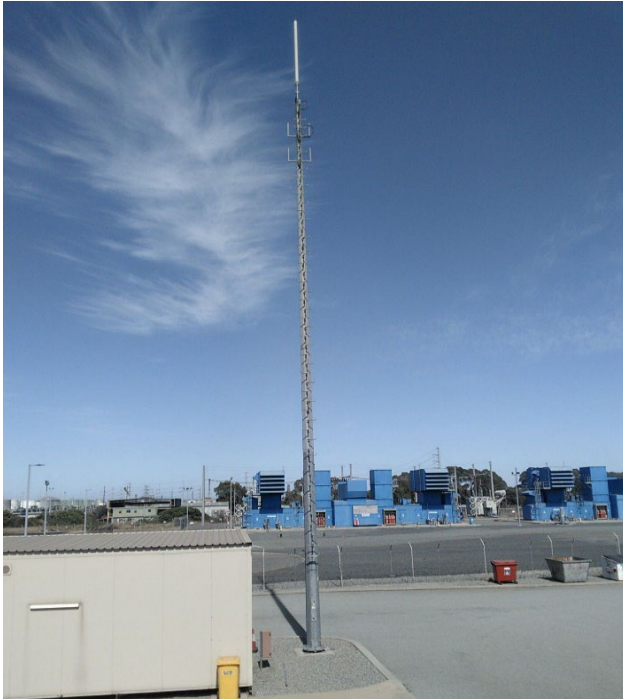
CS10-27	15/12/2023	Telecommunications Tower	<p>1) Unlike some other Repeater Stations, the ladder at this location can be access from ground level. No gate or means of accessing the ladder on a platform at height to prevent unauthorised access, has been implemented.</p> <p>2) No fall restraint/arrest system in place for personnel using the ladder. This exposes personnel to a significant fall that would likely result in a fatality or serious injury.</p> <p>3) No hi vis (yellow) anti-slip tread installed on the ladder rungs. They are currently smooth metal rungs.</p> <p>4) No landing is available. Personnel step off / onto blue metal.</p>	C. Unlikely	4. Major	High	<p>1) Consider installing a lockable gate or similar and signage is provided to prevent unauthorised access.</p> <p>2) Install a certified fall restraint/arrest system that is suitable for the end users.</p> <p>3) Install hi vis (yellow) anti-slip tread on the ladder rungs.</p> <p>4) Pour a new landing.</p>

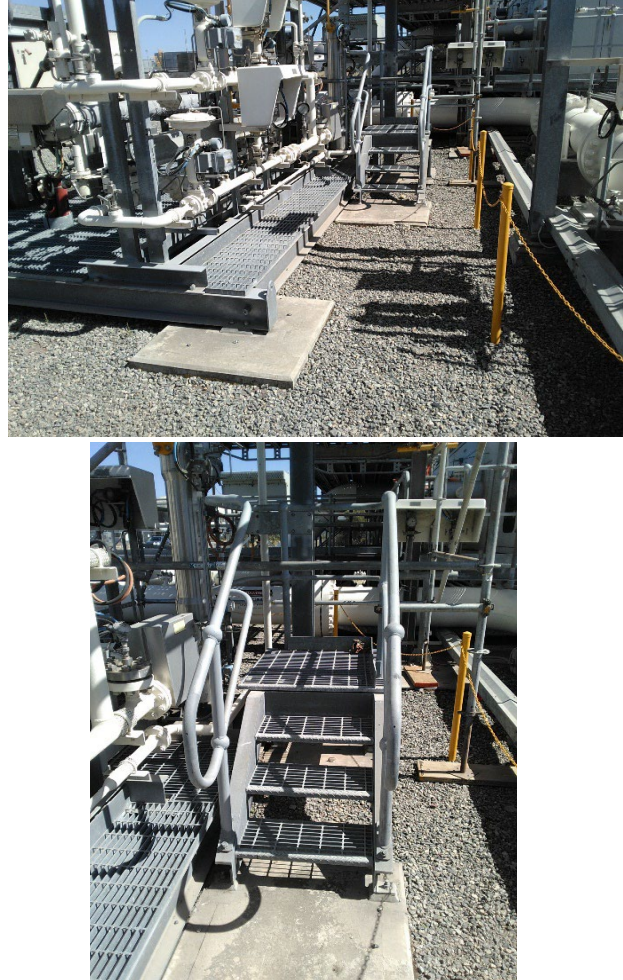
CS10-29	15/12/2023	Unit 3 Fuel Gas Skid - East and West Sides	<p>1) No hi vis tread installed on the edge of skid.</p> <p>2) No hi vis (yellow) tread installed on the nosing of the stairs.</p> <p>3) Work platform on the East side does not meet AS requirements for depth (actual 430mm, AS requires >=600mm) and step up (actual 330mm, AS requires 1 stair for 300-450mm).</p> <p>4) Concrete footings pose a trip hazard.</p>	C. Unlikely	3. Severe	Medium	<p>1) Install hi vis (yellow) non-slip tread installed on the nosing of the skid.</p> <p>2) Install hi vis (yellow) non-slip tread installed on the nosing of the stairs.</p> <p>3) Modify the work platform to meet AS requirements (i.e. step up, depth).</p> <p>4) Option A: Extend the concrete landing to incorporate the whole of the walkway.</p> <p>Option B: Install additional blue metal until level with the concrete footing.</p>

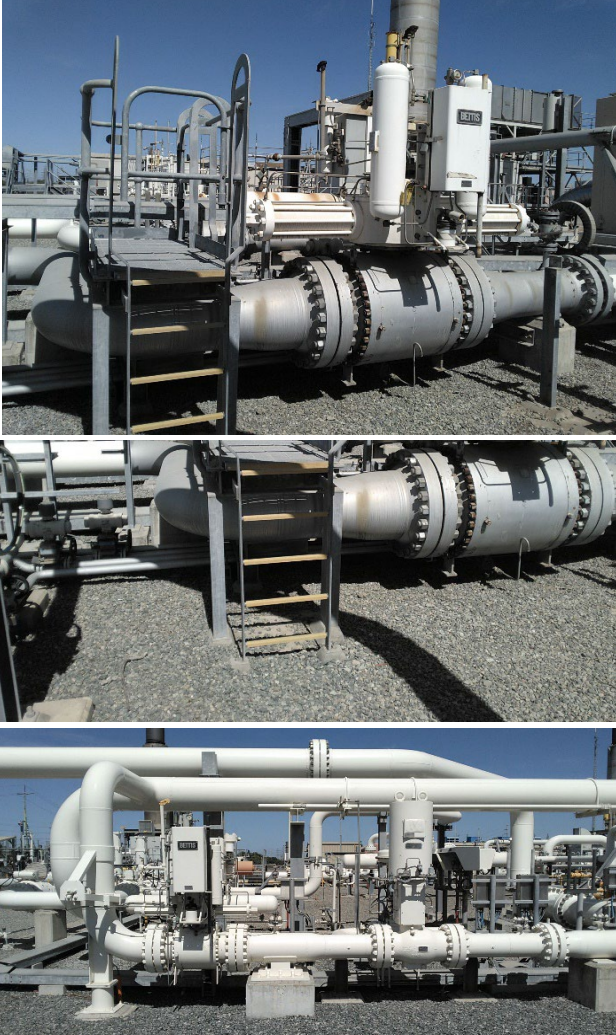
Reference	Date added	Location on Site	Issue	Likelihood	Consequence	Risk Score	Suggestions	Evidence	What is being completed	Date planned for completion	Date completed
CS10-30	15/12/2023	Bettis Equipment Installed on Pipework for Unit 1/2	1) No landing available at the base of the ladders and equipment panels.	C. Unlikely	2. Minor	Low	1) Pour a new landing for access ladders and equipment panels.
