Revised Final Plan
Attachment 9.12

Structures & Operational Sites - Working at Heights - Appendix B

**Dampier Bunbury
Pipeline**

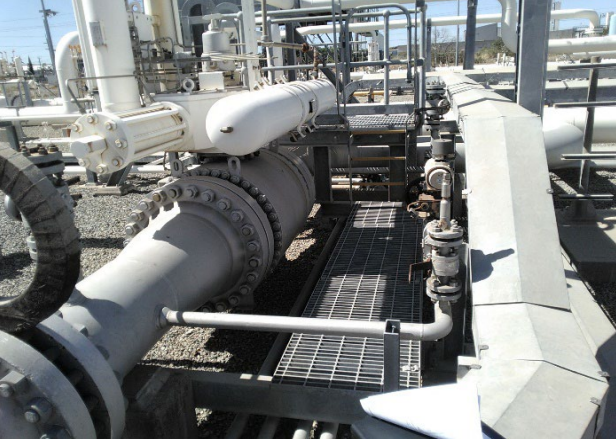
CS10-31	15/12/2023	Bettis Equipment Installed on Pipework for Unit 1/2 - Platforms	1) Gap between the pipe / structure and grid mesh and no kick plate, creates the potential for personnel to fall. 2) No handrail to prevent personnel climbing between the platform and pipework at the end the platform. 3) No hi vis tread installed on the nosing of the platform.	C. Unlikely	3. Severe	Medium	1) Modify the platform to eliminate the potential for a fall through the gap. 2) Consider installing handrails at the end of the platform to prevent personnel from climbing between the adjacent pipework and the platform. 3) Install hi vis (yellow) non-slip tread installed on the nosing of the platform.

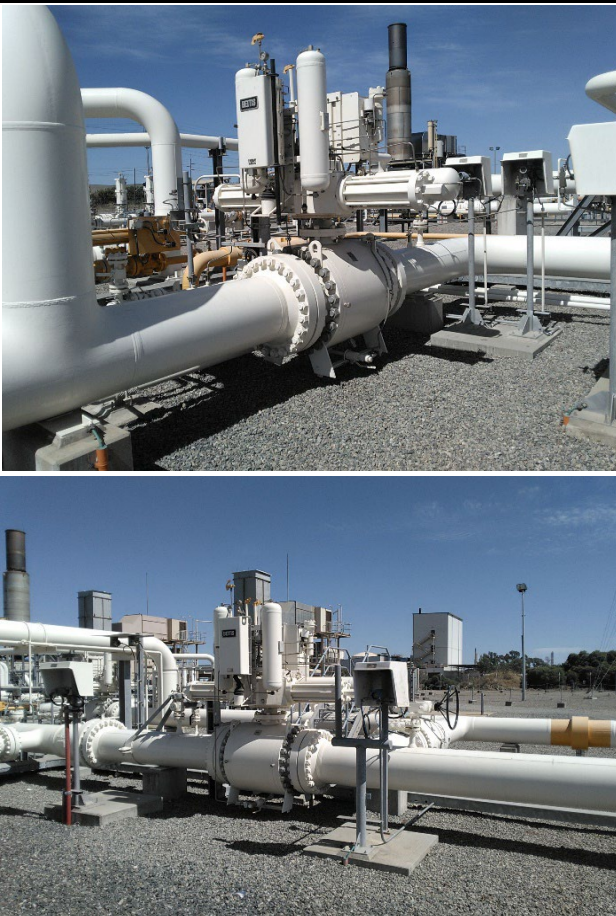
CS10-32	15/12/2023	Bettis Equipment Installed above Pipework for Unit 1/2 - Platforms	1) Current design requires personnel to work from platform ladders on blue metal. This creates the potential for the ladder to be unstable and cause a fall from height. There is also the potential that some personnel may choose to site on the pipework itself.	C. Unlikely	3. Severe	Medium	1) Option A: Install concrete landing for platform ladder to be set up on. Option B: Install a purpose built platform and access stairs or ladder that is AS compliant.

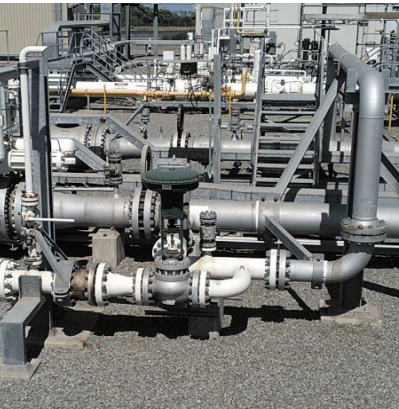
CS10-33	15/12/2023	Various Valves installed above Ground Level	1) Several actuated and hand valves are installed above ground level and where a platform ladder or safety step is required to access them. Setting these up on blue metal creases the potential for them to be unstable and cause a fall from height.	C. Unlikely	3. Severe	Medium	1) Option A: Install concrete landing for platform ladder or safety step to be set up on. Option B: Install a purpose built platform and access stairs or ladder that is AS compliant.

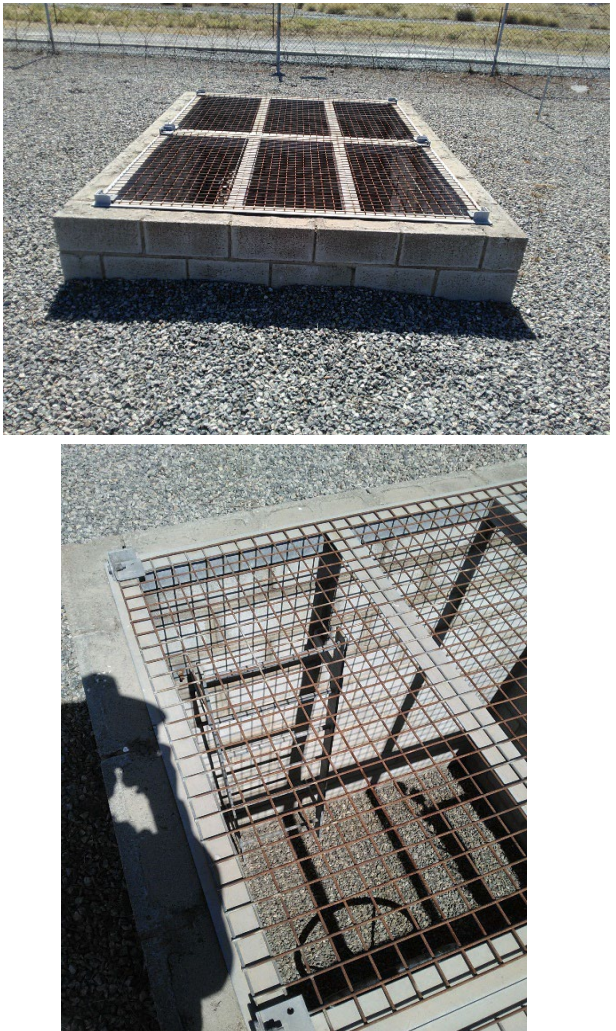
CS10-34	15/12/2023	Inspection / Access Pit for Hand Valve - East Side of CS10	1) Design of the ladder and hold points does not allow for easy access to / from and creates the potential for a fall. 2) No non-slip tread on ladder rungs.	B. Remote	3. Severe	Medium	1) Modify or replace the ladder, ensuring it extends 1m past the top landing, with sufficient locations to hold onto when mounting / dismantling the ladder and provides easy access to personnel. 2) Modified or replacement ladder to have hi vis (yellow) non-slip tread installed on the rungs.

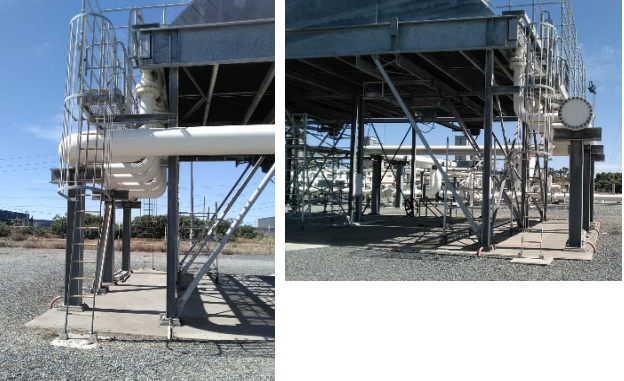
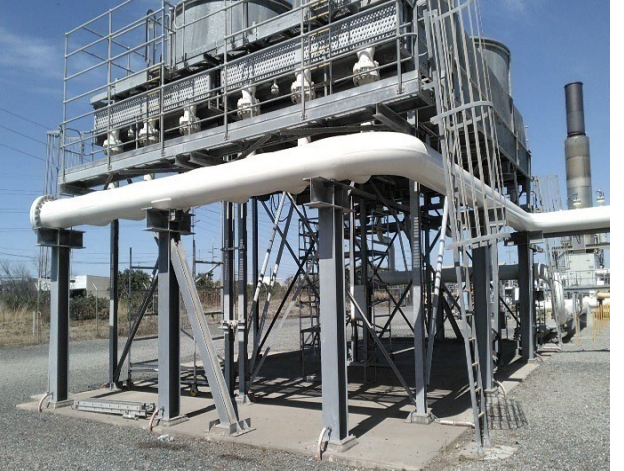
Reference	Date added	Location on Site	Issue	Likelihood	Consequence	Risk Score	Suggestions	Evidence	What is being completed	Date planned for completion	Date completed
CS10-35	15/12/2023	Middle Platform (Access Way) For After Cooler Fans	1) No hi vis (yellow) tread installed onto the ladder rungs. 2) The landing for the ladders (from ground to first platform) does not meet AS1657 requirements of 600mm minimum.	C. Unlikely	2. Minor	Low	1) Install hi vis (yellow) tread onto the ladder rungs. 2) Extend the landing.

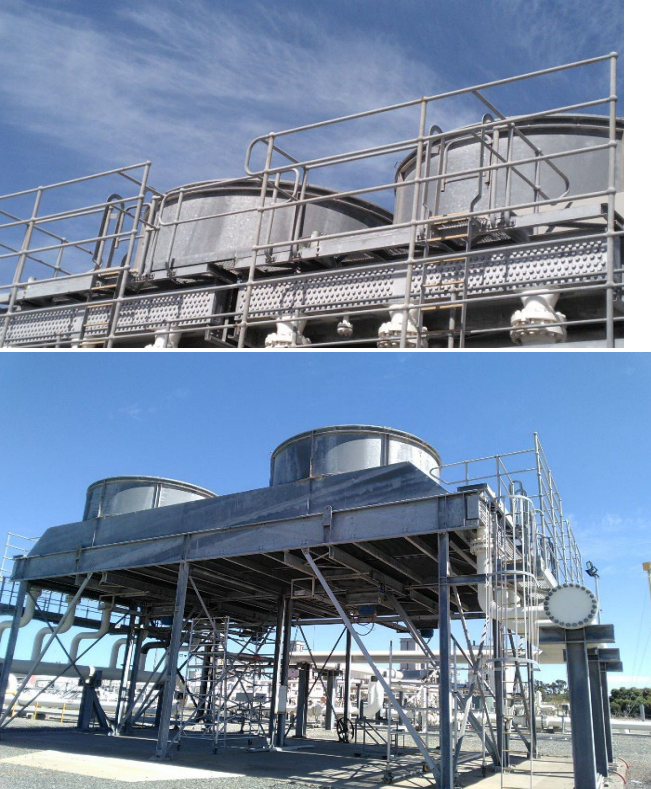
CS10-36	15/12/2023	Top Platform for each After Cooler Fan	1.1) There is no method for accessing this platform from the below walkway without climbing onto structural steel and being exposed to a fall. 1.2) Gap between the existing handrail and the structure on both sides of the platform. This poses a potential of a slip / trip. 2) No hi vis (yellow) tread installed onto the ladder rungs.	C. Unlikely	4. Major	High	1.1) Install signage to highlight the fall from height risk until a suitable means of access is installed. 1.2) Modify the platform to - allow for safe access to the top of the fans; - eliminate or reduce the gap between the existing handrail and floor / structure. 2) Install hi vis (yellow) tread onto the ladder rungs.

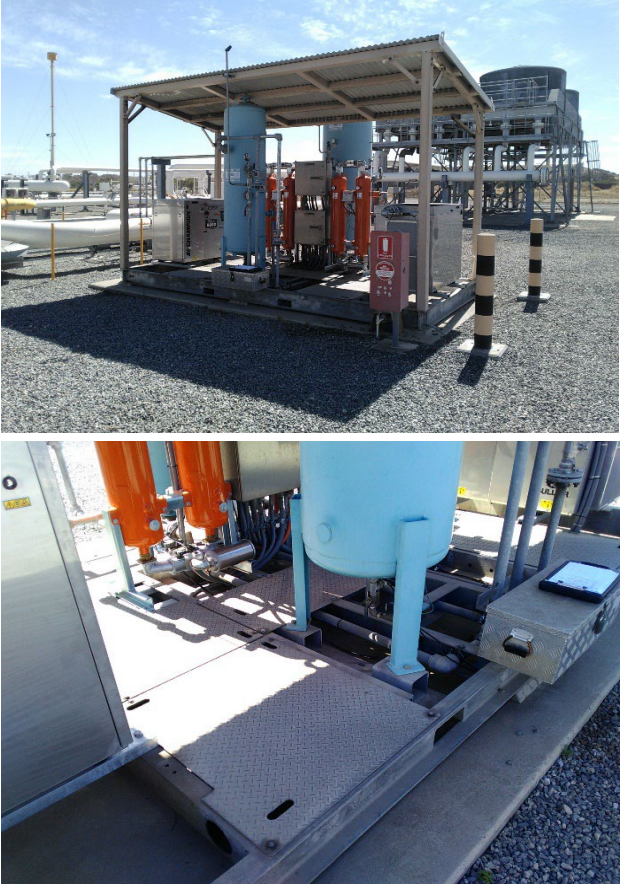
CS10-37	15/12/2023	Desiccant Dryers x 2	1) No hi vis (yellow) tread installed on the nosing of the platform. 2) Landing does not meet AS requirement of 900mm and poses a trip / slip hazard. 3) No kick plate, grid mesh or other means installed to stop personnel inadvertently placing their feet in the gaps. This creates the potential for a slip / trip / fall incident to occur.	C. Unlikely	3. Severe	Medium	1) Install hi vis (yellow) tread onto the nosing of the two access points. 2) Extend the landing 3) Install kick plates, grid mesh or similar means.

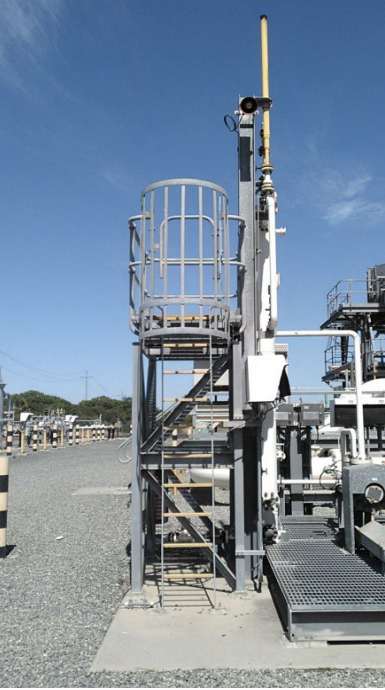
CS10-38	15/12/2023	Unit 4 Fuel Gas Skid - Platform	1) To access the top vent, a safety step on the platform grid mesh deck is required. This practice puts personnel at risk of a fall, including over the existing handrail.	C. Unlikely	4. Major	High	1) Option A: Modify the platform or install additional platform to provide access. Option B: Install additional handrails to permit a safety step to be used on the platform whilst edge protection is available.

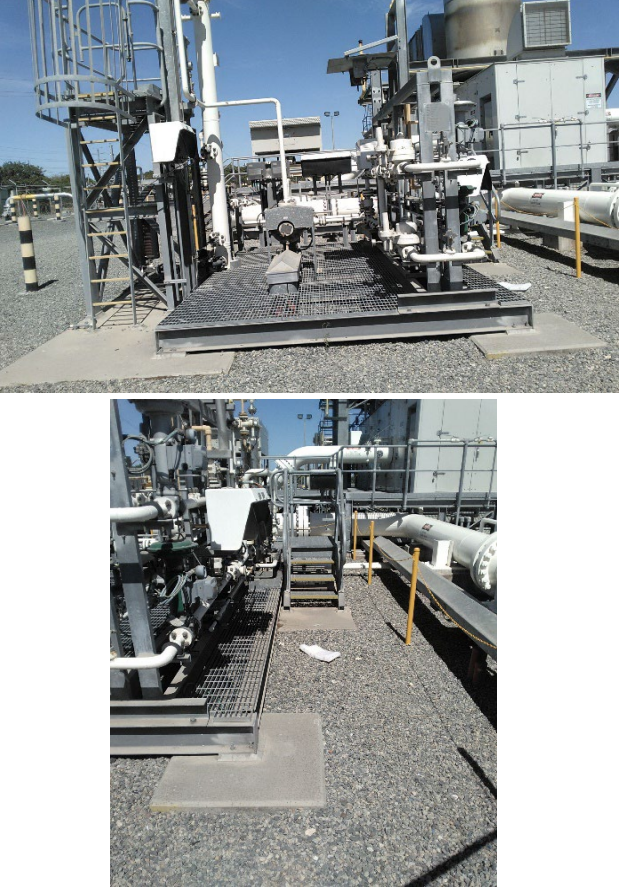
CS10-39	15/12/2023	Unit 4 Fuel Gas Skid - East and West Sides	1) No hi vis tread installed on the edge of skid. 2) Work platform on the East side does not meet AS requirements for depth (actual 430mm, AS requires >=600mm) and step up (actual 330mm, AS requires 1 stair for 300-450mm). 3) Concrete footings pose a trip hazard.	C. Unlikely	3. Severe	Medium	1) Install hi vis (yellow) non-slip tread installed on the nosing of the skid. 2) Modify the work platform to meet AS requirements (i.e. step up, depth). 3) Option A: Extend the concrete landing to incorporate the whole of the walkway. Option B: Install additional blue metal until level with the concrete footing.

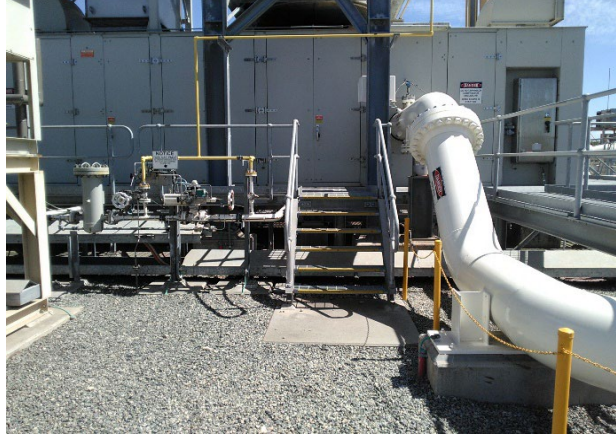
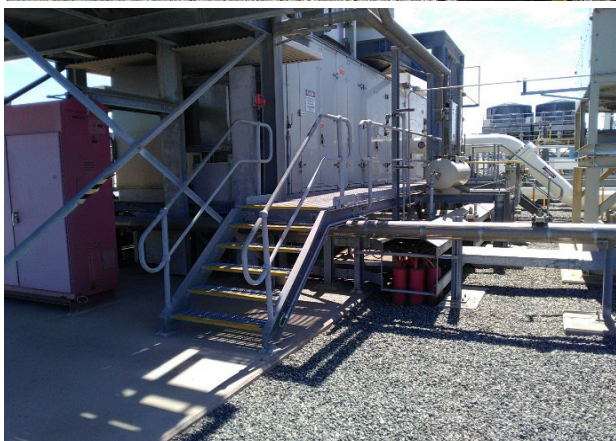
Reference	Date added	Location on Site	Issue	Likelihood	Consequence	Risk Score	Suggestions	Evidence	What is being completed	Date planned for completion	Date completed
CS10-40	15/12/2023	Unit 4 Access Stairs	1) Pipe crosses walkway creating a head high hazard as personnel reported walking under it.	C. Unlikely	2. Minor	Low	1) Consider installing barricading to prevent access below the pipe. Or alternatively install hi vis tap and Scaff Pad (or similar padding) to highlight and protect personnel from the hazard.

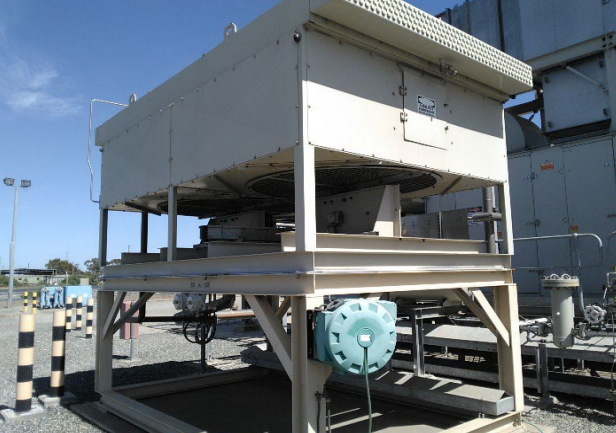
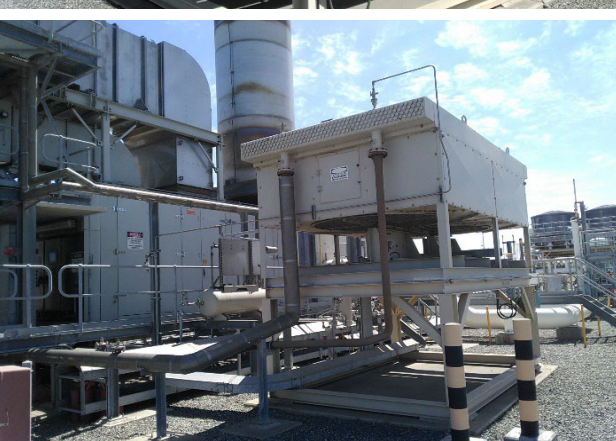
CS10-41	15/12/2023	Unit 4 Air X-Changers	1) Access to the top of the equipment, fans and small bore piping in some locations, by setting up a platform ladder on blue metal. This creates the potential for the ladder to be unstable and cause a fall from height. <i>Note: Potential for a fall of up to ~3m.</i>	C. Unlikely	3. Severe	Medium	1) Option A: Install concrete landing for platform ladder to be set up on. Option B: Install a purpose built platform and access stairs or ladder that is AS compliant.

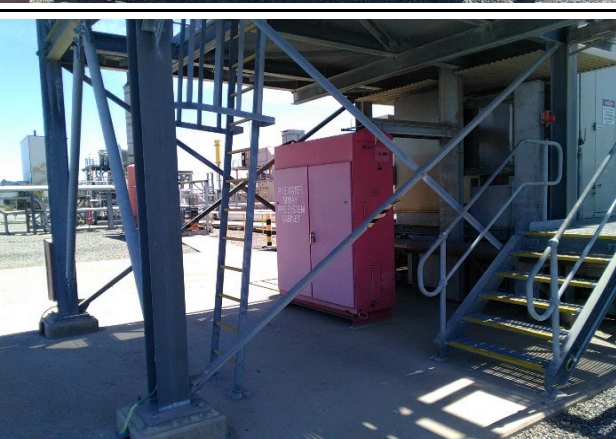
CS10-42	15/12/2023	Unit 4 Fire Suppression System Cabinet	1) Insufficient head room for personnel to walk under the cross bracing without having to duck down. This is a access route between the Unit 4 stairs and the Fire Suppression System Cabinet. <i>Note: INX-19106 FMO struck head on the steel bracing at identical location at Unit 3. FAI Injury.</i>	D. Occasional	2. Minor	Low	1) Option A: Install a handrail to prevent personnel using this as a access route (shortcut). Option B: Install hi vis tape and/or scaff pad (or similar) to highlight the hazard and protect personnel if contact is made.

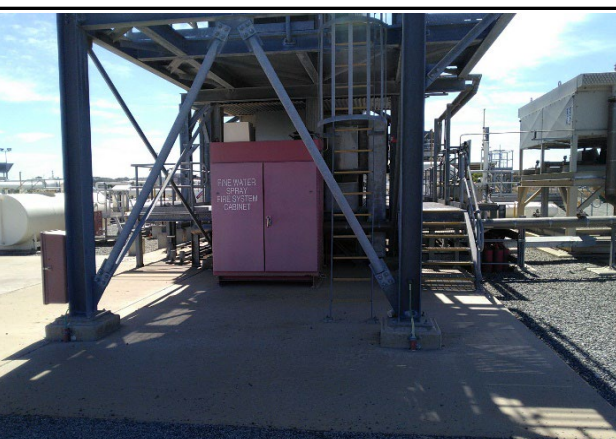
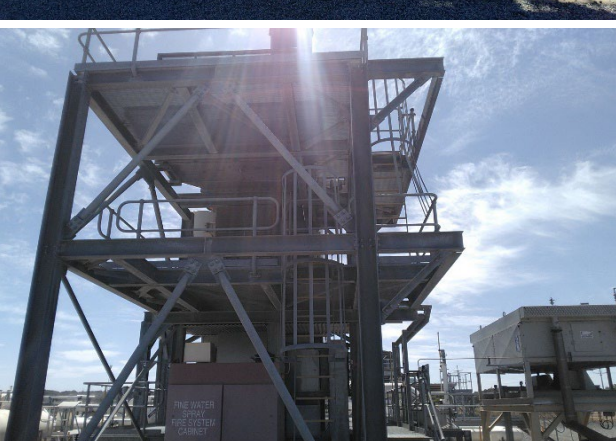
CS10-43	15/12/2023	Unit 4 Middle Platform	1) Gaps in handrails and structure were identified. The gaps varied between 150mm and 250mm (AS states maximum of 100mm). <i>Note: Cross beam prevents a fall from occurring.</i>				No Action Required.

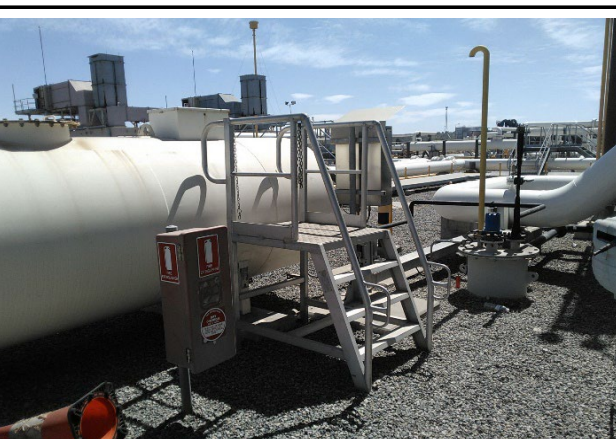
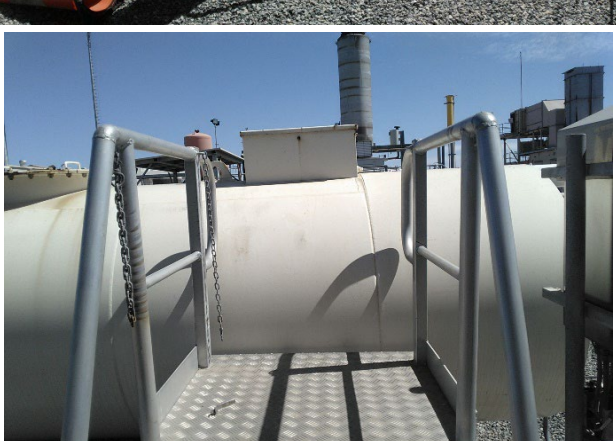
CS10-45	15/12/2023	Waste Tank T-1404	1) Access stairs and work platform do not meet AS requirements (e.g chain used as gate, steps not deep enough, no hi vis tread on stair nosing).	C. Unlikely	3. Severe	Medium	1) Remove the existing access stairs / work platform and install with AS compliant stairs, platform and landing.

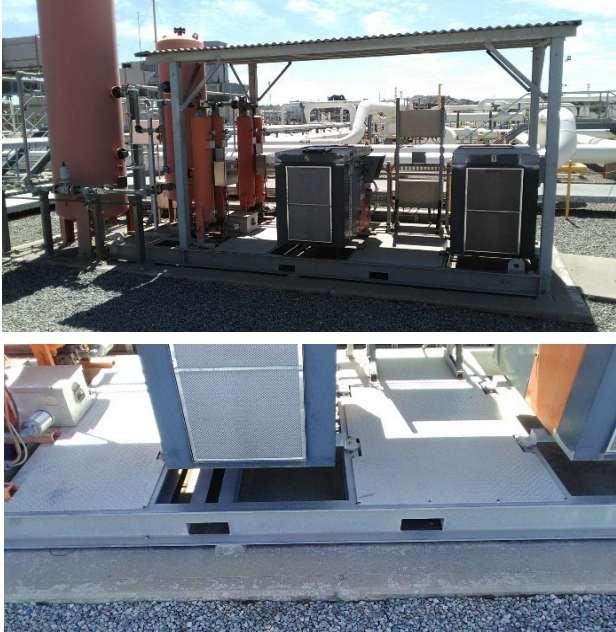
Reference	Date added	Location on Site	Issue	Likelihood	Consequence	Risk Score	Suggestions	Evidence	What is being completed	Date planned for completion	Date completed
CS10-46	15/12/2023	Desiccant Dryers x 2	1) No hi vis (yellow) tread installed on the nosing of the platform. 2) Landing does not meet AS requirement of 900mm and poses a trip / slip hazard.	C. Unlikely	2. Minor	Low	1) Install hi vis (yellow) tread onto the nosing of the two access points. 2) Extend the landing

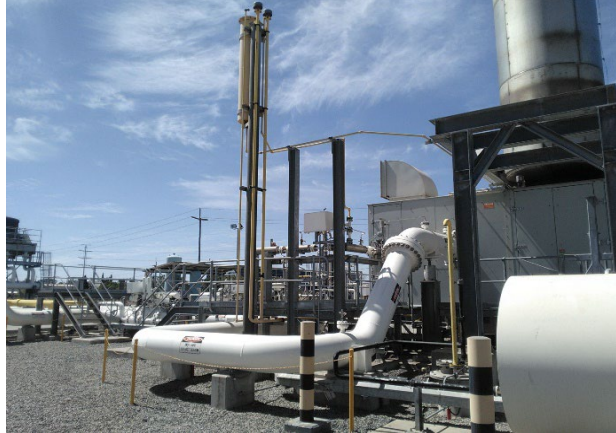
CS10-47	15/12/2023	Unit 4 Vent	1) Access to Unit 4 Vents up to ~5m for maintenance tasks are currently completed using a platform ladder on blue metal. This creates the potential for the ladder to be unstable and cause a fall from height.	C. Unlikely	3. Severe	Medium	1) Option A: Install concrete landings for platform ladder to be set up on. Option B: Install a purpose built platforms and access stairs or ladders that are AS compliant.

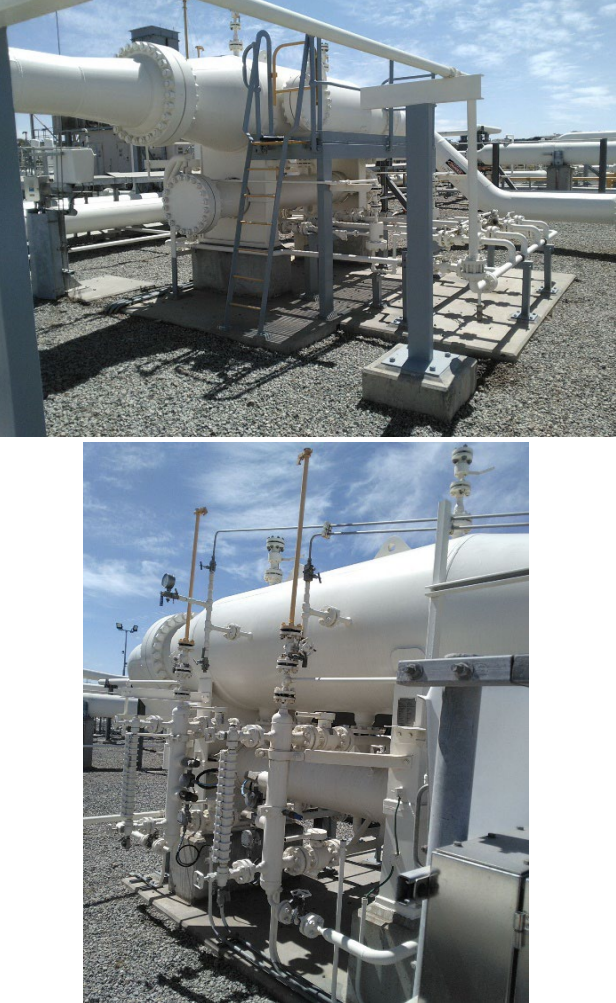
CS10-48	15/12/2023	Scrubber Skid and Platform	1) Landing for the access ladder does not meet AS requirement of 900mm and poses a trip / slip hazard. 2) Ladder rungs do not have hi vis anti-slip tread installed. The ladder rungs were painted yellow. 3) Access to the Piping / Vents / Valves up to ~5m for maintenance tasks are currently completed using a platform ladder on blue metal. This creates the potential for the ladder to be unstable and cause a fall from height.	C. Unlikely	3. Severe	Medium	1) Extend the landing for the access ladder. 2) Install hi vis (yellow) tread onto all Ladder rungs. 3) Option A: Install concrete landings for platform ladder to be set up on. Option B: Install a purpose built platforms and access stairs or ladders that are AS compliant.

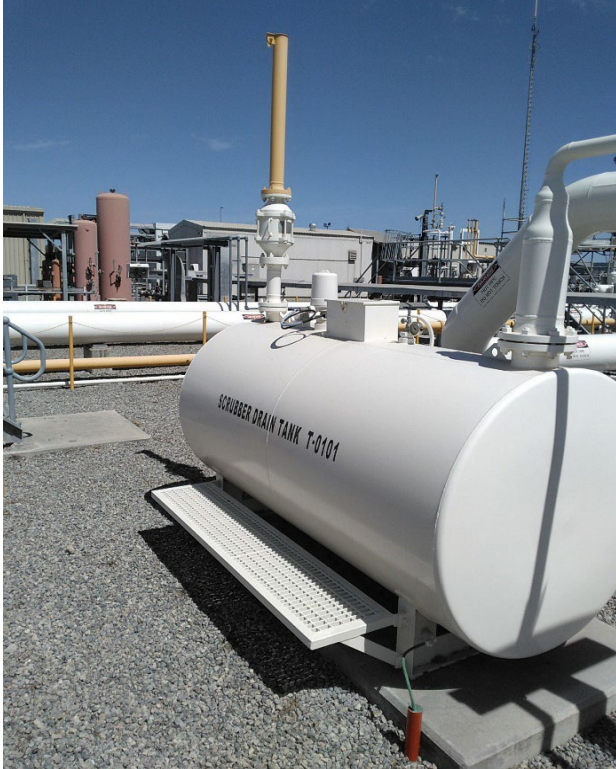
CS10-49	15/12/2023	Scrubber Drain Tank T-0101	1) The work platform (step) has no edge protection installed (width 1830mm, depth 370mm, height 350). This creates a fall risk of 350mm. Note: Conversations with FMOs confirmed that the black work platform is used during inspection and maintenance tasks and when refuelling. 2) Step up of 350mm exceeds AS requirements (300-450mm requires 1 step). 3) No hi vis (yellow) tread installed on the nosing of the platform.	C. Unlikely	3. Severe	Medium	1) Modify or replace the work platform to meet AS1657 requirements. 2) Install the required number of stairs to provide access to the modified / new work platform, in line with AS1657 requirements. 3) Install hi vis (yellow) tread onto the nosing of the work platform.

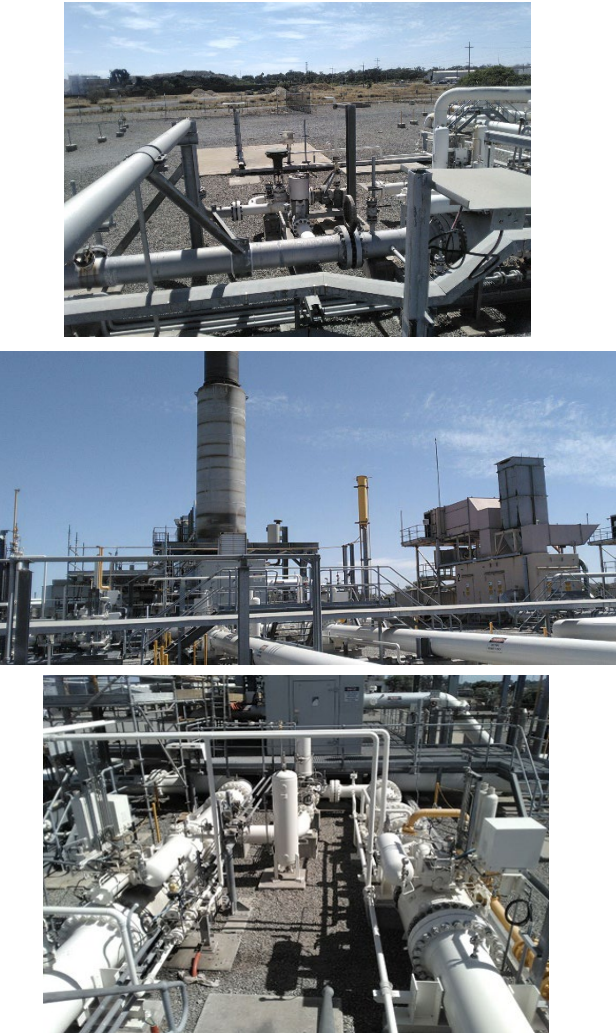
CS10-50	15/12/2023	Pipework - Various Rises / Vents / Piping	1) Access to Piping, Risers and Vents up to ~5m for maintenance tasks are currently completed using a platform ladder on blue metal. This creates the potential for the ladder to be unstable and cause a fall from height.	C. Unlikely	3. Severe	Medium	1) Option A: Install concrete landings for platform ladder to be set up on. Option B: Install a purpose built platforms and access stairs or ladders that are AS compliant.

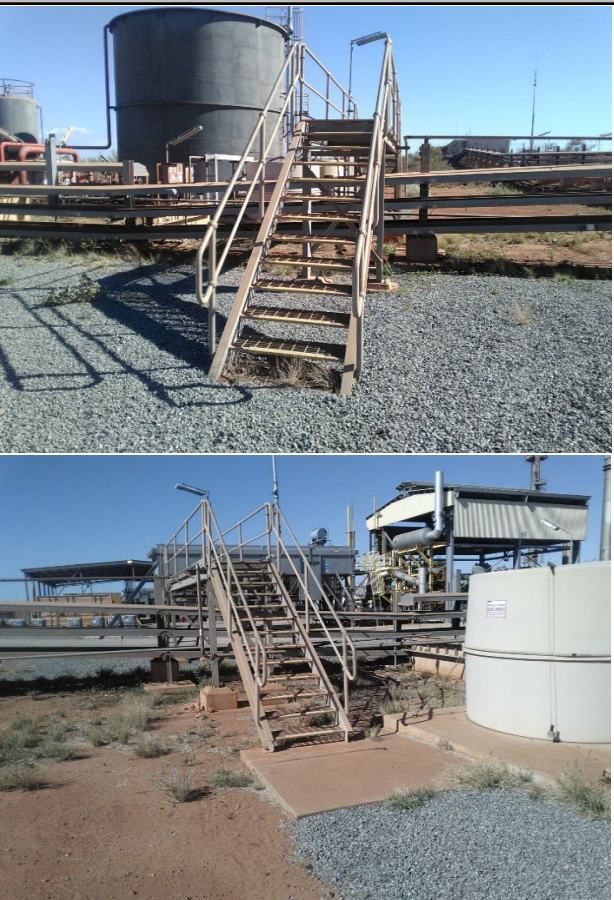
Reference	Date added	Location on Site	Issue	Likelihood	Consequence	Risk Score	Suggestions	Evidence	What is being completed	Date planned for completion	Date completed
TGS-1	27/03/2024	Access Stairs adjacent to the Diesel Fuel Tank	1) No landing for one side of stairs. Blue metal has been built up to bottom stair.	B. Remote	2. Minor	Low	1) Monitor blue metal levels and if difficult to maintain, replace with a concrete landing.

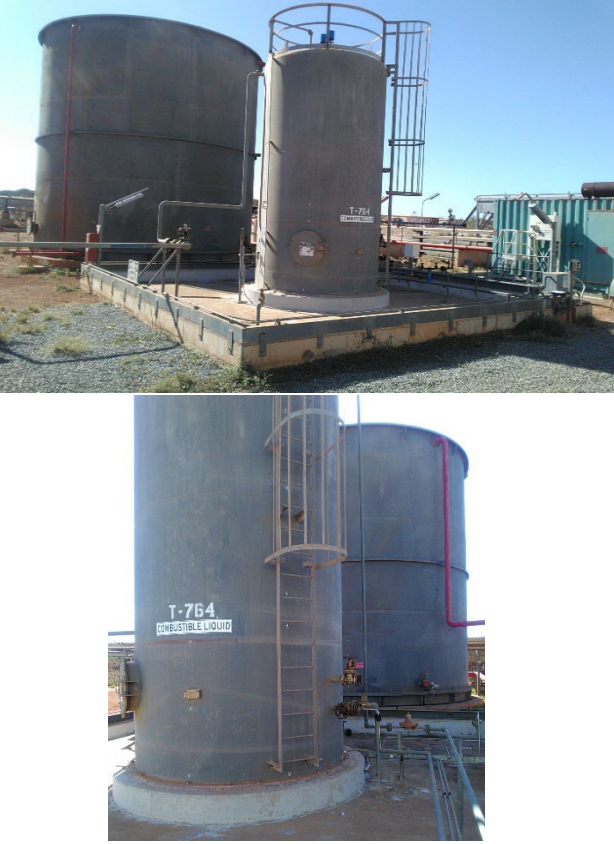
TGS-2	27/03/2024	1-764 Combustible Liquid Tank and Bund	1) Stepping into and out of bund is too high. No hoppers available. 2) The landing around the tank base of the ladder has a lip and is a trip / slip hazard. Step up to first ladder rung further impacted. 3) The ladder rungs do not have hi vis anti slip tread. 4) A chain has been used at the top of the ladder in lieu of a self closing gate. The chain likely break if a person falls onto it.	C. Unlikely	3. Severe	Medium	1) Install stairs to provide hopover access for the bund. 2) Install landing below the access ladder to eliminate lip and excessive step up. 3) Install hi vis (yellow) anti slip tread onto all ladder rungs. 4) Replace the chain with a self closing gate.

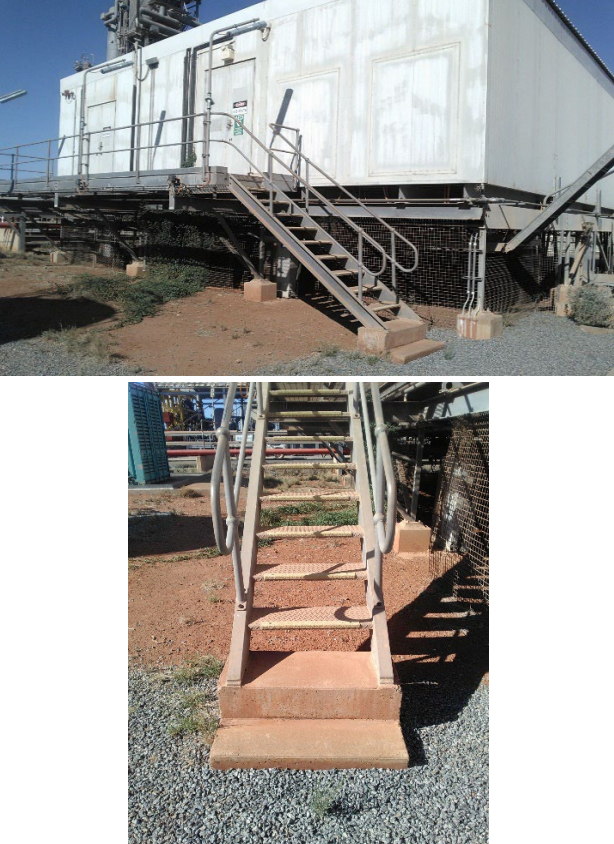
TGS-3	27/03/2024	2 x Access Stairs for Electrical Substation	1) The stairs have landings that does not meet the AS1557 requirements. 2) The stairs are installed on top of concrete steps due to being the incorrect size.	C. Unlikely	3. Severe	Medium	1) Pour a new landing for both staircases. 2) Replace both ladders with the correct size, to ensure it runs from the landing to the platform.

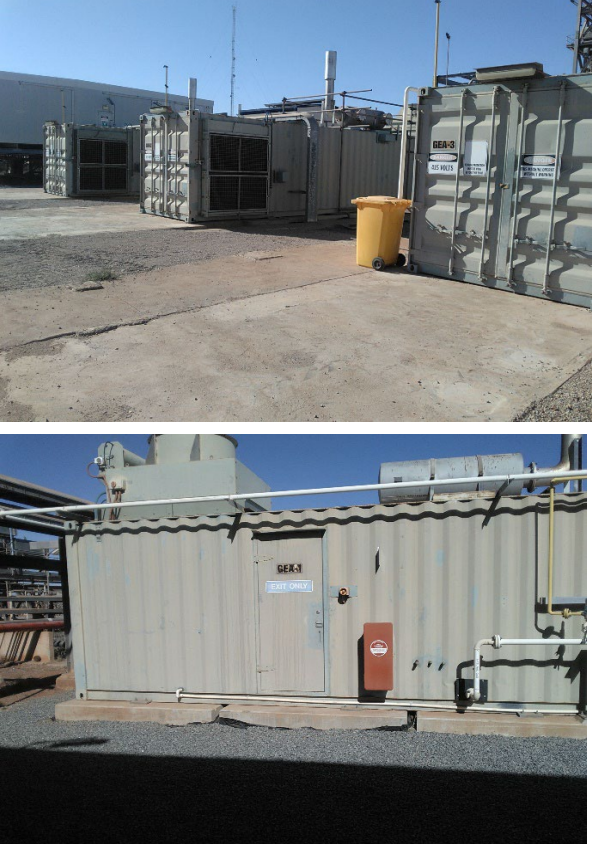
TGS-6	4/04/2024	GEA 1-3	1) The concrete landing for each GEA is too small to be used as step when using the side access doors. 2) No landing for the side access doors. 2) No hi vis anti slip tread on stair nosing.	D. Occasional	2. Minor	Medium	1.1) Extend the existing landing so it meets the AS1557 requirements for stairs. 2) Pour a concrete landing 3) Install hi vis (yellow) anti slip tread on nosing of the stairs.

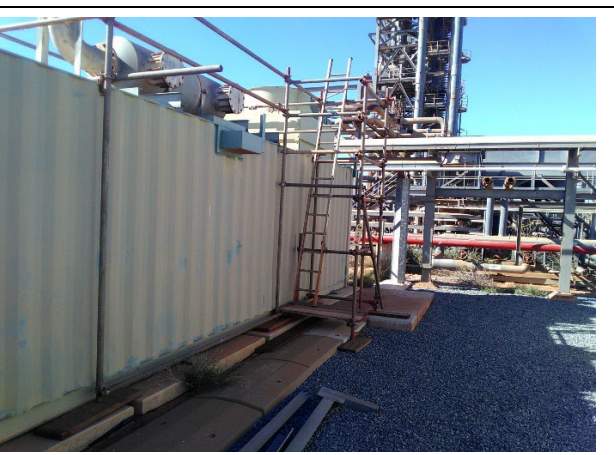
TGS-7	4/04/2024	GEA 2 - Scaffold	<i>Unclear if access and scaffolding is still required. Discuss with TGS OPS.</i> 1) No scaffold tag present. If scaffolding is still required, then install a scaff-tag and discuss permanent access solution with TGS OPS. 2) No scaffold tag present. If scaffold is not required, then dismantle and remove.	B. Remote	3. Severe	Low	1) Discuss solutions with TGS OPS. 2) Remove scaffold

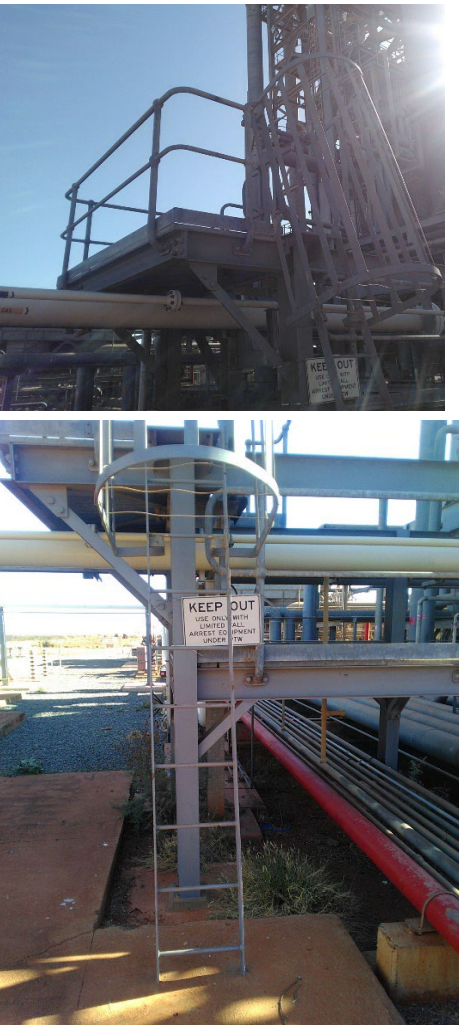
TGS-8	4/04/2024	Platform adjacent to XV-7506	Mothballed Equipment - If brought back online, assessment to be completed and modifications made to achieve compliance with AS1567.				Mothballed Equipment - Pending assessment if brought back online.

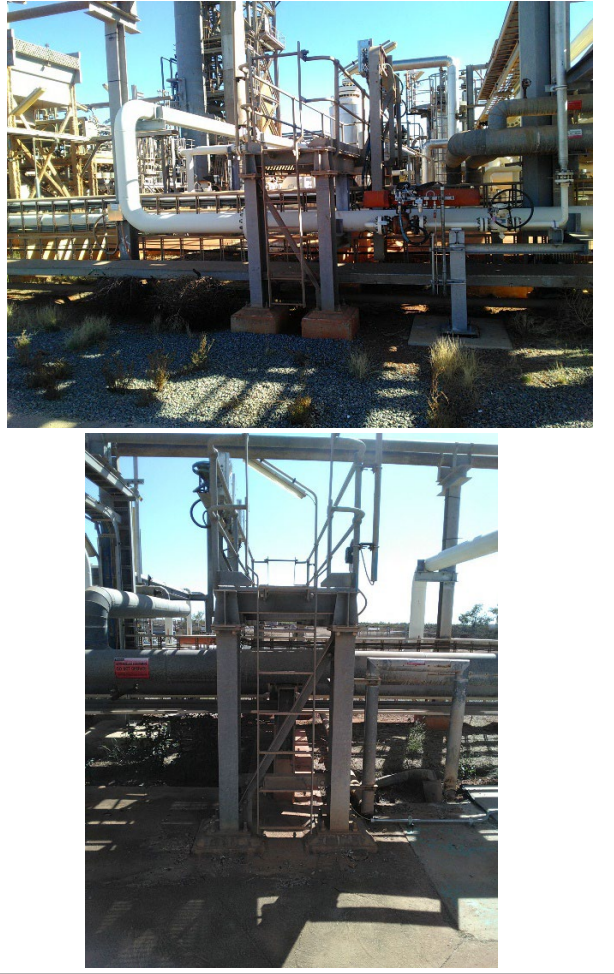
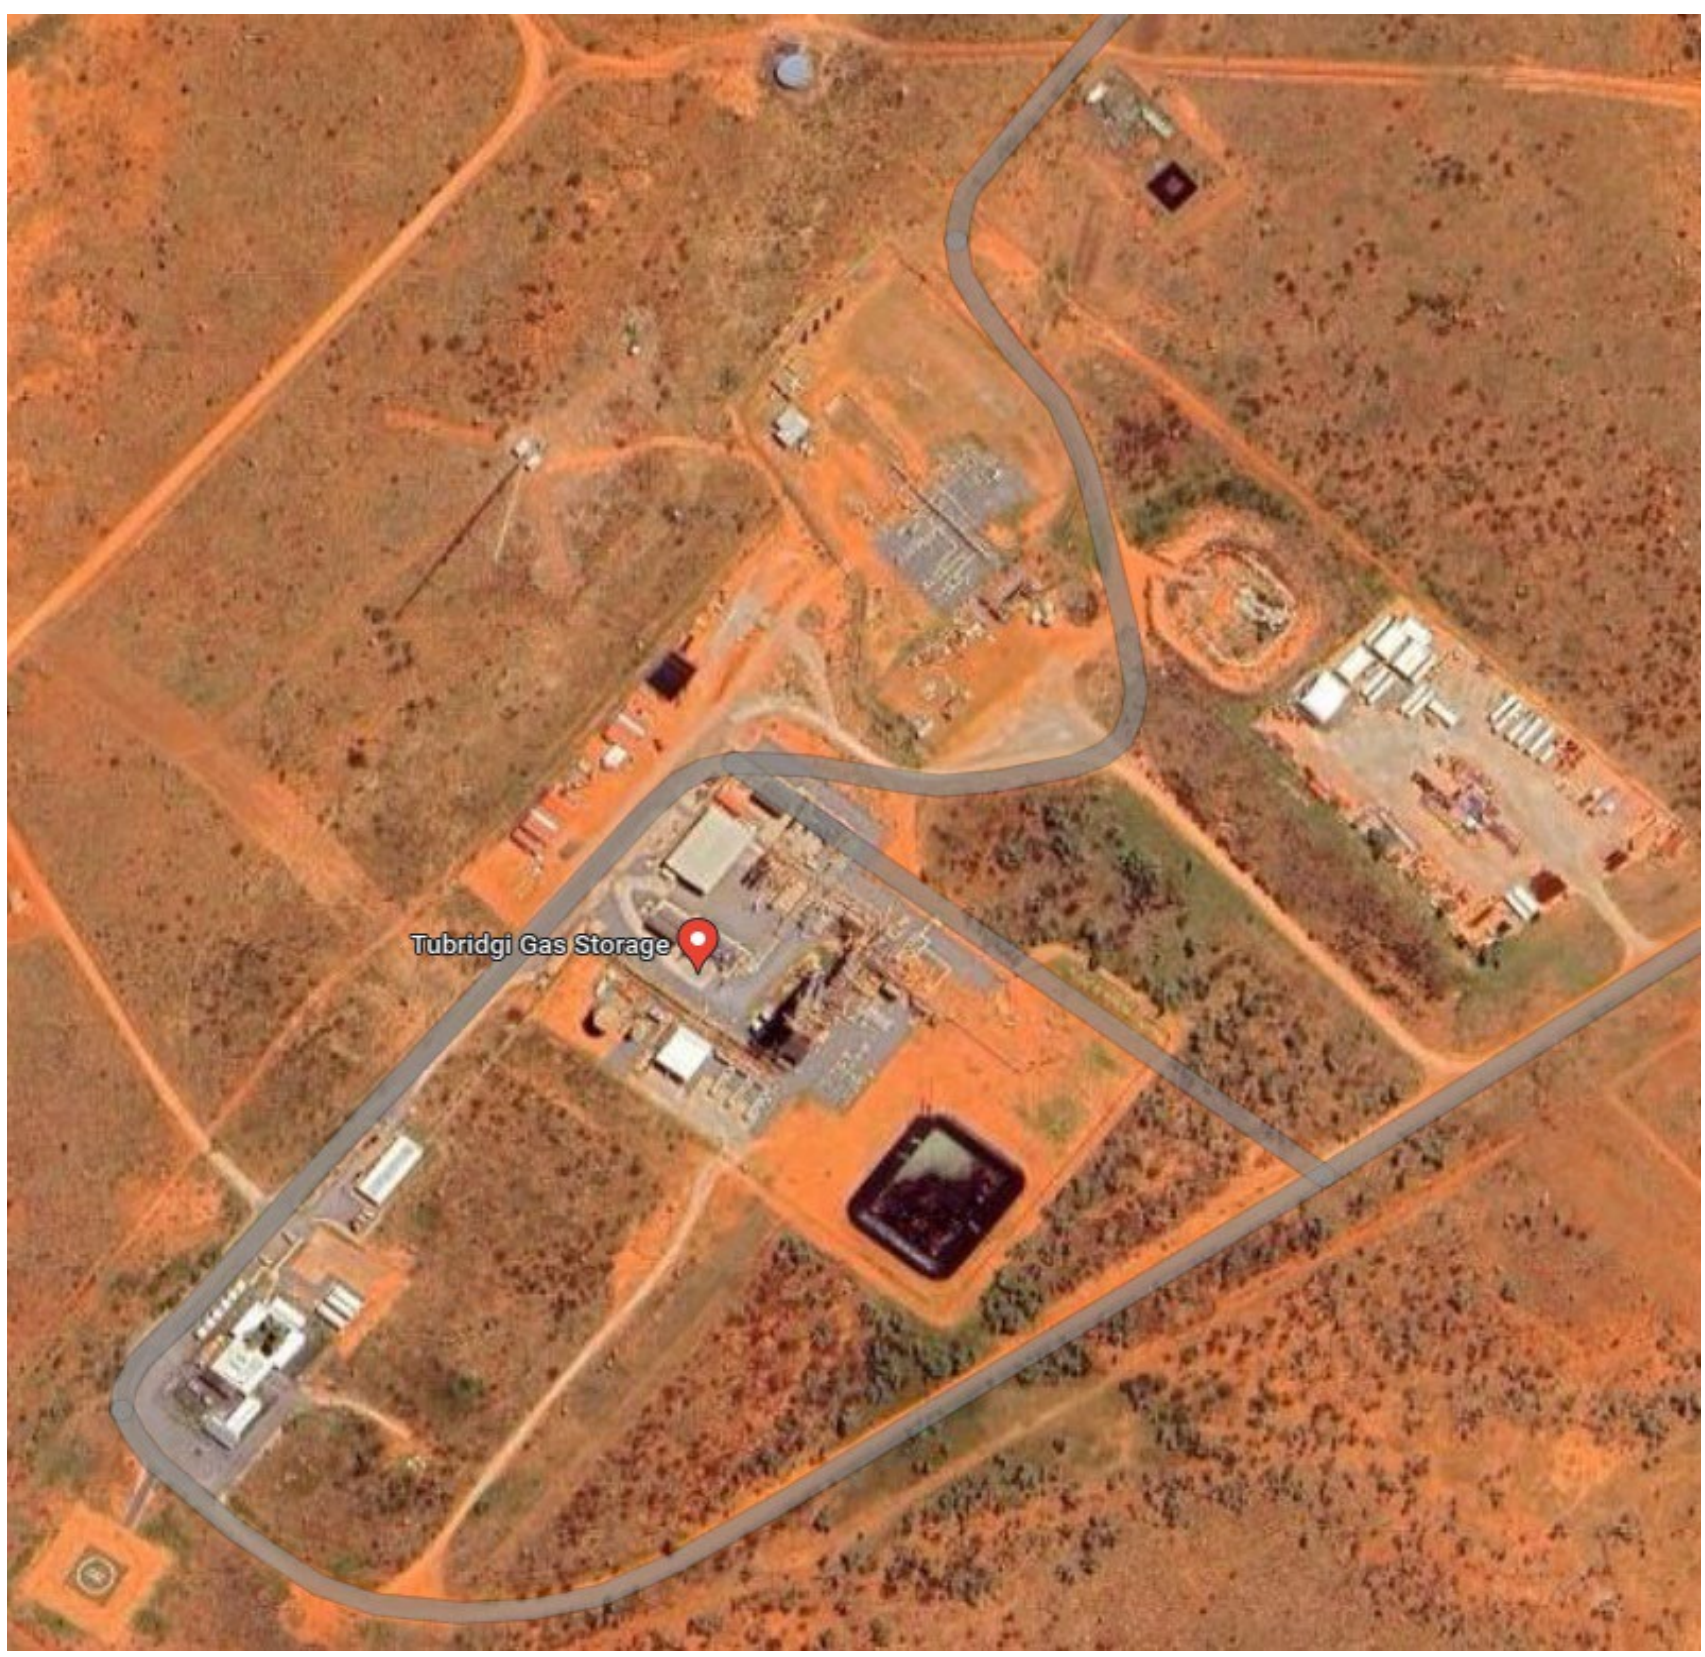
TGS-9	4/04/2024	Platform for Mothballed Tank	Mothballed Equipment - If brought back online, assessment to be completed and modifications made to achieve compliance with AS1567.				Mothballed Equipment - Pending assessment if brought back online.	 			
TGS-10	4/04/2024	Access to Risers / Vents (North Side of Plant)	1) Access to Risers and Vents for maintenance tasks currently completed using a platform ladder on blue metal. This creates the potential for the ladder to be unstable and cause a fall from height.	B. Remote	3. Severe	Medium	1) Option A: Install concrete landing for platform ladder to be set up on. Option B: Install a purpose built platform and access stairs or ladder that is AS compliant.	 			
TGS-11	4/04/2024	Platform adjacent to XV-7048. Also means of access over pipework.	2) A drop bar has been installed for both ladders. A self closing gate is required by AS1567. 3) No landing at the base of both ladders. 4) No hi vis anti-slip tread installed on ladder rungs.	C. Unlikely	3. Severe	Medium	1) Replace the drop bar with a self closing gate at the top of each ladder. 2) Modify the ladder to meet step up requirements. 3) Pour a landing at the base of both ladders. 4) Install hi vis (yellow) anti-slip tread on all ladder rungs.

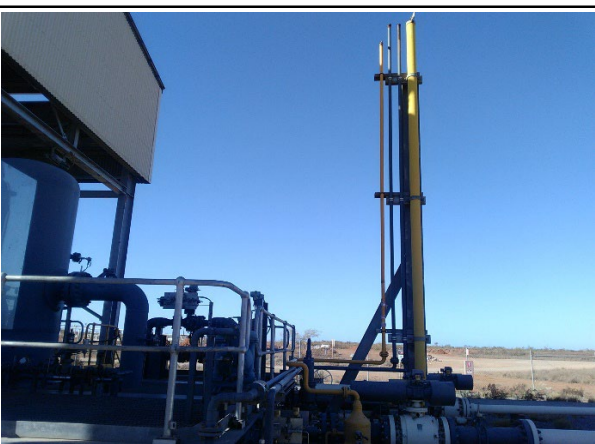
TGS-12	4/04/2024	Multiple Risers / Vents adjacent to K163 Compressor	1) No means of access identified. Confirm means of access with TGS OPS.	C. Unlikely	3. Severe	Medium	1) Option A: Install concrete landing for platform ladder to be set up on. Option B: Install a purpose built platform and access stairs or ladder that is AS compliant.

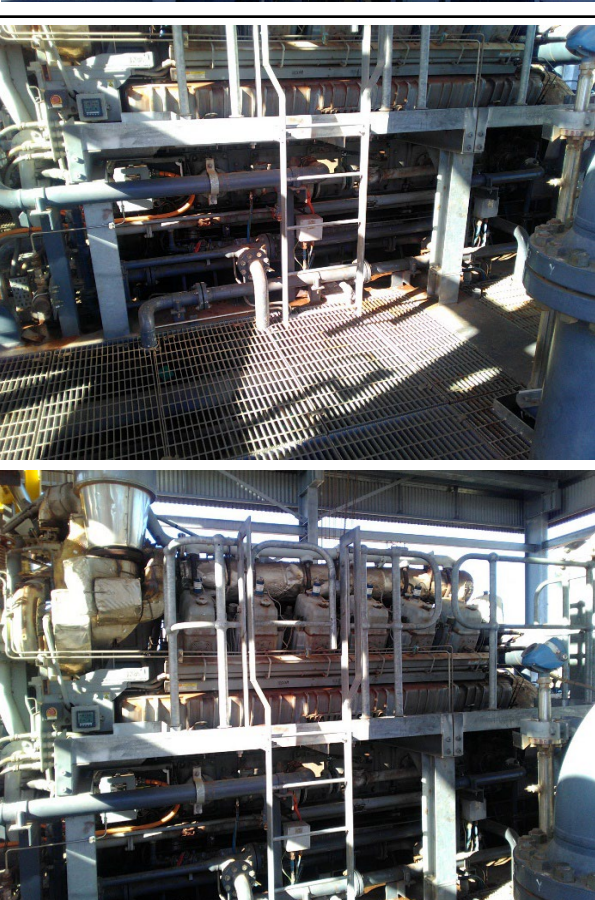
TGS-13	4/04/2024	K163 Compressor - Motor Access Platform x 2	1) No hi vis anti-slip tread installed on ladder rungs.	B. Remote	2. Minor	Low	1) Install hi vis (yellow) anti slip tread onto all ladder rungs.

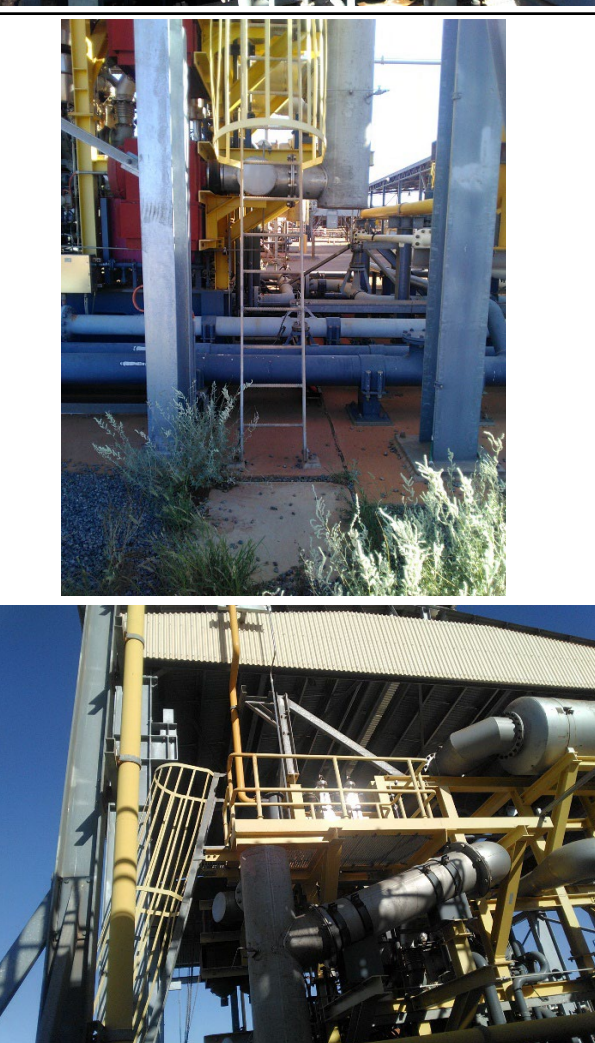
TGS-14	4/04/2024	K163 Compressor - Access Ladder and Platform for Oil Tank (7)	1) Landing does not meet AS requirement of 900mm. Gap between existing concrete also identified. 2) No hi vis anti-slip tread installed on ladder rungs.	C. Unlikely	2. Minor	Medium	1) Pour a new landing. 2) Install hi vis (yellow) anti slip tread onto all ladder rungs.

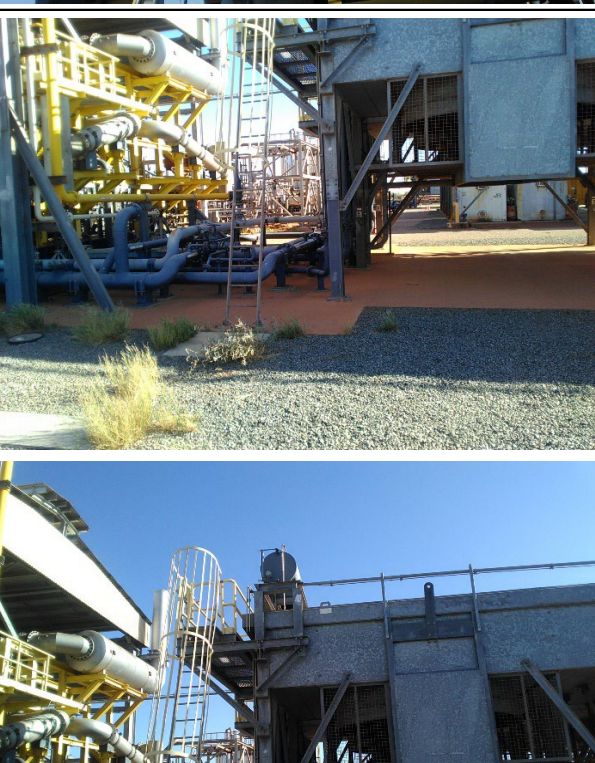
TGS-15	4/04/2024	K163 After Cooler Fans - North Platform	1) Landing does not meet AS requirement of 900mm. 2) No hi vis anti-slip tread installed on ladder rungs (400mm width).	C. Unlikely	2. Minor	Medium	1) Pour a new landing. 2) Install hi vis (yellow) anti slip tread onto all ladder rungs.

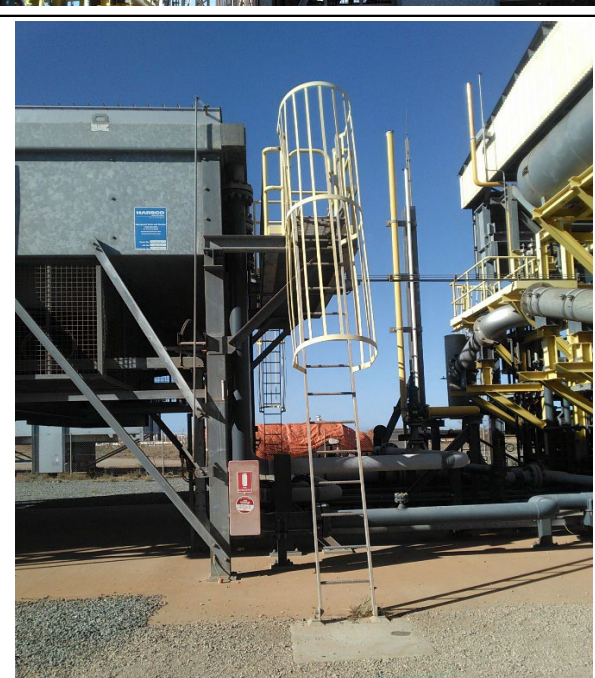
TGS-16	4/04/2024	K163 After Cooler Fans - South Platform	1) Landing does not meet AS requirement of 900mm. 2) No hi vis anti-slip tread installed on ladder rungs (400mm width).	C. Unlikely	2. Minor	Medium	1) Pour a new landing. 2) Install hi vis (yellow) anti slip tread onto all ladder rungs.

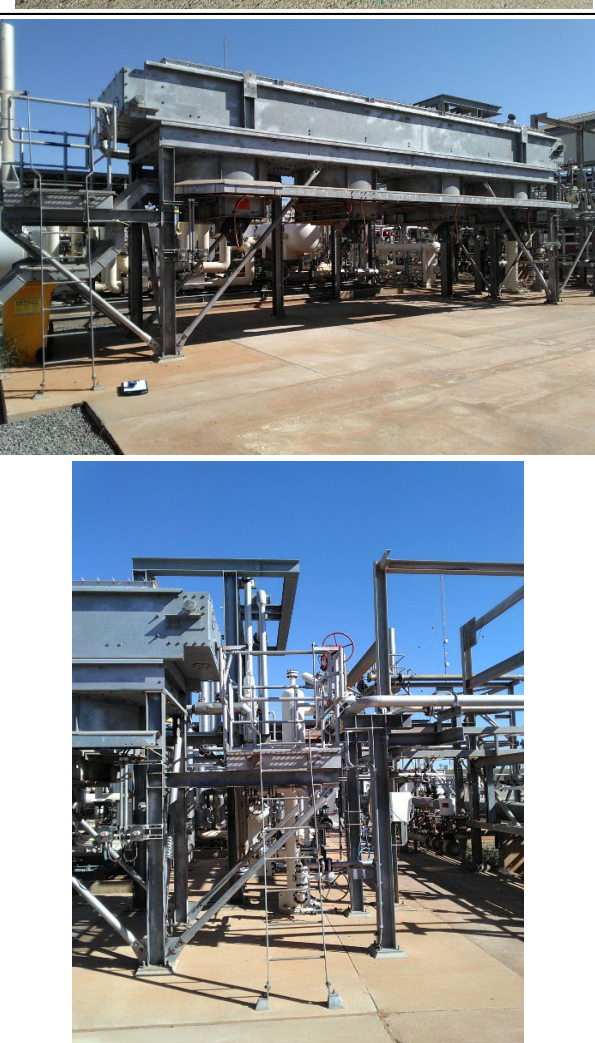
TGS-17	4/04/2024	After Cooler Fans - 2 x Ladders and Platforms adjacent to Workshop	1) Landing does not meet AS requirement of 900mm. 2) No hi vis anti-slip tread installed on ladder rungs.	C. Unlikely	2. Minor	Medium	1) Pour a new landing. 2) Install hi vis (yellow) anti slip tread onto all ladder rungs.
