Revised Final Plan
Attachment 9.12

Structures & Operational Sites - Working at Heights - Appendix B

**Dampier Bunbury
Pipeline**

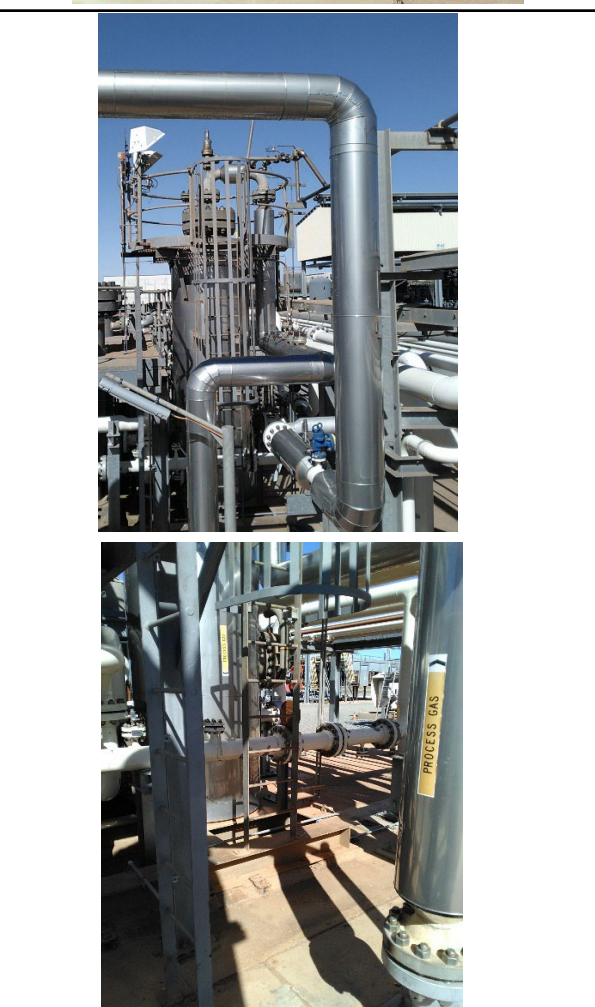
TGS-18	4/04/2024	Process Gas Pipework and Vessel - Ladder and Top Platform	1) A drop bar has been installed at the top of the ladder. A self closing gate is required by AS1657. 2) The ladder does not run to the concrete landing and there the step up to the first ladder rung exceeds AS1657 requirement of <=150mm). 3) No hi vis anti-slip tread installed on ladder rungs.	C. Unlikely	3. Severe	Medium	1) Replace the drop bar with a self closing gate at the top of the ladder. 2) Option A: Modify or replace the ladder, so it runs the full length to the landing, ensuring the step up requirements are also met. Option B: Install a step(s) and landing that is flush with the ladder, to ensure the step up and handrail requirements are met, where applicable). 3) Install hi vis (yellow) anti-slip tread on all ladder rungs.

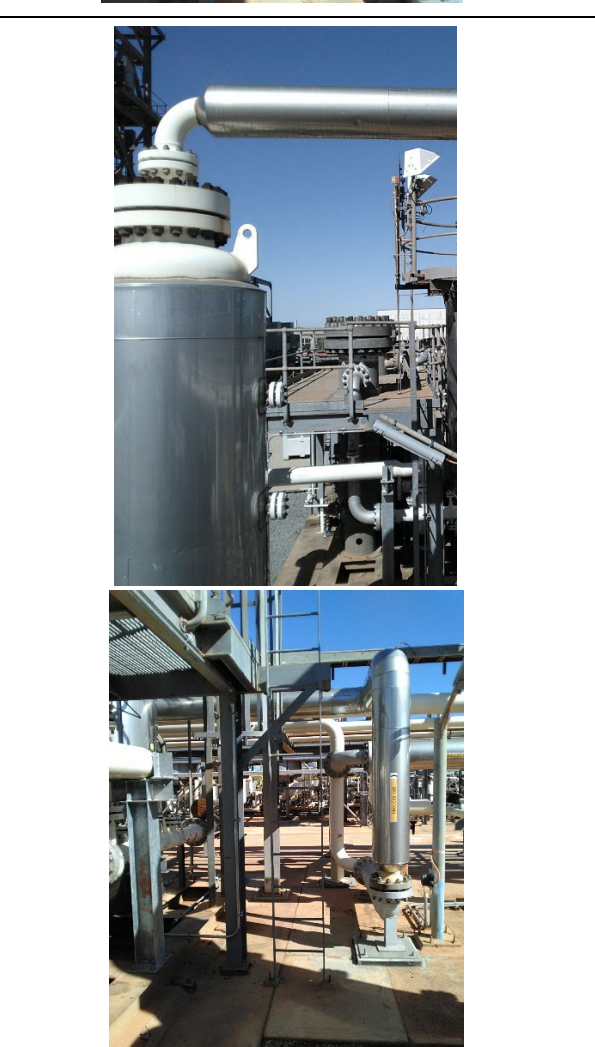
TGS-19	4/04/2024	Process Gas Pipework and Flange - Ladder and Middle Platform	1) A drop bar has been installed for both ladders. A self closing gate is required by AS1657. 2) The step up from ground level to the first ladder rung exceeds AS1657 requirement of <=150mm). 3) Landing does not meet AS requirement of 900mm. Existing landing is uneven surface as well. 4) No hi vis anti-slip tread installed on ladder rungs.	C. Unlikely	3. Severe	Medium	1) Replace the drop bar with a self closing gate at the top of each ladder. 2) Modify the ladder to meet step up requirements. 3) Pour or modify the existing landing to meet AS1657 requirements. 4) Install hi vis (yellow) anti-slip tread on all ladder rungs.
